ARBORIST REPORT

Port Street Condo

42 Port Street E.
91-93 & 99
Lakeshore Road E.
Port Credit, Mississauga, Ontario

December 2, 2022

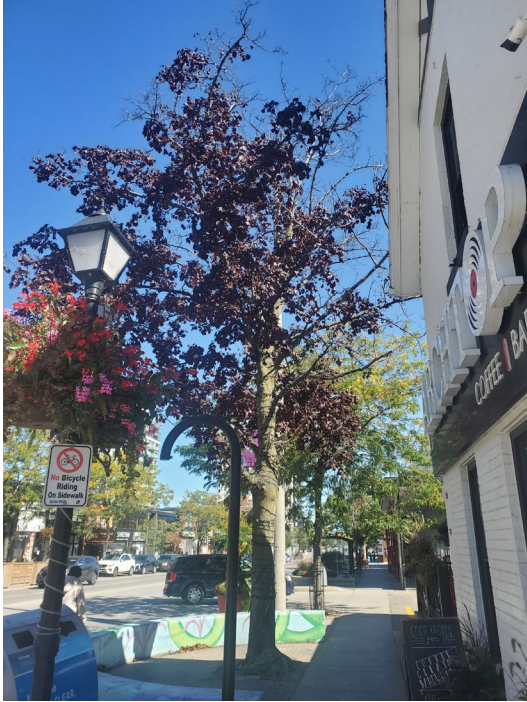
Species	dbh (cm)	Canopy diameter (m)	Biological Health	Structural Condition	Recommended Action	Comments	Location
1	Acer platanoides 'Crimson King' (Crimson King Norway Maple)	39	8	ML	ML	P	Girdling roots, wounds on surface roots, crack on main union, lights on trunk, 8 large dead branches, leader dead, and canopy 50% dead.	M
2	Gleditsia triacanthos (Honey Locust)	22.5	7	M	M	P	Trunk guard, girdling root, lights on trunk, and crossing branches.	M
3	-	-	-	-	-	-	Tree does not exist	M
4	-	-	-	-	-	-	Tree does not exist	M
5	Acer platanoides (Norway Maple)	23	3	L	L	P	Canopy 75% dead, backfilled, many cracks, lights on trunk.	M
6	-	-	-	-	-	-	Tree does not exist	M
7	Gleditsia triacanthos (Honey Locust)	27	10	M	ML	RC	Trunk guard girdling base of tree, girdling roots, multi-branch node, Medium-sized dead branches in middle of canopy.	M
8	Acer platanoides (Norway Maple)	47.5	10	M	M	RC	2 large dead limbs, tight union, crack from 0.5-3m ht., wound from growing against building	SP

Figure 3: Tree 1 along Lakeshore Blvd.

- a. **Preserve trees 1, 2, 5 and 7 on the municipal boulevard** from construction as identified on the Tree Inventory & Preservation Plan. Trees 1, 2, and 5 should be enclosed within high-visibility framed tree protection hoarding (See figure 9 for details and Tree Inventory & Preservation Plan for locations).

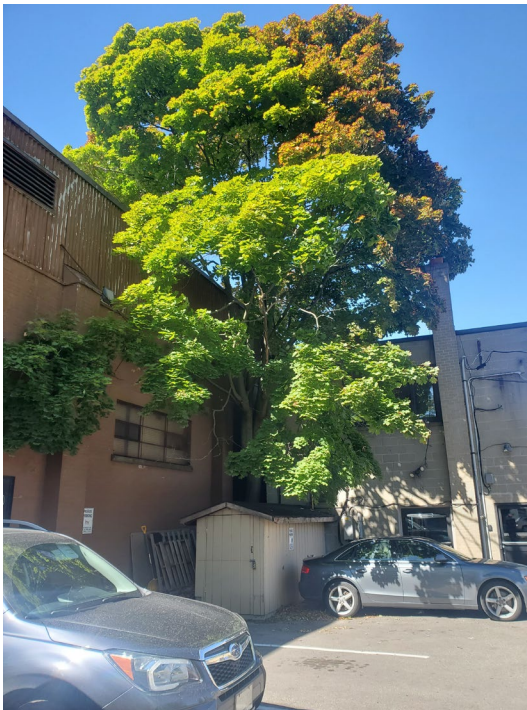
Figure 5: Tree 8 in courtyard at east side of property.

- a. **Remove trees 8, 9, and 12-18 on private property for construction** as identified on the Tree Inventory & Preservation Plan.
- b. **Remove trees 10 and 11 on the municipal boulevard for construction** as identified on the Tree Inventory & Preservation Plan.

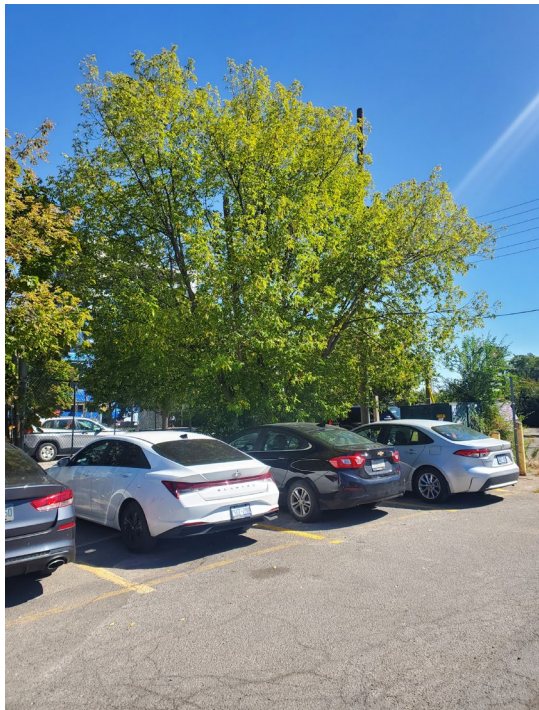
11	Acer platanoides (Norway Maple 'fastigiate')	30	7	ML	M	RC	1 large dead branch, backfilled, multiple crack at base to 2.5m height	M
12	Acer negundo (Manitoba Maple)	26.5, 14, 15, 16	10	M	M	RC	Multiple leaders, grown around electrical pole, smaller leaders lean 70° southwest	SP
13	Juglans nigra (Black Walnut)	20, 5, 17	6	M	M	RC	Co-dominant leaders from base	SP
14	Juglans nigra (Black Walnut)	28.5, 17.5, 20	8	M	M	RC	Barbed wire stuck along trunk, 3L, 1 leader broken (mid sized), 2nd leader leans 20° northeast (smallest), 1 medium sized broken branch at top, included bark between leaders	SP
15	Acer negundo (Manitoba Maple)	15, 17.5	6	M	L	RC	Large wound at main union, with fence injury & pruned limbs, concrete piled up to base of tree	SP
16	Acer negundo (Manitoba Maple)	20x4 trunks	6	L	L	RC	Multiple leaders & dead leans southwest, some small branches remain alive	SP
17	Ulmus pumila (Siberian Elm)	48.5, 57.5	10	M	ML	RC	3 trunks but middle dead Northwest trunk leans 35°, southeast trunk leans 60° southeast, and 10 dead or broken medium-sized branches.	SP

Figure 6: Tree 12 along fence line in middle of site.

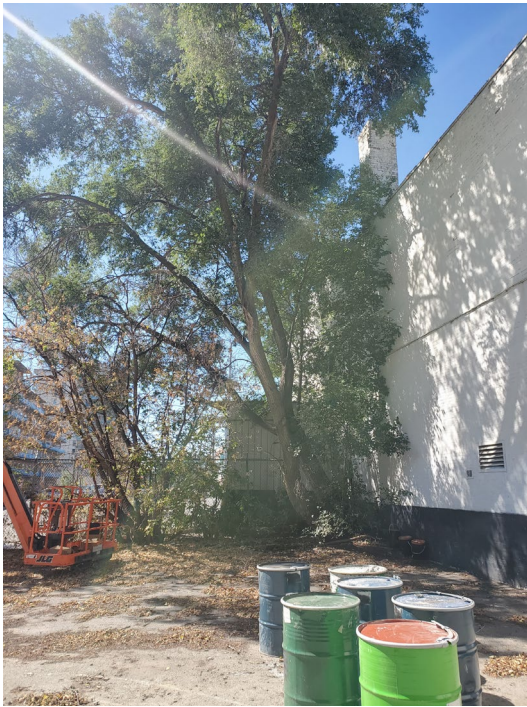
Figure 7. Tree 17 within derelict property.

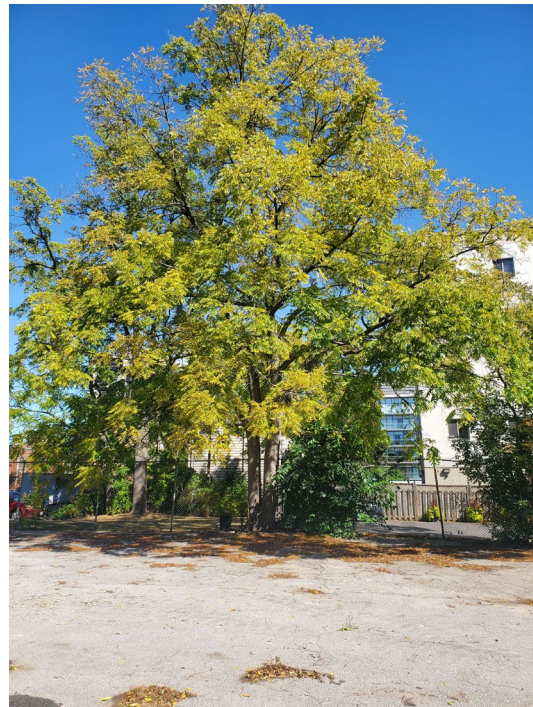
9	Juglans nigra (Black Walnut)	43,48	15	M	M	RC	2L, asphalt up to base of tree, Crack in large trunk 2m-4m ht., 8 medium-large branches dead	SP
10	Acer platanoides (Norway Maple 'fastigate')	22.5	5	ML	ML	RC	Crack at base to 1.5m ht., Canopy 30% dead, 2 large pruned limbs & a large dead branch stub, backfilled	M

Figure 8. Tree 9 along east boundary.
