ARBORIST REPORT & TREE PROTECTION PLAN

DIXIE MALL

1250 South Service Road
Mississauga L5E 1V4

Date: October 21, 2020

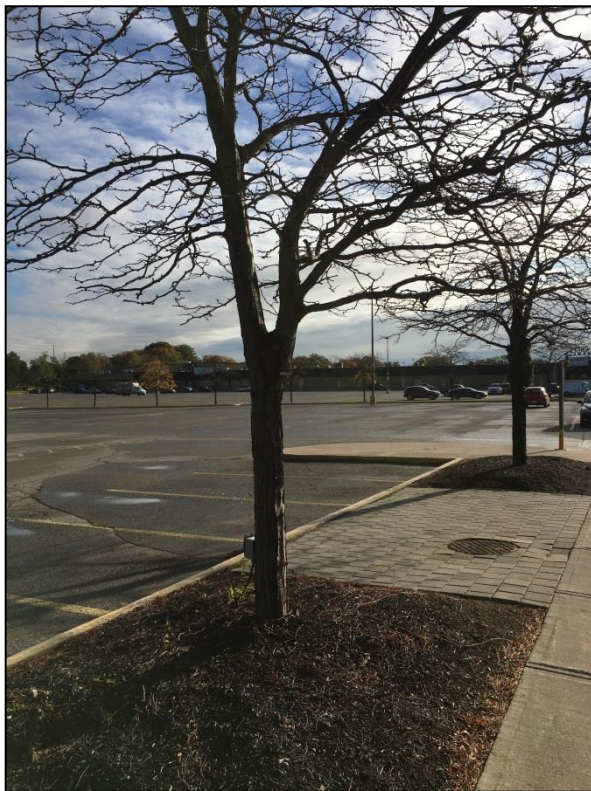
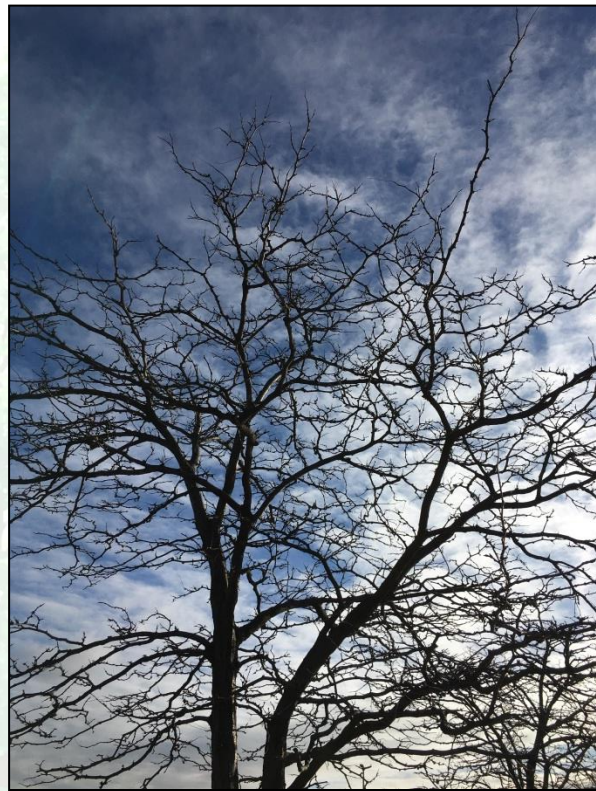
Tree #155 – Honey Locust (20cm dia. DBH) – REMOVAL PERMIT REQUIRED

Tree #155, a 20cm dia. Honey Locust (*Gleditsia tricanthos*) is a privately-owned deciduous tree growing on the west portion of the subject site.

Due to the condition of this tree and the proposed construction, my client will require permission to remove this tree. As a result of the removal of this tree, my client is required to plant one (1) deciduous trees of 6cm diameter or greater, or one (1) evergreen tree that is 1.8m tall or larger, as compensation. The species and planting location will be determined during the landscape design phase of the project. An application to remove this tree will have to be submitted to Mississauga Urban Forestry.
