**LAKESHORE TRANSPORTATION STUDIES -  
NEW CREDIT RIVER ACTIVE TRANSPORTATION (AT) BRIDGE STUDY  
FLUVIAL GEOMORPHOLOGY ASSESSMENT REPORT  
MISSISSAUGA, ONTARIO**

Prepared for:  
**HDR CORPORATION**

Prepared by:  
**MATRIX SOLUTIONS INC.**

Version 2.0  
January 2023  
Mississauga, Ontario

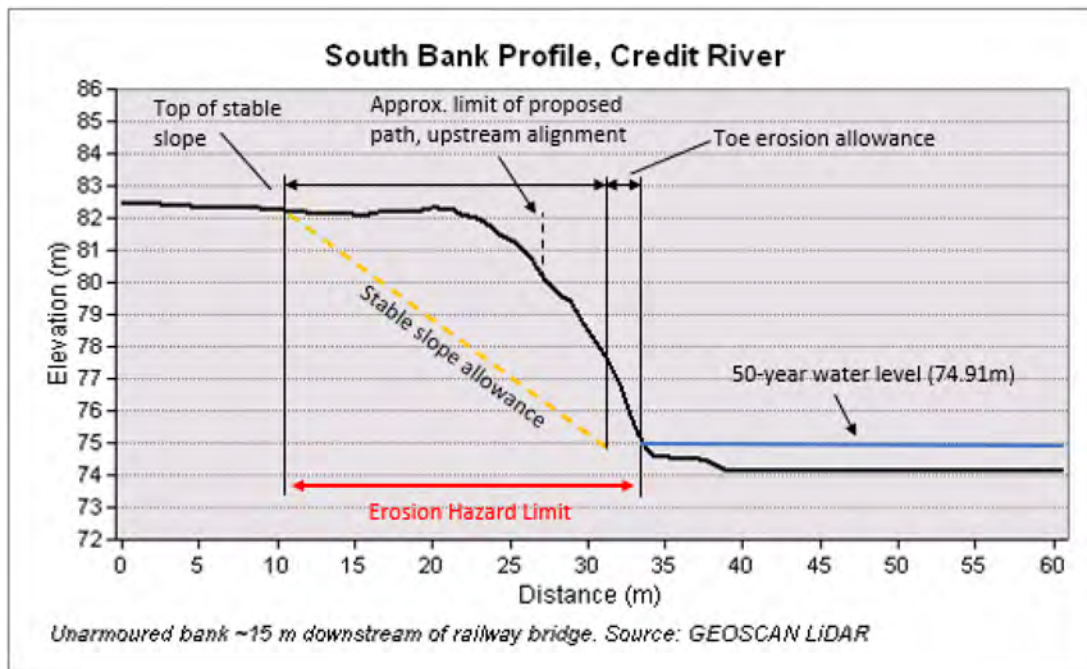
**FIGURE G Local Erosion Hazard of Unarmoured South Riverbank ~15 m Downstream of Train Bridge**

3 m high segment at the bottom and a gentler (>3:1) slope above. Evidence of erosion was observed on the lower 2 to 3 m bank face. The local erosion risk hazard limits were calculated to reflect the change in slope and profile. Sample calculations for the area at the train bridge are provided in Equations 1 and 2.

Local erosion hazard limit allowance	= stable slope allowance + toe erosion allowance
	= 21 m + 2 m
	= 23 m

The local erosion hazard limit ranged from 8 to 23 m from the toe of bank. Figure G presents the south bank profile and a schematic depiction of the local erosion hazard limit at a section near the rail bridge. Figure H presents a plan view of the extent of the unprotected bank and the local erosion hazard limits. As part of the detailed design for the AT bridge crossing, a detailed geotechnical study is recommended for this location to confirm or refine the erosion hazard limit and to inform the design and construction of the bridge abutment foundation, local grading, and potential erosion control works.

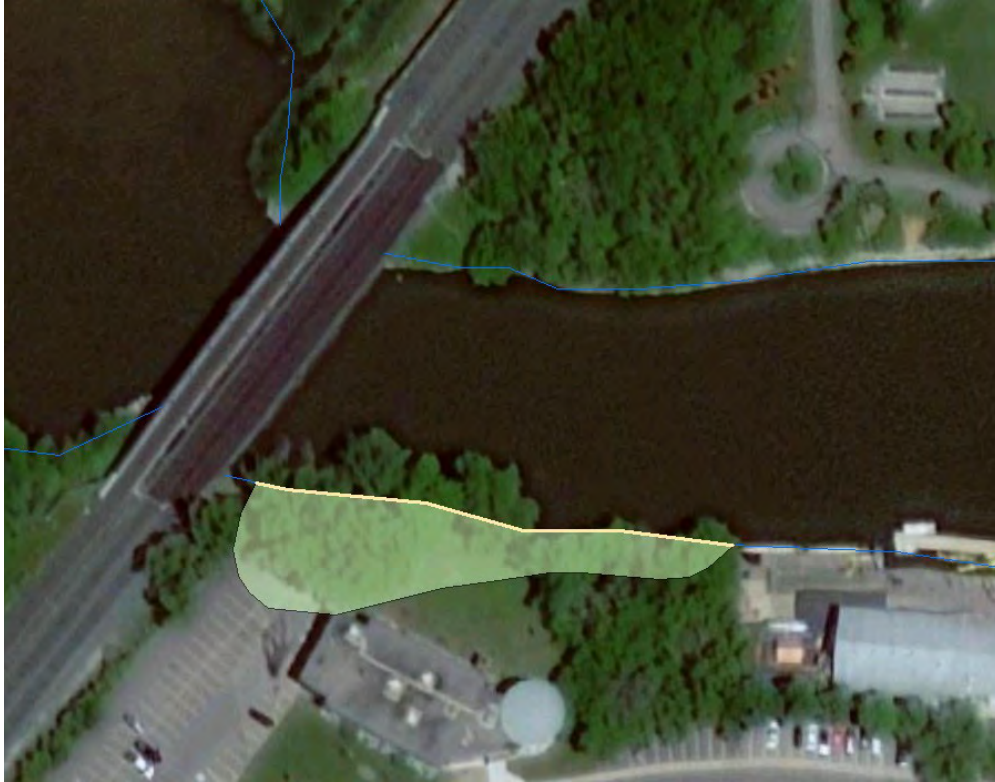
**FIGURE H Local Erosion Hazard Limits and Extent of Unarmoured Portion of the South Riverbank**

Local erosion risk can still exist in this context for areas hydraulically impacted by existing crossings, particularly if banks are not armoured. Based on the field assessment, the south bank immediately downstream of the train bridge lacks bank protection. To estimate a local erosion hazard limit for the unprotected portion of the south bank, a procedure adapted from the Ontario Ministry of Natural Resources *Technical Guide - River and Stream Systems: Flooding Hazard Limit* (currently the Ontario Ministry of Northern Development, Mines, Natural Resources and Forestry; MNR 2002) for confined watercourses was used for this study. The local erosion limit was defined by a 3:1 stable slope allowance plus a toe erosion allowance. For this location, a 2 m toe erosion allowance is recommended as a reasonable setback in the context of the low-energy reach and surrounding artificial bank structures (Table 3 of MNR [2002]). Although evidence of bank instability was noted at this location, the local bank conditions were not classified as “actively eroding,” again based on the low energy in the reach and lack of channel change observed over the historic period (Section 2.2.4).

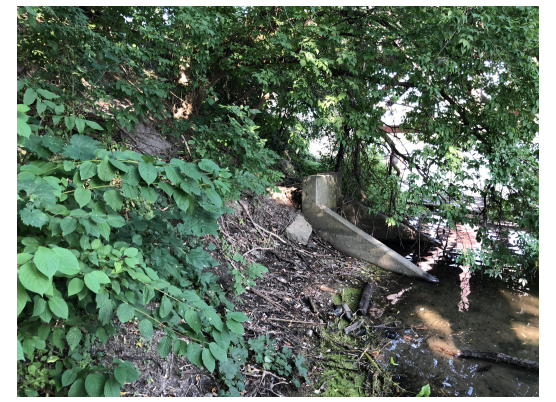
**South bank - outfall**

-Existing outfall located <5 m upstream of proposed south bridge abutment

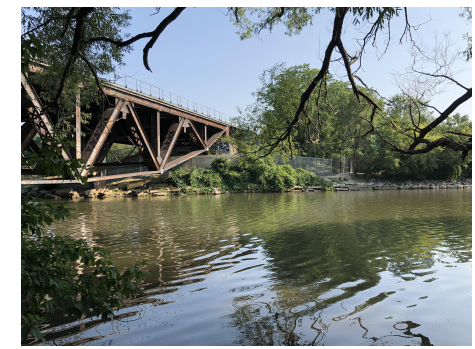
**North bank**

-Bank is approximately 2-3 m high  
 -Bank is protected with boulders and armourstone  
 -Floodplain is forested

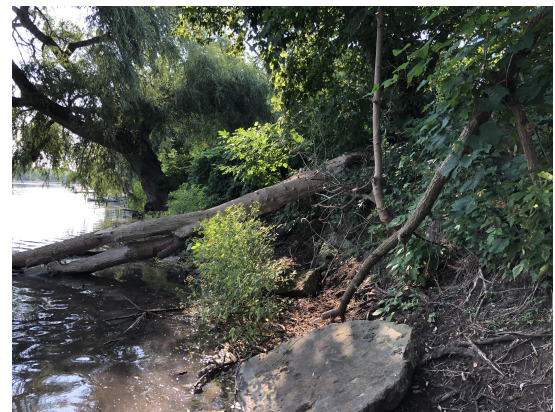
**South bank**

-Bank height is up to 7 m near train embankment  
 -Not protected or armoured (occasional concrete pieces present at toe)  
 -Evidence of erosion observed  
 -Forested, tree roots provide some stability  
 -Composed of soil and fill

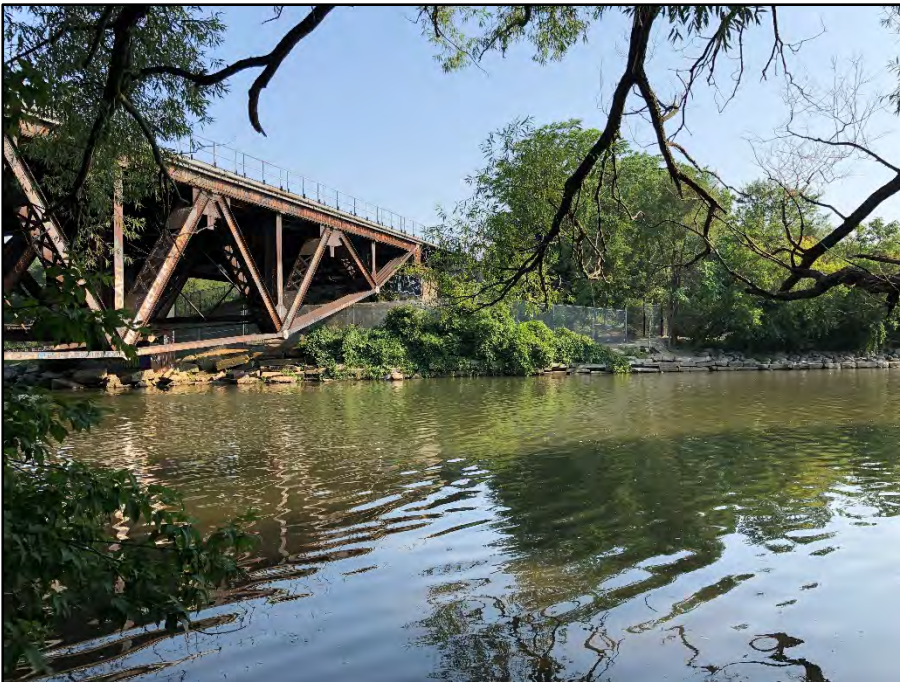
1. North bank downstream of railway bridge. Floodplain is forested and bank is armoured.

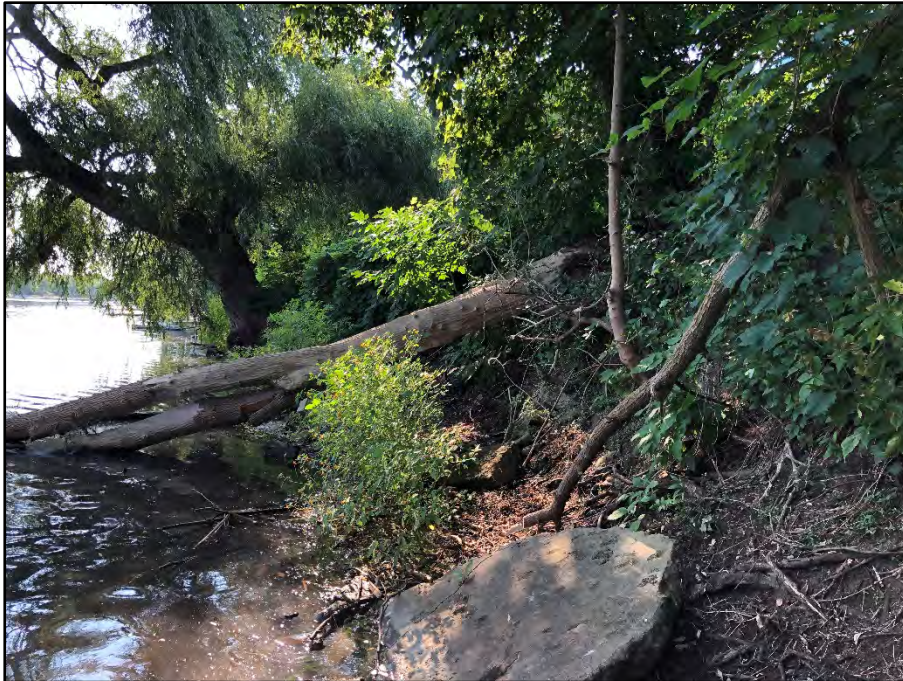
3. South bank in vicinity of proposed Active Transport Bridge (ATB) - bank is forested, lacks consistent bank protection (occasional concrete pieces at toe) and some evidence of erosion was observed.

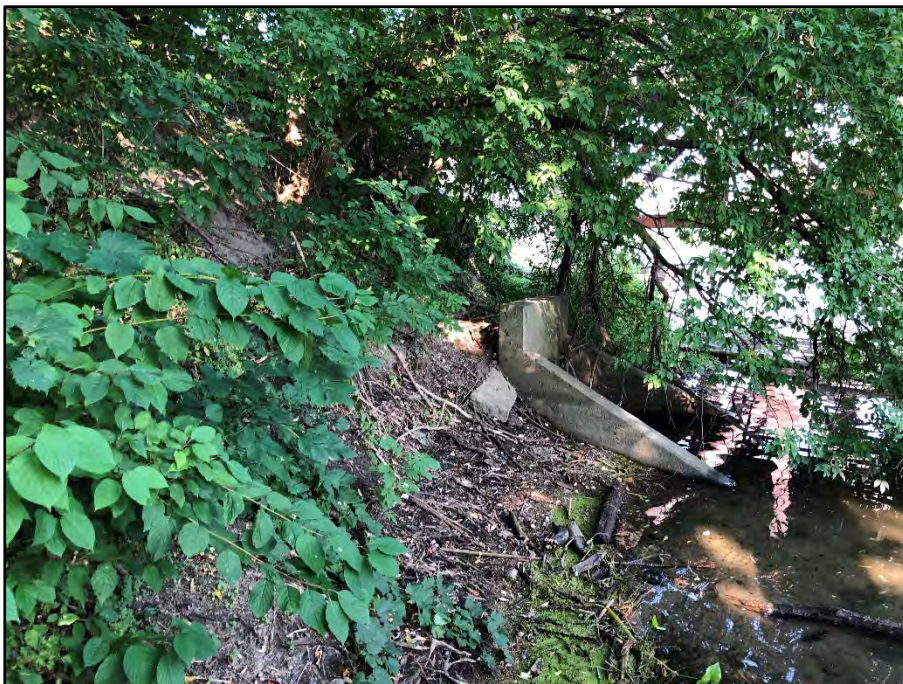
4. South bank in vicinity of proposed ATB - outfall several meters upstream of proposed ATB.

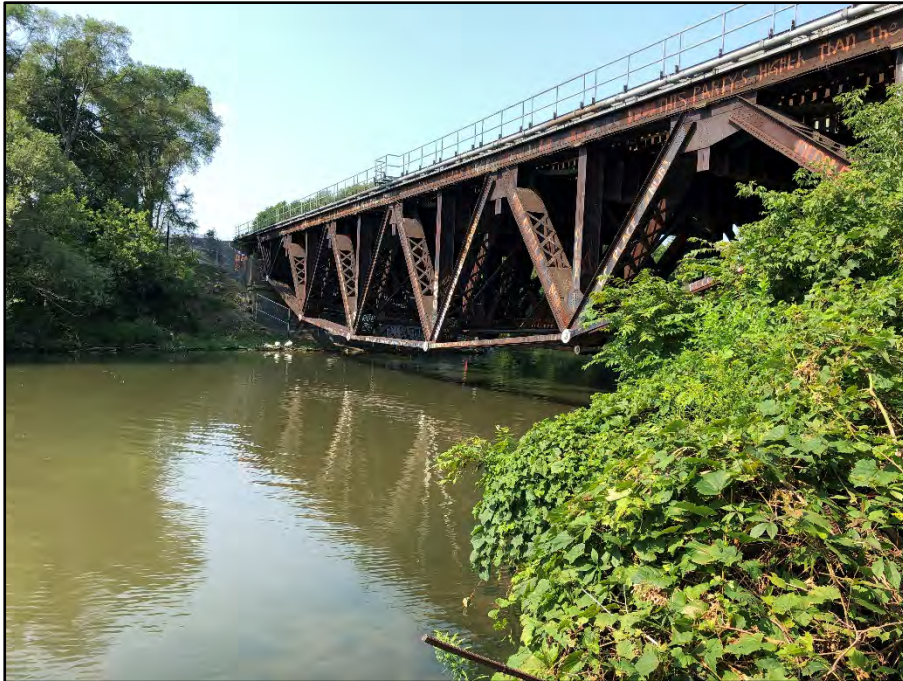
5. Railway Bridge – Looking toward the south bank. South bank near railway bridge is approximately 7 m high, lacks bank protection.

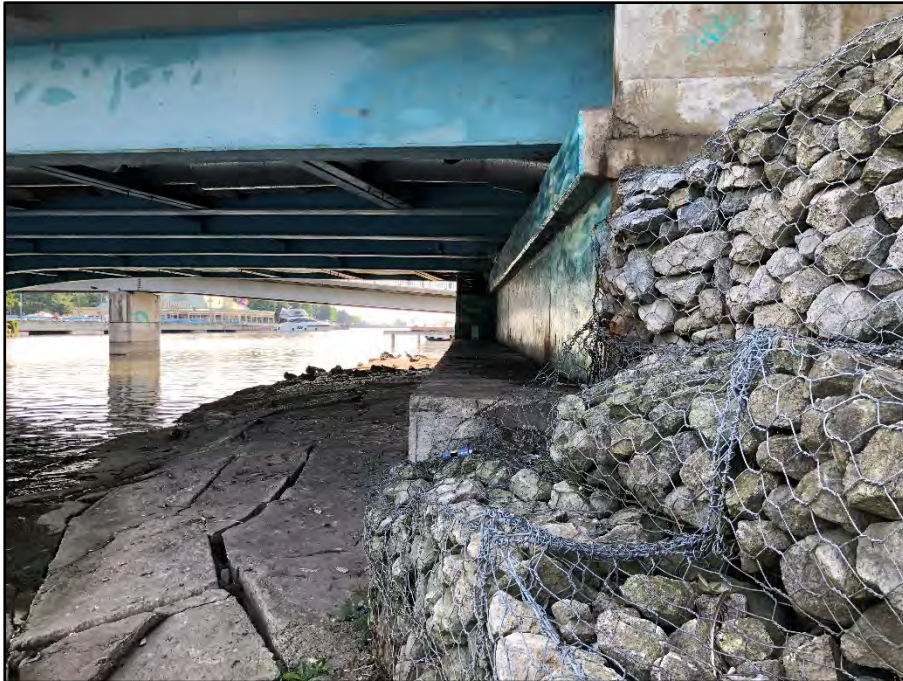
7. Lakeshore Road Bridge – bridge footing and gabion cages on the south bank.
