**Tree Inventory and Preservation Plan Report
7198 – 7214 Airport Road and 5 – 9 Beverley Street
Mississauga, Ontario**

22 December 2021

KUNTZ FORESTRY CONSULTING Inc. Project P3092

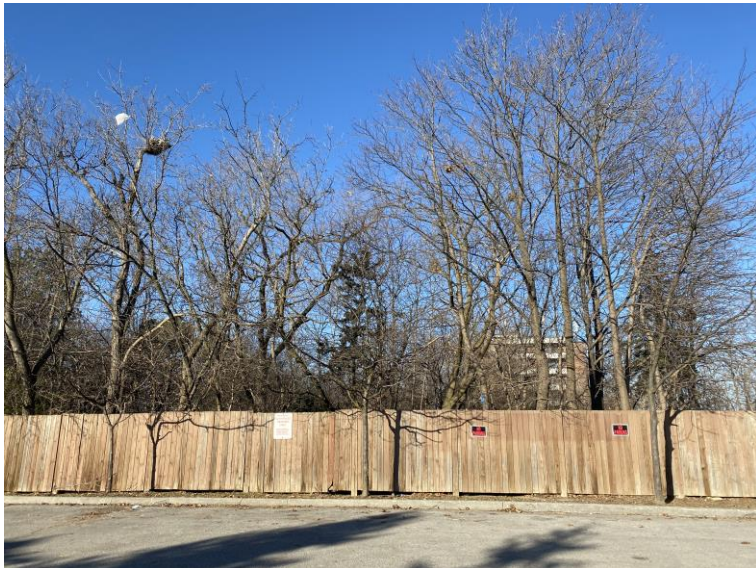
Image 1. Trees 188 (right) and 189 (centre)

Encroachment into the driplines and mTPZs of Trees 188 – 191, I, N, S, and T is required for the removal of the existing asphalt and the construction of the proposed parking area. Given that there is existing asphalt within the mTPZs of these trees, it is anticipated that few roots extend into these areas. Tree protection fencing has been prescribed at the edge of the existing surface parking area. If the following mitigation measures are followed, long-term adverse effects are not anticipated for these trees.

1. Prior to the proposed demolition, tree protection fencing should be installed as indicated on Figure 1.
2. The existing asphalt must be removed carefully using small machinery (i.e. a bobcat).
3. No machinery use will be allowed within the mTPZs of Trees 188 – 191, I, N, S, and T after the removal of the asphalt to minimize the impacts on the trees.
4. The existing granular base should be used for the proposed surface parking area.
5. If roots are encountered in the subsurface material, they are to be left intact.
6. Tree protection fencing must be maintained throughout the construction.
7. Branches that extend into the proposed development and require pruning must be pruned by a Certified Arborist or other tree professional in accordance with Good Arboricultural Standards.

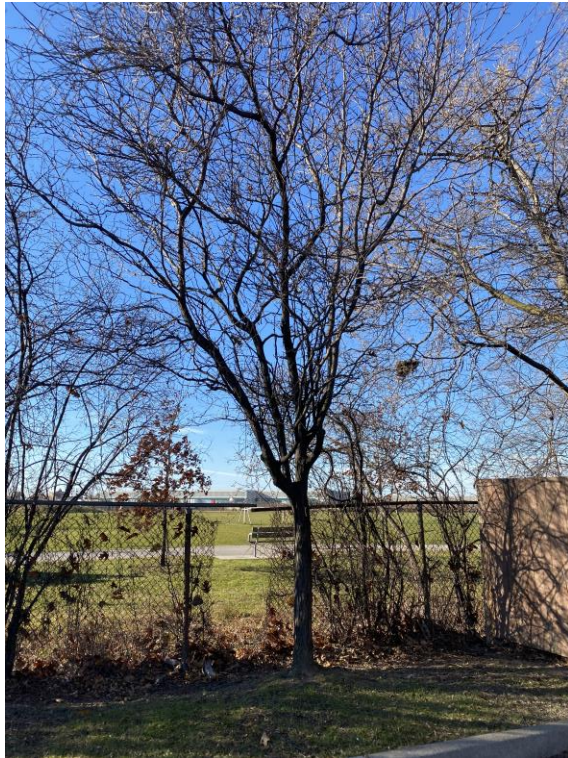
Image 3. Tree 192

The removal of 15 trees is required to accommodate the proposed development. The required tree removals include Trees 192 – 200 and 641 – 646. All trees identified for removal are located on the subject site. Trees 192 – 200, 641, 643, and 644 and are greater than or equal to 15cm DBH. Trees noted as dead on Figure 1 should also be removed.

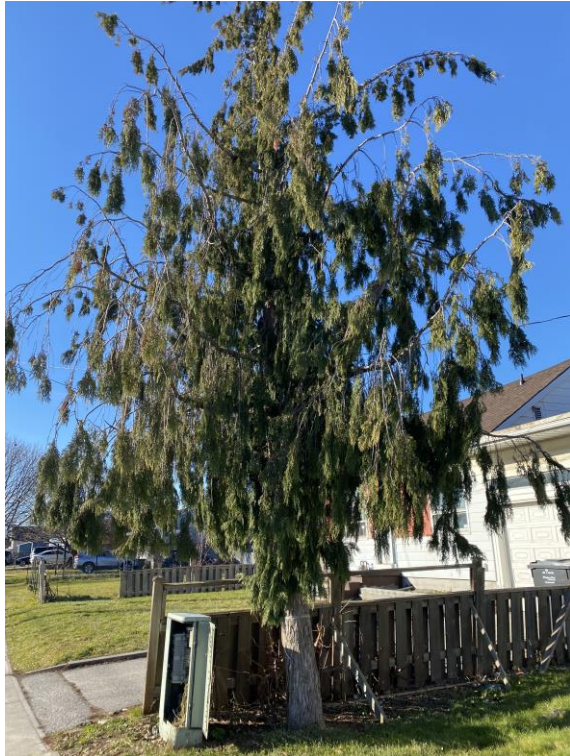
Image 13. Tree 647

Encroachment into the dripline and mTPZ of Tree 647 is required to facilitate the removal of the existing driveway. Tree protection fencing has been prescribed at the limit of the mTPZ for Tree 647. The tree protection fencing may be adjusted to facilitate the removal of the existing driveway; however, it must be reinstalled as shown on Figure 1 once the driveway removal is complete. Any softscaping required within the mTPZ of Tree 647 must occur by hand. Branches that extend into the proposed development and require pruning must be pruned by a Certified Arborist or other tree professional in accordance with Good Arboricultural Standards.
