**Tree Inventory and Preservation Plan Report
2105, 2087, 2097, and 2077 Royal Windsor Drive
Mississauga, Ontario**

**DARC submission: 22-226 W2
(Temporary) EPlans Number: OPZR-91934**

KUNTZ FORESTRY CONSULTING Inc. Project P3438

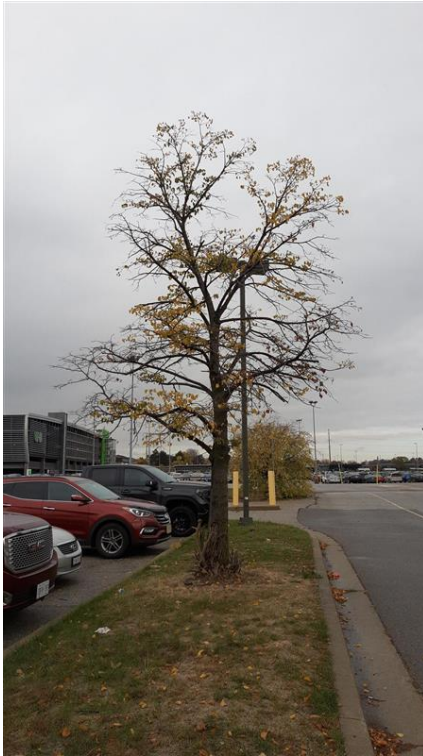
Tree 671

Tree #	Common Name	Scientific Name	DBH	TI	CS	CV	CDB	DL	mTPZ	Ownership	DL in SP	Comments	Action	Comp.
671	Little Lead Linden	<i>Tilia cordata</i>	24	F/P	G/F	F		2.5	1.8	Private		Trunk injury (H), epicormic branching (H), poor vigor (L)	Remove	2
672	Little Lead Linden	<i>Tilia cordata</i>	24	F/P	G/F	F		2.5	1.8	Private		Epicormic branching (M), asymmetrical crown (L), poor vigor (L)	Remove	2
673	Little Lead Linden	<i>Tilia cordata</i>	20	-	-	-	-	-	-	Private	-	Dead.	Remove (condition)	2
674	Little Lead Linden	<i>Tilia cordata</i>	21	F/P	F	F		2	1.8	Private		Leaning south (M), asymmetrical crown (M), epicormic branching (H)	Remove	2
675	Norway Maple	<i>Acer platanoides</i>	16	P	P	P	70	2	1.8	Private		Cracks (H), poor form (H), trunk injury (H), crown dieback (H)	Remove	2
676	Norway Maple	<i>Acer platanoides</i>	23	G	G/F	G/F		3	1.8	Private		Asymmetrical crown (L), poor form (L)	Remove	2
677	Norway Maple	<i>Acer platanoides</i>	22	G/F	G/F	G		3	1.8	Private		Exposed roots (L), asymmetrical crown (L)	Remove	2

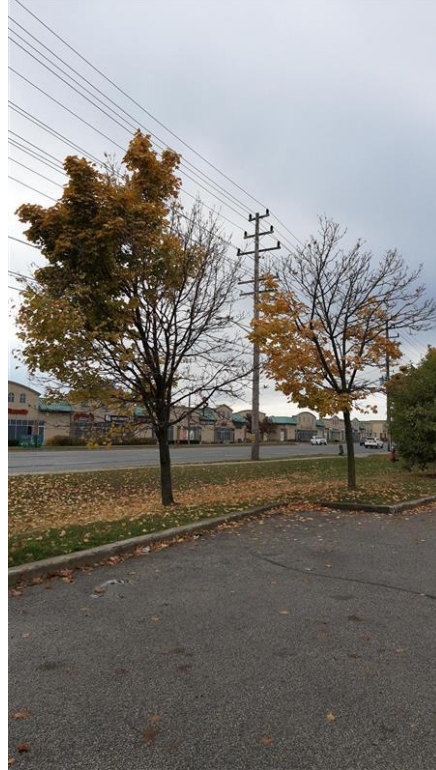
Trees 678-679 (left-right)

678	Norway Maple	<i>Acer platanoides</i>	23	G/F	G	G		3	1.8	Private		Exposed roots (L), root injury (L), leaning south (L)	Remove	2
679	Norway Maple	<i>Acer platanoides</i>	16	G	G	F	20	2.3	1.8	Private		Crown dieback (M)	Remove	2
680	White Spruce	<i>Picea glauca</i>	31.5	F	G/F	F		2	2.4	Private		Leaning south (L), exposed roots (L), trunk injury (L), poor vigor (L)	Remove	3
681	White Spruce	<i>Picea glauca</i>	23	G/F	G/F	G/F		2	1.8	Private		Trunk injury (L), pruning wounds (L), asymmetrical crown (L)	Remove	2
682	White Spruce	<i>Picea glauca</i>	18	F	F/P	F	20	1.5	1.8	Private		Leaning south (L), pruning wounds (L), crown dieback (L), poor form (M)	Remove	2
683	Norway Maple	<i>Acer platanoides</i>	25	F	G/F	G/F		3	1.8	Private		Exposed roots (L), root injury (L), leaning south (L)	Remove	2
684	Norway Maple	<i>Acer platanoides</i>	20	G/F	G	F/P	20	2.5	1.8	Private		Exposed roots (L), root injury (L), crown dieback (M)	Remove	2

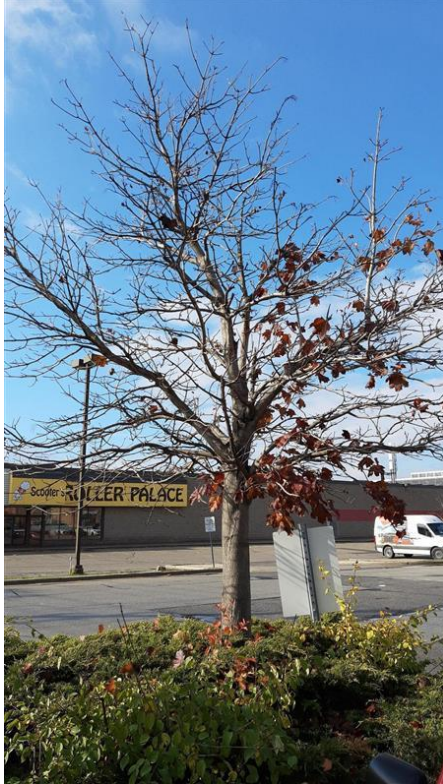
Tree 685

685	Norway Maple	<i>Acer platanoides</i>	19	G/F	G/F	F	10	1.5	1.8	Private		Crown dieback (L), cracks (L)	Remove	2
686	Austrian Pine	<i>Pinus nigra</i>	35	F	F	G		4	2.4	Private		Bowed (L), poor form (M), pruning wounds (L)	Remove	3
687	Austrian Pine	<i>Pinus nigra</i>	20	F	F	G		3.5	1.8	Private		Crook (L), poor form (M)	Remove	2
688	Austrian Pine	<i>Pinus nigra</i>	34	G/F	F	G		4	2.4	Private		Poor form (L), pruning wounds (L)	Remove	3
689	Norway Maple	<i>Acer platanoides</i>	17	G	G/F	G/F		2	1.8	Private		Asymmetrical crown (L), broken branches (L)	Remove	2
690	Norway Maple	<i>Acer platanoides</i>	16	F	G/F	G/F		2	1.8	Private		Leaning east (L), union at 2.2m	Remove	2
691	Norway Maple	<i>Acer platanoides</i>	12	G/F	G/F	G		2	1.8	Private		Trunk injury (L), asymmetrical crown (L)	Remove	
692	Austrian Pine	<i>Pinus nigra</i>	26	G/F	F	G		3	1.8	Private		Exposed roots (L), poor form (L)	Remove	2
693	Austrian Pine	<i>Pinus nigra</i>	31	F	F	G		3.5	2.4	Private		Exposed roots (M), bowed (L), pruning wounds (L)	Remove	3

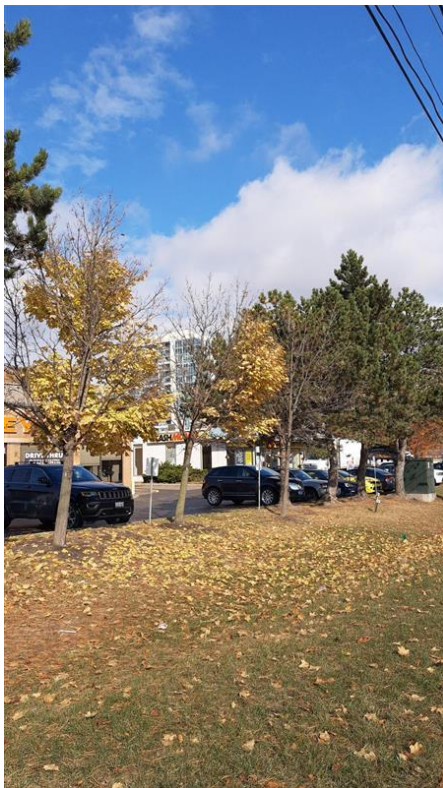
Trees 689-695

694	Austrian Pine	<i>Pinus nigra</i>	34	G/F	F	G		3.5	2.4	Private		Exposed roots (L), bowed (L), poor form (L)	Remove	3
695	Austrian Pine	<i>Pinus nigra</i>	35	G/F	F	F	10	4	2.4	Private		Exposed roots (L), union at 2.1m, poor vigor (M)	Remove	3
696	Norway Maple	<i>Acer platanoides</i>	28.5	G	F	G/F		1.5	1.8	Private		Cracks (M), crown dieback (L), union at 2.5m	Remove	2
697	Norway Maple	<i>Acer platanoides</i>	17.5	G/F	F	G		1.5	1.8	Private		Trunk injury (L), union at 1.6m	Remove	2
698	Norway Maple	<i>Acer platanoides</i>	30	F/P	G/F	G/F		2	2.4	Private		Trunk injury (M)	Remove	2
699	Norway Maple	<i>Acer platanoides</i>	19	-	-	-	-	-	-	Private	-	Dead.	Remove (condition)	2
700	Norway Maple	<i>Acer platanoides</i>	21.5	F	F	F		1.5	1.8	Private		Frost crack (M), asymmetrical crown (M), poor vigor (M) Union at 2.1m, asymmetrical crown (M), poor vigor (M)	Remove	2
701	Norway Maple	<i>Acer platanoides</i>	23	G	F	F		3	1.8	Private		Union at 2.1m, asymmetrical crown (M), poor vigor (M)	Remove	2

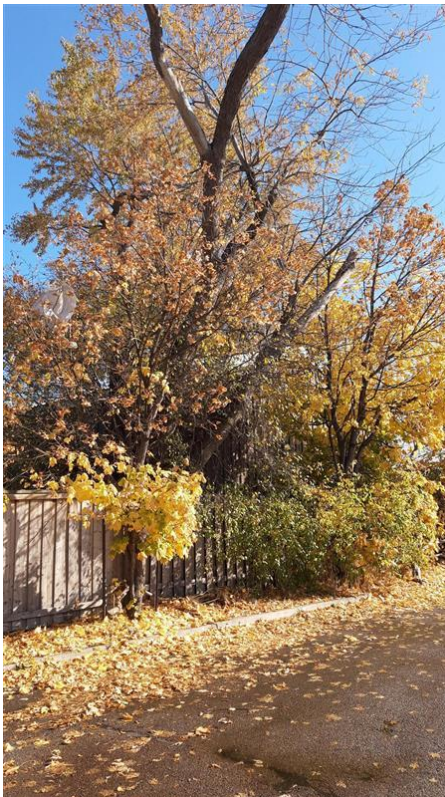
Trees 701-702 (right-left)

702	Norway Maple	<i>Acer platanoides</i>	21	F	F	F	20	2.5	1.8	Private		Trunk injury (M), union at 1.5m, crown dieback (M)	Remove	2
703	Norway Maple	<i>Acer platanoides</i>	25	G	F/P	F/P	20	2	1.8	Private		Crown dieback (M), epicormic branching (H)	Remove	2
704	Norway Maple	<i>Acer platanoides</i>	~18	G	F	G/F		1.5	1.8	Private		Poor vigor (L), asymmetrical crown (M)	Remove	2
705	White Ash	<i>Fraxinus americana</i>	22	P	P	P	95	4	1.8	Private		Almost dead. Hazard.	Remove (condition)	2
706	Little Leaf Linden	<i>Tilia cordata</i>	30	F	F	G/F		3	2.4	Private		Leaning east (L), epicormic branching (H), pruning wounds (L)	Remove	2
707	Norway Maple	<i>Acer platanoides</i>	15	-	-	-	-	-	-	Private	-	Dead.	Remove (condition)	
708	Little Leaf Linden	<i>Tilia cordata</i>	24	G/F	G	G		2.5	1.8	Private		Epicormic branching (M)	Remove	2
709	Little Leaf Linden	<i>Tilia cordata</i>	19	G	G/F	G		2.5	1.8	Private		Bowed (L)	Remove	2

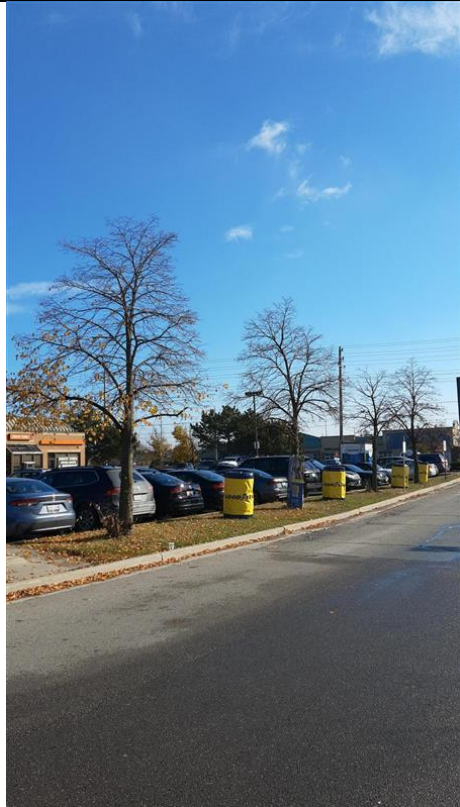
Trees 708-712 (left-right)

710	Little Leaf Linden	<i>Tilia cordata</i>	18	G	F	F		2	1.8	Private		Dead branches (L), asymmetrical crown (L)	Remove	2
711	Little Leaf Linden	<i>Tilia cordata</i>	21	G/F	G	G		2.5	1.8	Private		Exposed roots (L)	Remove	2
712	Norway Maple	<i>Acer platanoides</i>	17	G	G/F	F/P	25	2	1.8	Private		Crown dieback (M)	Remove	2
A	Manitoba Maple	<i>Acer negundo</i>	~10	P	P	F		4.5	1.8	Neighbour		Co-dominant at base, leaning south (H), poor form (M)	Preserve	
B	Silver Maple	<i>Acer saccharinum</i>	~83	F	P	F/P		10	5.4	Neighbour	8	Co-dominant at 1.4m, lost leader (M), epicormic branching (M), broken branched (H), poor form (H)	Remove (condition)	6
TOTAL														92
