**Tree Inventory and Preservation Plan Report  
60 Dundas Street East  
Mississauga, Ontario**

16 February 2022; revised 7 December 2022

KUNTZ FORESTRY CONSULTING INC. Project P3151

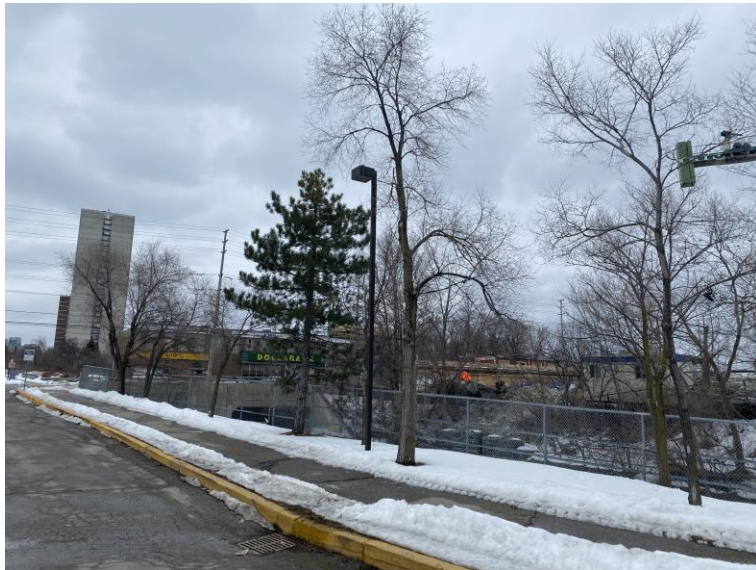
Image 1. From left to right, Trees 549 – 556

| Tree # | Common Name | Scientific Name | DBH | TI | CS | CV | CDB | DL | mTPZ | Comments | Owner | Action |
|---|---|---|---|---|---|---|---|---|---|---|---|---|
| 549 | Siberian Elm | <i>Ulmus pumila</i> | 34 | F | FG | FG | | 3 | 2.4 | V-unions at 1.5m and 2m with included bark, epicormic branching (L), pruning wounds (L) | Neighbour | Preserve |
| 550 | Siberian Elm | <i>Ulmus pumila</i> | 14, 13 | F | FG | FG | | 2 | 1.8 | V-union at 0.5m with included bark, asymmetrical crown (L), pruning wounds (L) | Neighbour | Preserve |
| 551 | Siberian Elm | <i>Ulmus pumila</i> | 12 | G | FG | FG | | 2 | 1.8 | Union at 1.5m, asymmetrical crown (L), pruning wounds (L) | Neighbour | Preserve |
| 552 | Austrian Pine | <i>Pinus nigra</i> | 22 | G | FG | G | | 2 | 1.8 | Pruning wounds (L) | Neighbour | Preserve |
| 553 | Norway Maple | <i>Acer platanoides</i> | 17.5 | P | PF | F | | 2 | 1.8 | Main leader lost at 2m, decay (H) in main stem, asymmetrical crown (M) | Neighbour | Preserve |
| 554 | Siberian Elm | <i>Ulmus pumila</i> | 25 | G | FG | FG | | 2 | 1.8 | Pruning wounds (L), epicormic branching (L) | Neighbour | Preserve |
| 555 | Siberian Elm | <i>Ulmus pumila</i> | 12.5, 12 | F | FG | F | 10 | 2 | 1.8 | V-union at base (codominance) with included bark, deadwood (L) | Neighbour | Preserve |
| 556 | Siberian Elm | <i>Ulmus pumila</i> | 11 | G | FG | FG | | 1 | 1.8 | Pruning wounds (M) | Neighbour | Preserve |

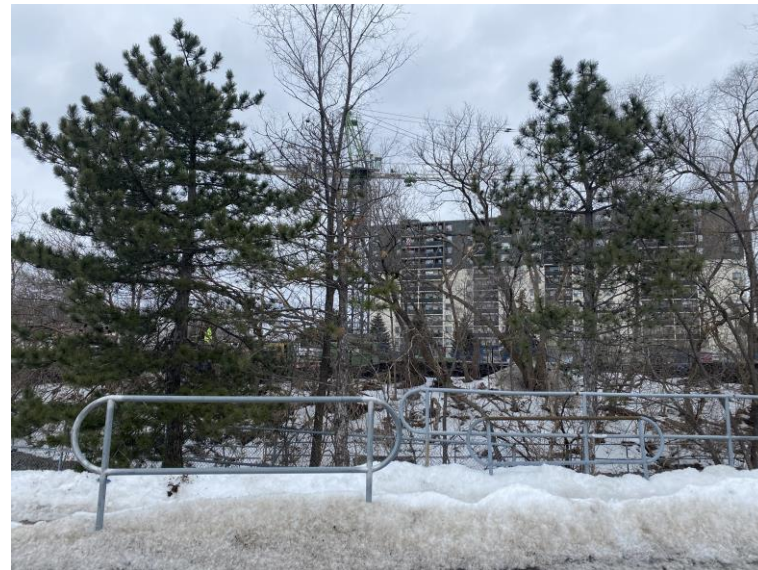
Image 2. From left to right, Trees 557 – 560

| Tree # | Common Name | Scientific Name | DBH | TI | CS | CV | CDB | DL | mTPZ | Comments | Owner | Action |
|---|---|---|---|---|---|---|---|---|---|---|---|---|
| 557 | Austrian Pine | <i>Pinus nigra</i> | 25 | FG | G | G | | 3 | 1.8 | Crook (L) | Neighbour | Preserve |
| 558 | Siberian Elm | <i>Ulmus pumila</i> | ~15 | PF | G | FG | | 2 | 1.8 | Sweep (M), included fence (H) | Neighbour | Preserve |
| 559 | Austrian Pine | <i>Pinus nigra</i> | 20 | G | P | P | 80 | 1 | 1.8 | Deadwood (H) | Neighbour | Preserve |
| 560 | Austrian Pine | <i>Pinus nigra</i> | 21 | FG | FG | FG | | 2 | 1.8 | Lean (L), broken branches (L) | Neighbour | Preserve |

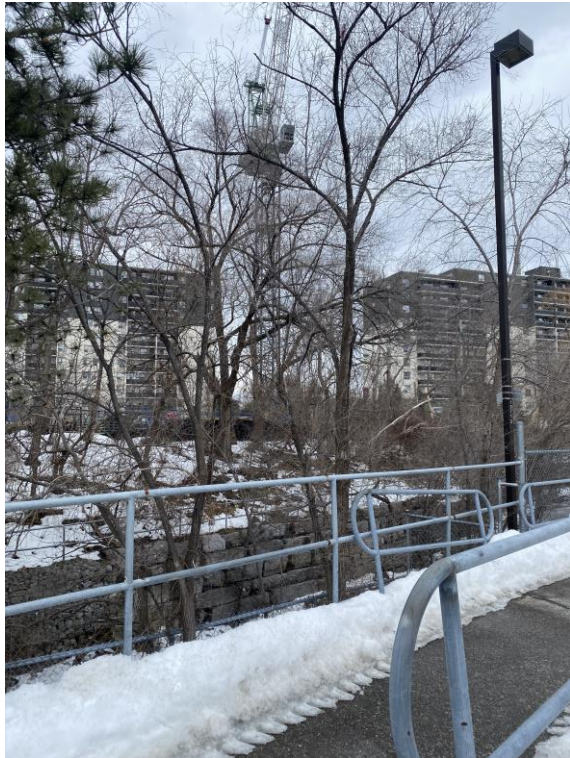
Image 3. From left to right, Trees 561 and 562

| Tree # | Common Name | Scientific Name | DBH | TI | CS | CV | CDB | DL | mTPZ | Comments | Owner | Action |
|---|---|---|---|---|---|---|---|---|---|---|---|---|
| 561 | Siberian Elm | <i>Ulmus pumila</i> | 12, 8 | F | F | F | 10 | 2 | 1.8 | V-union at 1m with included bark, asymmetrical crown (L), deadwood (L) | Neighbour | Preserve |
| 562 | Siberian Elm | <i>Ulmus pumila</i> | ~22, 12 | F | FG | FG | | 3 | 1.8 | V-union at 1m with included bark, pruning wounds (L), epicormic branching (L) | Neighbour | Preserve |

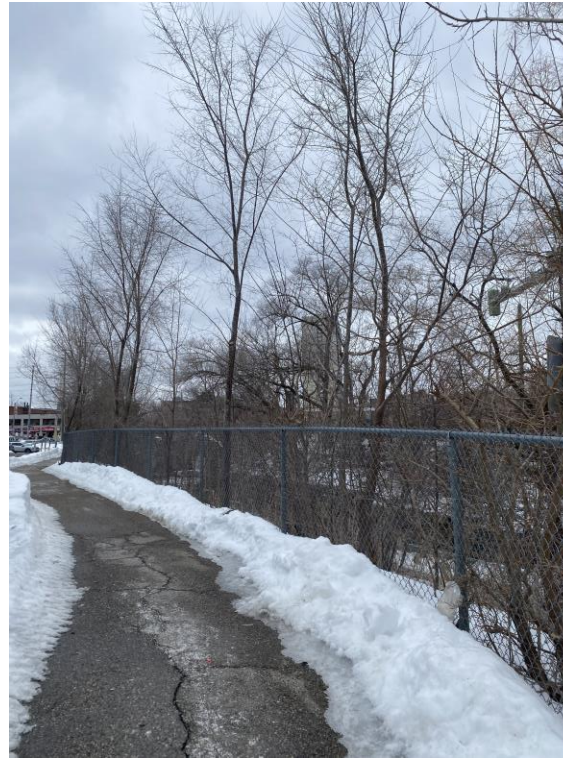
Image 4. Polygon 563

| Tree # | Common Name | Scientific Name | DBH | TI | CS | CV | CDB | DL | mTPZ | Comments | Owner | Action |
|---|---|---|---|---|---|---|---|---|---|---|---|---|
| P563 | Siberian Elm | <i>Ulmus pumila</i> | ~3 - 16 | FG | FG | FG | | 1 - 3 | 1.8 | ~ 26 trees, average DBH = 5cm | Neighbour | Preserve |

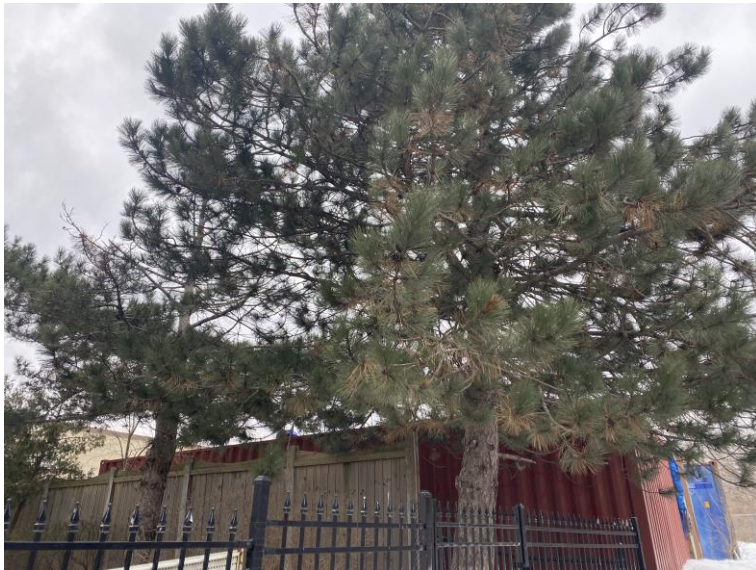
Image 5. From right to left, Trees 564 and 565

Encroachment into the driplines and mTPZs of Trees 564, 565, 571, 573 – 575 is required to allow for the removal of the existing asphalt driveway or the removal and replacement of the existing driveway with a proposed walkway. Given the presence of the existing asphalt, it is anticipated that few roots extend into the areas of encroachment. If the following protection and mitigation measures are employed before, during and after construction, long-term adverse effects are not anticipated for these trees.

| Tree # | Common Name | Scientific Name | DBH | TI | CS | CV | CDB | DL | mTPZ | Comments | Owner | Action |
|---|---|---|---|---|---|---|---|---|---|---|---|---|
| NT564 | Austrian Pine | <i>Pinus nigra</i> | ~42 | FG | FG | G | | 4 | 3.0 | Codominance in crown, crook (L) | Neighbour | Preserve |
| NT565 | Austrian Pine | <i>Pinus nigra</i> | ~36 | F | PF | P | 55 | 3 | 2.4 | Main leader dead, epicormic branching (L), deadwood (M), pruning wounds (L) | Neighbour | Preserve |

1. Prior to the commencement of the proposed work, tree protection fencing should be installed as shown on Figure 1.
2. Tree protection fencing may be adjusted to facilitate the removal of asphalt from within the mTPZs of these trees. Once the asphalt has been removed, the tree protection fencing must be reinstalled as shown on Figure 1.

3. The existing asphalt must be removed carefully using small machinery (i.e. a skidsteer) and by pulling radially away from the trunks.
4. No machinery use will be allowed within the mTPZs of these trees after the removal of the asphalt / concrete to minimize the impacts on the trees.
5. If roots are encountered in the subsurface material, they are to be left intact.
6. Where the installation of a new walkway is proposed where the asphalt driveway exists, the existing granular base should be used for the proposed surfaces.
7. Any softscaping to occur within the mTPZs of these trees should occur by hand.

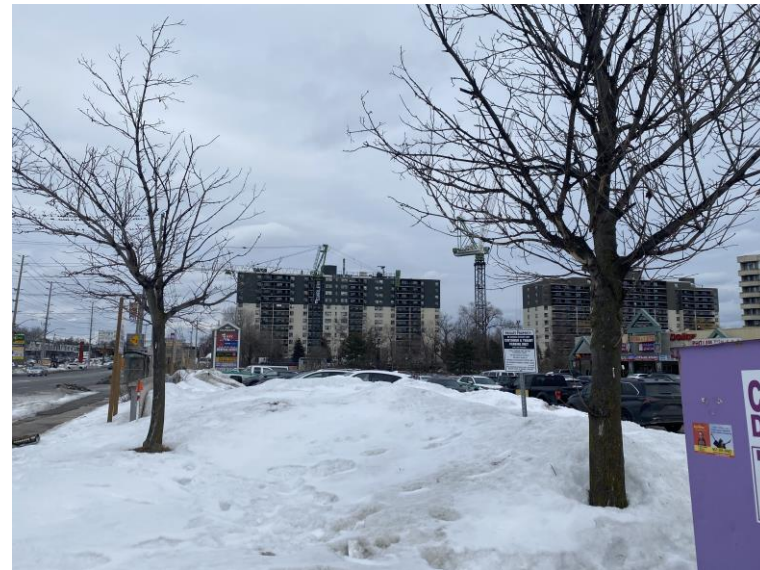
Image 6. From left to right, Trees 566 and 567

Trees 566 – 568 and 570 conflict directly with proposed walkways / sidewalks. Tree 569 conflicts directly with the proposed vehicular access from Shepard Avenue. Trees 579 – 583 are located close to the proposed subsurface parking garage such that their roots would be significantly impacted by the associated excavation.

| Tree # | Common Name | Scientific Name | DBH | TI | CS | CV | CDB | DL | mTPZ | Comments | Owner | Action |
|---|---|---|---|---|---|---|---|---|---|---|---|---|
| 566 | Norway Maple | <i>Acer platanoides</i> | 16 | F | F | F | 20 | 2 | 1.8 | Sweep (L), seam (L), multiple branch attachments, deadwood (L), pruning wounds (L) | Private | Remove |
| 567 | Norway Maple | <i>Acer platanoides</i> | 25 | PF | P | P | 80 | 3 | 1.8 | Deadwood (H), decay (M) in main stem, epicormic branching (L) | Private | Remove |

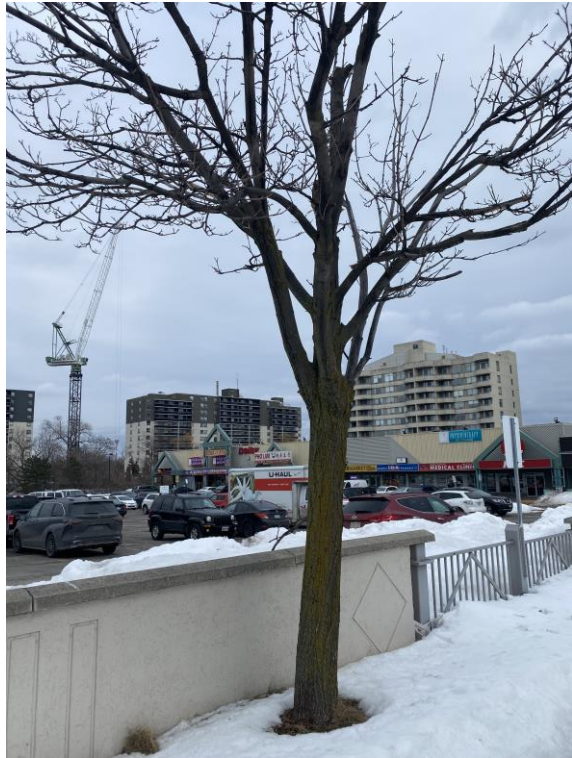
Image 7. Tree 568

| Tree # | Common Name | Scientific Name | DBH | TI | CS | CV | CDB | DL | mTPZ | Comments | Owner | Action |
|---|---|---|---|---|---|---|---|---|---|---|---|---|
| 568 | Norway Maple | <i>Acer platanoides</i> | 25.5 | PF | PF | PF | 30 | 3 | 1.8 | Main leader lost, deadwood (M), decay (M) in main stem | City | Remove |

| Tree # | Common Name | DBH | OC | Appraised Trunk Area (cm <sup>2</sup> ) | Unit Tree Cost (RPAC) (\$/cm <sup>2</sup> ) | Basic Tree Cost (\$) | Depreciation | | | Appraised Tree Value | Adjusted Tree Value |
|---|---|---|---|---|---|---|---|---|---|---|---|
| 568 | Norway Maple | 25.5 | PF | 511 | 6.51 | 3324.70 | 0.375 | 0.4 | 0.9 | \$ 448.83 | \$ 450.00 |

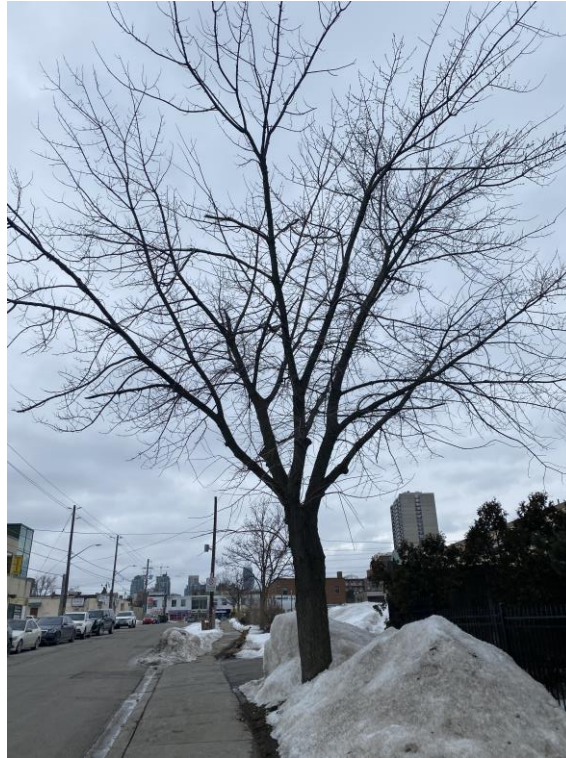
Image 8. Tree 569

| Tree # | Common Name | Scientific Name | DBH | TI | CS | CV | CDB | DL | mTPZ | Comments | Owner | Action |
|---|---|---|---|---|---|---|---|---|---|---|---|---|
| 569 | Norway Maple | <i>Acer platanoides</i> | 25 | P | PF | PF | 30 | 3 | 1.8 | Deadwood (M), v-union at 2m with included bark, cavity (L), decay (M) in main stem | City | Remove |

| Tree # | Common Name | DBH | OC | Appraised Trunk Area (cm <sup>2</sup> ) | Unit Tree Cost (RPAC) (\$/cm <sup>2</sup> ) | Basic Tree Cost (\$) | Depreciation | | | Appraised Tree Value | Adjusted Tree Value |
|---|---|---|---|---|---|---|---|---|---|---|---|
| 569 | Norway Maple | 25 | P | 491 | 6.51 | 3195.60 | 0.2 | 0.4 | 0.9 | \$ 230.08 | \$ 230.00 |

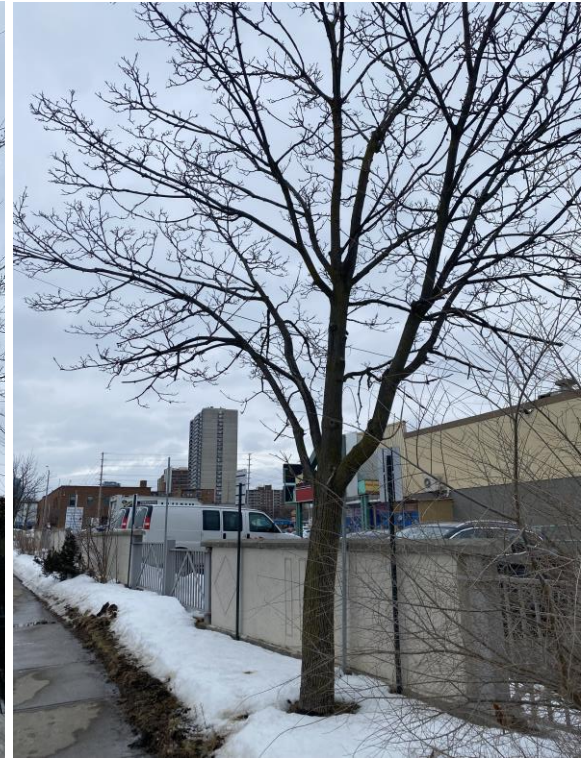
Image 9. Tree 570

| Tree # | Common Name | Scientific Name | DBH | TI | CS | CV | CDB | DL | mTPZ | Comments | Owner | Action |
|---|---|---|---|---|---|---|---|---|---|---|---|---|
| 570 | Norway Maple | <i>Acer platanoides</i> | 22.5 | FG | FG | F | 10 | 3 | 1.8 | Bow (L), deadwood (L) | City | Remove |

| Tree # | Common Name | DBH | OC | Appraised Trunk Area (cm <sup>2</sup> ) | Unit Tree Cost (RPAC) (\$/cm <sup>2</sup> ) | Basic Tree Cost (\$) | Depreciation | | | Appraised Tree Value | Adjusted Tree Value |
|---|---|---|---|---|---|---|---|---|---|---|---|
| 570 | Norway Maple | 22.5 | F | 398 | 6.51 | 2588.43 | 0.55 | 0.5 | 0.9 | \$ 640.64 | \$ 640.00 |

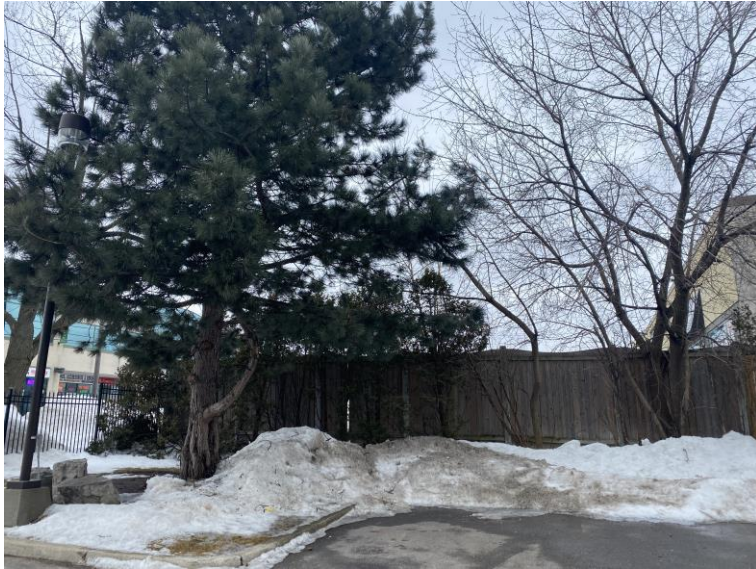
Image 10. From left to right, Trees 572 – 574

Encroachment into the mTPZs of Trees 573 – 575 is required to accommodate the construction of the proposed subsurface parking garage. If the following protection and mitigation measures are employed before, during and after construction, long-term adverse effects are not anticipated for these trees.

| NT572 | Austrian Pine | <i>Pinus nigra</i> | ~45 | F | G | G | | 4 | 3.0 | Included bark at base | Neighbour | Preserve |
| NT573 | White Mulberry | <i>Morus alba</i> | ~10 | G | G | G | | 2 | 1.8 | | Neighbour | Preserve |
| NT574 | Manitoba Maple | <i>Acer negundo</i> | ~13 | F | FG | G | | 1 | 1.8 | Lean (M) over neighbour, asymmetrical crown (L) | Neighbour | Preserve |

1. Prior to the commencement of the proposed work, tree protection fencing should be installed as show on Figure 1.
2. Air-spade or low-pressure hydro-vac technology should be used to excavate a trench at the limit of the proposed subsurface parking garage within the mTPZs of Trees 573 – 575, as shown in Figure 1 with solid cyan.
3. The trench must be a depth of at least 90cm.
4. The roots of Trees 573 – 575 are to be pruned inside the trench by a Certified Arborist in accordance with Good Arboricultural Standards.
5. The trench is to be backfilled with clean topsoil.
6. All works within the mTPZs of these trees should be supervised by a Certified Arborist in accordance with Good Arboricultural Standards.

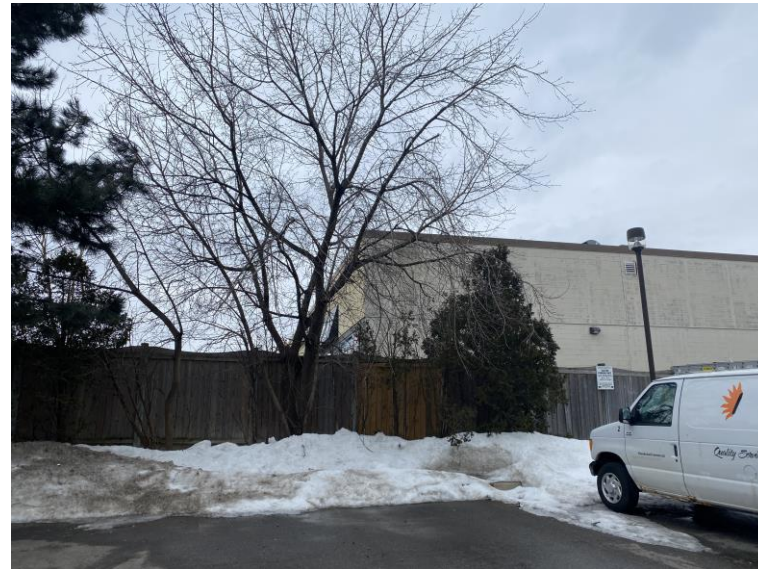
Image 11. From left to right, Trees 574 and 575

| NT575 | Manitoba Maple | <i>Acer negundo</i> | ~26,<br>24 | F | FG | G | | 4 | 1.8 | V-union at 0.5m | Neighbour | Preserve |

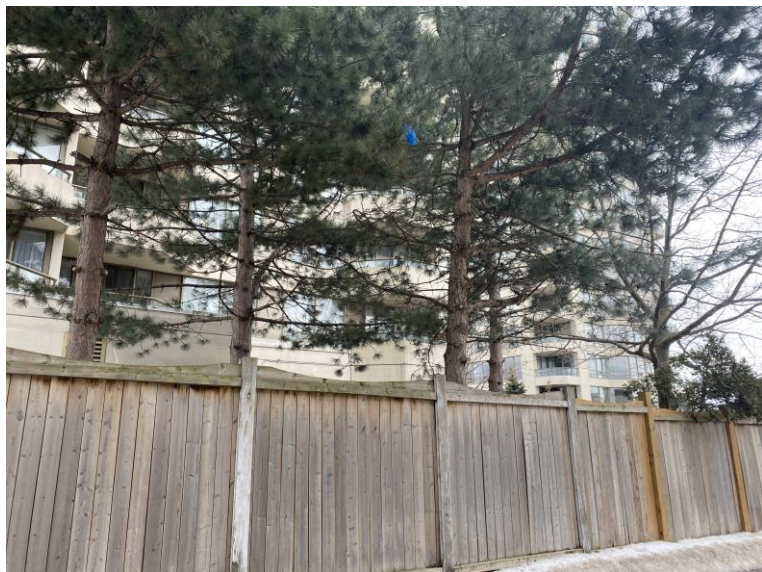
Image 12. From right to left, Trees 576, 577, 579, 578, and 580

Tree 576 is afforded at least 3.0m of protection from its base. This level of protection is expected to be sufficient to protect this tree during construction.

| NT576 | Red Oak | <i>Quercus rubra</i> | ~42 | G | FG | FG | 10 | 8 | 3.0 | Deadwood (L) | Neighbour | Preserve |
| NT577 | Austrian Pine | <i>Pinus nigra</i> | ~26 | G | G | F | | 3 | 1.8 | | Neighbour | Preserve |
| NT578 | Austrian Pine | <i>Pinus nigra</i> | ~32 | G | G | G | | 4 | 2.4 | | Neighbour | Preserve |
| NT579 | Austrian Pine | <i>Pinus nigra</i> | ~28 | FG | FG | G | | 4 | 1.8 | Lean (L), pruning wounds (M) | Neighbour | Remove |
| NT580 | Austrian Pine | <i>Pinus nigra</i> | ~26 | G | FG | G | | 3 | 1.8 | Pruning wounds (L) | Neighbour | Remove |

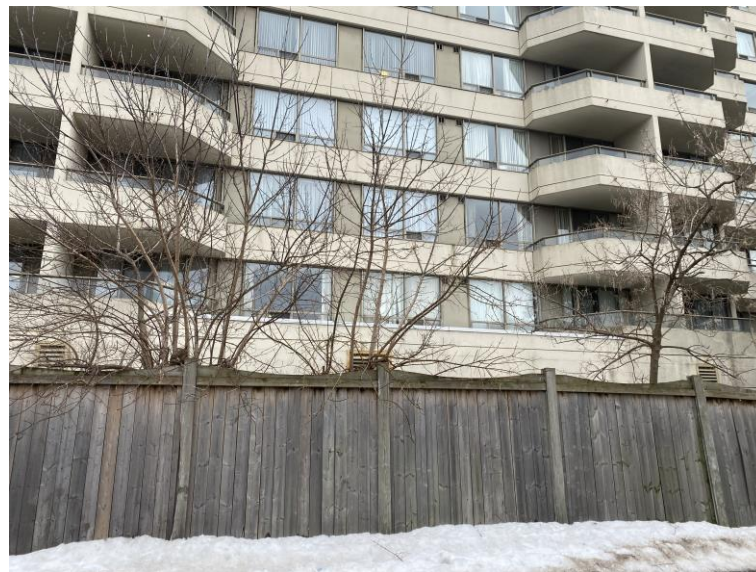
Image 13. From right to left, Trees 581 – 583

| NT581 | Manitoba Maple | <i>Acer negundo</i> | ~12 | G | G | G | | 2 | 1.8 | | Neighbour | Remove |
| NT582 | White Ash | <i>Fraxinus americana</i> | ~15 | FG | F | FG | | 2 | 1.8 | Topped at 2m, coppice growth | Neighbour | Remove |
| NT583 | White Ash | <i>Fraxinus americana</i> | ~15 | FG | F | FG | | 2 | 1.8 | Topped at 2m, coppice growth | Neighbour | Remove |

In addition, Trees 579 – 583 are located on a neighbouring property and as such, permission from the respective property owner is required prior to the removal of these trees.
