ARBORIST REPORT

Sunningdale Bend Residential

890 Meadow Wood Road
Mississauga, Ontario

Revised: February 16, 2023

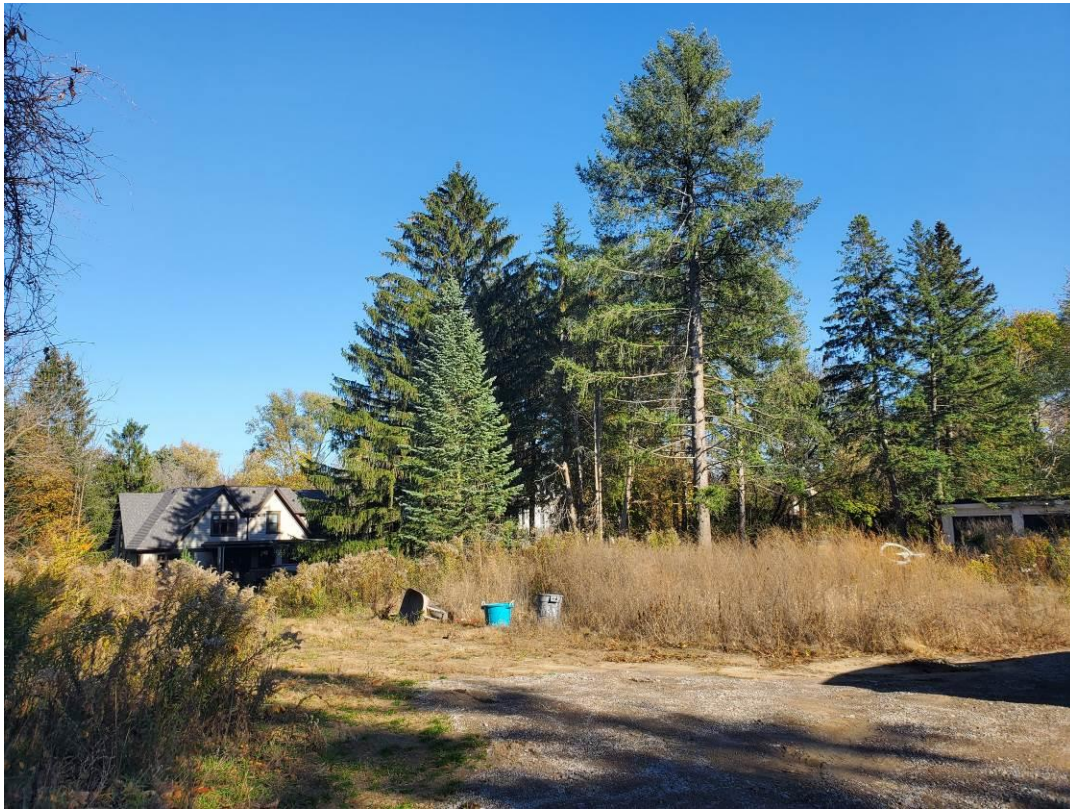
Figure 4: View to Southeast at Centre of Site.

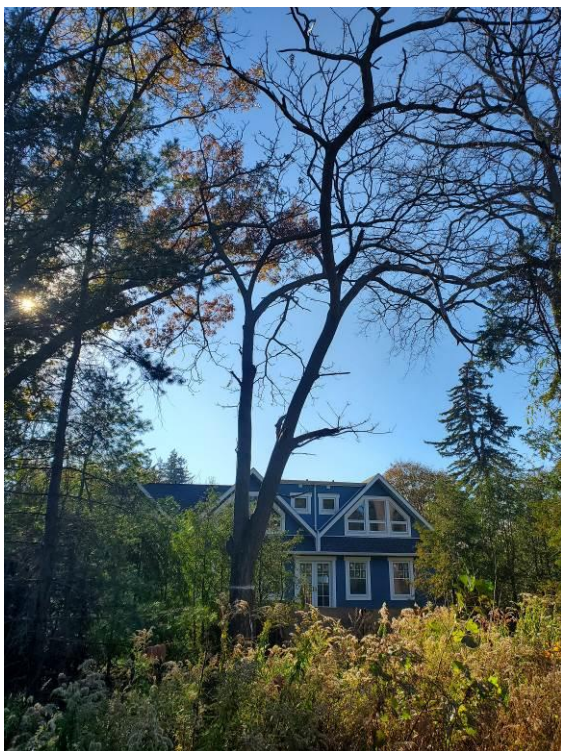
From this list one important consideration is the presence of butternut trees on the site and in the adjacent ravine. These trees have been marked on site and described in the tree inventory where they meet the criteria for this list. There are also Butternut trees that were too small to be included in this inventory. Further information regarding the Butternuts will be made available through a butternut assessment that is independent of this report.

20	Thuja occidentalis	18		3	L	L	regrown in - leans 10° E, nearly 100% canopy dead	R	S
21	Thuja occidentalis	23		3	L	L	Leans 10° E, nearly 100% canopy dead	R	S
22	Thuja occidentalis	21.5		3	L	L	Leans 10° E, nearly 100% canopy dead	R	S
23	Juglans cinerea	54		14	M	M	>10 Large DBS, 10% canopy dead. Also tagged 350.	P	S
24	Pinus strobus	18		4	M	M	Grape, crack to 2m. Also tagged 351.	RC	S
25	Thuja occidentalis	19		3	M	M	2L, IB, Virginia Creeper in canopy	RC	S
26	Pinus strobus	18		4	M	M	Virginia Creeper in canopy. Suppressed by #27	RC	S
27	Juglans nigra	33		8	M	M	Virginia creeper in canopy, leans 10° E Many medium DBs	P	S
28	Juglans nigra	50.5		9	M	M	Large BB UB(E)	P	S
29	Juglans nigra	100		22	M	M	>5 long piece cuts of branch stubs	P	N
30	Acer platanoides	20		7	M	M		P	N
31	Prunus serotina	36		7	L	L	large 25%trunk damage @ 0-5m, large BB, leans 20° S	P	N

Figure 5: Butternut on site (Tree 23)

Preserve trees #16-19, 23, 27-34, 39-43, 46-55, 58, 59, 73-80, 86-110, 112-114, 117-123, 125 and 126.
