ARBORIST REPORT & PLAN OF PRESERVATION

7211 & 7233 AIRPORT ROAD

CITY OF MISSISSAUGA

Revised: June 5, 2023

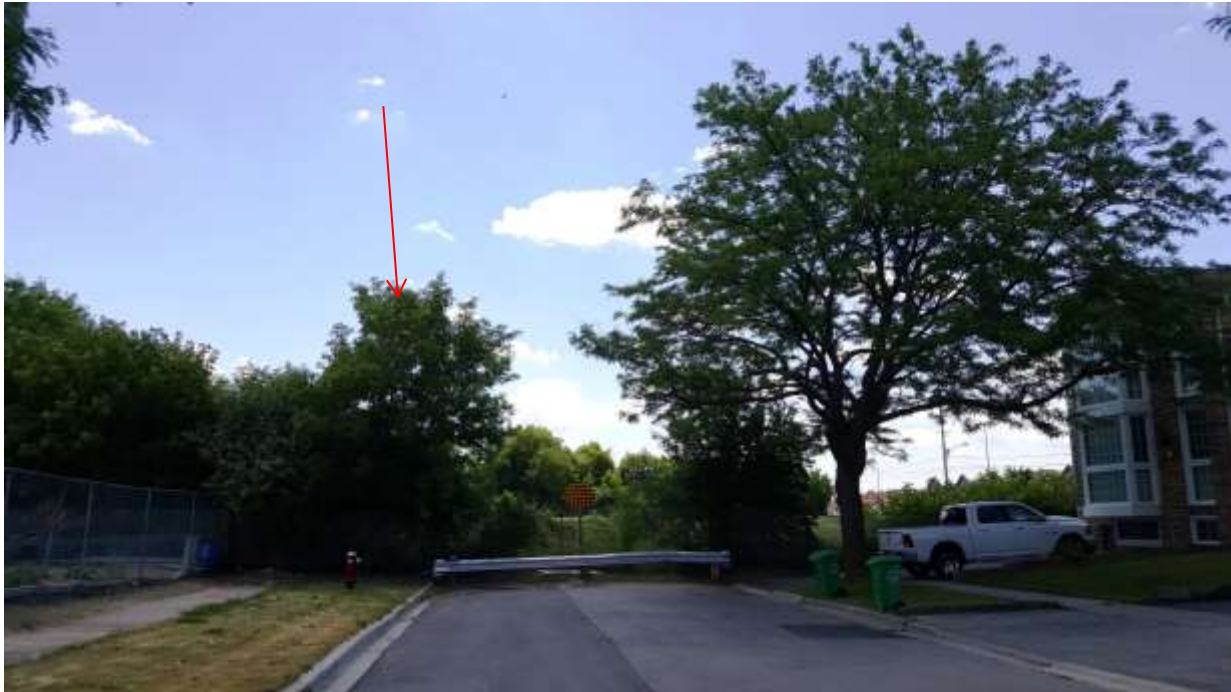
Trees #1736 & #1703. Large Honeylocust on municipal road allowance of Collette Road (right). Manitoba Maple located on east side of Collette Road (Left, red arrow)

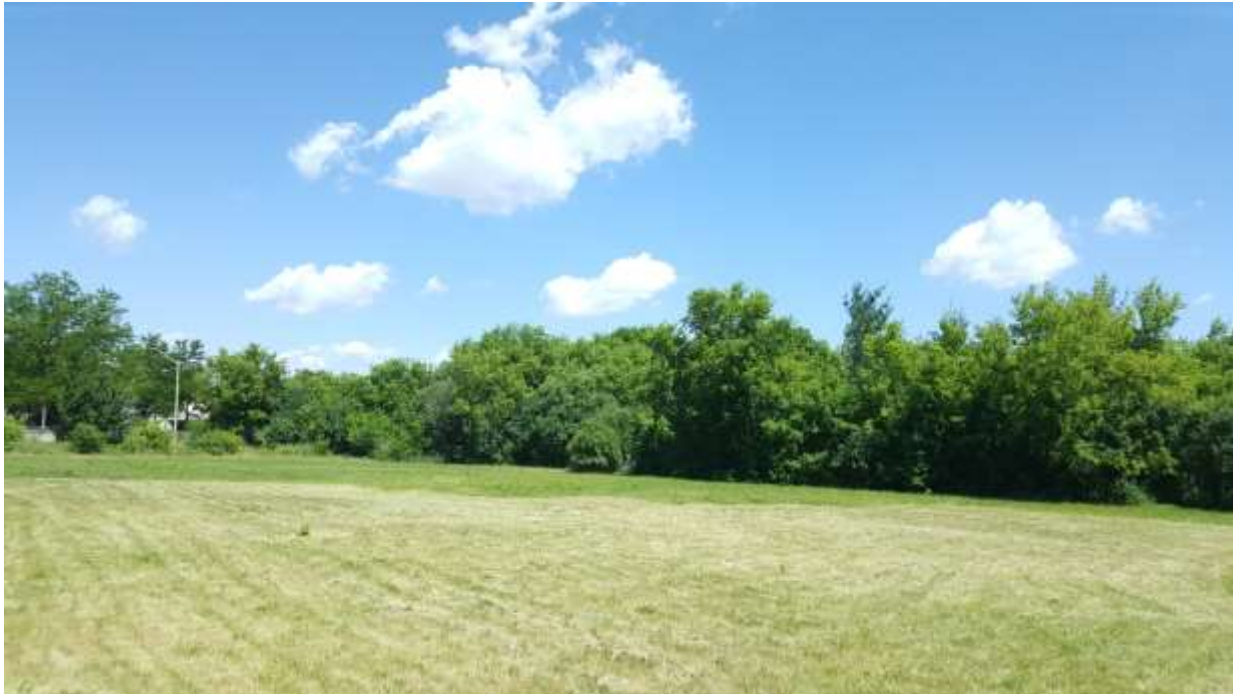
Northeast side of site, Collette Road at the left of the photo. Trees along this boundary are dense and naturally regenerated .

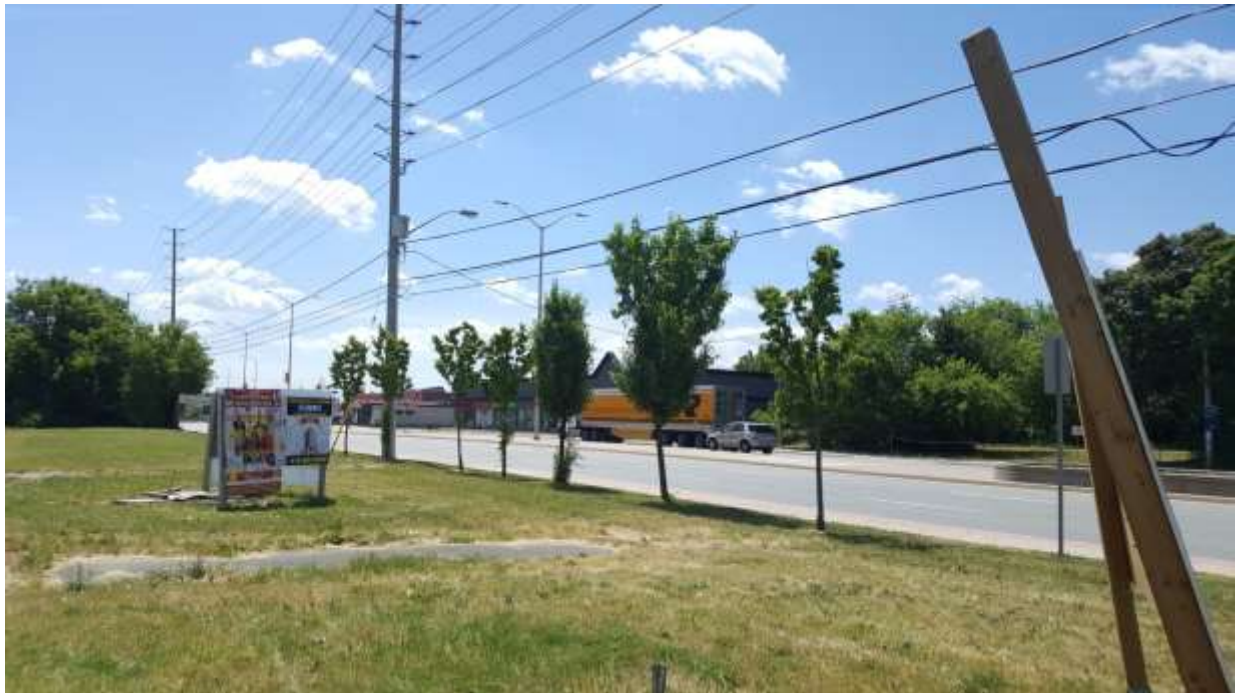
Facing southwest (towards Airport Road) viewing trees #1729-1735 along regional road allowance

A total of SEVEN (7) regionally-owned trees are recommended to be removed to accommodate the proposed development. The following table outlines the trees to be removed.
