Tree Inventory and Preservation Plan Report 3085 Hurontario Street Mississauga, Ontario

11 May 2021 Revised: 23 June 2021 14 September 2023

KUNTZ FORESTRY CONSULTING Inc. Project P2631

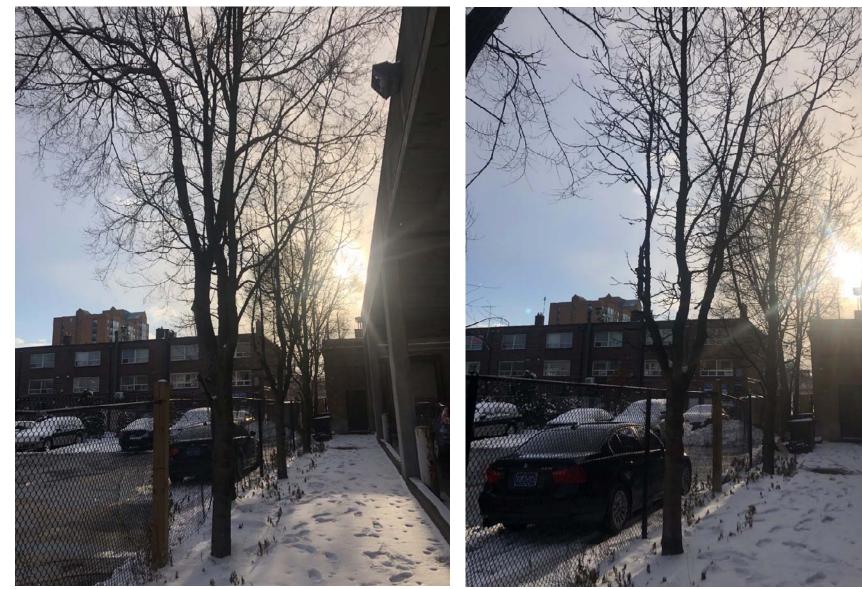
Image 45. Tree 523

523	Norway Maple	Acer platanoides	22	P-F	F	Р	50	1.0	Deadwood (H), declining	Private	Remove (Condition)	-
524	Norway Maple	Acer platanoides	20	P-F	P-F	Ρ	50	1.0	Deadwood (M), crack (H) from base to 2 metres	Private	Remove (Condition)	-
525	Norway Maple	Acer platanoides	24	F	F-G	P-F	30	1.0	Deadwood (M), declining	Private	Remove (Condition)	-
526	Siberian Elm	Ulmus pumila	~20, ~18, ~15	F	F	F		2.0	Multi-stem at base, epicormic branching (H)	Private	Remove	1
527	Manitoba Maple	Acer negundo	~15	F	F	F	10	1.5	Deadwood (L), epicormic branching (M), pruning wounds (L)	Private	Remove	1
N1	Siberian Elm	Ulmus pumila	~65	F	F	F		6.0	One stem previously pruned at 0.5 metres, broken branches (M), deadwood (L), co-dominant stems at 2 metres, epicormic branching (M), pruning wounds (H), wetwood	Shared	Remove	2
N2	Manitoba Maple	Acer negundo	~75	F	F	P-F	15	6.0	Co-dominant stems at 2 metres, deadwood (M), coppice growth (M), epicormic branching (M), included fence (L), broken branches (L)	Neighbouring	Remove	2

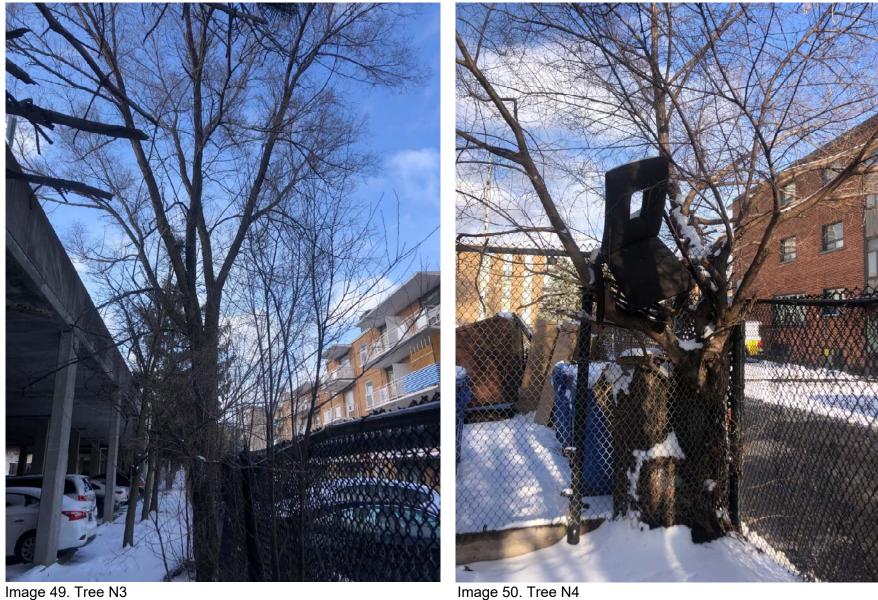
Image 50. Tree N4

N3	Siberian Elm	Ulmus pumila	~30, ~30	F	F	F		4.0	Co-dominant stems at 0.5 metres, broken branches (M), epicormic branching (M), included fence (L), deadwood (L)	Shared	Remove	1
N4	Siberian Elm	Ulmus pumila	~20, ~10	Р	Р	Ρ		2.0	Tree previously cut down at 1 metre, all growth is epicormic branching, included fence (M)	Neighbouring	Remove (Condition)	-
N5	Siberian Elm	Ulmus pumila	~35	F	F-G	F-G		3.5	Included fence (M), broken branches (L), epicormic branching (M), co-dominant stems at 4.5 metres	Shared	Remove	1
