THURBER ENGINEERING LTD.

August 10, 2023

File No.: 25025

**EXPANDED GEOTECHNICAL DESKTOP STUDY
DIXIE-DUNDAS FLOOD MITIGATION
MISSISSAUGA, ONTARIO**

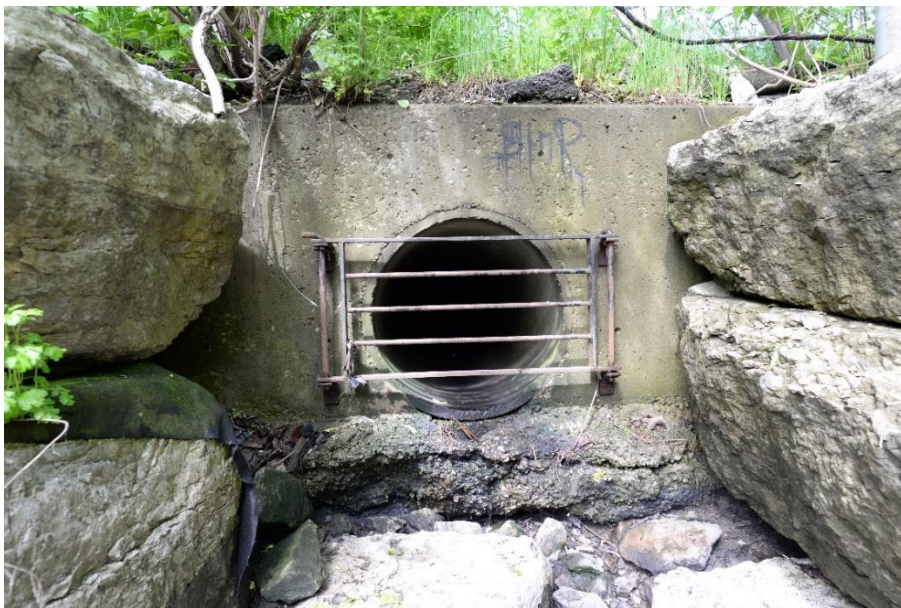
- Two concrete stormwater outfall structures with armourstone drop-spillways were observed, one approximately 7 m and another about 390 m downstream (east) of the existing Dixie Road Bridge.

Photo 4: Looking north at stormwater outfall structure located approximately 7 m downstream of Dixie Road bridge. [taken June 2019]

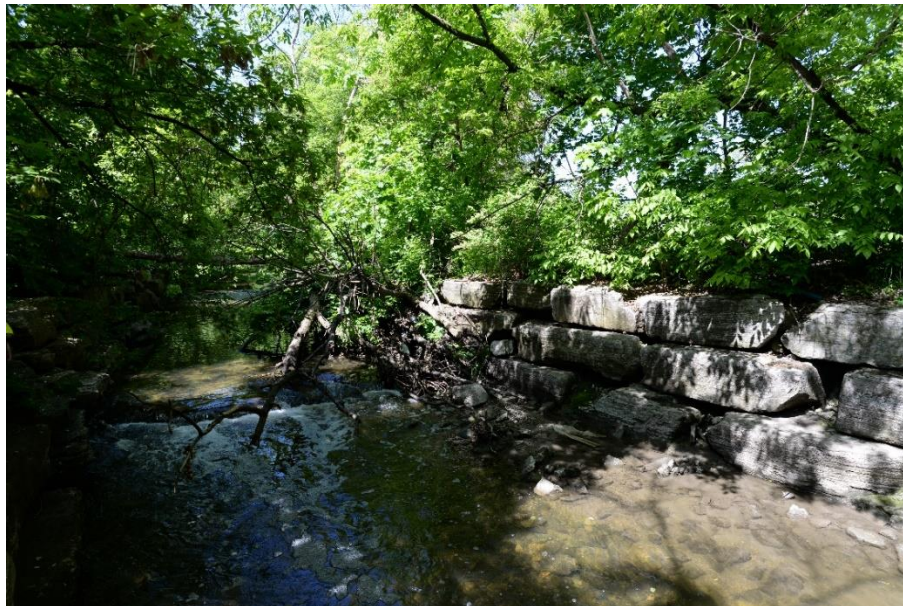
Photo 10: Looking upstream at a fallen tree located approximately 50 m west of Dixie Road bridge. [taken June 2019]

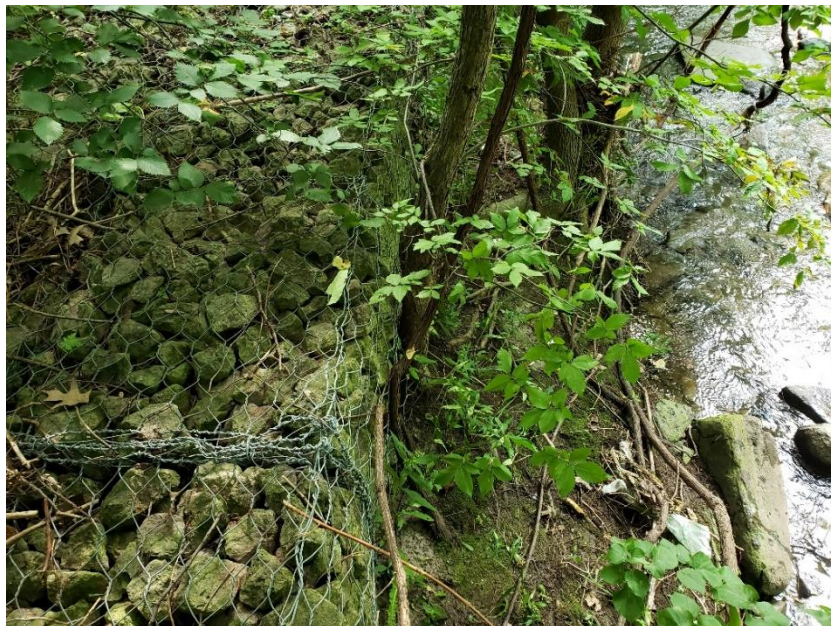
Photo 20: Looking at gabion baskets along east bank at Willowcreek Park. [taken June 2019]

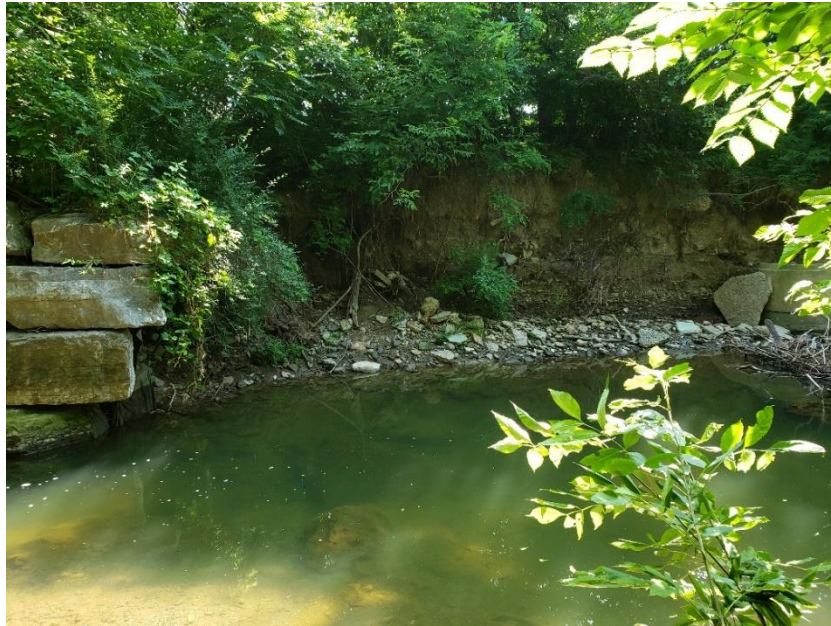
Willowcreek Park and behind Eddies Meat Market. Significant toe erosion was noted at these locations.

Photo 23: Looking at near vertical slope along east bank opposite Eddie's Meat Market. [taken June 2019]

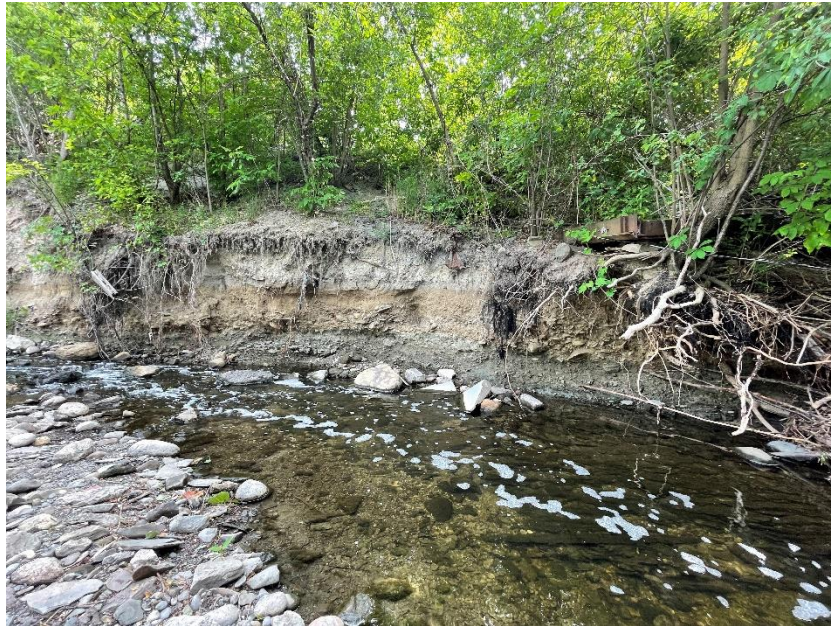
- Localized toe erosion/undermining along the west bank was observed approximately 300 m downstream of the existing Dundas Street East bridge.
- The existing slopes adjacent to the creek within the project site are predominantly heavily vegetated with mature trees and brush, except at areas of toe erosion as noted above.
- Multiple downed trees were observed within the project site.
- The creek flows in a southerly direction towards Lake Ontario.
- The creek bed generally consists of fluvial deposits consisting of sand and gravel with cobbles and boulders with potential slabs of shale bedrock.

Photo 28: Looking east towards steep slope along east bank 300 m downstream from Dundas Street East bridge. [taken June 2021]

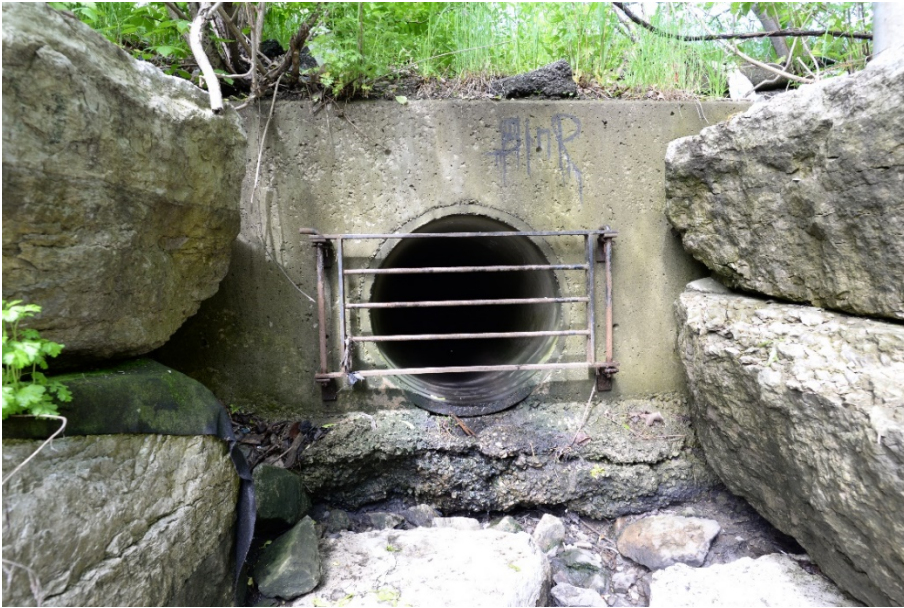
Photograph 4: Looking north at stormwater outfall structure located approximately 7 m downstream of Dixie Road Bridge.

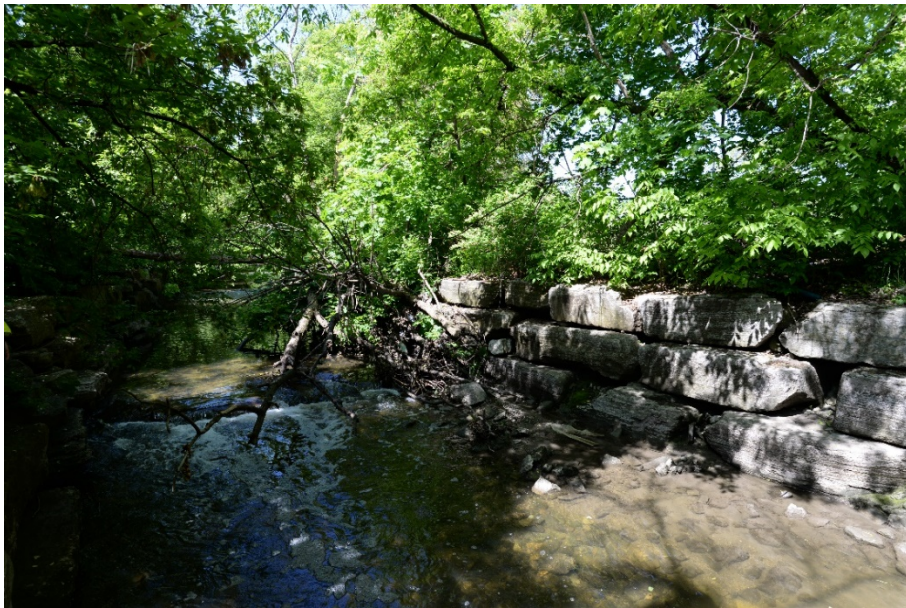
Photograph 10: Looking upstream at a fallen tree located approximately 50 m west of Dixie Dundas Bridge.

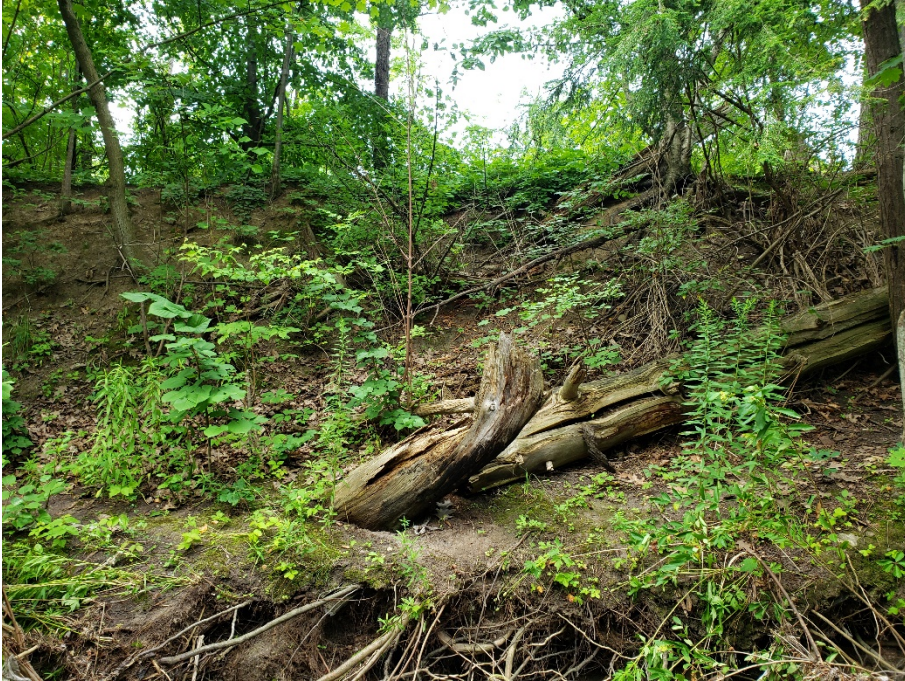
Photograph 19: Looking at steep slope along west bank opposite Willowcreek Park.

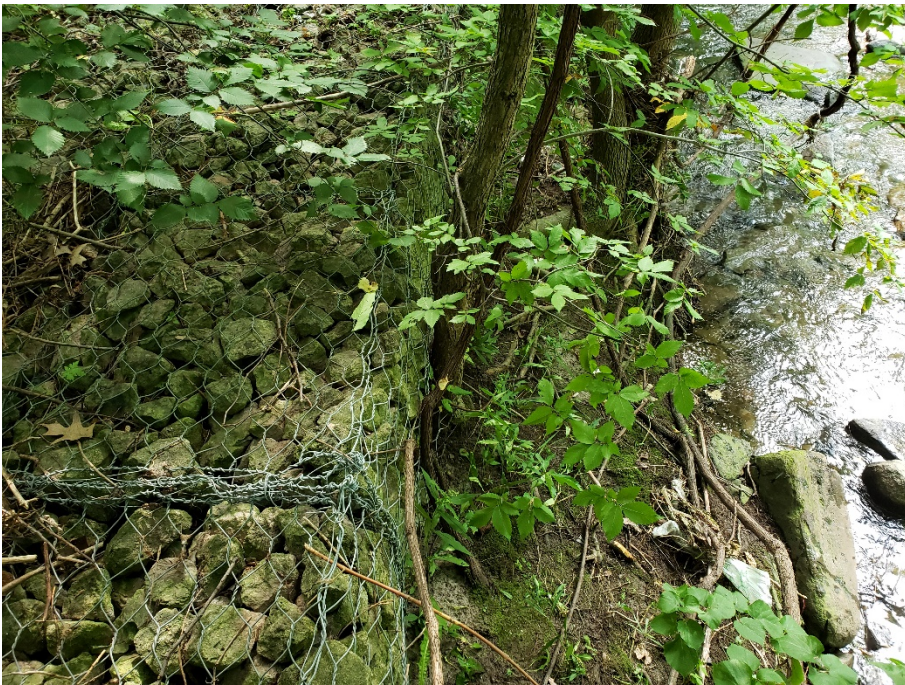
Photograph 20: Looking at gabion baskets along east bank at Willowcreek Park.

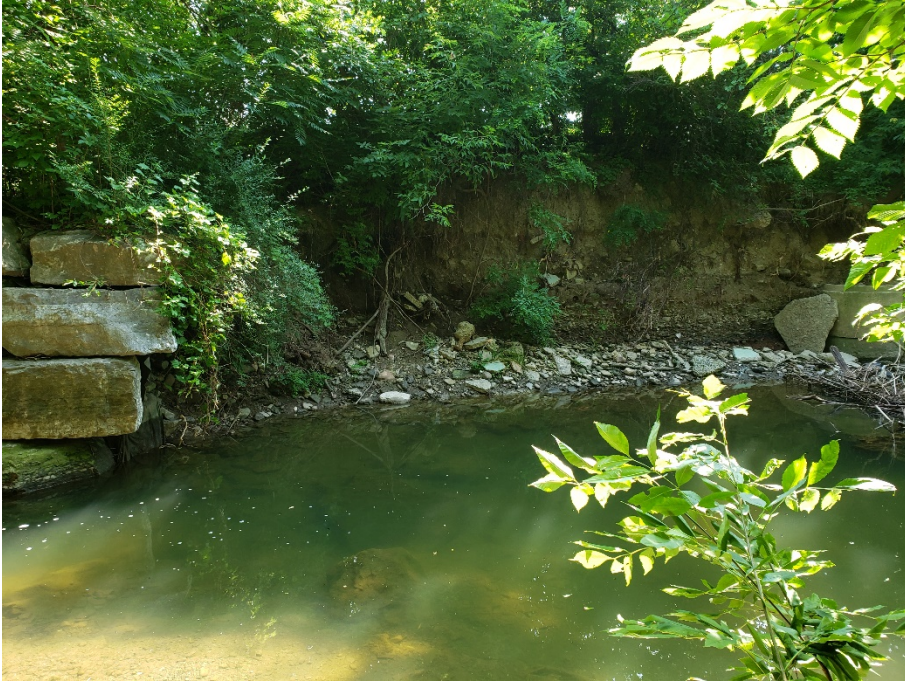
Photograph 23: Looking at near vertical slope along east bank opposite Eddie's Meat Market.
