**Tree Inventory and Preservation Plan  
1470 Williamsport Drive  
Mississauga, Ontario**

KUNTZ FORESTRY CONSULTING INC. Project P4285

## Tree Inventory and Preservation Plan

Project	P4285	Figure	<b>1</b>
Date	14 November 2024		
Scale	1:250

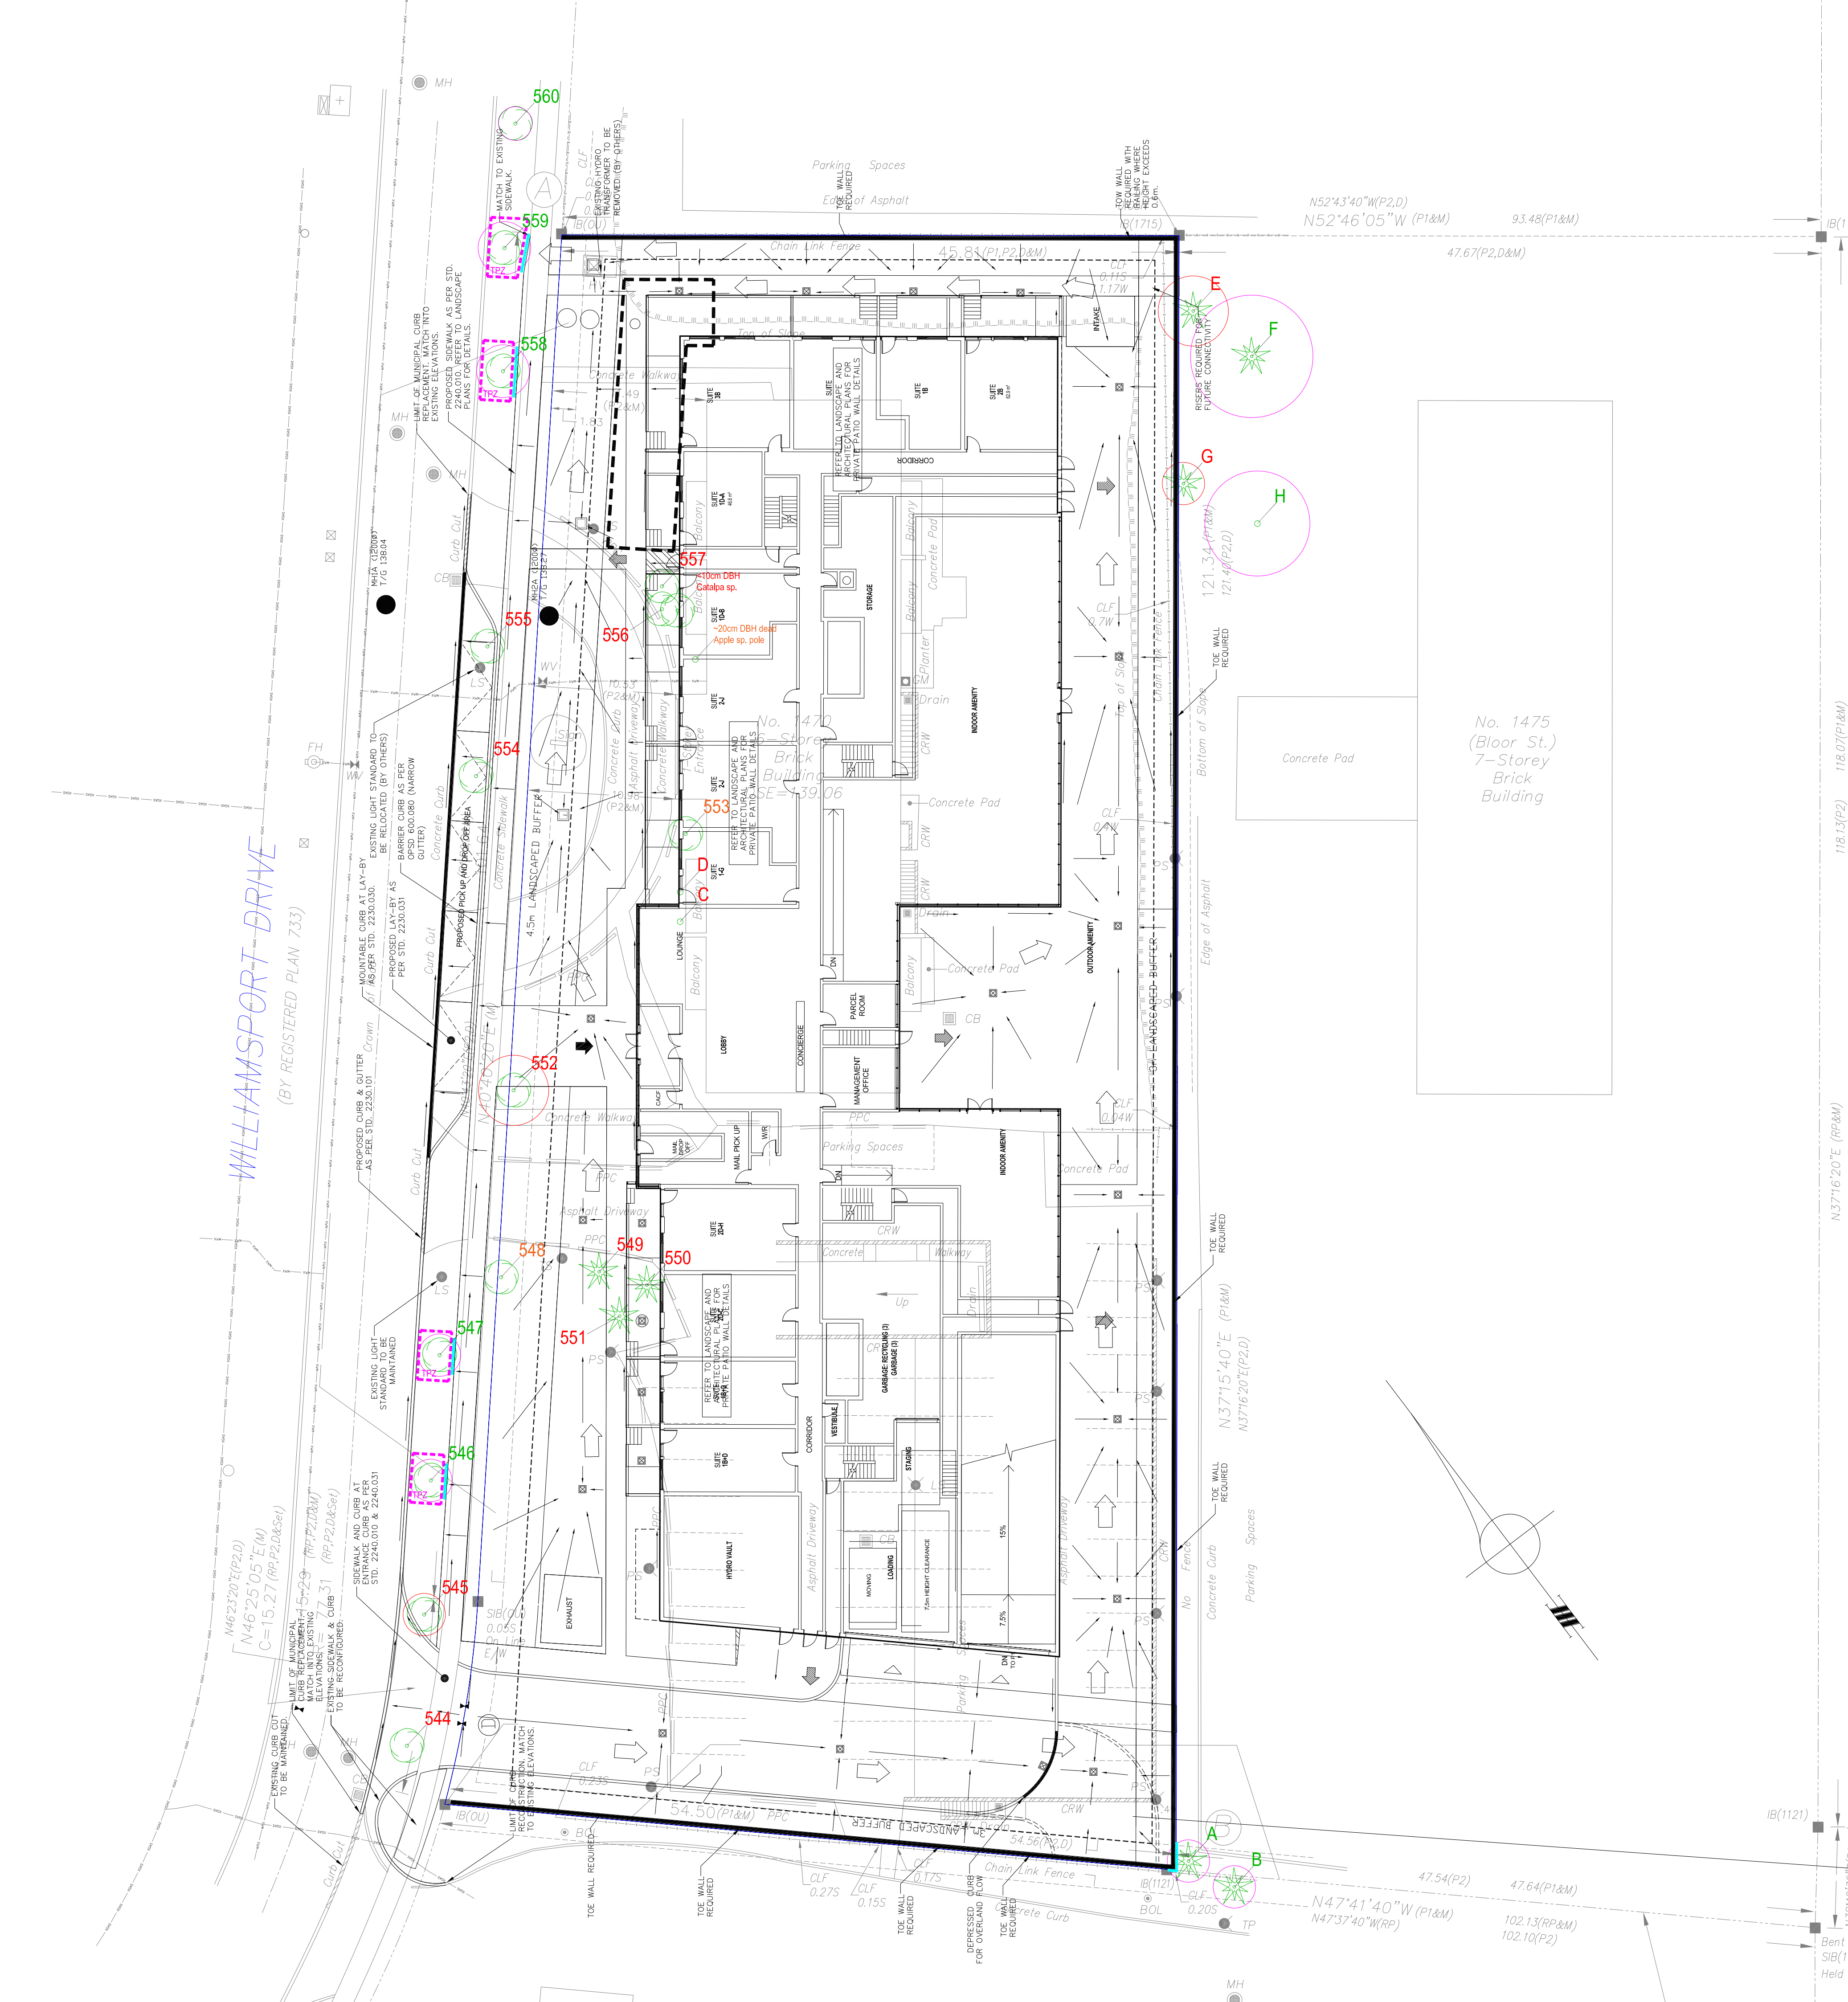
The removal of 14 trees, including Trees 544, 545, 549 – 552, 554 – 557, C – E, and G, will be required to accommodate the proposed development. These trees either conflict directly with the proposed development or the level of encroachment into their minimum tree protection zones (mTPZs) resulting from the proposed work would be at an intolerable level such that the trees would not be expected to overcome the injury. The removal of two additional trees, identified as Trees 548 and 553, is recommended regardless of the proposed development due to their poor or dead condition.

Trees 548 – 553, 557, C, E, and G measure 15cm DBH or greater and are located on private property and as such, are protected under the City of Mississauga's Private Tree Protection By-law. Trees 544, 545, 554, and 555 are located within the Williamsport Drive right-of-way and as such, permission from the City of Mississauga will be required prior to the removal of these trees. It should be noted that Trees E and G are located on a neighbouring property. As such, written permission from the respective neighbouring property owner will be required prior to the removal of these trees.

The preservation of the remaining nine trees, including Trees 546, 547, 558 – 560, A, B, F, and H, will be possible with the use of appropriate tree protection measures as indicated on Figure 1. Tree protection measures must be implemented prior to the commencement of the proposed works to ensure tree resources designated for preservation are not impacted.

Where the minimum tree protection zone (mTPZ) of a tree cannot be fully respected, including for Trees 546, 547, 558, 559, and A, special mitigation measures have been prescribed and are outlined below.

Encroachment into the mTPZs of Trees 546, 547, 558, 559, and A will be required to accommodate the construction of a proposed sidewalk or a proposed toe wall. Tree preservation fencing has been prescribed at the anticipated limit of encroachment within the mTPZs of these

1. Prior to the commencement of the proposed works, tree preservation fencing must be installed as show on Figure 1.
2. Air-spade or low-pressure hydro-vacuum technology is to be used to excavate trenches, under the supervision of a Certified Arborist, at the anticipated limit of excavation within the mTPZs of these trees.

3. The depths of the trenches will depend on the depth of excavation required for the construction of the proposed sidewalk or toe wall.
4. Within the trenches, the exposed roots of these trees are to be pruned by a Certified Arborist in accordance with Good Arboricultural Standards.

5. The trenches are to be backfilled with clean topsoil.
6. Any work to occur within the mTPZs of these trees should be supervised by a Certified Arborist in accordance with Good Arboricultural Standards.

7. Branches that extend into the proposed development and require pruning must be pruned by a Certified Arborist or other tree professional in accordance with Good Arboricultural Standards.
