**Tree Inventory and Preservation Plan  
42 Park Street, 44 Park Street, 46 Park Street, and 23 Elizabeth Street  
Mississauga, Ontario**

**SPA No.: SP 22-12 W1  
OLT File No.: OLT-21-002260**

15 April 2020  
Revision 1: 17 April 2020  
Revision 2: 14 February 2023  
Revision 3: 22 May 2025

KUNTZ FORESTRY CONSULTING INC. Project P2371

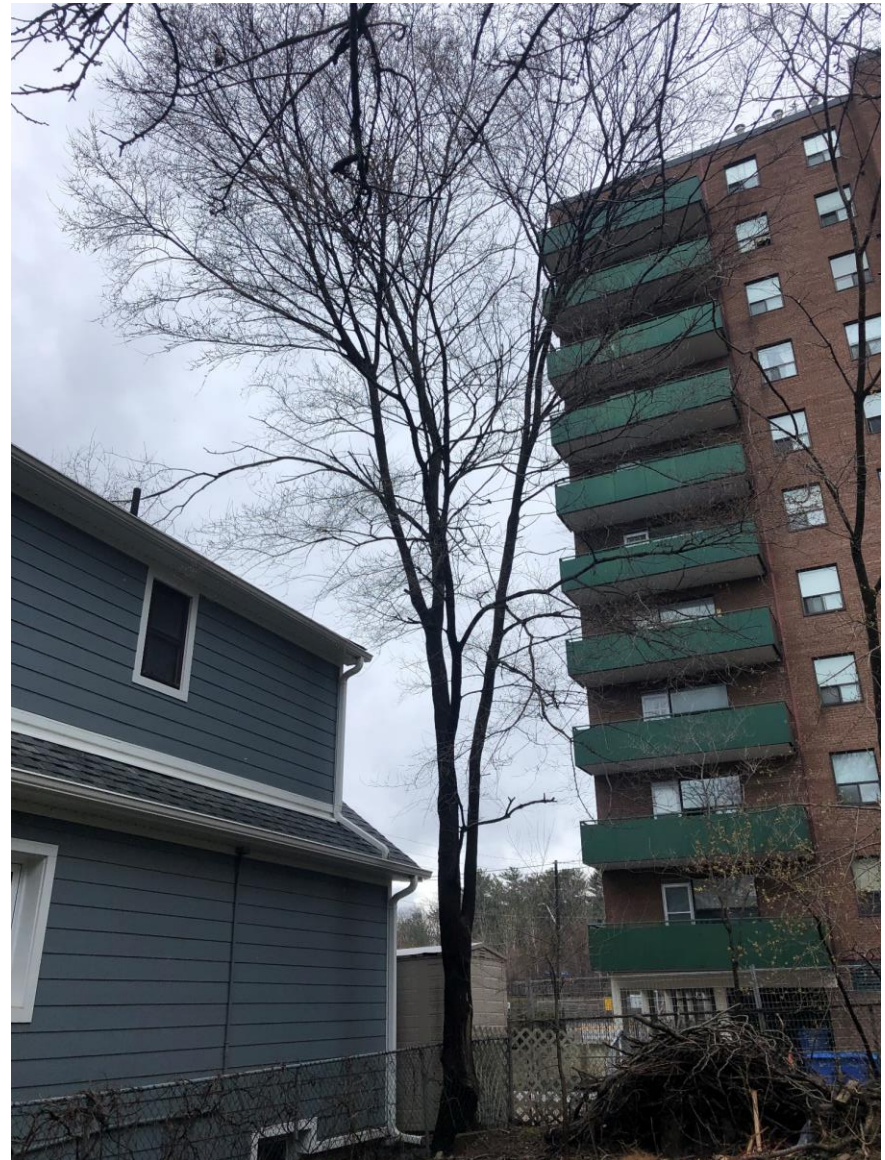
Image 12. Tree 688

687	Little-leaf Linden	<i>Tilia cordata</i>	16	G	G	FG	F		4.0		Remove
688	Siberian Elm	<i>Ulmus pumila</i>	33	PF	F	FG	F		5.0	Co-dominant stems at 2 metres, broken branches (L), included fence, girdling trunk (H) from fence, epicormic branching (L)	Remove
689	Cherry species	<i>Prunus</i> spp.	32	F	PF	F	F		6.0	Pruning wounds (H), sweep (L), debris in root zone, epicormic branching (M)	Remove
690	Cherry species	<i>Prunus</i> spp.	31	F	PF	F	FG		4.5	Pruning wounds (H), co-dominant stems at 1.5 metres, broken branches (L)	Remove
691	Tree-of-Heaven	<i>Ailanthus altissima</i>	~95	F	FG	FG	F		9.0	Seams (L), cavity (L) from pruning wound, pruning wounds (M), included fence, clothesline pulley inserted into trunk, vine competition (L)	Remove
692	Tree-of-Heaven	<i>Ailanthus altissima</i>	110	F	F	F	F		9.0	One stem dead, asymmetrical crown (M), pruning wounds (M), cavity (L)	Remove
693	Siberian Elm	<i>Ulmus pumila</i>	3	G	FG	G	F		0.5		Remove

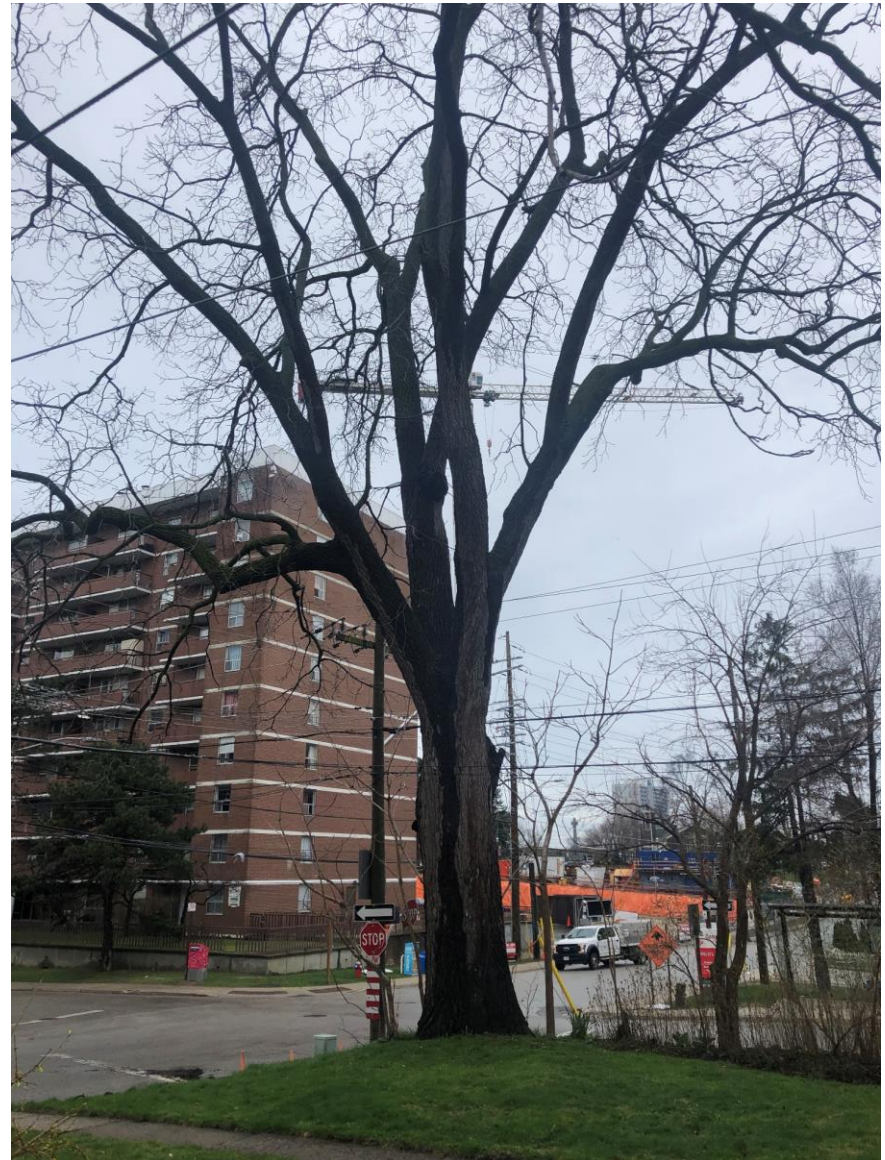
Image 24. Tree 700

700	Black Walnut	<i>Juglans nigra</i>	116	G	FG	G	F		10.0	Co-dominant stems at 3 metres, pruning wounds (L)	Remove
