**Tree Inventory and Preservation Plan Report  
128 Lakeshore Road East  
Mississauga, Ontario**

29 October 2021, revised 5 May 2022 and 24 July 2025

KUNTZ FORESTRY CONSULTING Inc. Project P4724

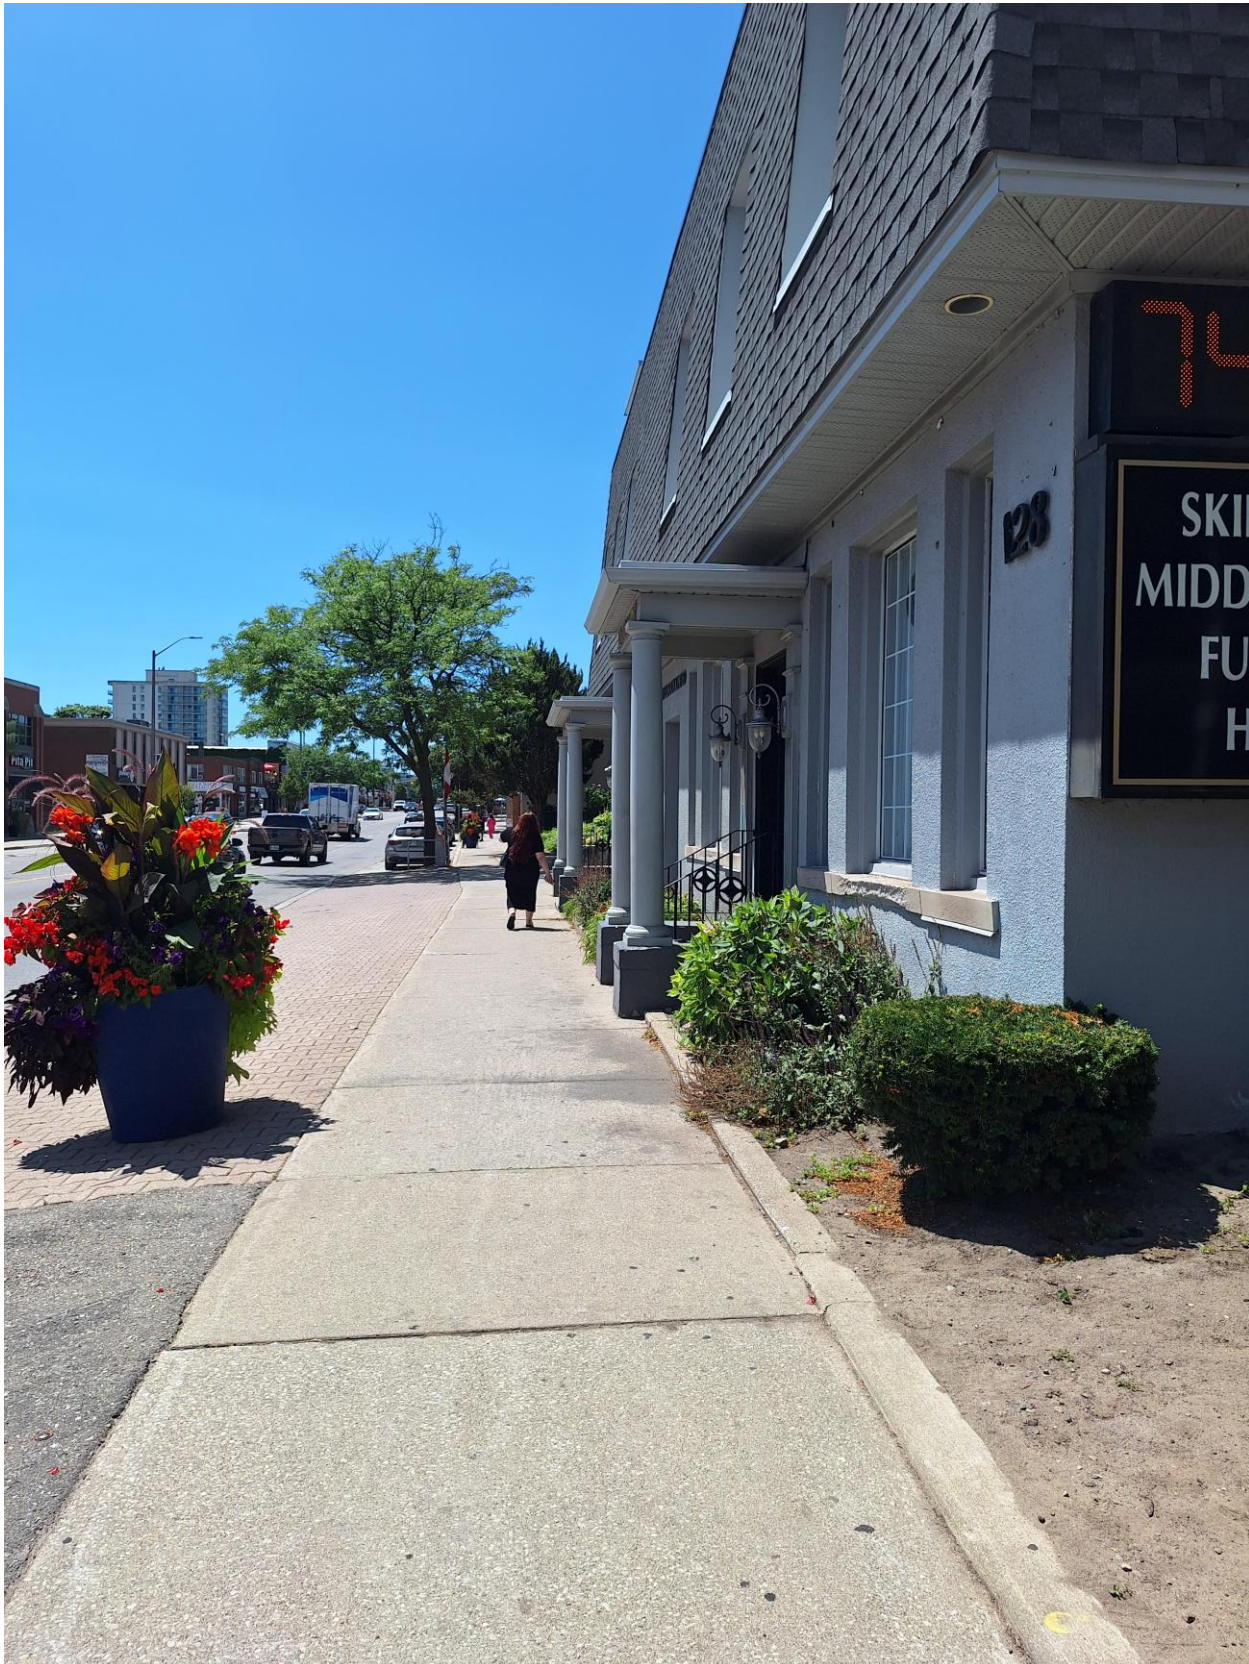
Image 1. Lakeshore Frontage

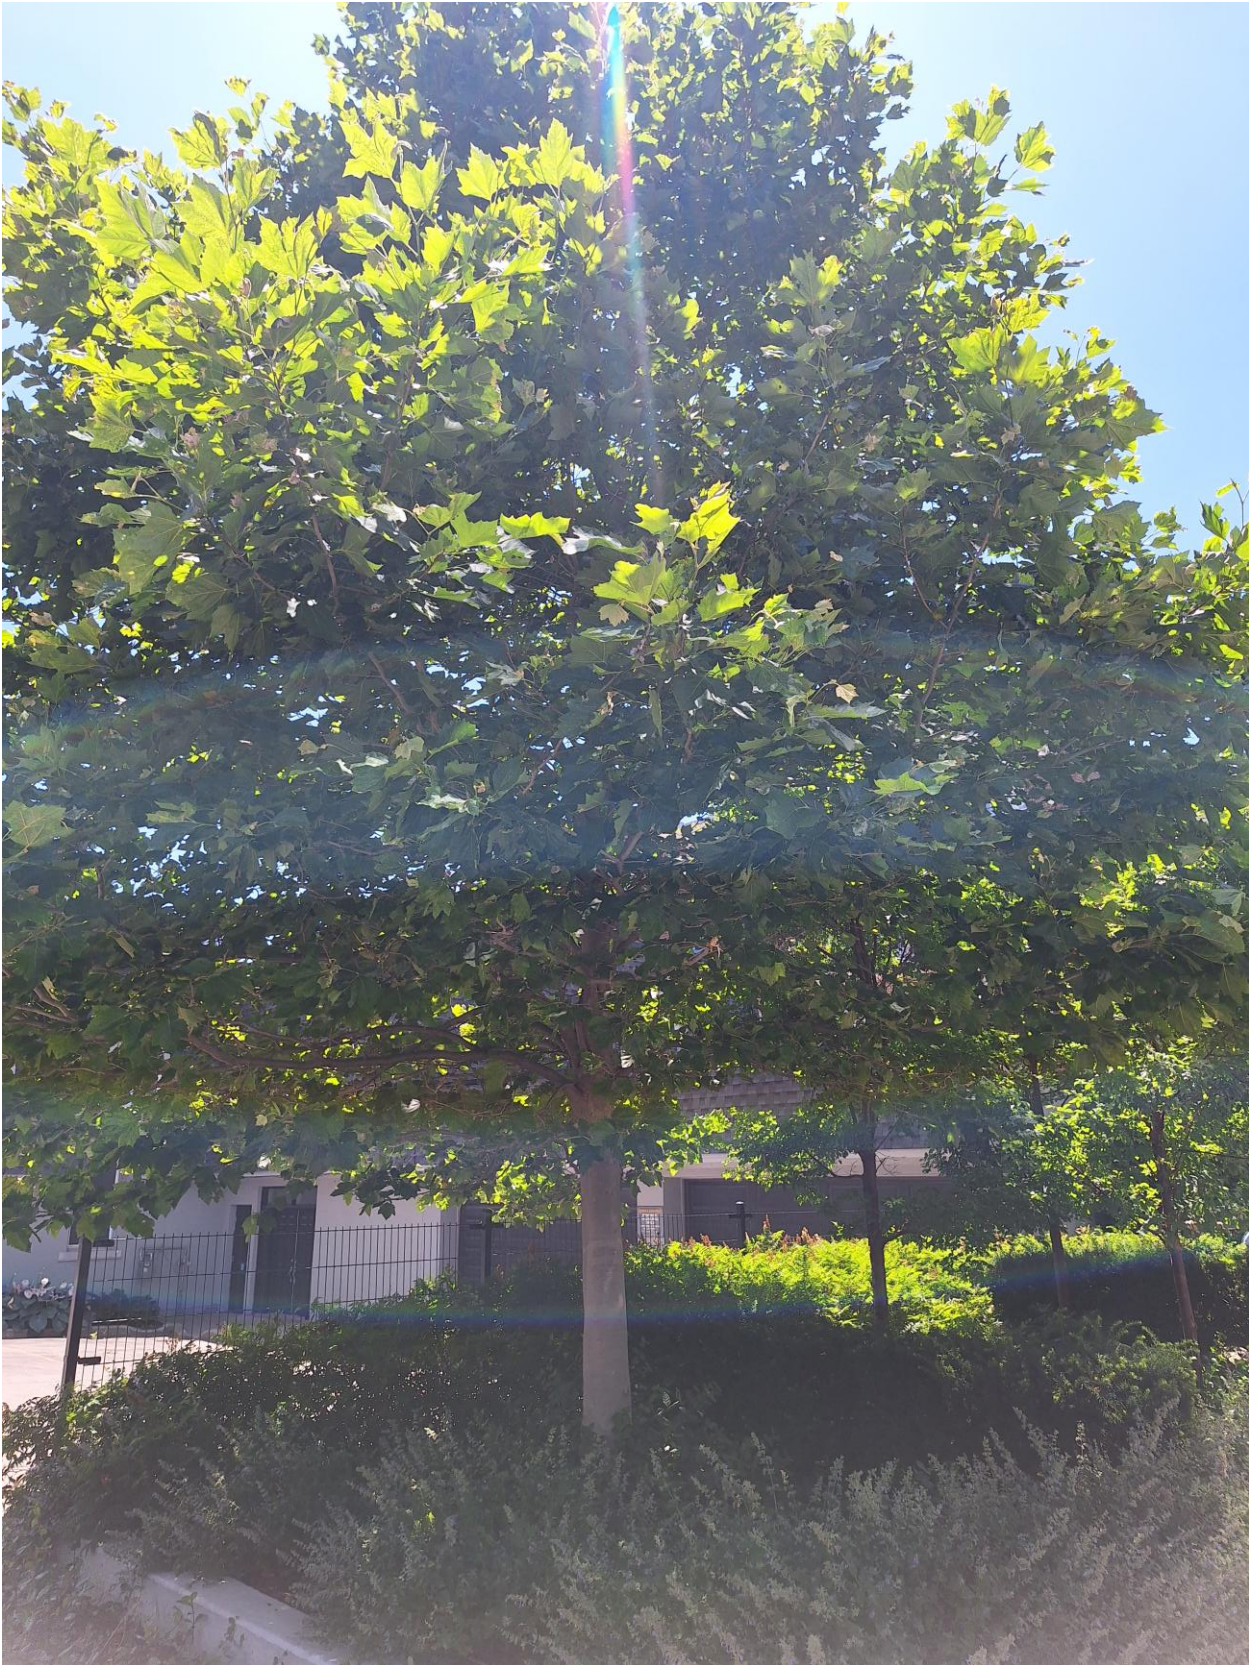
Image 2. Tree 1

The preservation of Tree 1 will be possible. Given that the dripline of Tree 1 is completely within the neighbouring property, tree preservation fence will not be required. Refer to Figure 1 for the proposed tree preservation and general Tree Protection Plan Note.

Tree #	Common Name	Scientific Name	DBH	TI	CS	CV	CDB	DL	mTPZ	Comments	Owner	Action
1	London Planetree	<i>Platanus x acerifolia</i>	19.5	G	G	G		3.5	1.5		Neighbour	Preserve
2	Serviceberry species	<i>Amelanchier sp.</i>	~1 - 5	G	G	G		1.0	1.5	Multistem at base with approximately 20 stems	City	Remove

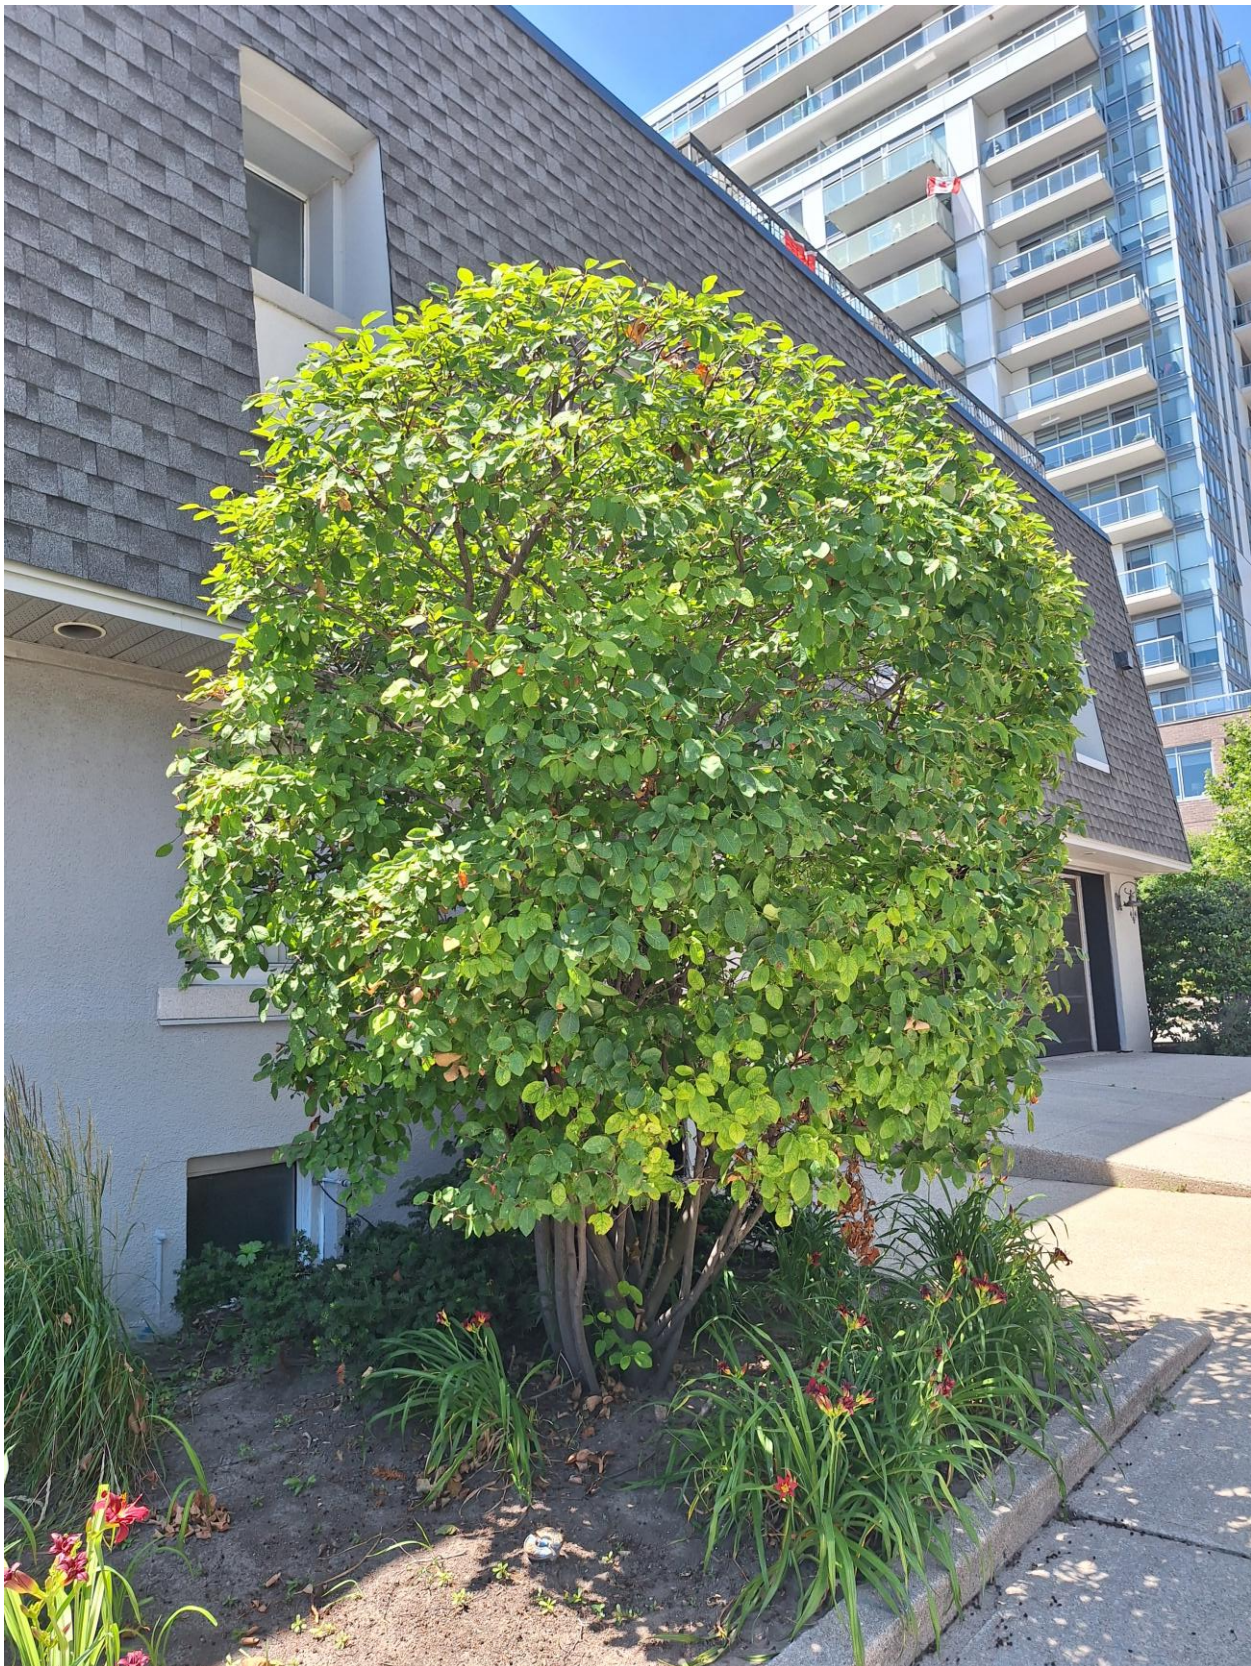
Image 3. Tree 2

The removal of Tree 2 is required as shoring for the underground parking is required at the property boundary. Tree 2 is a shrubby, multi-stemmed serviceberry tree planted in a small flower garden in front of the subject property – the tree is likely planted by the previous owner/tenants and not a city standard street tree. Per comments from City Arborist on 28 March 2022, Tree 2 is not considered a city boulevard tree and no permit will be required for its removal. Refer to Figure 1 for the locations of the proposed tree removals.

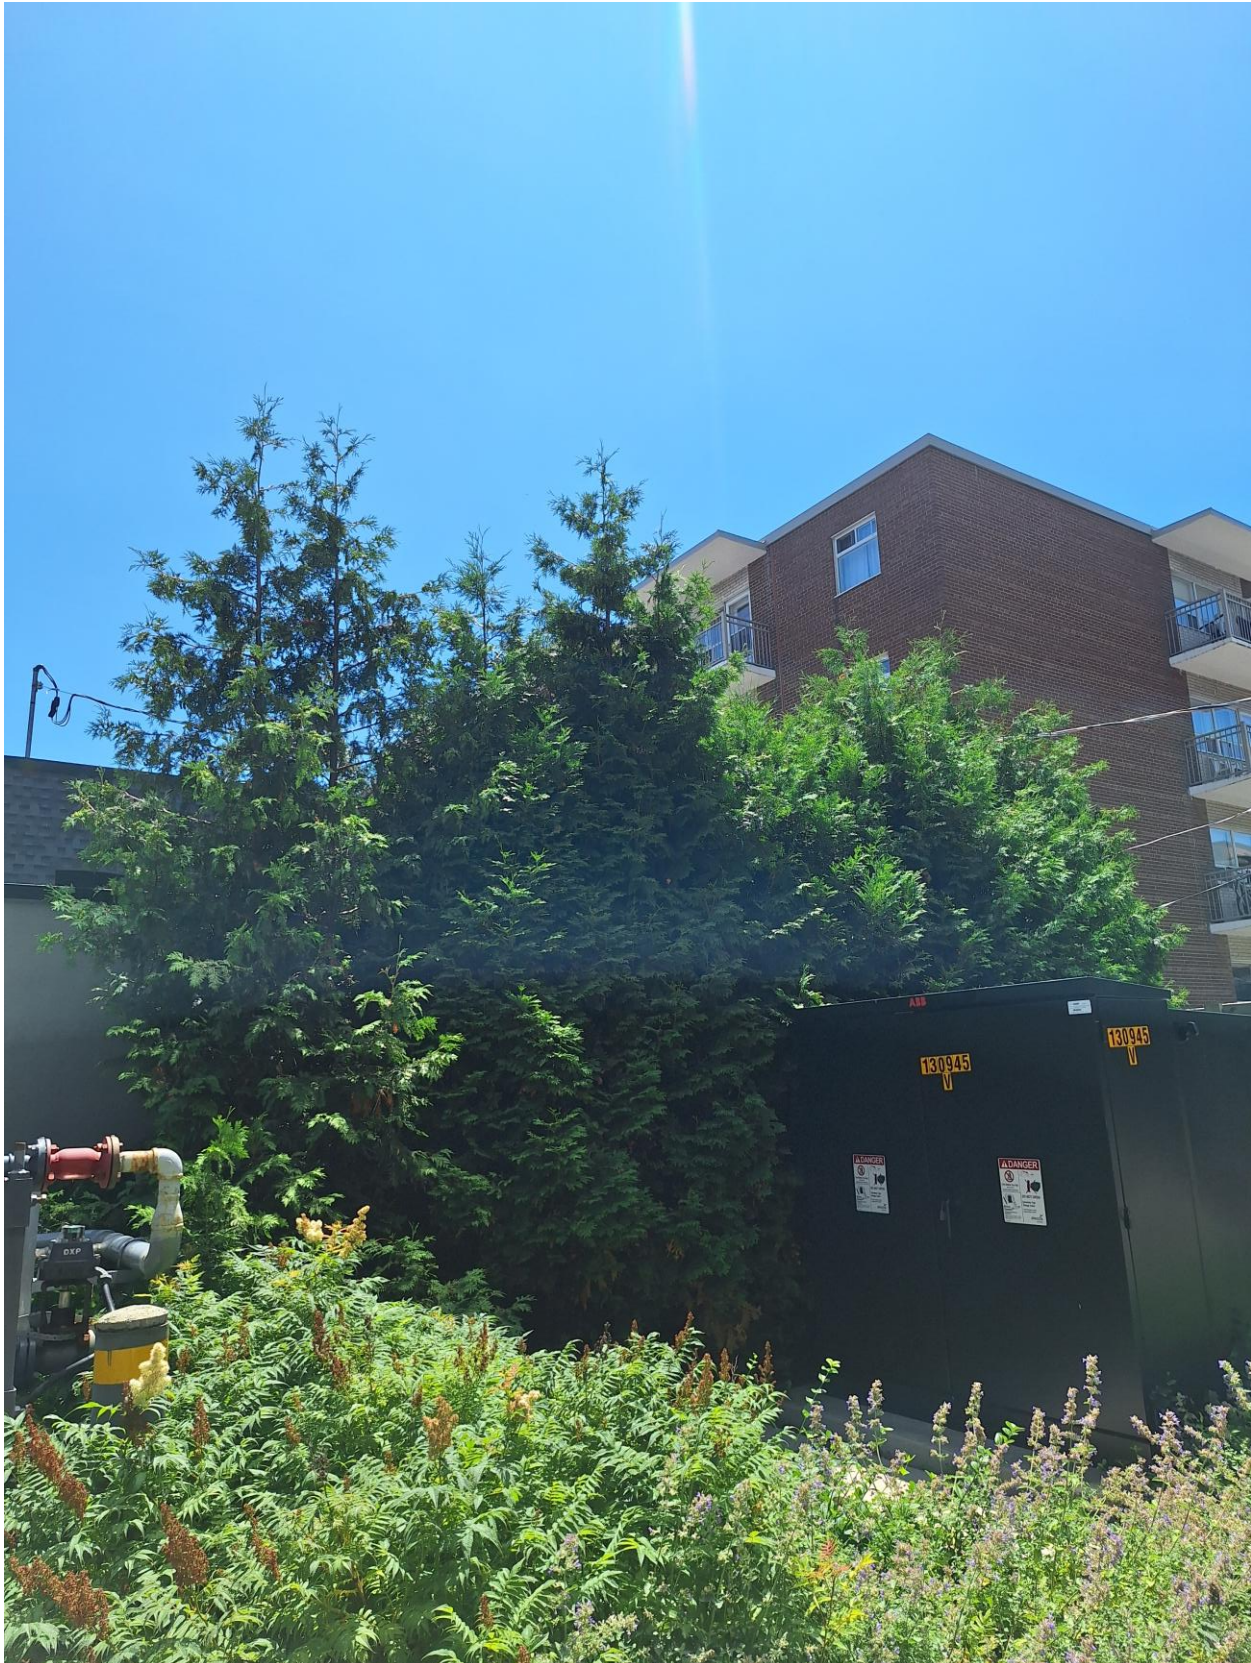
Image 4. Undersized Cedar Hedge

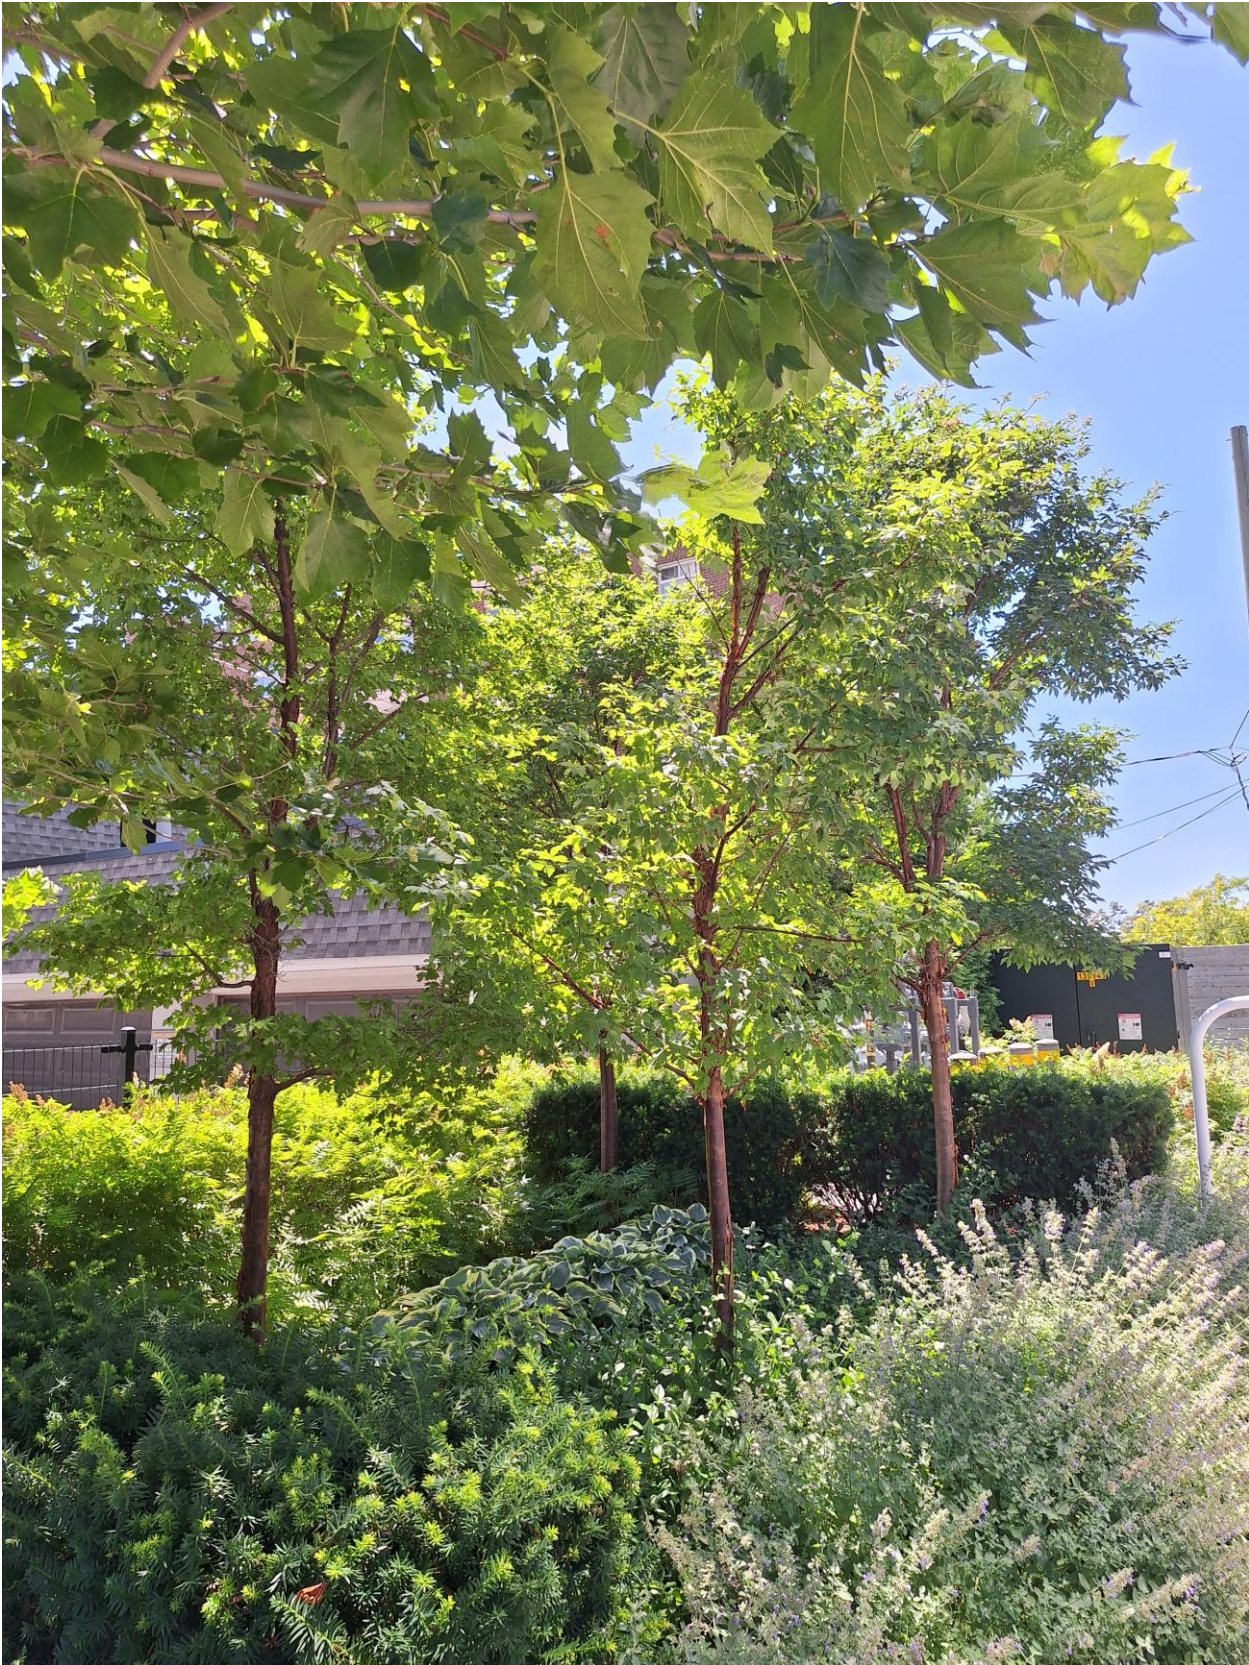
Image 5. Undersized Paperbark Maple
