**Tree Inventory and Preservation Plan
42 Park Street, 44 Park Street, 46 Park Street, and 23 Elizabeth Street
Mississauga, Ontario**

**SPA No.: SP 22-12 W1
OLT File No.: OLT-21-002260**

15 April 2020
Revision 1: 17 April 2020
Revision 2: 14 February 2023
Revision 3: 22 May 2025
Revision 4: 26 August 2025

KUNTZ FORESTRY CONSULTING INC. Project P2371

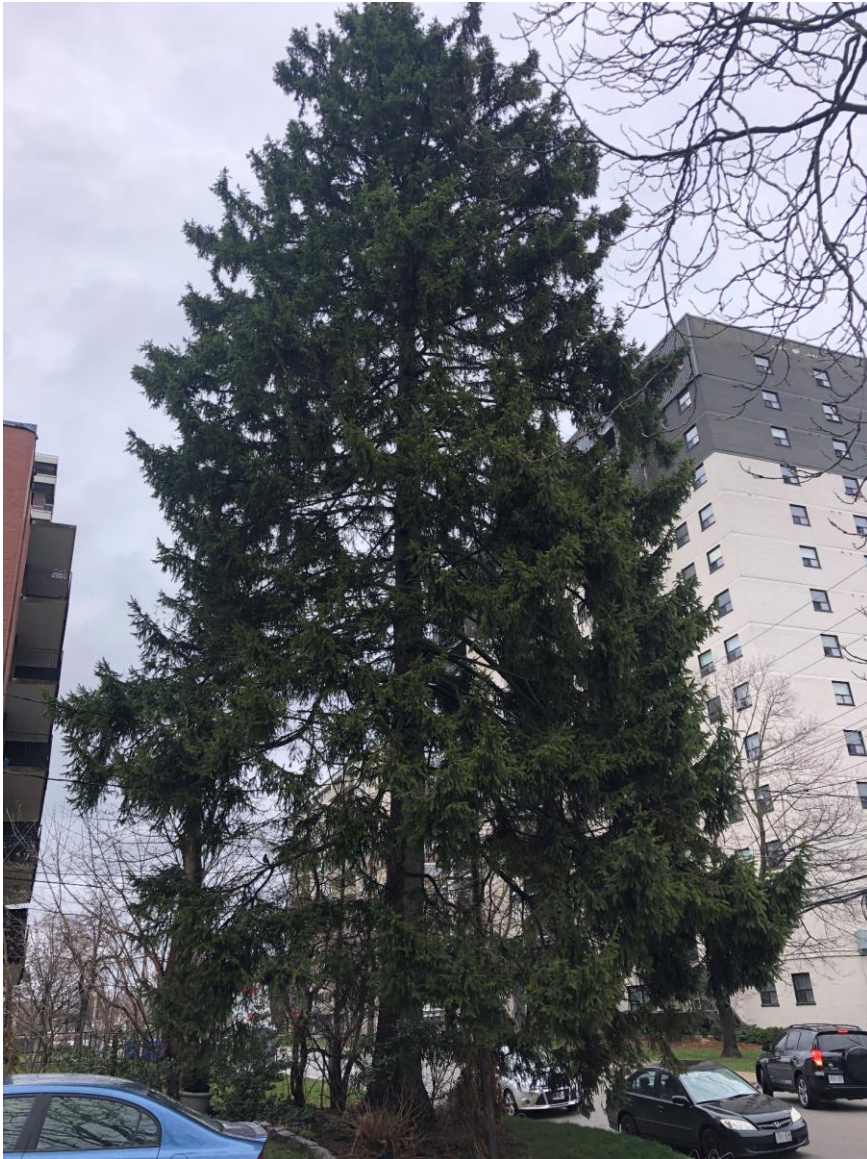
Image 1. Tree 673

Tree #	Common Name	Scientific Name	DBH	TI	CS	CV	RZE	CDB	DL	Comments	Owner	Action
673	White Spruce	<i>Picea glauca</i>	~65	G	G	G	FG		6.0	Included fence, exposed roots (M)	City	Remove
674	Manitoba Maple	<i>Acer negundo</i>	~40	P	P	P	F		2.5	Topped at 6 metres, epicormic branching (H), cavity (H)	Subject	Remove (Condition)
675	Weeping White Mulberry	<i>Morus alba</i> 'Pendula'	13	G	G	G	FG		1.5	Broken branches (L)	Subject	Remove
676	Manitoba Maple	<i>Acer negundo</i>	~30, ~20	P	P	P	F		4.0	Multiple stem failures, cavities (H), deadwood (H), epicormic branching (H), multi-stem at base, coppice growth (H), included fence, leaning on utility pole	Shared (Subject / Neighbour)	Remove (Condition)
677	Manitoba Maple	<i>Acer negundo</i>	~75	P	F	PF	PF		4.5	Pruning wounds (H), coppice growth (H), epicormic branching (H), included fence	Shared (Subject / Neighbour)	Remove (Condition)
678	Manitoba Maple	<i>Acer negundo</i>	13	F	F	FG	PF		4.5	Impervious surface in 50% of root zone	Shared (Subject / Neighbour)	Remove

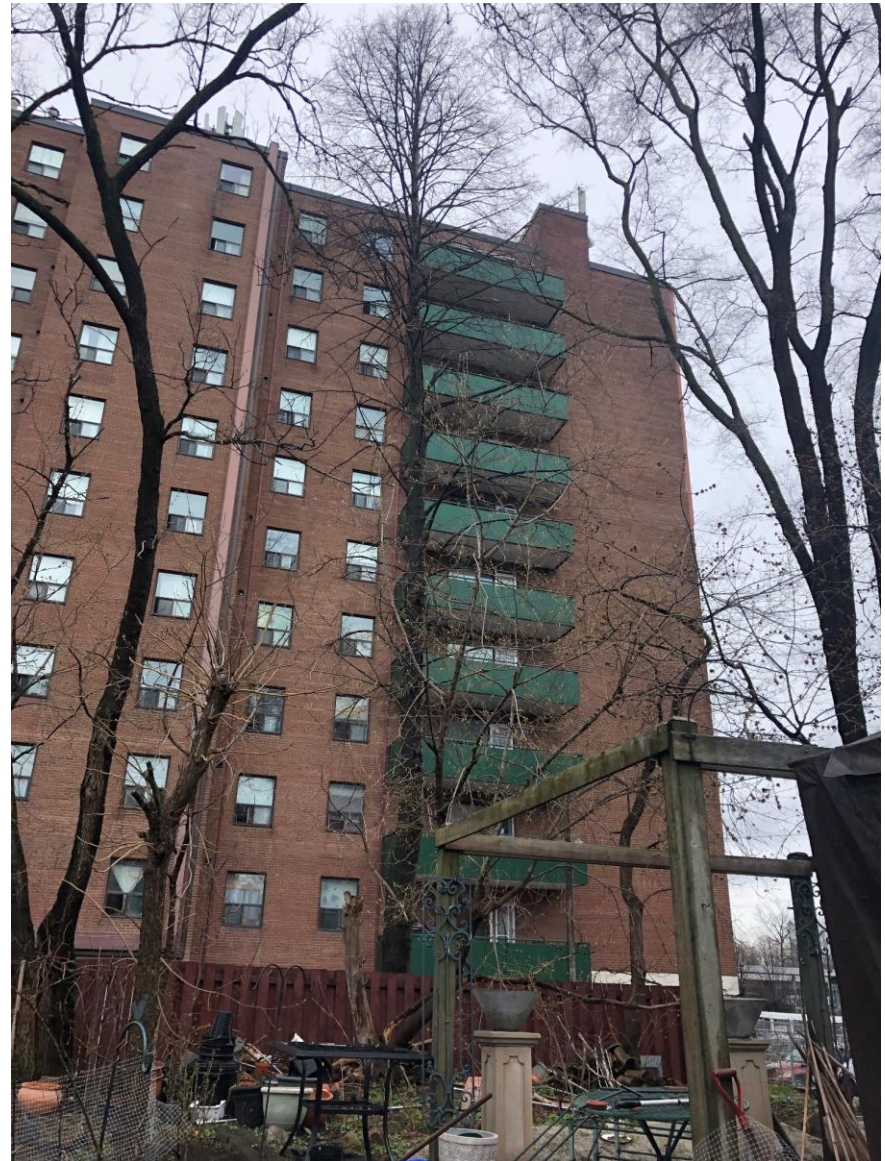
Image 8. Tree 681

Encroachment into the driplines of Trees 681 and 685 will be required to facilitate the construction of a proposed retaining wall. If the following mitigation measures are employed, long-term adverse effects are not anticipated for these trees.

1. Air-spade or low-pressure hydro-vacuum technology should be used to excavate trenches in the locations indicated on Figure 1, under the supervision of a Certified Arborist.

2. The depth of the trenches will depend on the depth of excavation required to construct the proposed retaining wall, to a maximum depth of 90cm, or as determined by the conditions encountered.
3. Any roots that require pruning within the trenches should be pruned by a Certified Arborist in accordance with Good Arboricultural Standards.
4. The trenches should be backfilled with clean topsoil.
5. Any branches that require pruning to accommodate the proposed works should be pruned by a Certified Arborist or other tree professional in accordance with Good Arboricultural Standards.

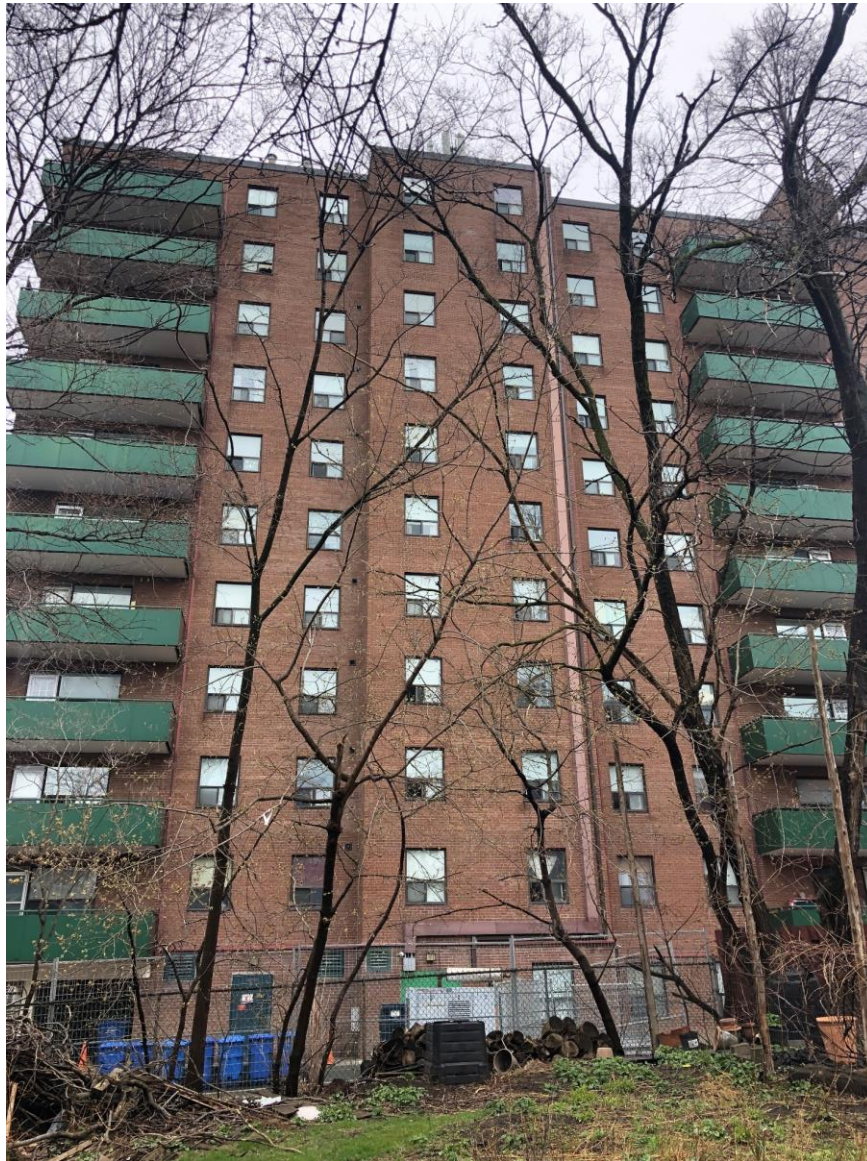
Image 11. Trees 685 – 687

685	Manitoba Maple	<i>Acer negundo</i>	12	F	F	FG	PF		2.5	Pruning wounds (M), impervious surface in 50% of root zone, included fence	Neighbour	Preserve (Injure)
686	Manitoba Maple	<i>Acer negundo</i>	12, 6, 6	F	F	F	F		4.0	Coppice growth (H), lean (L), pruning wounds (H), deadwood (M)	Neighbour	Remove
687	Little-leaf Linden	<i>Tilia cordata</i>	16	G	G	FG	F		4.0		Neighbour	Remove
688	Siberian Elm	<i>Ulmus pumila</i>	33	PF	F	FG	F		5.0	Co-dominant stems at 2 metres, broken branches (L), included fence, girdling trunk (H) from fence, epicormic branching (L)	Subject	Remove
689	Cherry species	<i>Prunus spp.</i>	32	F	PF	F	F		6.0	Pruning wounds (H), sweep (L), debris in root zone, epicormic branching (M)	Subject	Remove
690	Cherry species	<i>Prunus spp.</i>	31	F	PF	F	FG		4.5	Pruning wounds (H), co-dominant stems at 1.5 metres, broken branches (L)	Subject	Remove
691	Tree-of-Heaven	<i>Ailanthus altissima</i>	~95	F	FG	FG	F		9.0	Seams (L), cavity (L) from pruning wound, pruning wounds (M), included fence, clothesline pulley inserted into trunk, vine competition (L)	Subject	Remove

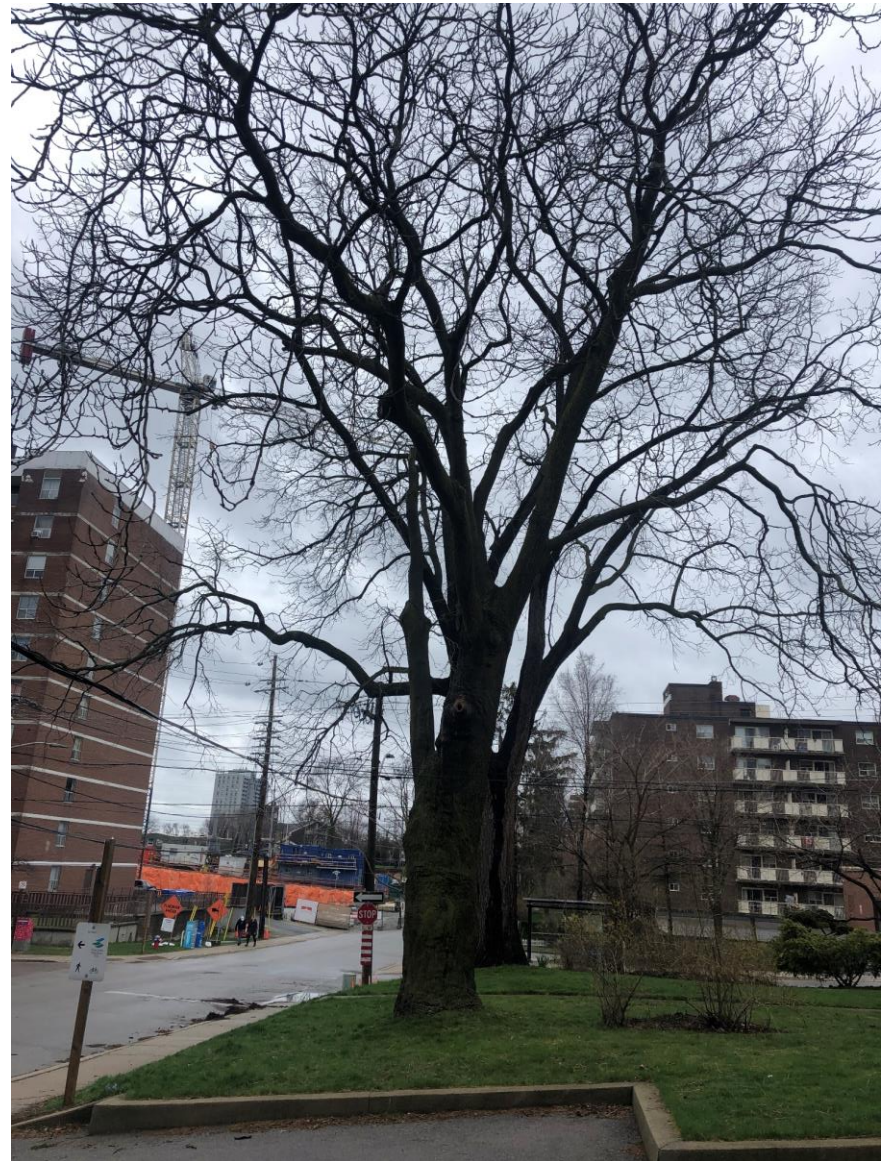
Image 16. Tree 692

692	Tree-of-Heaven	<i>Ailanthus altissima</i>	110	F	F	F	F		9.0	One stem dead, asymmetrical crown (M), pruning wounds (M), cavity (L)	Shared (Subject / City)	Remove
693	Siberian Elm	<i>Ulmus pumila</i>	3	G	FG	G	F		0.5		City	Remove
694	White Mulberry	<i>Morus alba</i>	~15, ~8, ~8	F	F	F	F		2.5	Multi-stem at base, pruning wounds (M), included bark (M), epicormic branching (H), lean (L)	City	Preserve (Injure)
695	Eastern White Cedar	<i>Thuja occidentalis</i>	27, 27	P	PF	FG	PF		3.5	Co-dominant stems at base, included bark (M), cavity (H) at union, one stem topped at 6 metres, pruning wounds (M)	City	Remove (Condition)
696	Weeping White Mulberry	<i>Morus alba</i> 'Pendula'	11	G	FG	G	F		1.0	Broken branches (L), included bark (L)	City	Remove
697	Manitoba Maple	<i>Acer negundo</i>	64	PF	PF	PF	F		6.0	Pruning wounds (H), epicormic branching (H), asymmetrical crown (M), seams (M), cavities (M), cavity (H) where large stem was previously pruned, broken branches (L)	City	Remove (Condition)

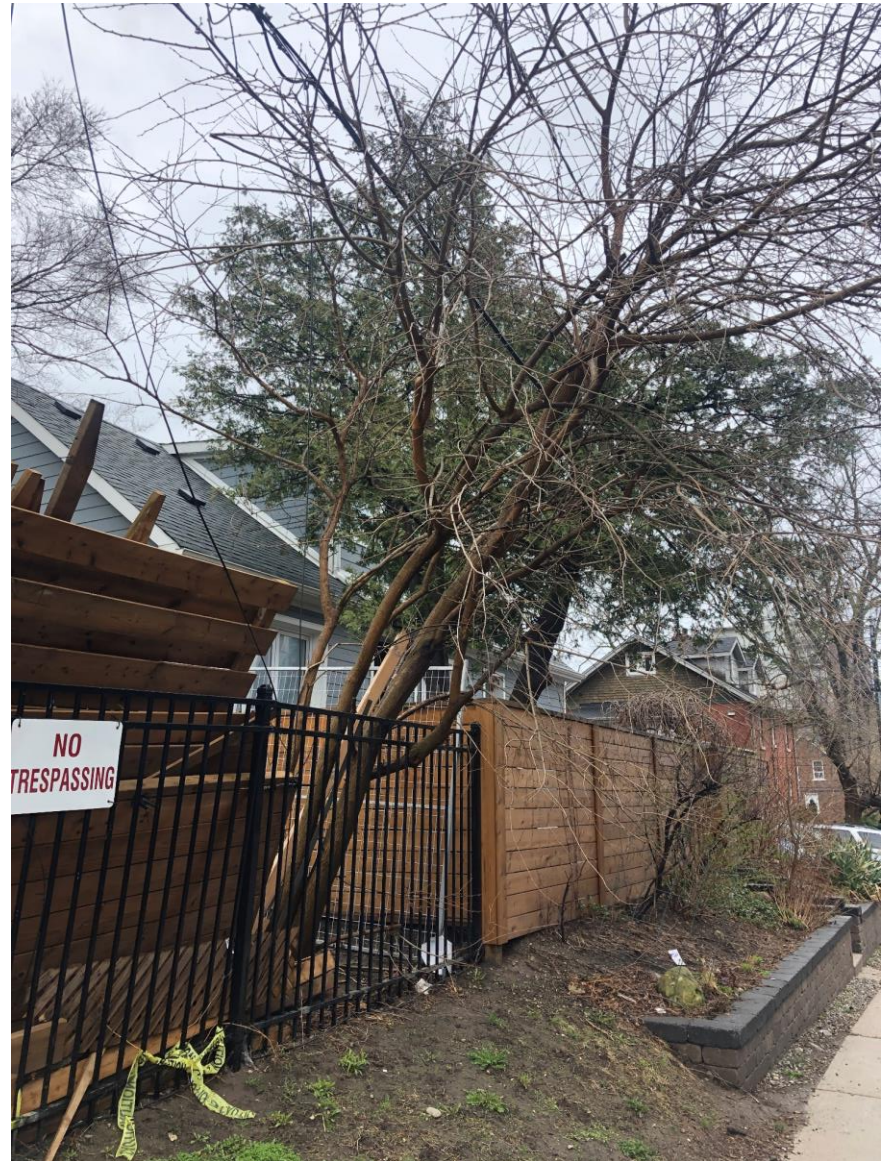
Image 18. Tree 694

Encroachment into the dripline of Tree 694 will be required to facilitate the proposed regrading works. If the following mitigation measures are employed, long-term adverse effects are not anticipated for this tree.

1. Prior to the commencement of the proposed works, tree preservation fencing should be installed as shown on Figure 1.
2. Where filling is required within the dripline of this tree, the depth of fill should be minimized as much as possible.
3. Where cutting is required within the dripline of this tree, it should occur by hand or using small machinery (i.e. a skidsteer or miniature excavator) and under the supervision of a Certified Arborist.
 - a. Any roots encountered during the cutting process should be pruned by a Certified Arborist in accordance with Good Arboricultural Standards.

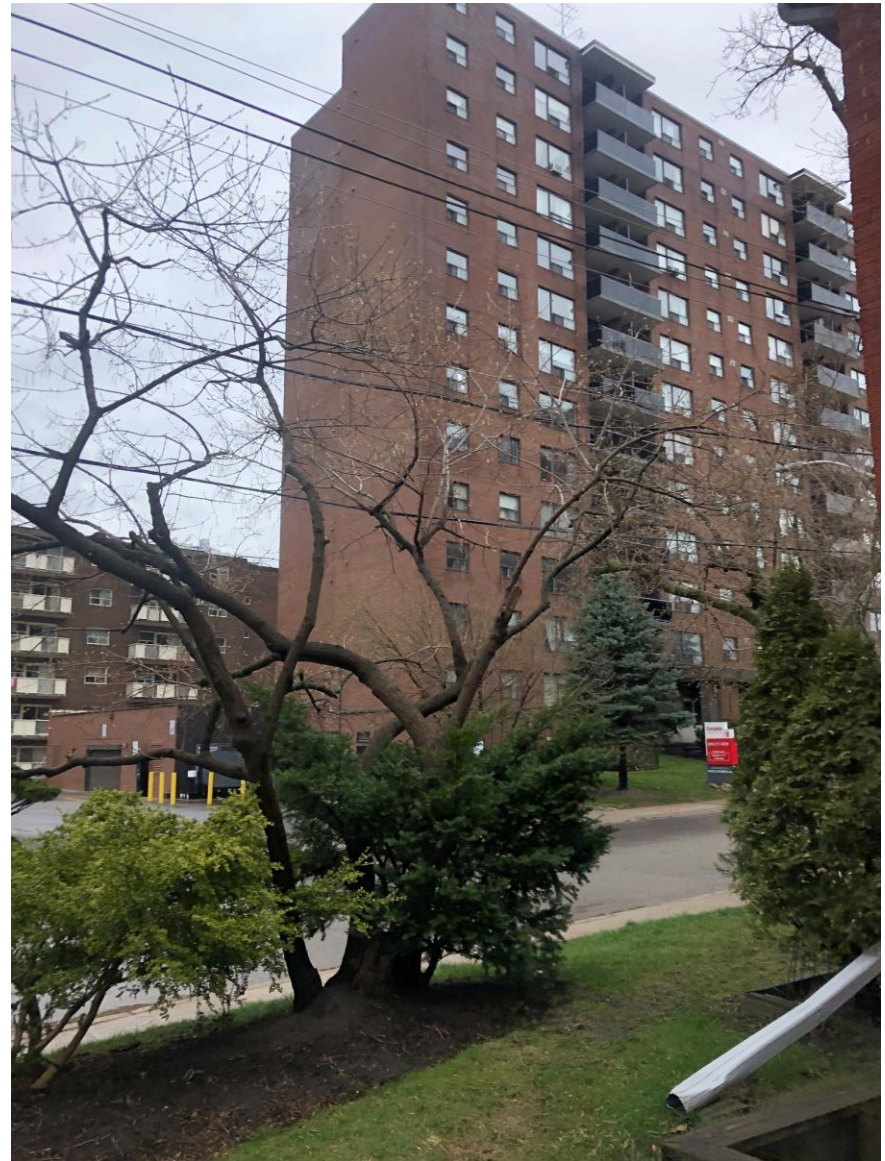
Image 22. Tree 698

698	Manitoba Maple	<i>Acer negundo</i>	18, 15, 11	F	PF	F	FG		4.0	Multi-stem at base, one stem pruned at base, pruning wounds (M), broken branches (L)	City	Remove
699	Manitoba Maple	<i>Acer negundo</i>	15, 14	F	F	FG	FG		2.5	Pruning wounds (M), co-dominant stems at 0.25 metres, included bark (H), epicormic branching (M)	Subject	Remove
700	Black Walnut	<i>Juglans nigra</i>	116	G	FG	G	F		10.0	Co-dominant stems at 3 metres, pruning wounds (L)	Subject	Remove
