ATTACHMENT TO THE TREE INVENTORY/ PRESERVATION PLAN

SUBJECT: Arborist Report for 50 High Street E, Mississauga, proposed Townhouse Development

**ARBORIST REPORT**

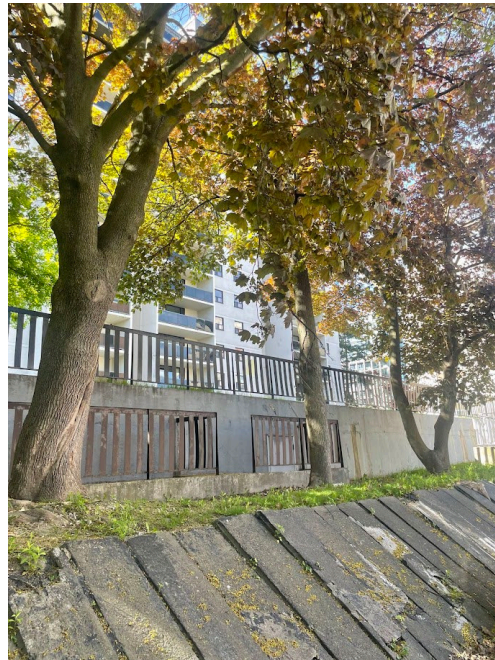
Because the slope and the parking area at the rear of the ex. building are paved (see photo #2, 3, 5, 6) the extend of the roots of the trees #1-6 (Norway Maples) cannot be assess at this time. It is recommended that before any earth works take place on site, a min. 0.3m wide trench to be dug at the limit of grading using a HVAC; small roots can be clear cut by a certified arborist.

**Photo 2:** Trees #1-3 (numbered right to left) on top of slope at rear of property.

However, avoid cutting large roots, thicker than 2-3cm in the TPZ. If large roots are present, plant beds or a permeable surface to be considered in this area; otherwise, the trees cannot be retained.

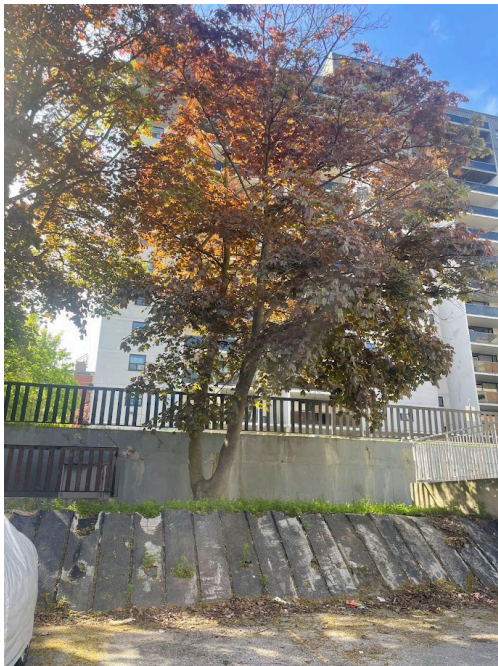
**Photo 3:** Tree #1

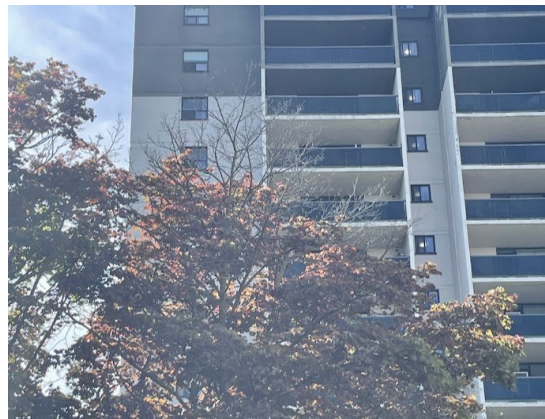
**Photos 4:** Tree #1 on top of slope at rear of property showing dieback on select top branches.

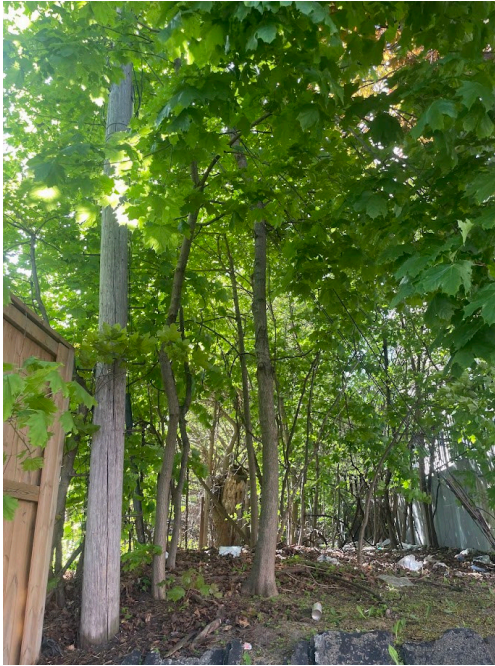
**Photo 5:** Trees #4-5 atop slope at rear of property.

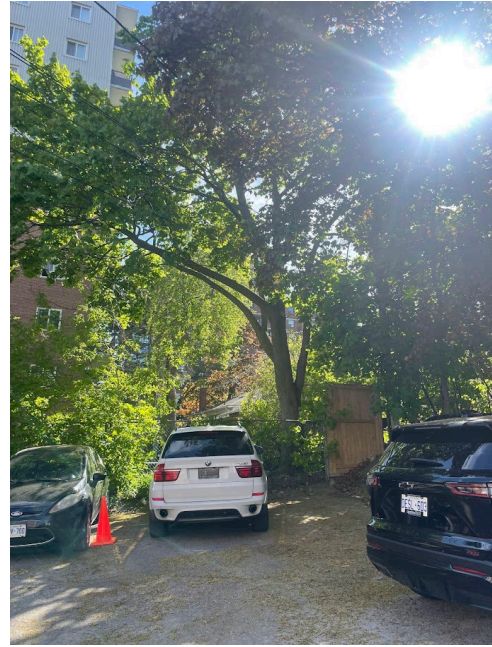
**Photo 6:** Tree #6 beyond chain-link fence on neighbor's side.

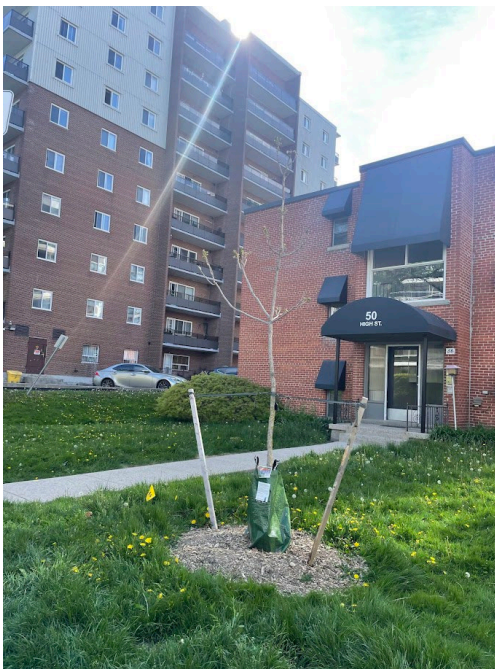
**Photo 7:** Tree #7, newly planted deciduous tree to be removed and replaced.

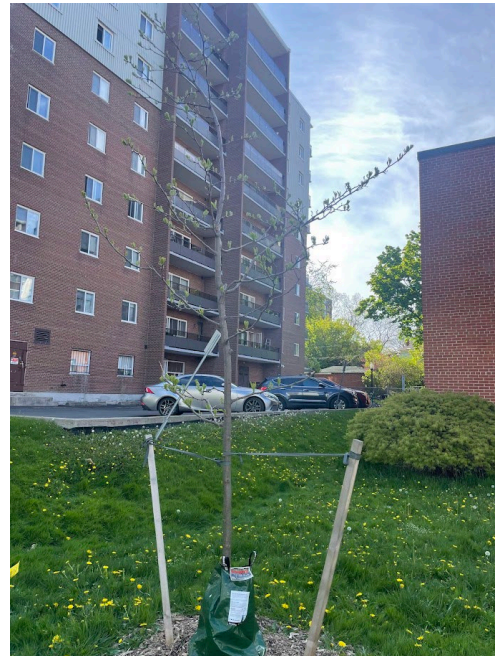
**Photo 8:** Tree #8 to be transplanted

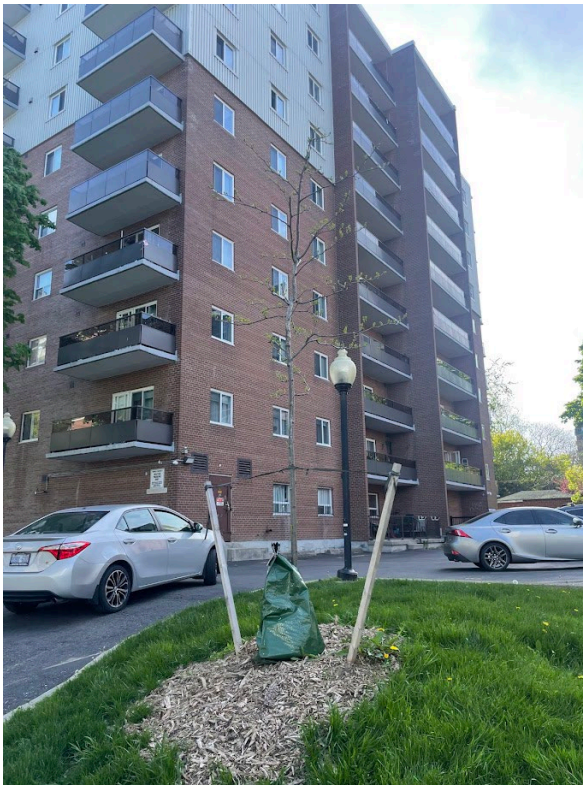
**Photo 9:** Tree #9 on adjacent property, to be preserved.
