# ARBORIST REPORT & TREE PROTECTION PLAN

**900 LAKESHORE ROAD WEST**  
MISSISSAUGA, ON  
L5H 1H9

Date: January 25, 2024

Revised: January 30, 2026

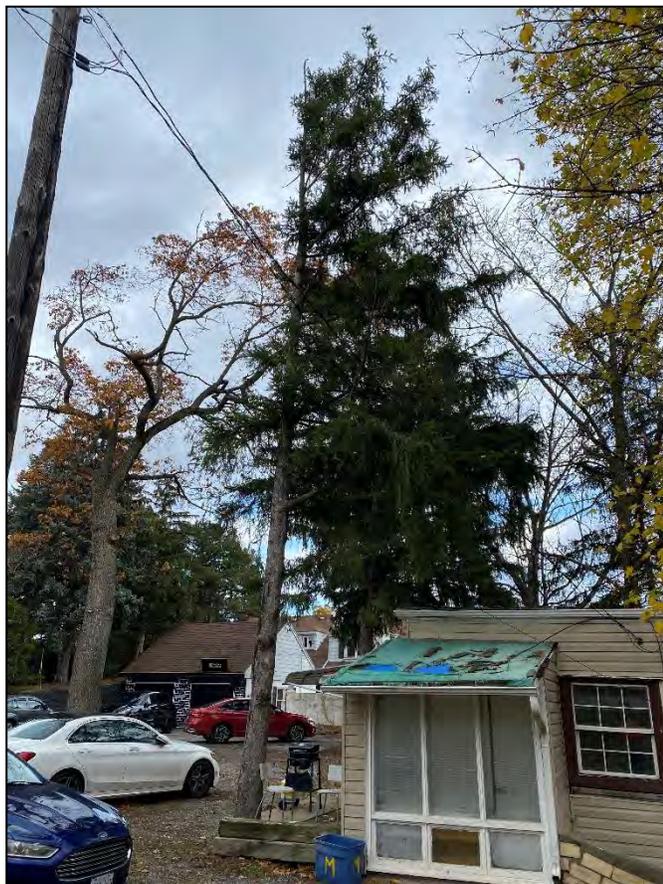
Tree #	Tree Species	Botanical Name	DBH (cm)	Root Zone	Trunk Integrity	Crown Structure	Crown Vitality	Overall Condition
389	Norway Spruce	<i>Picea abies</i>	34	Fair	Fair	Poor	Fair	Fair

Tree #389, a 34cm DBH Norway Spruce (*Picea abies*) is a privately owned evergreen tree growing in the west portion of the property. This tree has an uneven crown, unhealed trunk wounds, dieback and deadwood. Overall this tree is in fair condition.

Due to the location that this tree is growing and the proposed construction, this tree is recommended for removal. A permit is required for the removal of this tree.

Two (2) replacement trees will require to be planted as compensation. The compensation trees should be at least 6cm diameter (deciduous), or at least 1.8m tall (evergreen). Tree species and quantities will be included in the landscape design drawings.

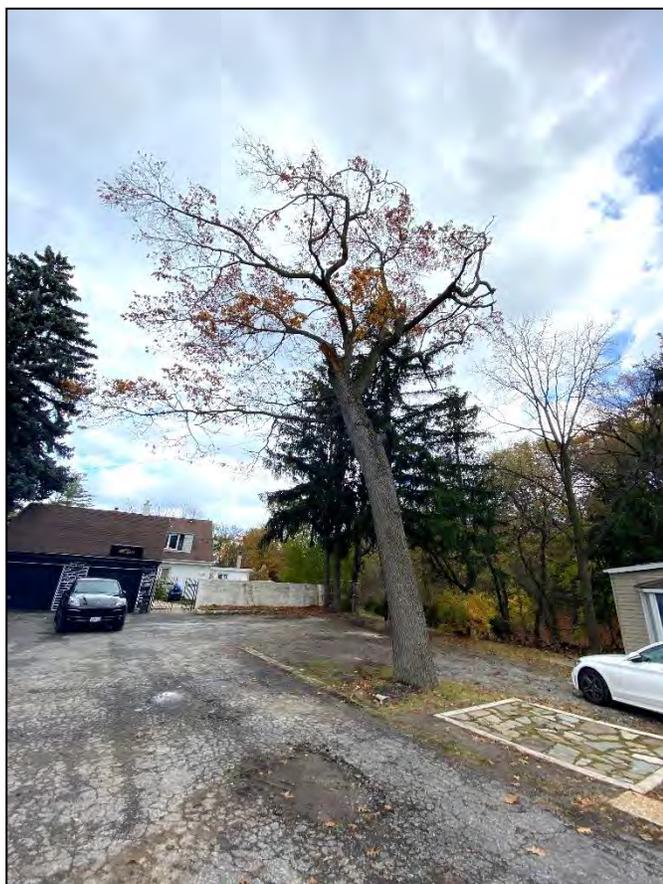
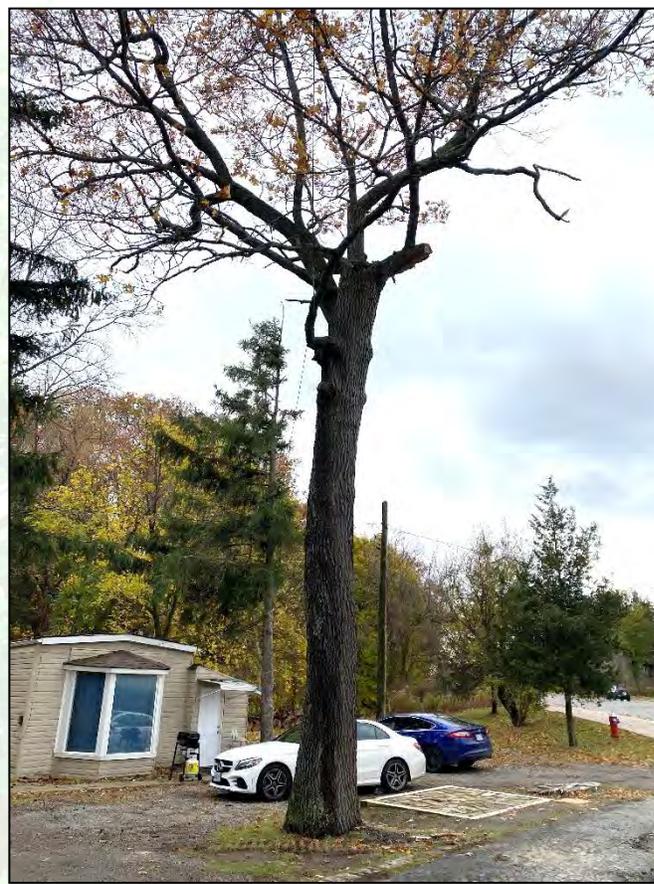
### Tree #390 – Red Oak (79cm DBH)

Tree #	Tree Species	Botanical Name	DBH (cm)	Root Zone	Trunk Integrity	Crown Structure	Crown Vitality	Overall Condition
390	Red Oak	<i>Quercus rubra</i>	79	Fair	Poor	Fair	Fair	Fair

Tree #390, a 79cm DBH Red Oak (*Quercus rubra*) is a privately owned deciduous tree growing in the west portion of the property. This tree is growing on a lean, has unhealed trunk wounds, cavities with decay, and has been topped. Overall this tree is in fair condition.

Due to the location that this tree is growing and the proposed construction, this tree is recommended for removal. A permit is required for the removal of this tree.

Five (5) replacement trees will require to be planted as compensation. The compensation trees should be at least 6cm diameter (deciduous), or at least 1.8m tall (evergreen). Tree species and quantities will be included in the landscape design drawings.

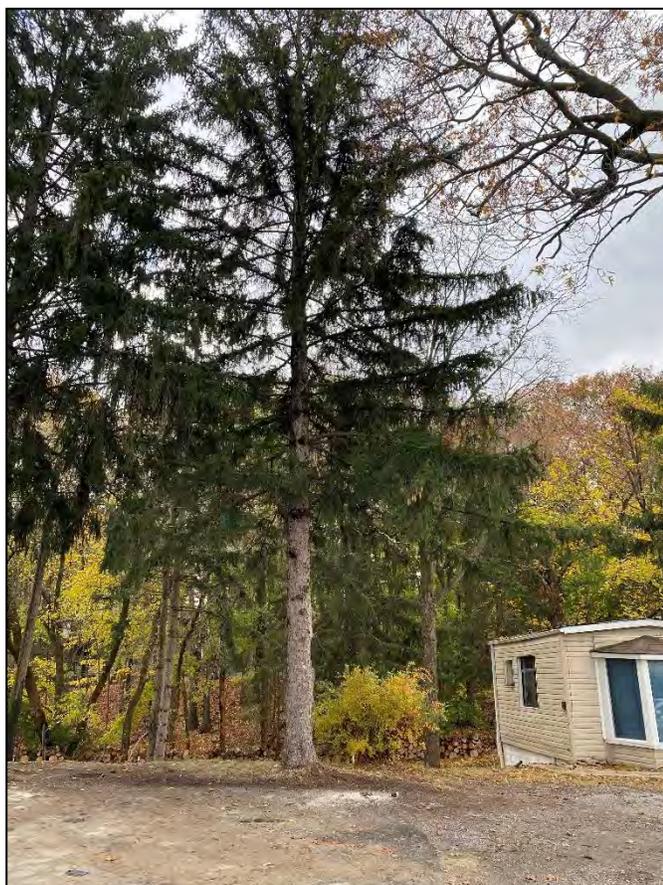
### Tree #391 – Norway Spruce (49cm DBH)

Tree #	Tree Species	Botanical Name	DBH (cm)	Root Zone	Trunk Integrity	Crown Structure	Crown Vitality	Overall Condition
391	Norway Spruce	<i>Picea abies</i>	49	Good	Good	Good	Good	Good

Tree #391, a 49cm DBH Norway Spruce (*Picea abies*) is a privately owned evergreen tree growing in the west portion of the property. This tree has exposed and girdling roots, and unhealed pruning wounds. Overall this tree is in good condition.

Due to the location that this tree is growing and the proposed construction, this tree is recommended for removal. A permit is required for the removal of this tree.

Three (3) replacement trees will require to be planted as compensation. The compensation trees should be at least 6cm diameter (deciduous), or at least 1.8m tall (evergreen). Tree species and quantities will be included in the landscape design drawings.

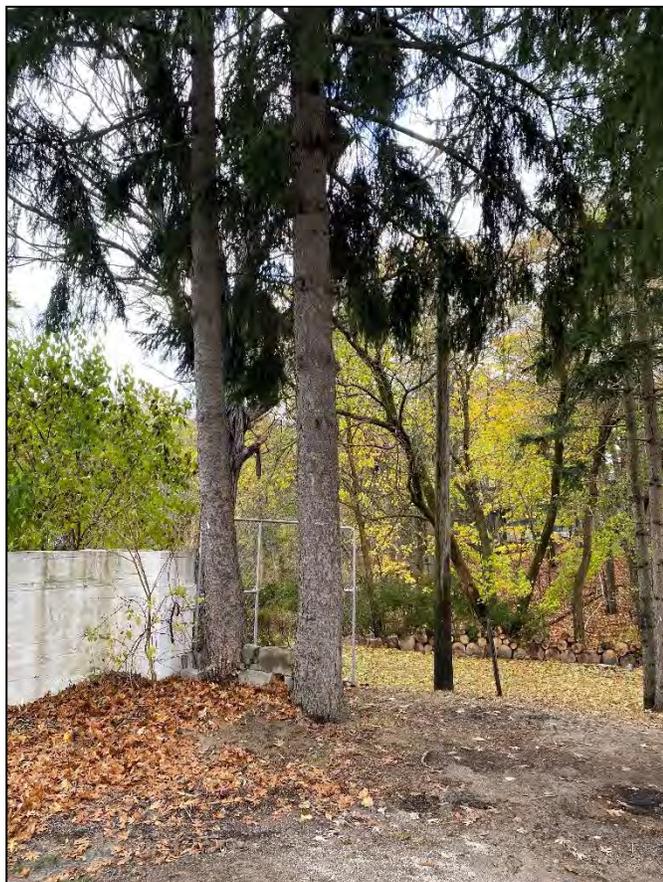
### Tree #392 – Norway Spruce (40cm DBH)

Tree #	Tree Species	Botanical Name	DBH (cm)	Root Zone	Trunk Integrity	Crown Structure	Crown Vitality	Overall Condition
392	Norway Spruce	<i>Picea abies</i>	40	Fair	Fair	Good	Good	Fair

Tree #392, a 40cm DBH Norway Spruce (*Picea abies*) is a privately owned evergreen tree growing in the west portion of the property. This tree is growing into a stone wall and has exposed and girdling roots, and unhealed pruning wounds. Overall this tree is in fair condition.

Due to the location that this tree is growing and the proposed construction, this tree is recommended for removal. A permit is required for the removal of this tree.

Two (2) replacement trees will require to be planted as compensation. The compensation trees should be at least 6cm diameter (deciduous), or at least 1.8m tall (evergreen). Tree species and quantities will be included in the landscape design drawings.

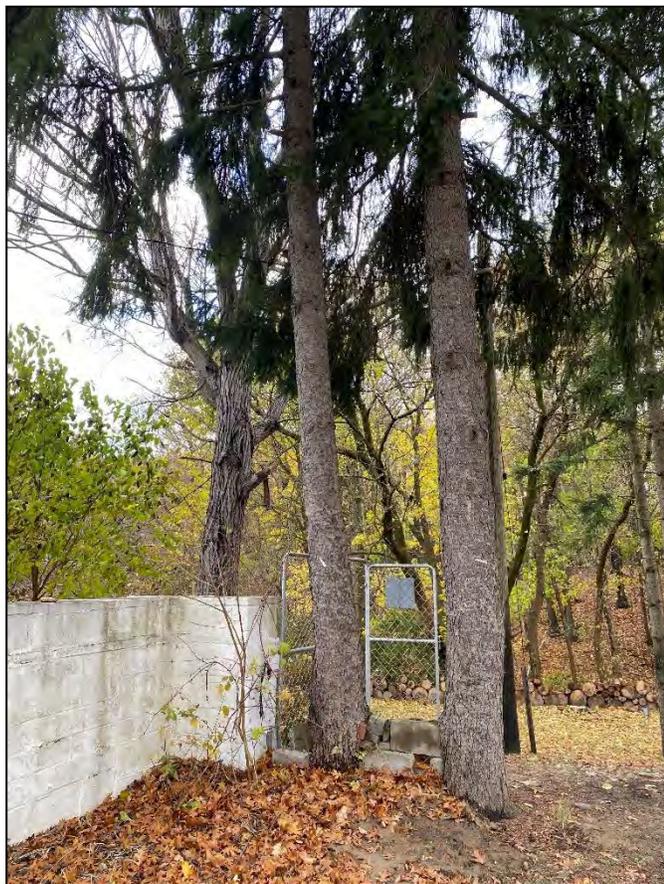
### Tree #393 – Norway Spruce (33cm DBH)

Tree #	Tree Species	Botanical Name	DBH (cm)	Root Zone	Trunk Integrity	Crown Structure	Crown Vitality	Overall Condition
393	Norway Spruce	<i>Picea abies</i>	33	Fair	Fair	Good	Good	Fair

Tree #393, a 33cm DBH Norway Spruce (*Picea abies*) is a privately owned evergreen tree growing in the west portion of the property. This tree is growing into a stone wall, has exposed and girdling roots, and unhealed pruning wounds. Overall this tree is in fair condition.

Due to the location that this tree is growing and the proposed construction, this tree is recommended for removal. A permit is required for the removal of this tree.

Two (2) replacement trees will require to be planted as compensation. The compensation trees should be at least 6cm diameter (deciduous), or at least 1.8m tall (evergreen). Tree species and quantities will be included in the landscape design drawings.
