TREE PROTECTION PLAN
1:200

Thorny Brae Residential
1765, 1775 Thorny Brae Place
Mississauga, ON

Tree Protection Plan

Date	Issued
January 2025	
Job Number	Drawn By
BTI-1767	DA
Scale	Checked By
1:200	JW
Sheet Number	File Number
TS.3 of 4	FILE NO.

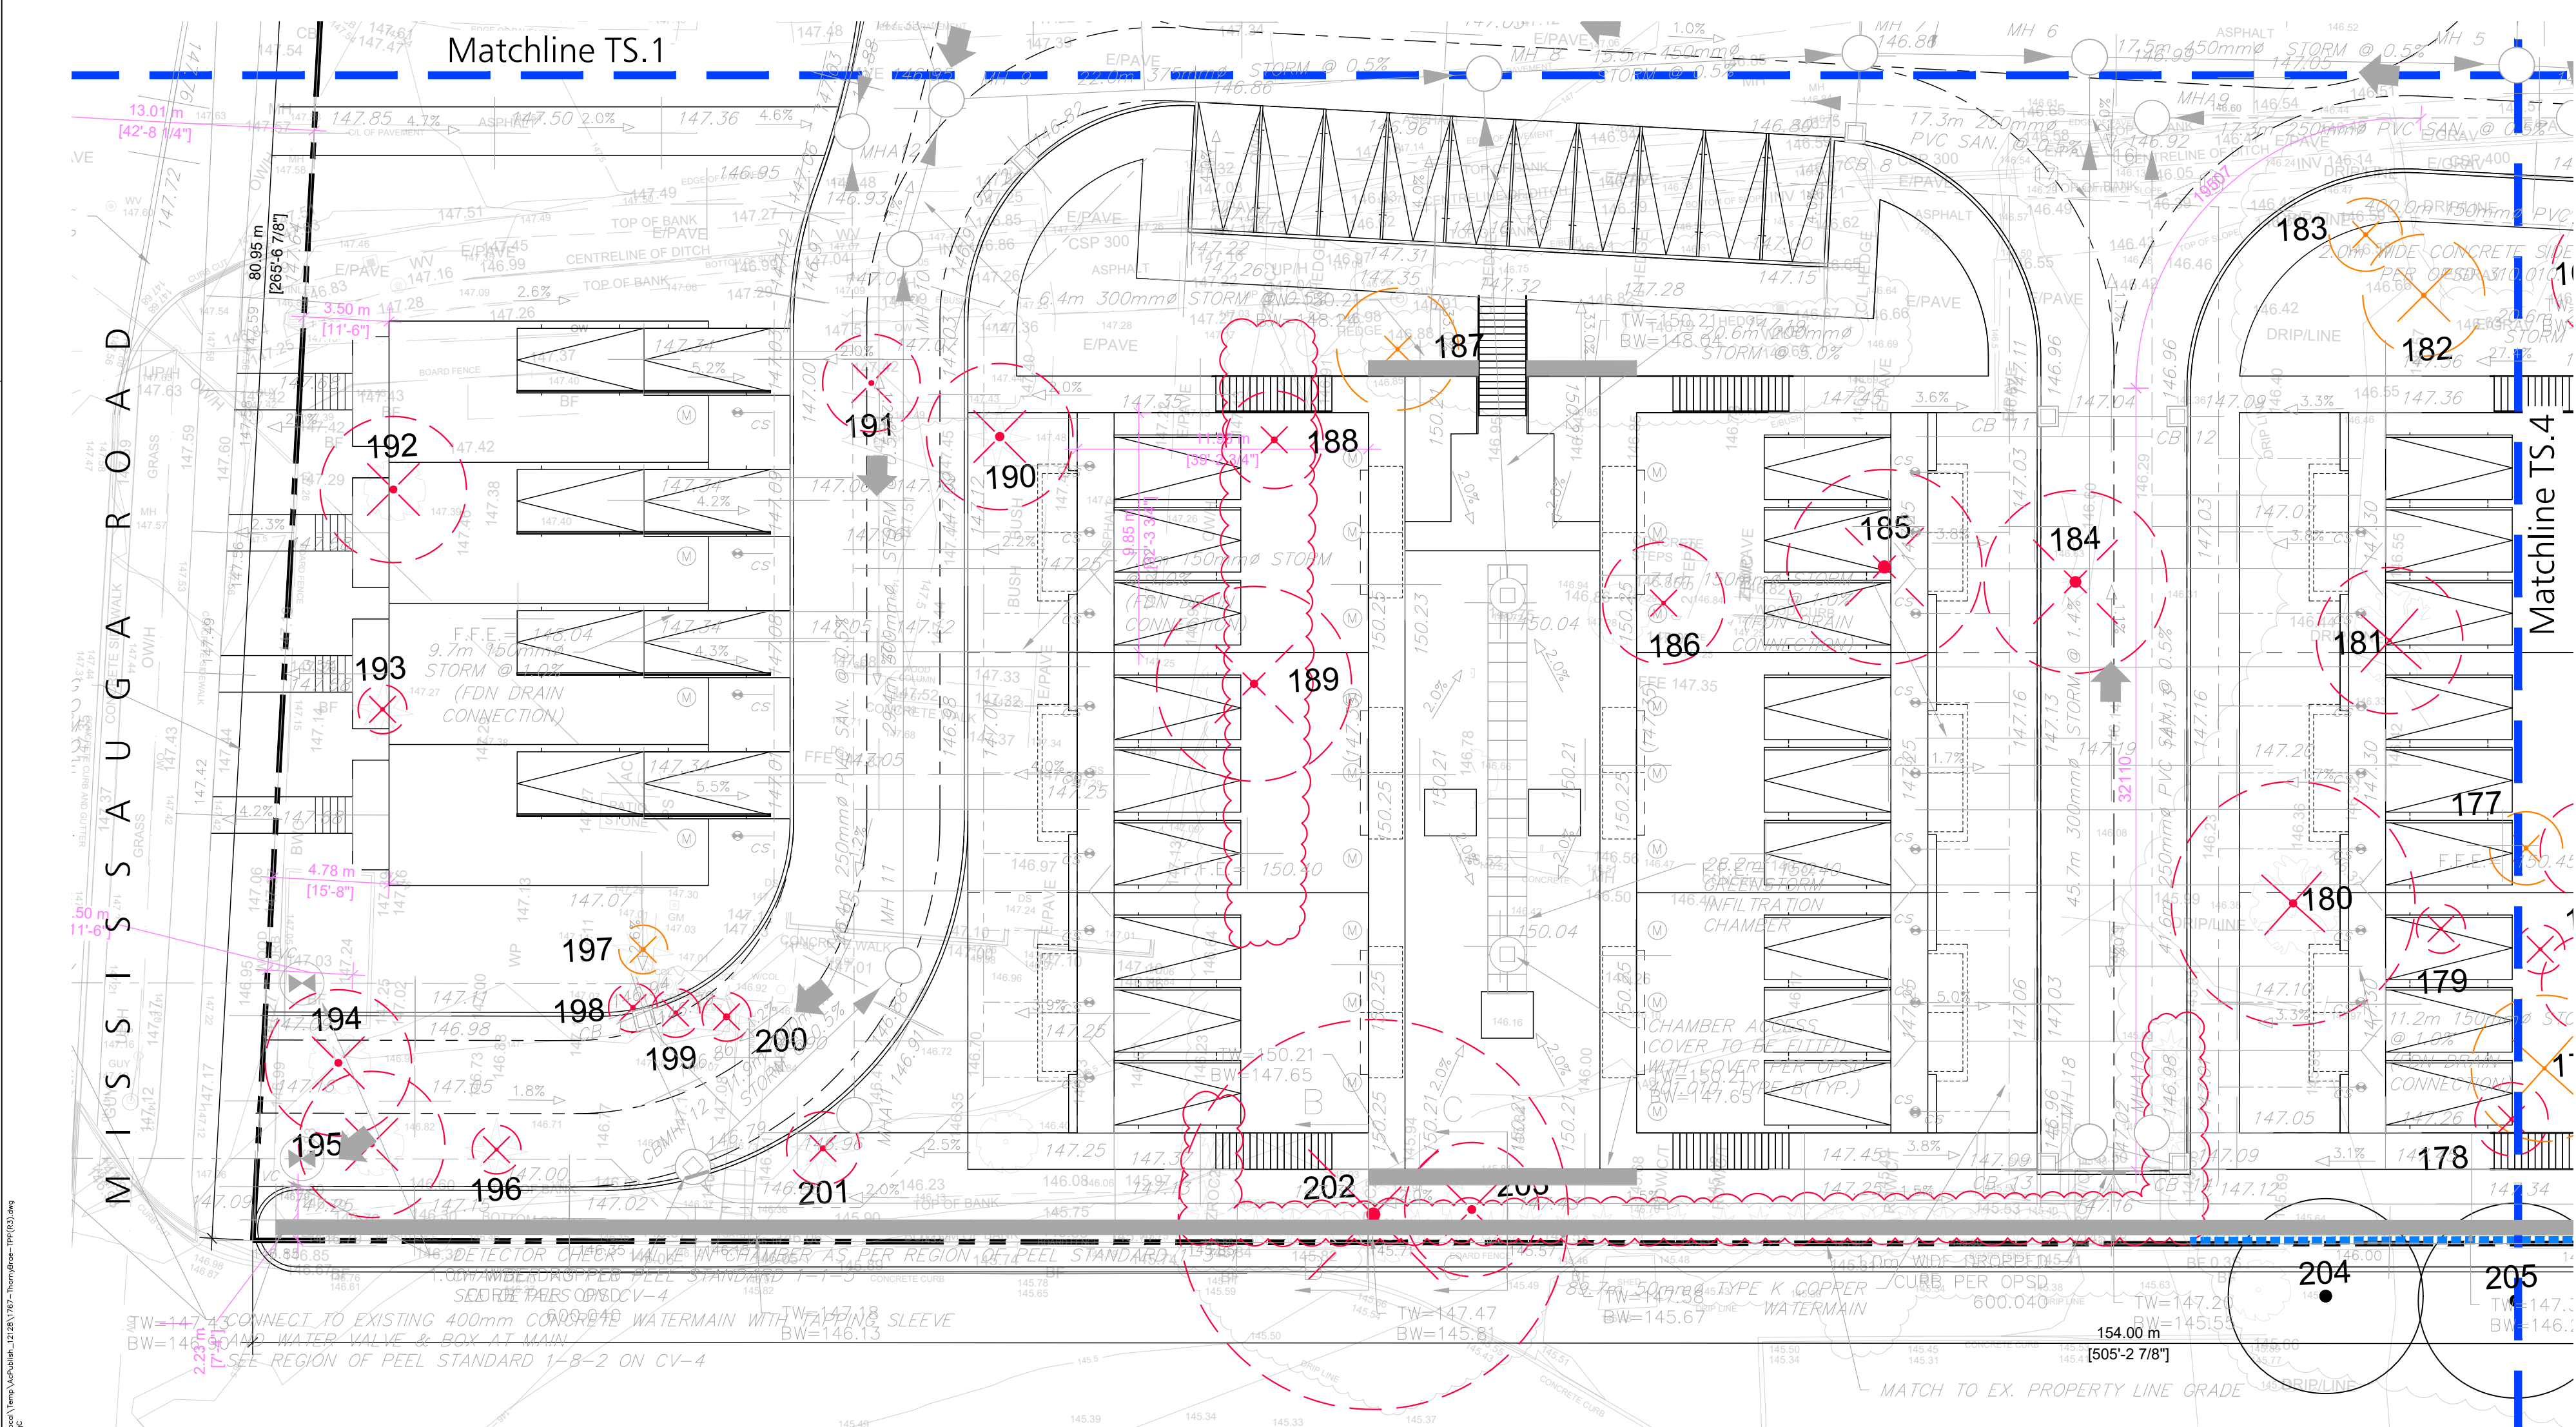
New Tree No.	Tree No.	Species	DBH (cm)	Combined DBH	Measure to Drop Line diameter (m)	Biological health	Structural Condition	Recommended Action	Comments	Location Designation
178		Tilia Americana	12		3	H	MH	RC	89% Crossing branches	S
179		Tilia Americana	10		2	M	ML	RC	Vine, 30% TD	S
180	88	Juglans nigra	37.9, 26.4	25.4	10	H	H	RC	2L, VS	S
181	87	Juglans nigra	32.2		8	H	H	RC		S
182		Fraxinus pennsylvanica	16, 14	17.3	5	L	L	R	2 Leaders, Vine	S
183		Fraxinus pennsylvanica	13.4		3	L	L	R	EAB	S
184		Picea glauca	41.8		7.5	H	H	RC		S
185		Picea glauca	48.4		8	H	H	RC		S
186		Ulmus pumila	11.7, 12.4	15.5	5	H	MH	RC	2L, IB	S
187		Fraxinus pennsylvanica	12, 9, 7	16.7	5	L	L	R		S
188		Ulmus pumila	21.8		4	ML	ML	RC	Little budding could be dead, at least 50% dead canopy	S
189		Ulmus pumila	28.1		8	M	M	RC		S
190		Picea pungens	32.1		6	M	M	RC	20% canopy dieback	S
191		Ulmus pumila	18		4	H	MH	RC	wire through canopy	S
192		Acer platanoides	26.8		6	H	H	RC		S

193		Picea pungens	12		2	M	M	RC		S
194		Prunus avium	26.2		6	M	M	RC	several cracks, IB with branch	S
195		Prunus avium	17, 18, 12, 10, 10	25.9	6	M	M	RC	MB, IB at main union	S
196		Picea pungens	9		1.5	M	M	RC	Top dead	S
197		Picea glauca	<15		2	D	D	RC	DEAD	S
198		Thuja occidentalis	10, 15, 10	18.7	2	M	M	RC		S
199		Thuja occidentalis	10, 10, 9, 14	20.7	2	M	M	RC		S
200		Thuja occidentalis	23, 15	19.5	2	M	M	RC	10' Lean (SE)	S
201		Picea pungens	19		3	H	H	RC		S
202		Salix rubens	47.4, 51.7, 21	34.7	16	M	M	RC	2L, -6 large dead/ broken limbs girdling wire, 20% TD	S
203		Malus sp.	30		5.5	M	ML	RC	2L, IB crossing branch, UB (W)	S
204		Tilia x cordata	47.4		8	M	M	P	4 pruned limbs, leaving 2 holes	N
205		Tilia x cordata	46.1		8	M	M	P	5 pruned limbs, tight unions	N
206		Tilia x cordata	43.2		8	M	M	P	Multibranch node, 3 pruned limbs leaving 1 hole, IB	N
207		Tilia x cordata	34.8		6	M	M	P	3L, 1 pruned limb, 10' Lean to parking lot, BF, 1 hanging branch	N

208		Tilia x cordata	39.4		8	M	M	P	2 pruned limbs, 1 hanging branch	N
209		Tilia x cordata	49.2		8	M	M	P	Crossing branches, IB, med. Pruned branch, 3 holes in trunk, BF	N
210		Malus sp.	18.5, 23	20.4	3	ML	ML	P	50% dead canopy, 1 dead trunk, 2L	N
211		Tilia Americana	18.7, 32.3	22.6	7	M	M	P	IB, 25' lean to parking lot	N
212		Juglans nigra	26.8		7	H	MH	P	vine, hanging branch	N
213	180	Juglans nigra	27		9	H	H	P	V	N
214	179	Juglans nigra	16		4	H	H	n/a	Tree removed since original survey	N
215	60	Ulmus laevis	20		6	D	D	R	DEAD	S
