# Tributary of Fletcher's Creek Fluvial Geomorphological Assessment

**DeZen Lands Development**  
7140 Hurontario Street, Mississauga

Submitted:  
September 12, 2025

GEO Morphix Project No. 25102

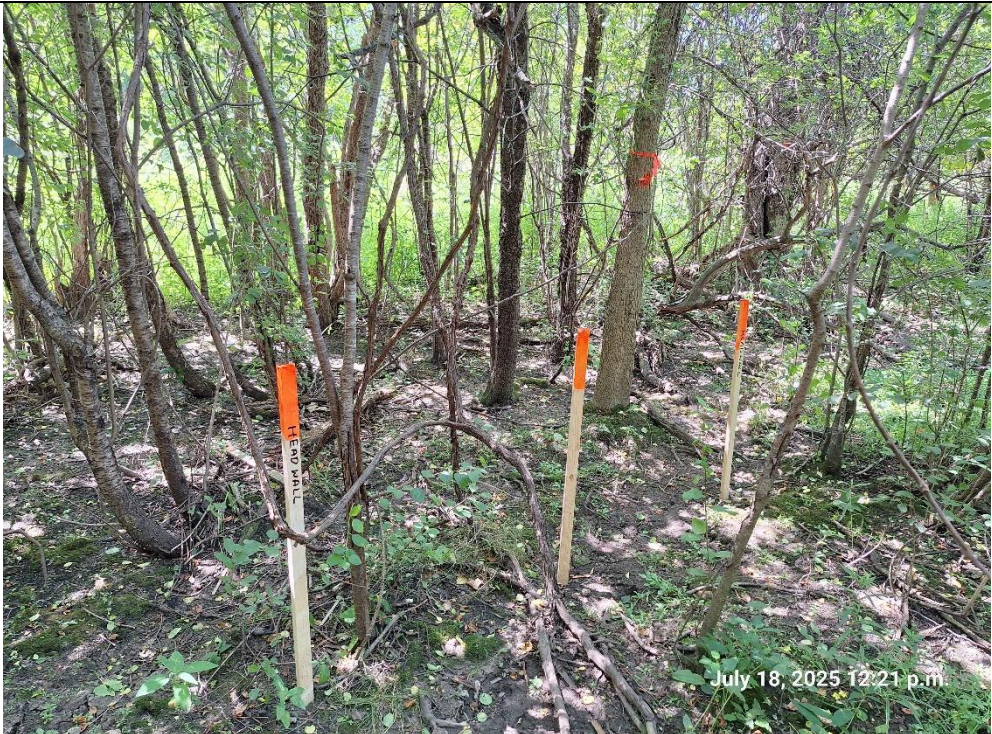
<p>Photograph of staked headwall location facing the direction of the tie-in location.</p>
<p><b>Photo 2</b> <b>Outlet Headwall Location, 7140 Hurontario Street, Mississauga, ON</b></p>

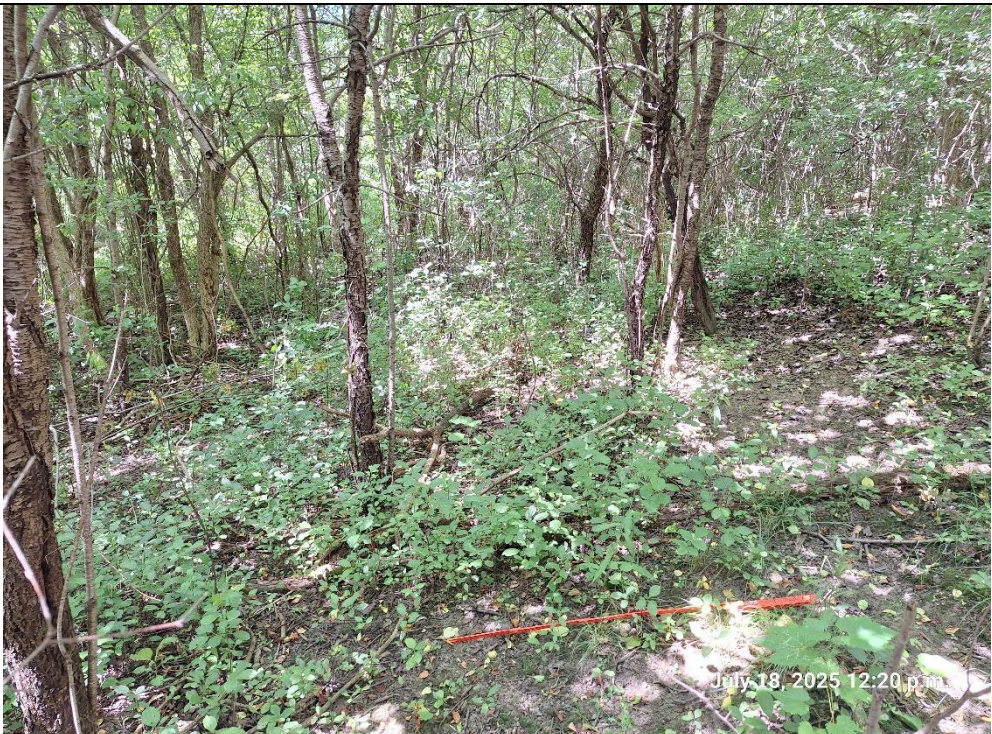
<p>Photograph of the valley wall behind the headwall location. The slope is well vegetated and showed a lack of erosion at the time of assessment.</p>

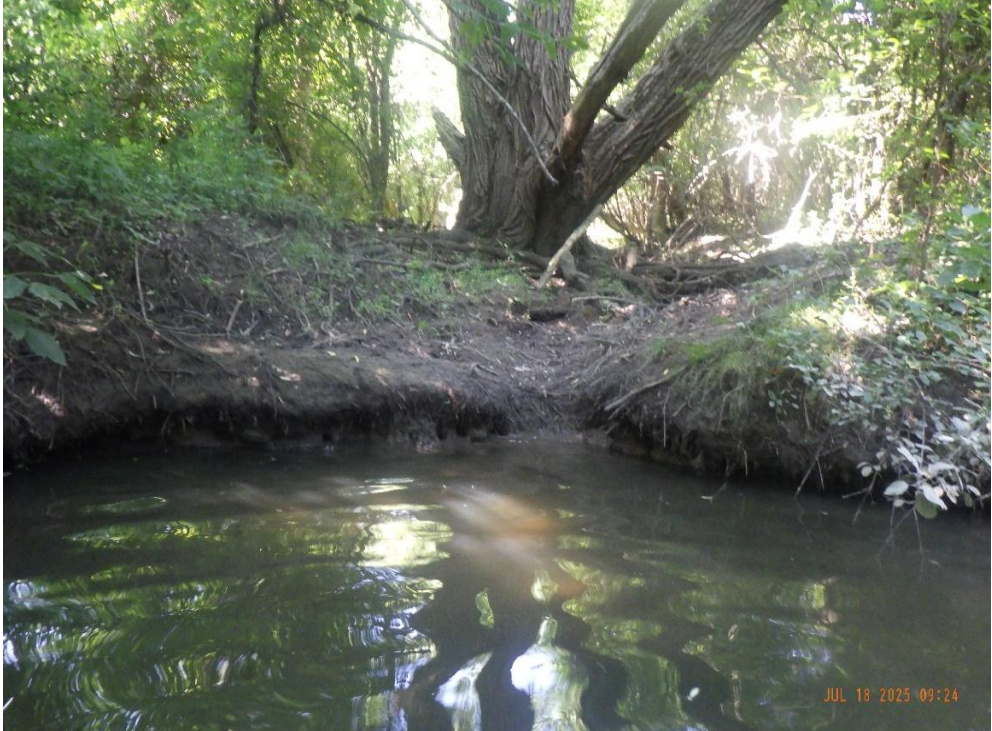
<p><b>Photo 3</b> <b>Reach FC-2, 7140 Hurontario Street, Mississauga, ON</b></p>

<p>Photograph showing the confluence between the historic channel and <b>Reach FC-2</b>. The confluence was located at an outer meander bend along <b>Reach FC-2</b>.</p>
<p><b>Photo 4</b> <b>Reach FC-2, 7140 Hurontario Street, Mississauga, ON</b></p>

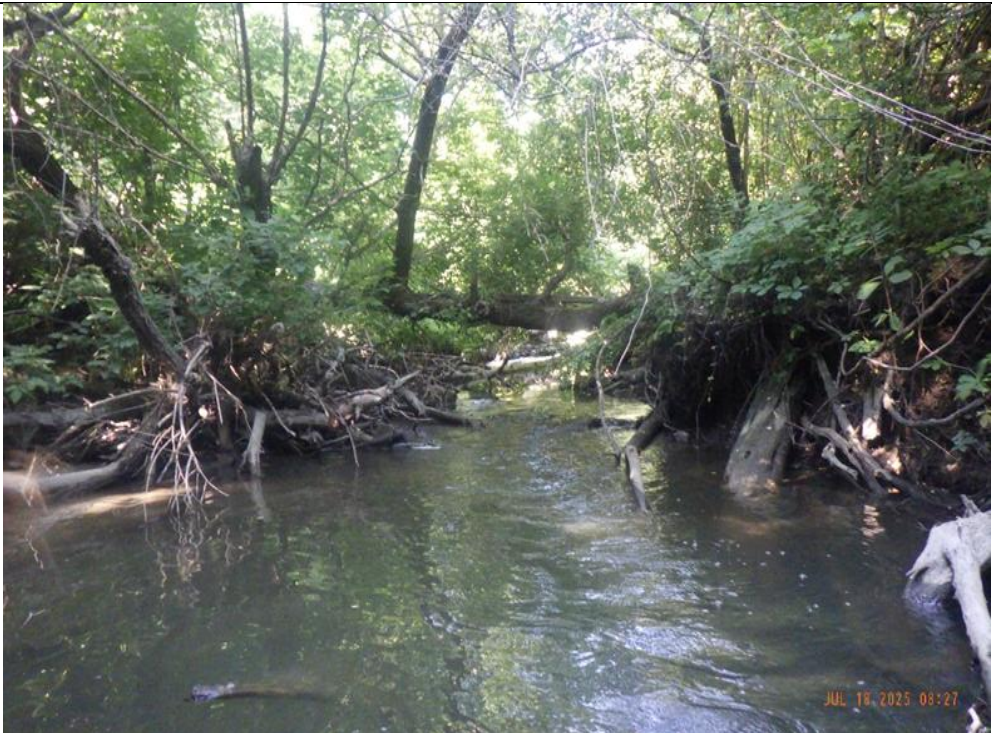
Reach **FC-2** was identified as primarily widening according to the RGA, as evidenced by the occurrence of fallen and leaning trees, large organic debris, exposed tree roots, and basal scour throughout more than 50% of the reach. Overall, the reach was assigned a stability index of 0.34 and classified as "in transition". The RSAT resulted in a *Good* ranking with a score of 27, with the limiting factor being channel stability, as evidenced by the frequently observed bank erosion also noted by the RGA. Using Downs' Model of Channel Evolution, the channel was determined to be U – undercutting, as evidenced by erosion and undercutting along the banks.

<p>Photograph of <b>Reach FC-2</b> facing upstream. Leaning trees and woody debris jams that impacted flow were common throughout the reach.</p>

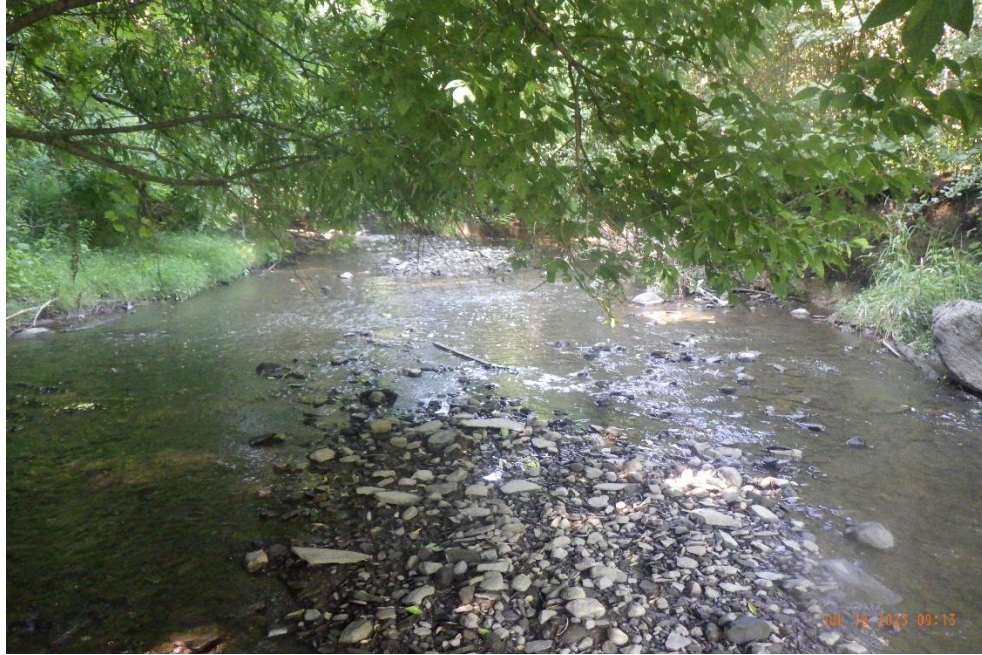
**Photo 5**  
**Reach FC-2, 7140 Hurontario Street, Mississauga, ON**

Coarse material was commonly observed along the channel bed. A suspended armour layer was observed in the channel banks as well. The bank materials consisted of clay, silt materials with some coarse materials due to the suspended armour layer.

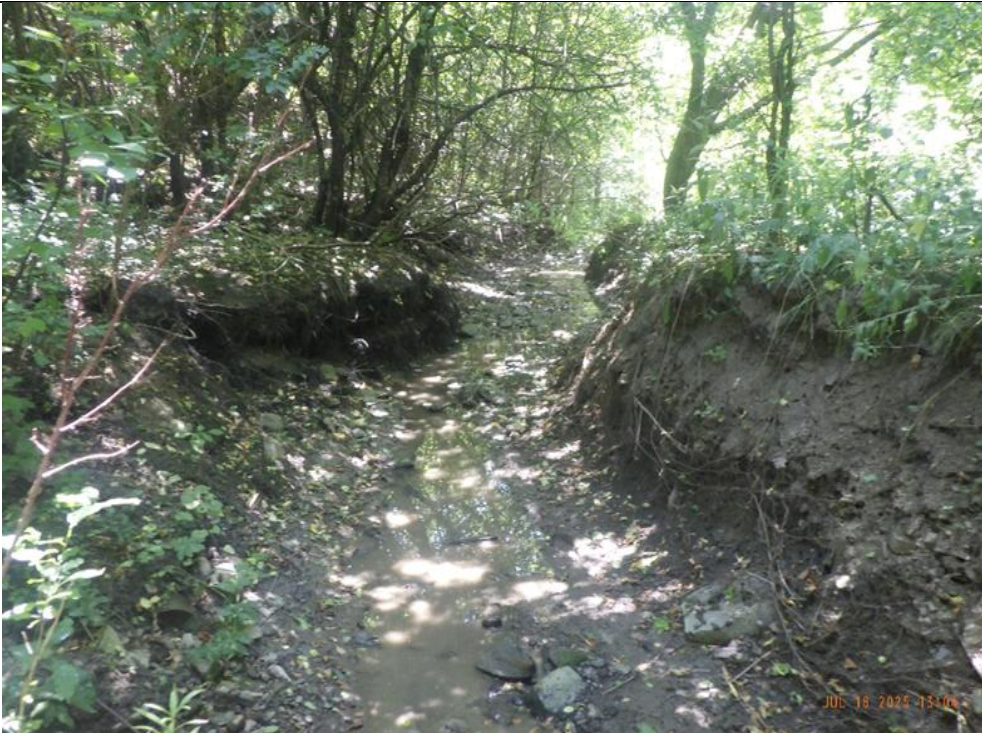
**Photo 6**  
**Reach FCT-1, 7140 Hurontario Street, Mississauga, ON**

Reach **FCT-1** was identified as primarily widening with some degradation according to the RGA, as evidenced by the fallen and leaning trees, exposed tree roots, and suspended armour layer. Overall, the reach was assigned a stability index of 0.37 and classified as "in transition". The RSAT resulted in a *good* ranking with a score of 27, with the limiting factor being physical instream habitat and channel stability, as evidenced by the lack of diverse geomorphological units and bank erosion also noted by the RGA. Using Downs' Model of Channel Evolution, the channel was determined to be e - Enlarging, as evidenced by erosion along both banks and a scoured bed.

Photograph of **Reach FCT-1** facing upstream. The channel was confined and had low flow conditions at the time of assessment. Exposed roots and undercutting were commonly observed. The bed was also eroded into parent material (till) in a localized portion of the reach upstream.

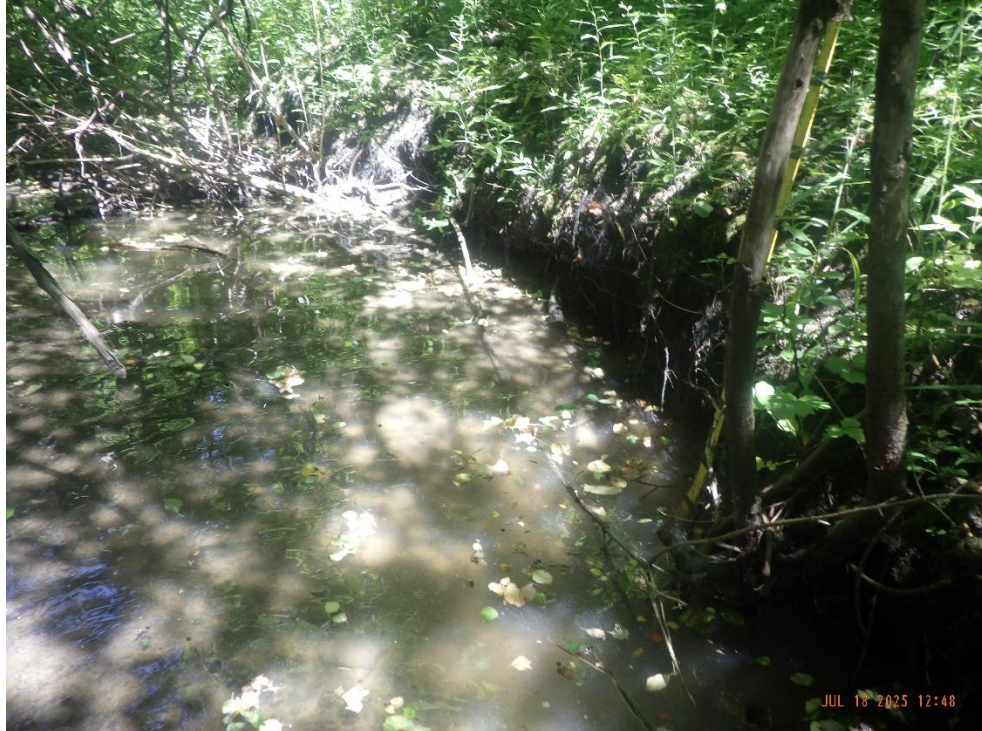
**Photo 7**

Photograph of **Reach FCT-1**. Active erosion was noted along this reach however; the channel banks were observed to be well vegetated. Some fallen and leaning trees were also observed, indicating some widening along the reach.

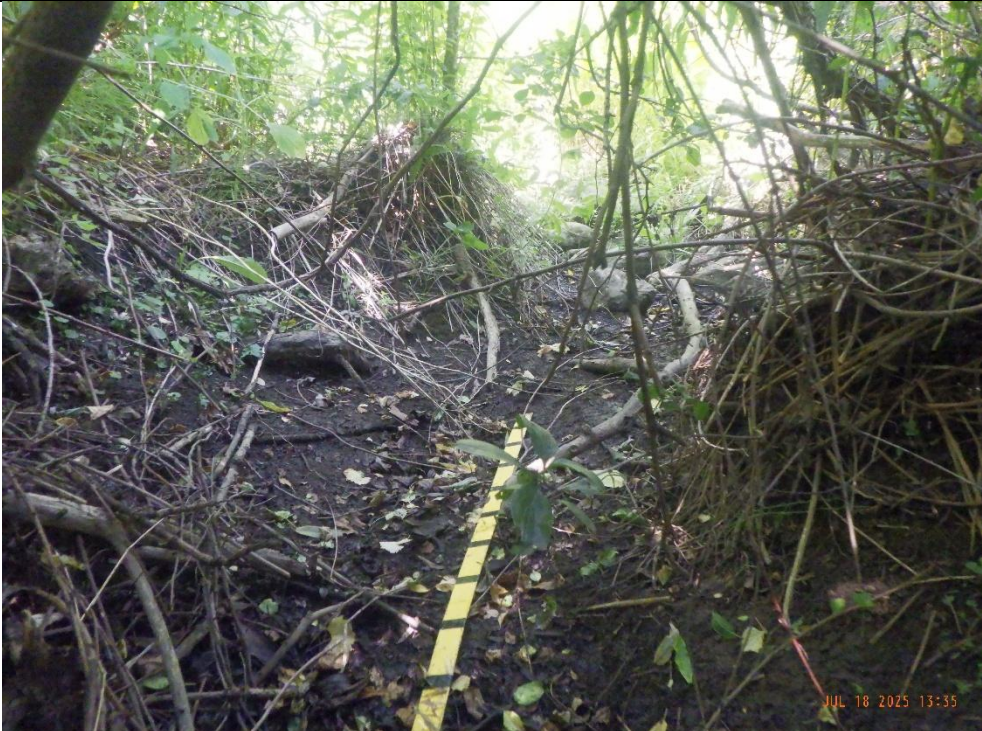
**Photo 8**

Reach **FCT-2** was identified by the RGA as being "In transition", with the score of 0.21, with the primary process being degradation and widening. This was evidenced by the suspended armour layer and leaning and fallen trees, and exposed roots. The RSAT resulted in a *fair* ranking with a score of 21, with the

Photograph of **Reach FCT-2** facing upstream. The reach was partially confined and had a high density of woody debris and exposed roots.

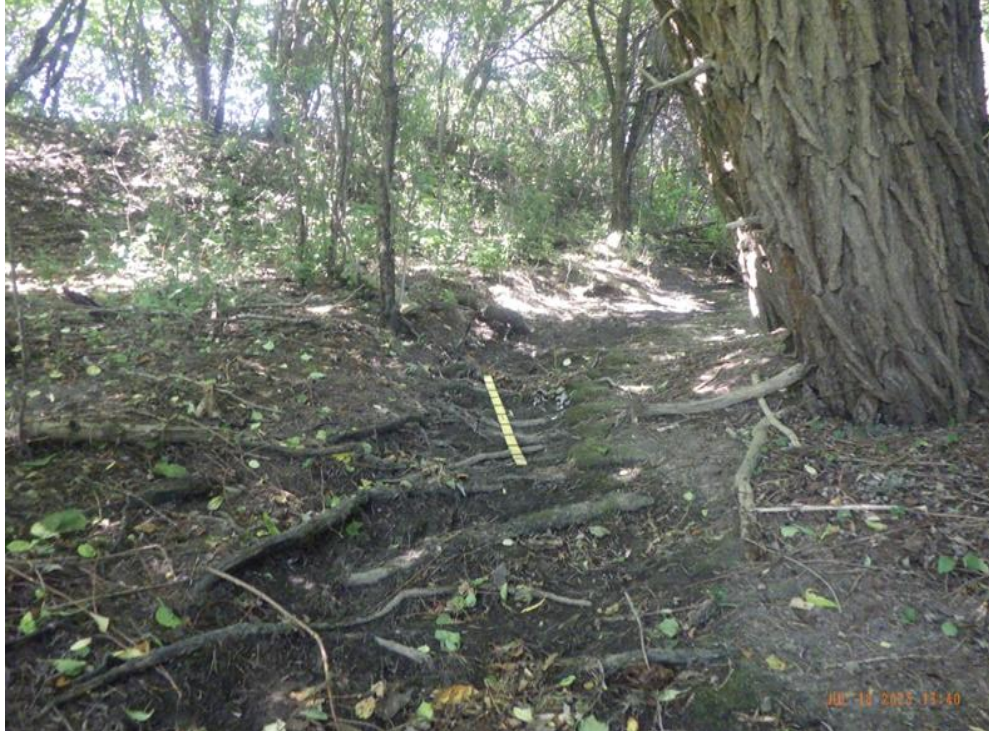
**Photo 9**  
**Reach FCT-2, 7140 Hurontario Street, Mississauga, ON**

Photograph of **Reach FCT-2** located at the upstream extent. Note that banks are less defined as the channel moved upstream towards **FCT-3**.

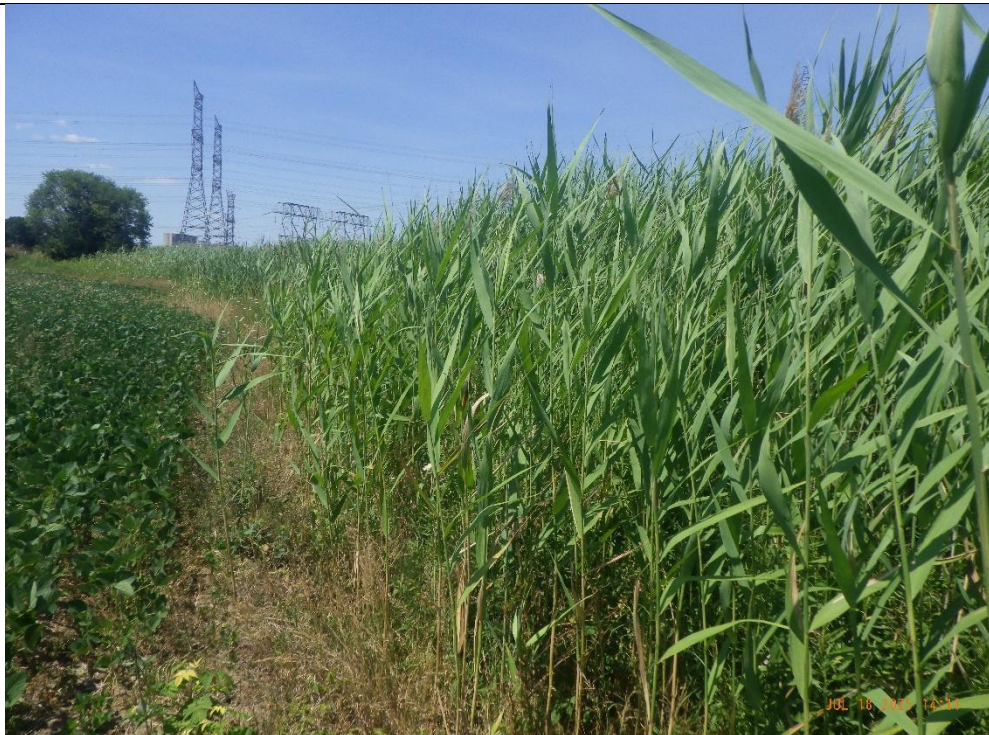
**Photo 10**  
**Reach FCT-3, 7140 Hurontario Street, Mississauga, ON**

Reach **FCT-3** was a poorly defined feature which was predominately dry throughout. The majority of the channel was heavily encroached with herbaceous vegetation and grasses. Phragmites and cattails were observed in the upstream portion of the feature as well. The feature had no riffle-pool sequence, a low gradient and bed and bank material which was homogeneously composed of a clay-silt, sand, gravel mixture. Generally, the feature was poorly defined however bankfull measurements were collected in the portions that were defined. Average bankfull width and depth for the defined portion were 0.79 m, and 0.12 m, respectively.

Photograph of **Reach FCT-3** facing upstream towards the pond. Though dry at the time of assessment, much of the reach was comprised of an online wetland containing cattails and phragmites.

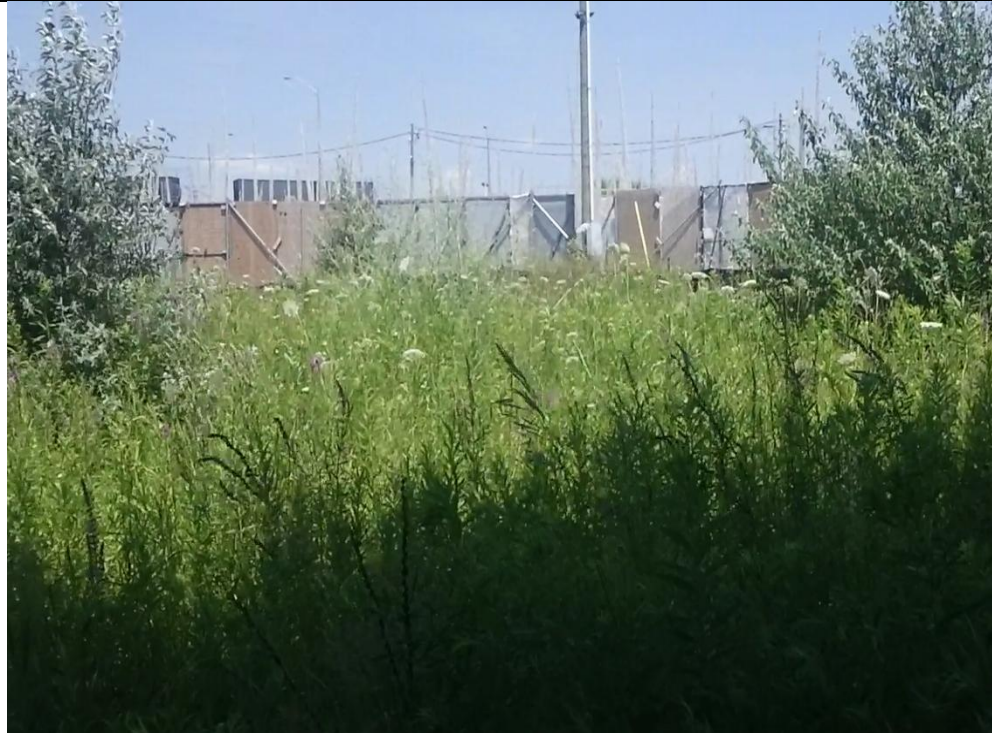
**Photo 11**  
**FCT-3** Approx. Crossing Location, 7140 Hurontario Street,  
 Mississauga, ON

The proposed water crossing location is situated across **Reach FCT-3**. The location's topography was unconfined, flat, and the feature was poorly defined. Herbaceous plants and tall grasses dominated the area.
