## Tree Preservation Report

Tree Inventory and Preservation Plan Report

Chick-fil-A Erin Mills Town Centre  
5100 Erin Mills Parkway  
Mississauga, Ontario

BRM-0023002042-U0

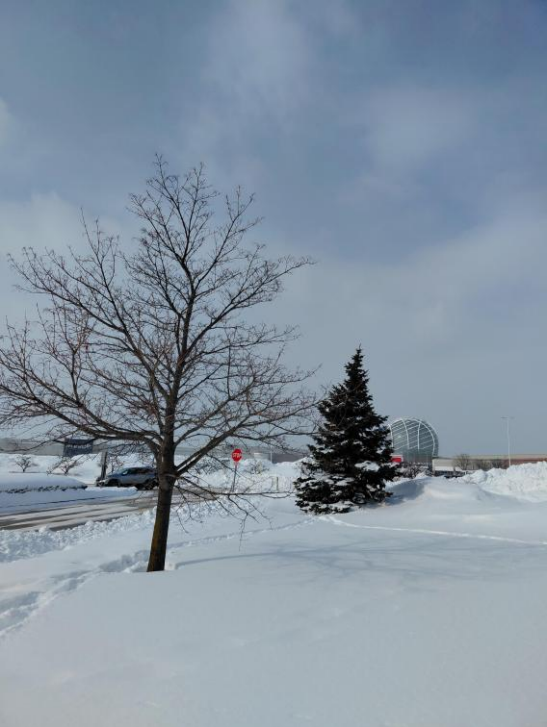
Image 3. Trees 5 and 6.

Trees 5 and 6 conflict with the proposed parking lot expansion. Tree 7 conflicts with the proposed monument sign.

The removal of three (3) trees will be required to accommodate the proposed design. These trees either directly conflict with proposed structures and/or excavation, or significant encroachment into their minimum tree protection zones (mTPZs) will be required such that they would not be expected to tolerate the resulting injuries. Tree removals include Trees 5-7.
