# AGENDA

## HERITAGE ADVISORY COMMITTEE

3. Request to Replace a Structure on a Heritage Designated Property within the Old Port Credit Village Heritage Conservation District, 24 John Street South, Ward 1

**SUBJECT:** **Request to Replace a Structure on a Heritage Designated Property  
Old Port Credit Village Heritage Conservation District  
24 John Street South  
(Ward 1)**

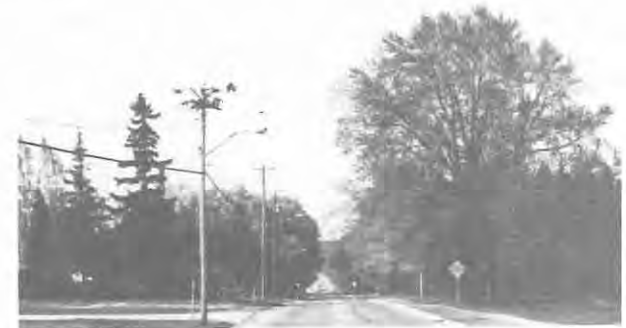
- a. The approach from the east across open fields is interrupted by a series of mature hedgerows at right angles to Derry Road West. A significant stand of coniferous trees to the north occurs near a visual narrowing of the road by large deciduous trees parallel to it. This point of narrowing forms a logical eastern edge.

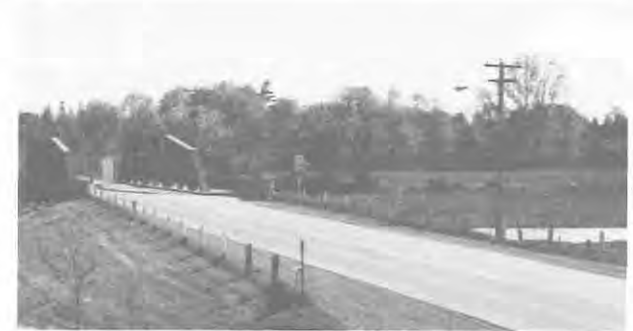
- b. Approaching Meadowvale Village from the west on Derry Road West results in a very definite sense of entry. The Credit River meanders across the landscape forming a natural boundary; but, one's sense of entry to the village is dramatically heightened by the constriction in the road with the approach to the bridge that crosses the river.

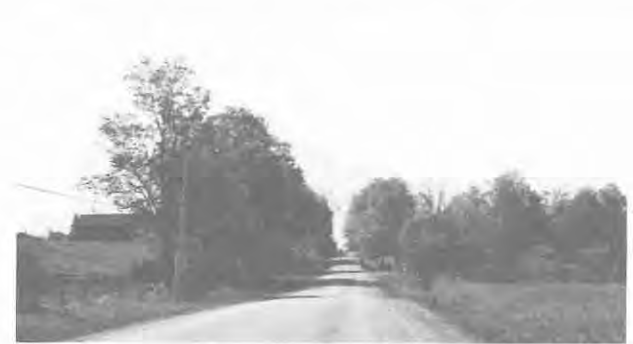
- c. The north-south approaches on Second Line West are equally obvious when considered in this sense. The perceived northern limit to the village occurs at the point where parallel mature hedgerows of deciduous trees begin to define the road - coincident with the intersection of Pond Street.

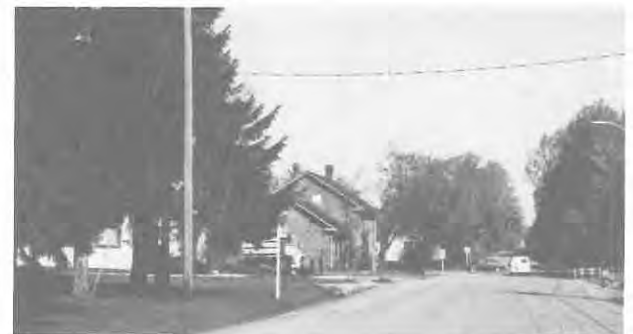
- d. From the south, most of the modern village is traversed before there is a definite image of the old Meadowvale. At the point where massive coniferous planting surrounds and defines the community hall property on the west side of the road, it is possible to view the old crossroads as well as the historic school (community hall) and church structures. At this particular point on the road there is a perceived awareness of transition to historic village.

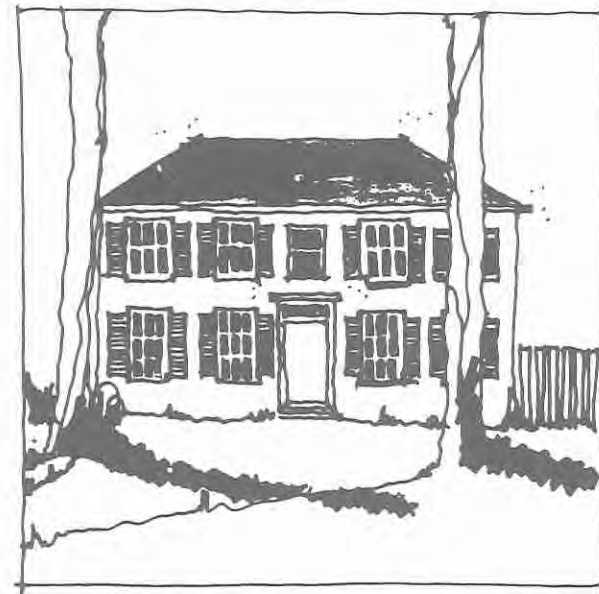
ARCHITECTURAL  
DESCRIPTION OF  
EXISTING STRUCTURE

The partial basement is externally accessible. A wooden sill sits upon the stone foundation just at grade. The walls are constructed of frame and covered in pebbled stucco.

There are five bays of six-over-six paned, double-hung sash on the second storey. The front six-panelled door is flanked on either side by engaged pilasters with a lighted transom above, the whole surmounted by a wooden entablature. There is structural evidence that there was once a front verandah as well as an entranceway on the east facade.

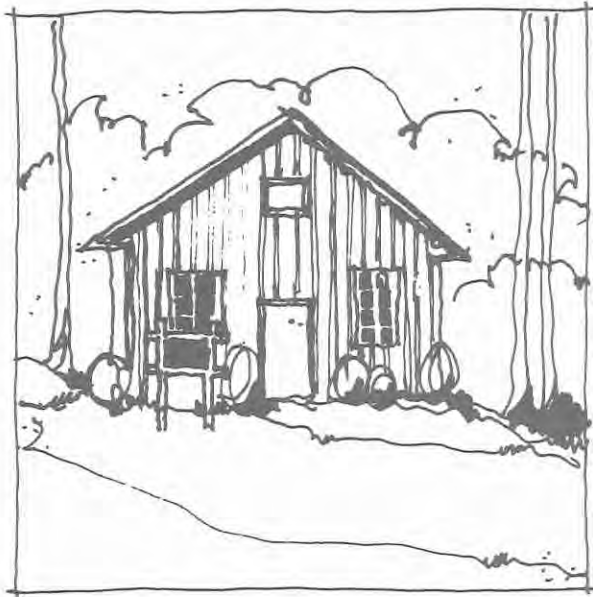
SITE NUMBER	15

STRUCTURE	Meadowvale Community Centre	
PRESENT USE	Community activities, recreation, day-care	
ORIGINAL OWNER	Presumably owned by the Methodist Church	
ORIGINAL USE	The children living in the upper and lower parts of School Section No. 15 attended school here.	
BUILDER	Unknown	
DATE	1871, according to plaque on front of structure.	
HISTORICAL SIGNIFICANCE	This building was the second schoolhouse built in Meadowvale. (Site #53 was the location of Miss Barber's original school)	
ARCHITECTURAL DESCRIPTION OF EXISTING STRUCTURES	<p>A medium-pitched gable roof covers the single storey rectangular structure with rear tail, also gable-roofed. There are returns on the eaves.</p> <p>The stone foundation supports a frame structure, the front section sheathed in board and batten, the rear in clapboard. An arcade of ellipses constitutes the frieze on the front section.</p> <p>The front gable end has a simple door flanked by two four-over-four, double-hung sash windows. On the south side of the front section, there are seven bays of six-over-six double-hung sash; four bays on the north, with similar pane configuration. There are five bays of sash at the rear.</p> <p>The chimney was originally external, but was later covered by the addition.</p>

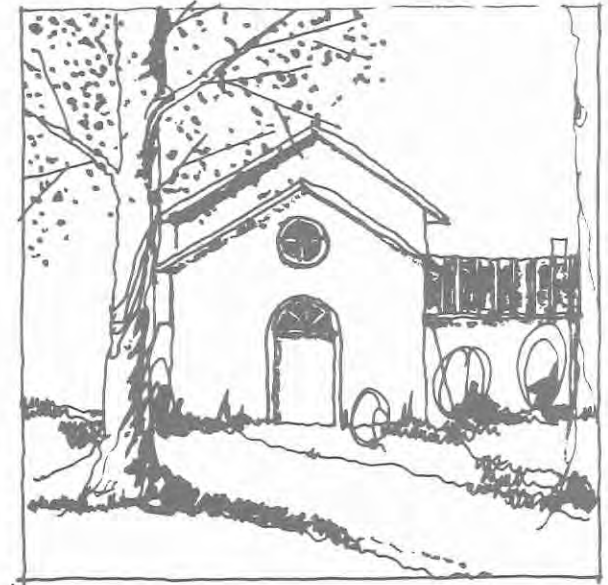
There is a full basement. The stone foundation has been supplemented with concrete and the walls are of common-bonded red brick. Yellow brick is used for quoining, lintels, buttresses and the "weeping" brickwork beneath the front gable. The side walls are divided into bays by the use of buttresses. A single buttress appears at the rear of the church. This one, together with those on the west facade, are of concrete.

There are three elongated, round-headed windows on each side. The glazing bars are rather complicated and there is some stained glass (each window is different). On the rear facade, there are two six-over-six paned, double-hung windows.

The front entrance has a double-leafed wooden door which is topped by a round-headed wooden fan transom.

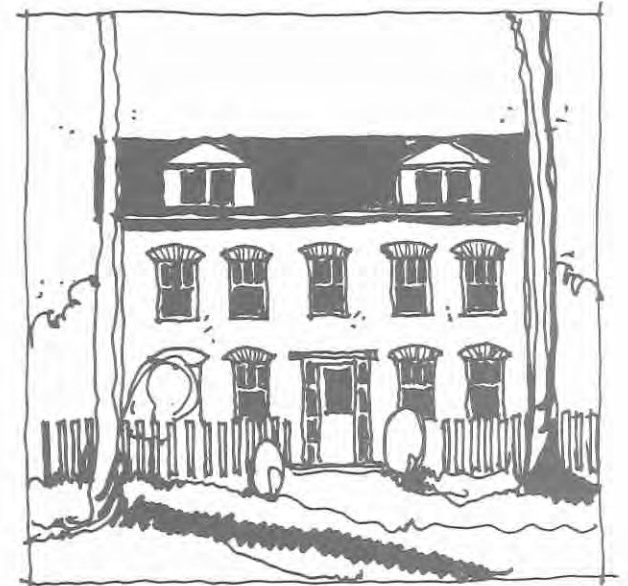
The gable roof has a medium pitch with returns on both ends. The eaves have a large overhang and both cornice and fascia are plain. There are two bracketed, brick chimneys at either side.

The fenestration program is extensive. Hipped gable dormers were added to the roofscape twenty-six years ago. They have casement windows. On the front facade, there are five bays of windows on the second storey, each with six-over-six panes and double-hung. Five windows of varying sizes cover the gable ends over two-and-one-half storeys. All are of the six-over-six pane, double-hung configuration. The window openings have flat stone arches with keystones.

This is a late neo-classical building with considerable modern alterations.

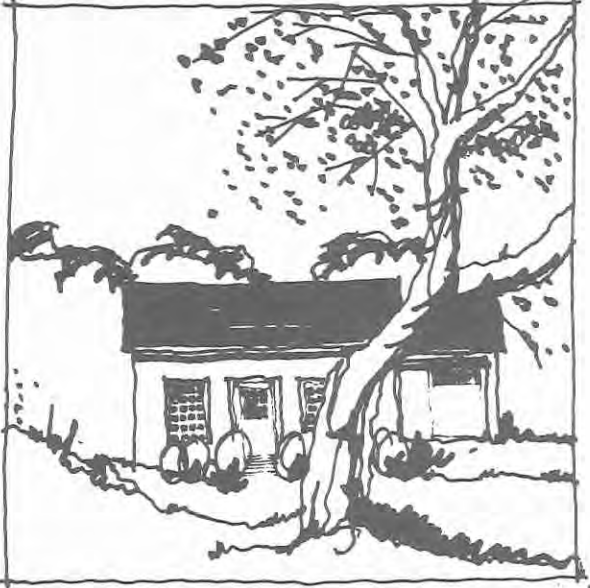
SITE NUMBER	47

STRUCTURE	Hill House	
PRESENT USE	Residential	
ORIGINAL OWNER	Francis Silverthorn first owned the land. The house was bought by James Lyons on June 18, 1904.	
ORIGINAL USE	Residential	
BUILDER	Unknown	
DATE	Probably between 1835 - 45, according to architectural stylistic evidence.	
HISTORICAL SIGNIFICANCE	One of Meadowvale's early homes.	
ARCHITECTURAL DESCRIPTION OF EXISTING STRUCTURE	<p>This one-and-one-half storey detached structure is rectangular with additions to the rear. A crawlspace is accessible from outside. The rubble foundation has a wooden sill on top which supports the plank construction of the walls, the whole being stuccoed.</p> <p>The gable roof is of medium pitch with returns at both ends. The mouldings are plain and there is no decoration on fascia or frieze. There is an external brick chimney on the south side. There are large, twelve-over-twelve paned, double-hung sashes on either side of the door. There are six-over-six paned, double-hung windows in the gables. Again, the trim is very simple.</p> <p>The front door is flanked by engaged pilasters with a wooden entablature overhead.</p>

STYLE	This is a simple building which has no identifiable style, but shows the charming result of sympathetic periodic alterations.

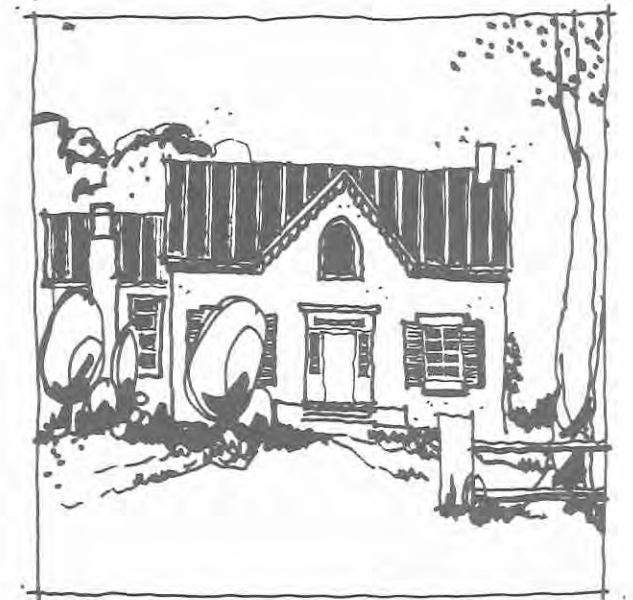
A wooden sill rests on the stone foundation. The walls, apparently of frame construction, are externally stuccoed.

There is one large six-over-six paned, double-hung sash on either side of the front door. The rear and side windows are similar, but of varying sizes. The four-panelled door is flanked by engaged pilasters, sidelights and a transom. The entablature above is richly moulded.

STYLE      The style is purely vernacular combining Classical and Gothic elements.

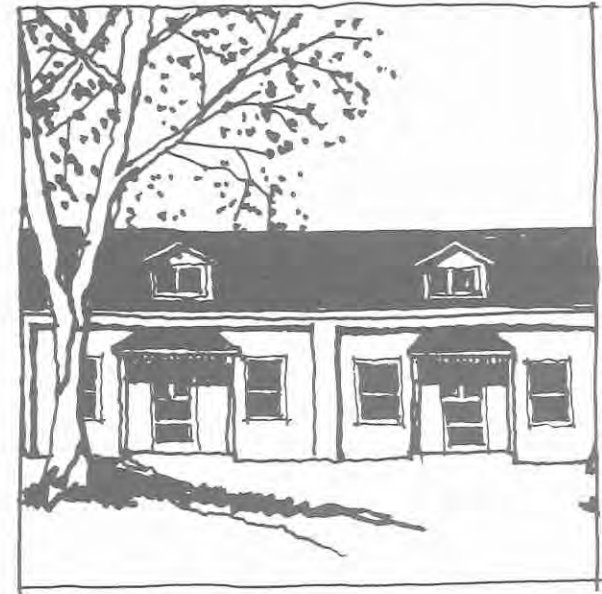
The brick chimney which serves both units is bracketed centrally near the point where the tail joins the main structure. There is no basement. The brick foundation supports a wooden sill. Three 8" x 10" vertical posts rise at the corners and in the centre to support the plate. These posts have been brought forward with lath and plaster to create a panelled effect along the front. The walls are constructed of white pine planks laid broadside, one on top of the other. Though the front facade is smooth, pebbled stucco covers all other walls, the whole painted a dark grey.

This is a simple, well-ordered building that has been carefully designed to produce a Classical feeling.

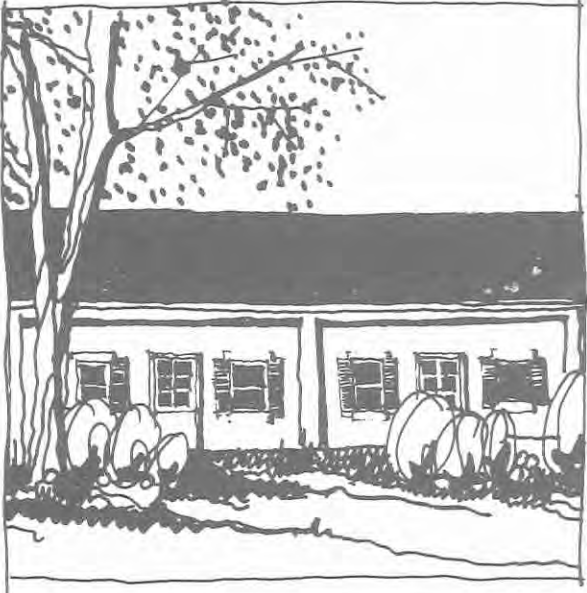
SITE NUMBER	57

STRUCTURE	Double home for mill workers.	
PRESENT USE	Residential	
ORIGINAL OWNER	Francis Silverthorn	
ORIGINAL USE	It housed mill workers' families in the last century.	
BUILDER	Presumably Francis Silverthorn.	
DATE	During the 1840's - Increased commercial activity in the village at this time necessitated the building of many simple lodgings for the workers, such as this one.	
HISTORICAL SIGNIFIANCE	One of the earliest structures in Meadowvale where mill workers lived.	
ARCHITECTURAL DESCRIPTION OF EXISTING STRUCTURES	This structure is identical to the structure on Site No. 56 with the exception of dormers, porches and vergeboard. Unlike the above-noted structure, it has been painted white.	
STYLE	This is a simple, well-ordered building that has been carefully designed to produce a Classical feeling.

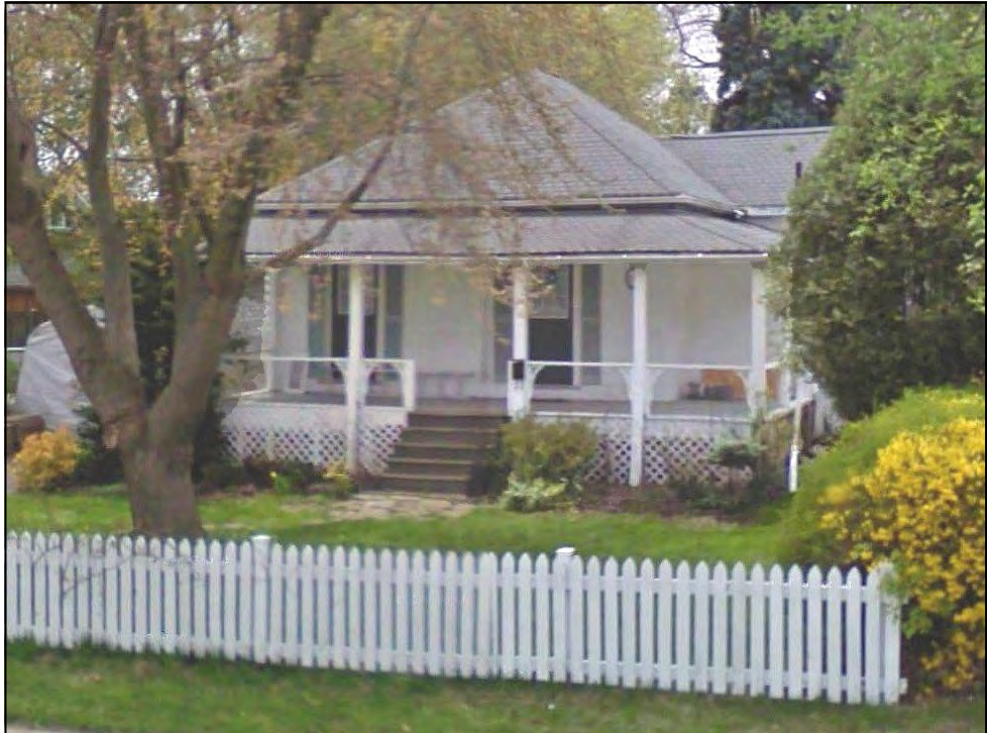
“Wrap-around” front porch, typical of earlier homes on John Street South.

This porch is in urgent need of reconstruction. The structural integrity of the posts that sustain the porch is seriously compromised. The planks of wood on its flooring are cracked and decaying. The roofing is rotten and sagging. The railing was damaged years ago and removed."

In spite of Chandler's curious preference for low-rises, his resale home at 24 John Street South does take some architectural cues from homes that already existed along John Street South. Notable among these features is the wrap-around veranda. These were a nearly universal feature on late Victorian-era homes, such as the nearby Peer brother homes at 38 and 42 John Street South. However, wrap-arounds became less popular in the early 20th century, replaced by full-width, front façade-only porches. The house at 24 John Street South was built during this later period when full-width front porches were common, yet Chandler opted for a more traditional L-shape verandah.

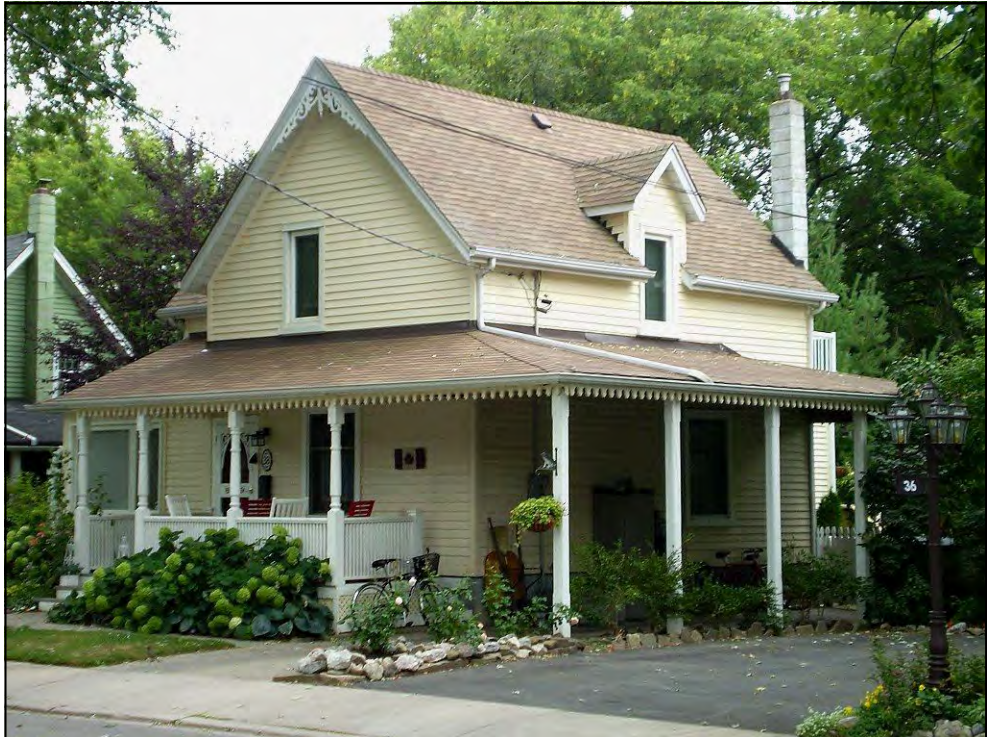
An earlier home with a “wrap-around” verandah: 36 John Street South.

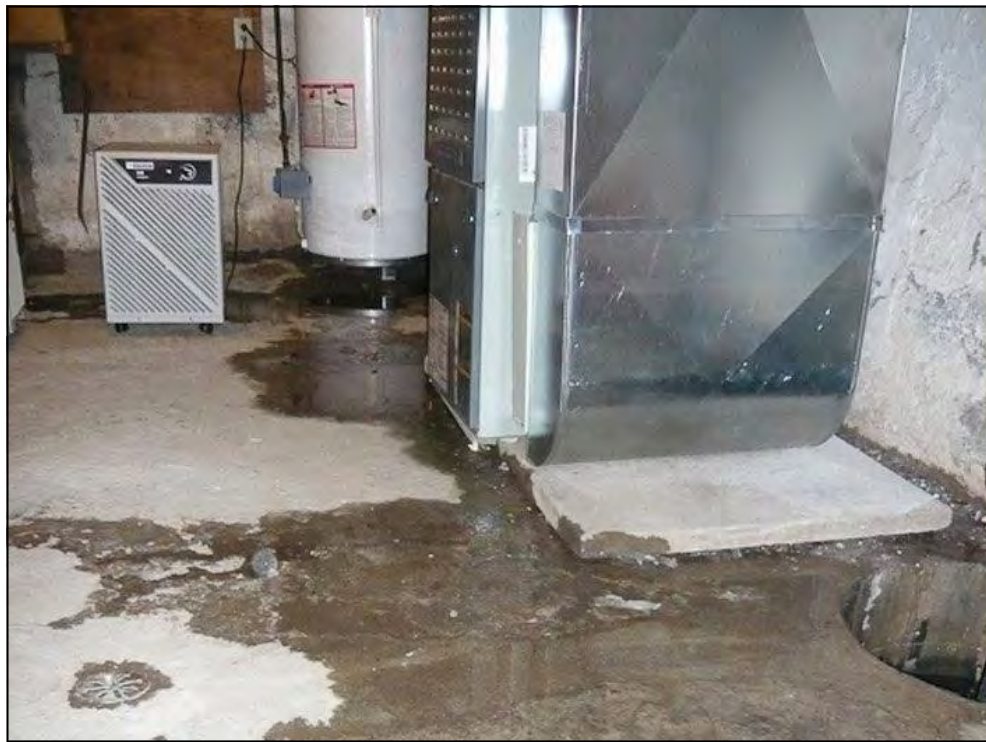
Groundwater seepage in the basement.

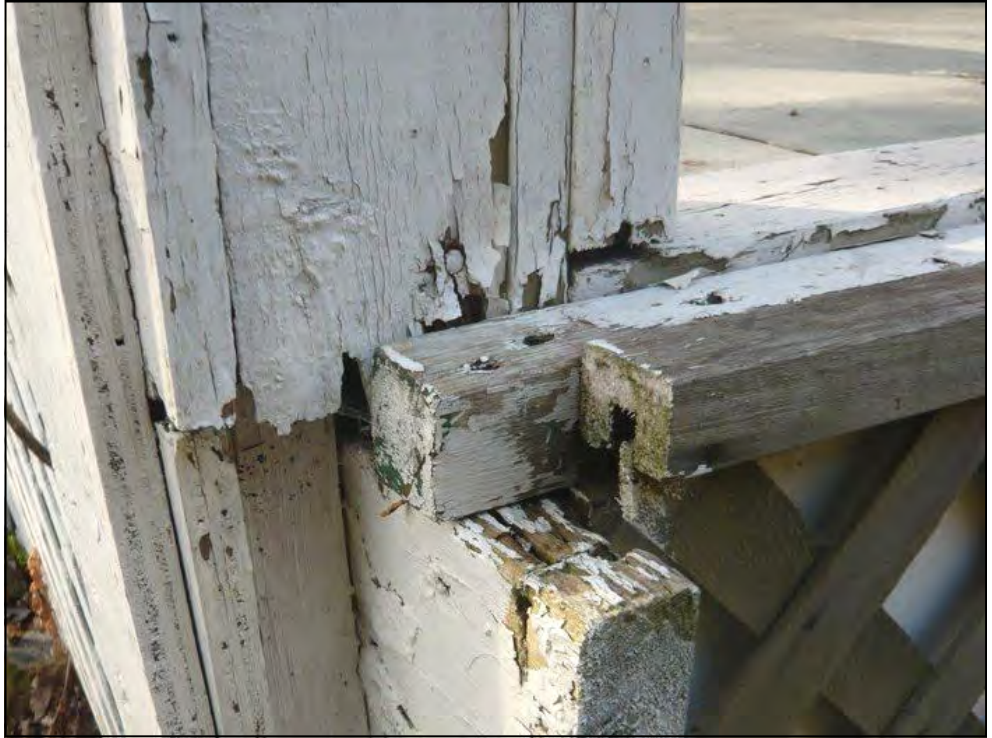
Poor condition of the porch.

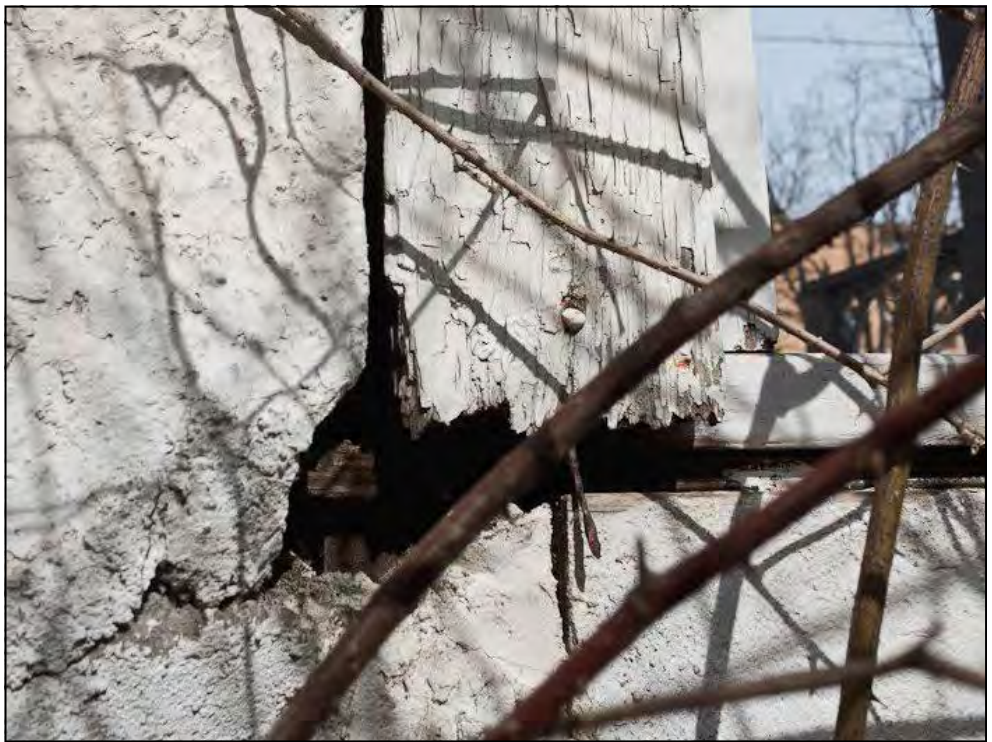
Rotting wood and chipped stucco.

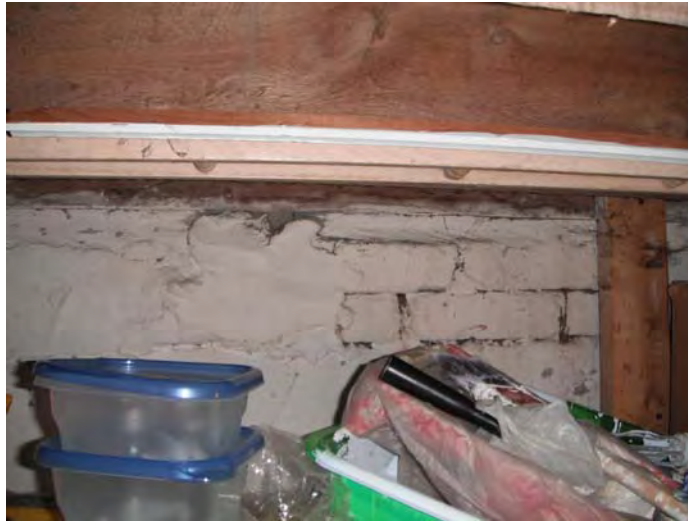
however it does extend under what is almost certainly a later addition. This leads one to believe that either the basement was constructed at the time of the addition and was extended under part of the existing house, or as the oral history states, the house was relocated from elsewhere onto an existing basement. After relocation of a building onto an existing concrete foundation, whether constructed for the purpose or remaining from another structure, it is common practice to build up the top of the foundation with masonry infill. This building has both brick masonry and concrete infill between the concrete foundation walls and the wood floor structure.

Brick infill

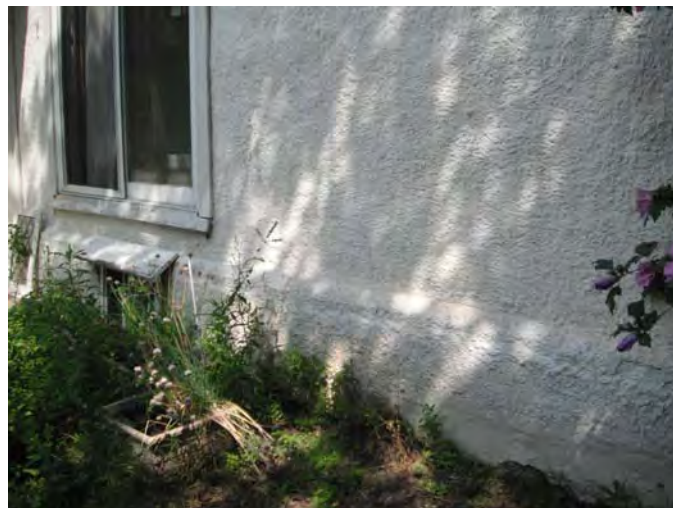
The addition could have been built when the house was relocated to extend the house and to cover the portion of the basement that the original house did not fit. This seems to be the more likely scenario given the brick infill at the top of the wall, the projection of the foundation beyond the rear wall of the house, and the arbitrary and illogical location of the front wall of the basement with respect to the structural requirements of the floor system.

Misaligned foundation at rear wall

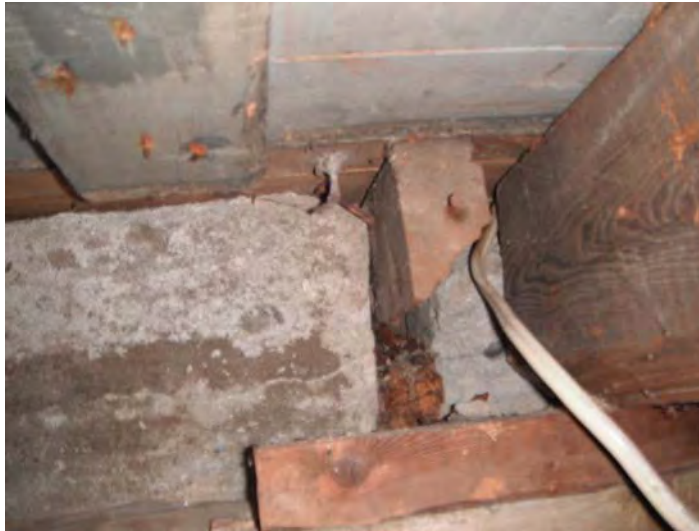
There is an inaccessible crawlspace under the front of the house, and the top of the basement wall has been infilled with concrete around the joists preventing one from seeing the condition of the crawlspace, however the foundation is not located at an original bearing line of the floor. The floor joists and beams are undersized and must be sistered if they are to remain in service. There are some previous floor openings that have been improperly filled; they must be framed in correctly. The close contact of the masonry and concrete has resulted in serious deterioration of the ends of some joists.

Concrete infill and rotted joist

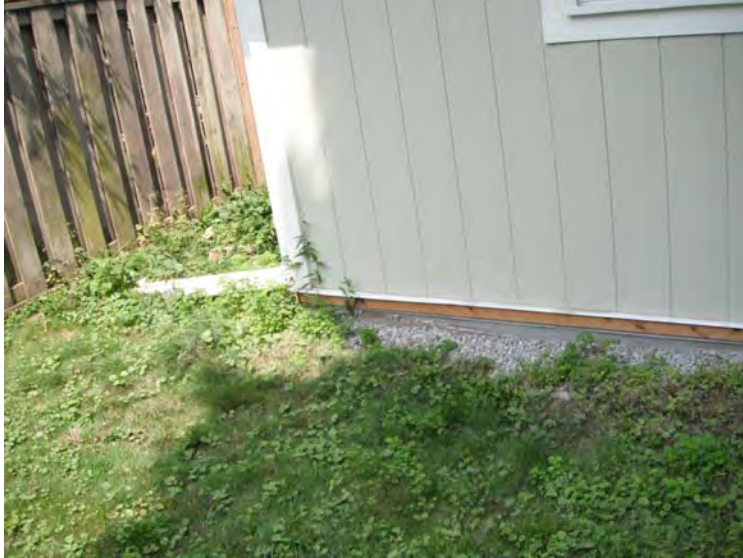
The structure of the main floor of the dwelling has been modified numerous times in its history. There are at least three, and possibly four additions to the original building, as well as substantial alterations to the original and subsequent structures. What appears to have been a rear porch has been winterized and finished, albeit improperly, and it does not meet the most basic standards for structural integrity and weatherability, and should be removed and replaced. It has fairly new siding and roofing, however there does not appear to be a proper foundation, there is unprotected spruce framing lumber within a few centimetres of the exterior grade, and flashing and caulking details are incorrect and will quickly lead to serious deterioration.

Rear addition with improper foundation and moisture protection

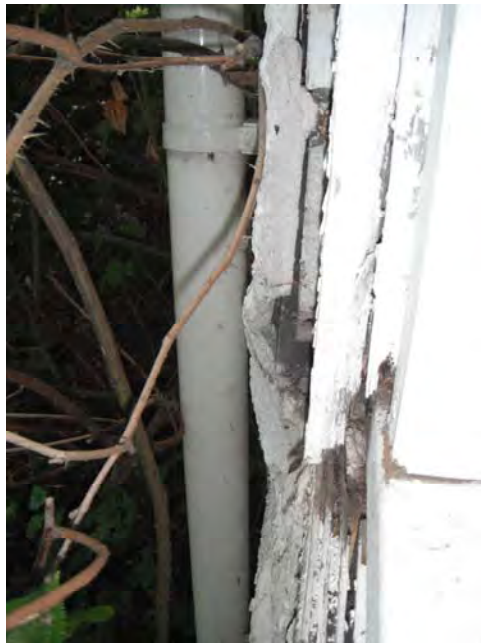
The main house and early west addition have an exterior finish of roughcast stucco. This appears to be the original finish on the addition, however the main house was originally clad with horizontal wood clapboard siding over which the stucco was applied. There was no attempt at proper flashing or weatherproofing of original wood trims and penetrations, and although the porch roof has protected some of these areas, there is serious deterioration in other areas, much of which has had subsequent substandard stucco repair, and requires further work. It is quite likely that the underlying sheathing and structure in these areas has experienced serious decay and should be repaired or replaced, however without intrusive or destructive investigation this cannot be confirmed.

Stucco over wood trim

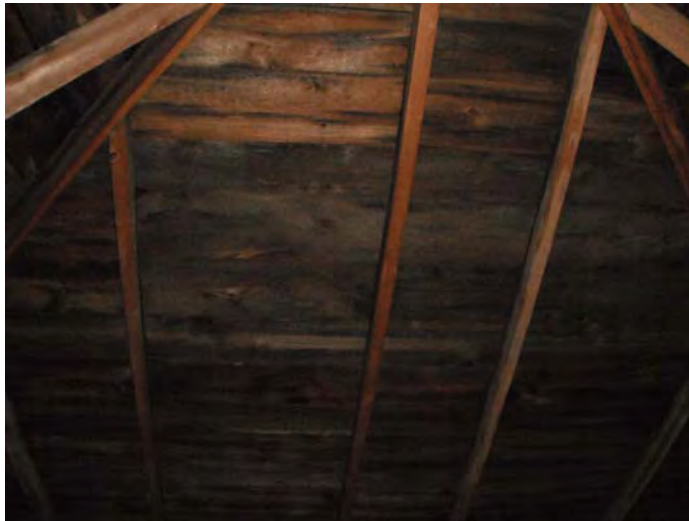
The interior structure of the house has been altered significantly, with the addition of windows and a patio door, conversion of a window to a door, changed sizing of windows, addition of skylights, and most significantly the removal of a large are of ceiling framing to create a cathedral ceiling and a storage loft. The remaining portion of attic where the structure is visible shows substantially undersized rafters with random spacing, requiring the installation of new rafters to straighten and strengthen the roof structure.

Inadequate and randomly spaced rafters

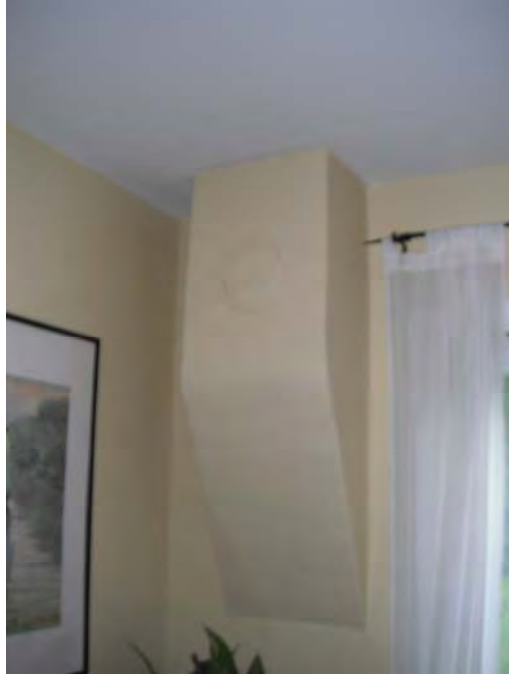
An apparently original chimney for a woodstove still exists on the rear wall of the house although it no longer extends through the roof. As was common in the 19th century, and less so in the 20<sup>th</sup>, the chimney is supported on the wood framing of the rear wall. While this is a poor construction detail and is not permitted under today's building code, the chimney could be permitted to remain if there were a good reason to do so. Because it no longer serves even a decorative purpose, it should be removed to eliminate the excessive stress that it places on the already inadequate building structure.

Obsolete and improperly supported chimney

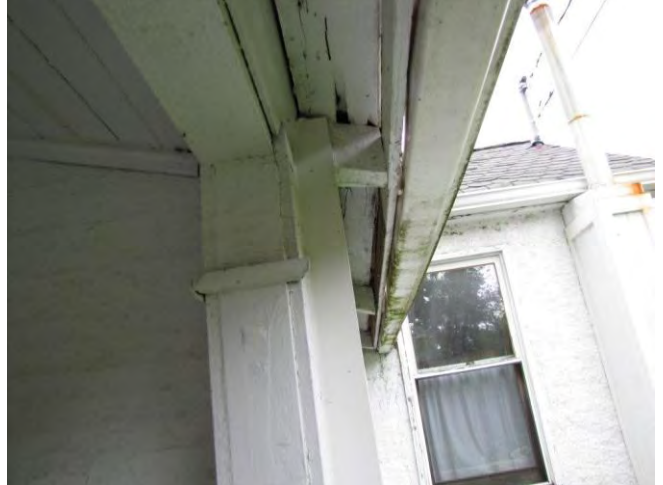
**Photo 2: Porch Overhang**

Wood is deteriorating over enclosed bathroom built into porch.

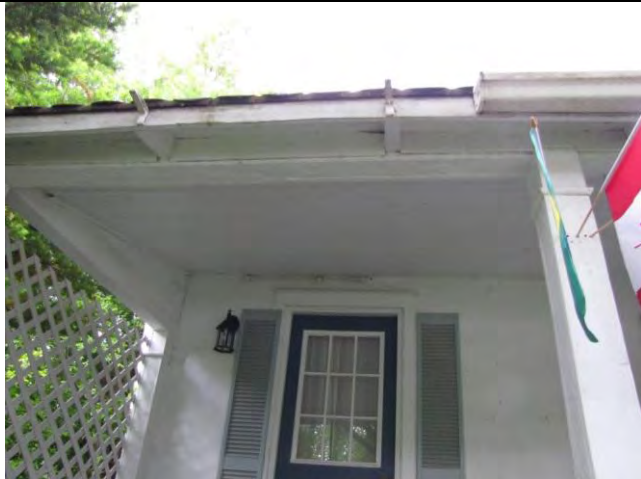
**Photo 3: Porch**

Unvented porch attic space.

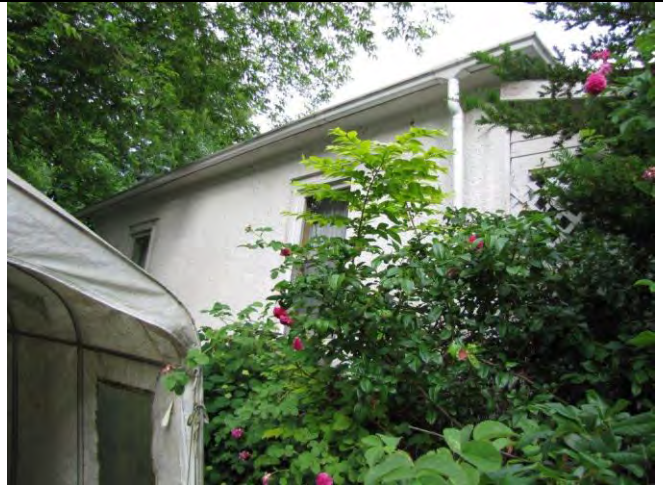
**Photo 4: Side View Exterior**

No soffit venting present for this attic.

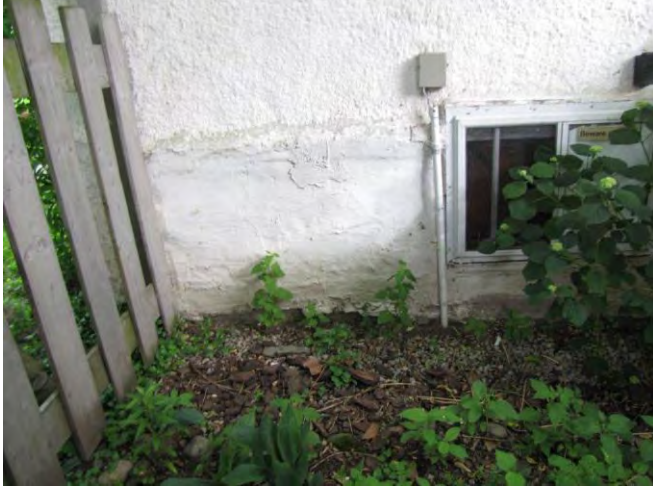
**Photo 5: Exterior**

Parging repairs to the foundation.

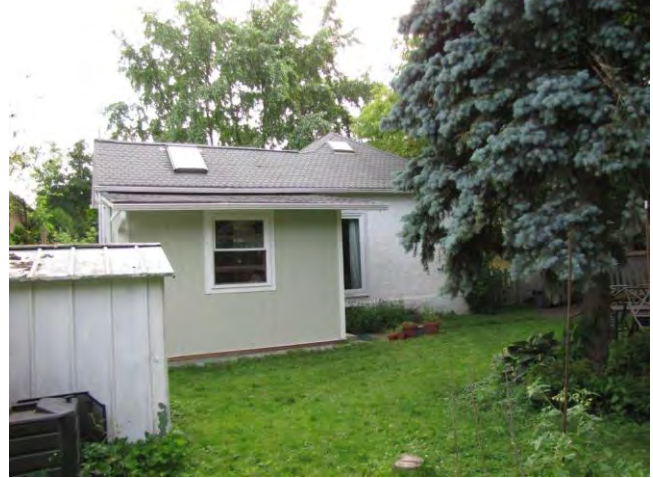
**Photo 6: Roof**

Unvented attic over addition, unvented main attic and unvented cathedral ceiling cavities. All roof/attic spaces are prone to condensation and mold growth because of insufficient ventilation.

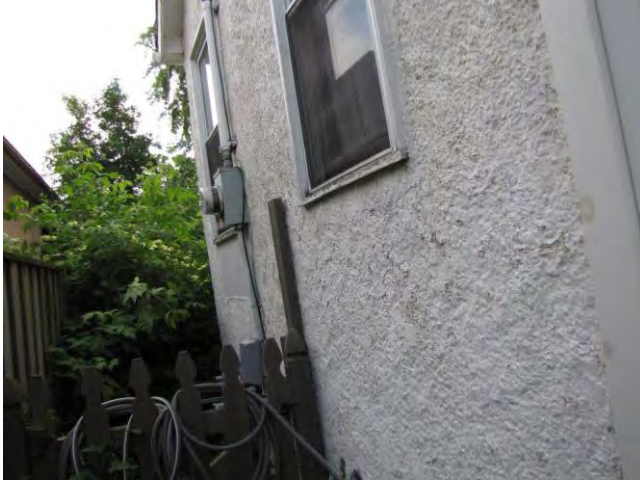
**Photo 7: Exterior**

Wood trim is built into the stucco finish. The trim is deteriorating around windows.

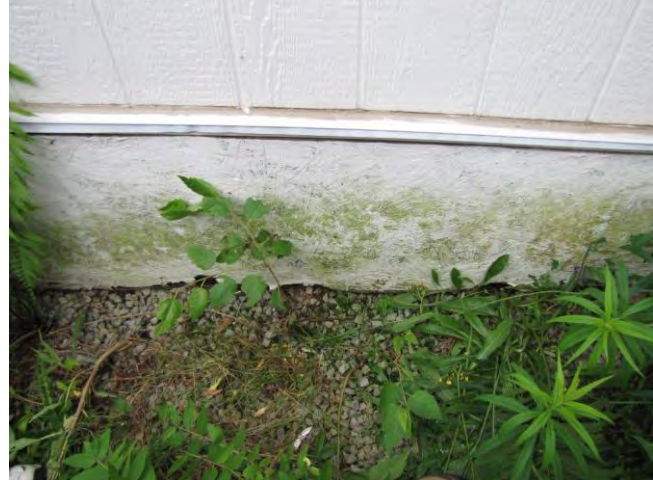
**Photo 8: Crawlspace**

No access available to the crawlspace under the bathroom at the side of the home or the crawlspace at the front of the home.

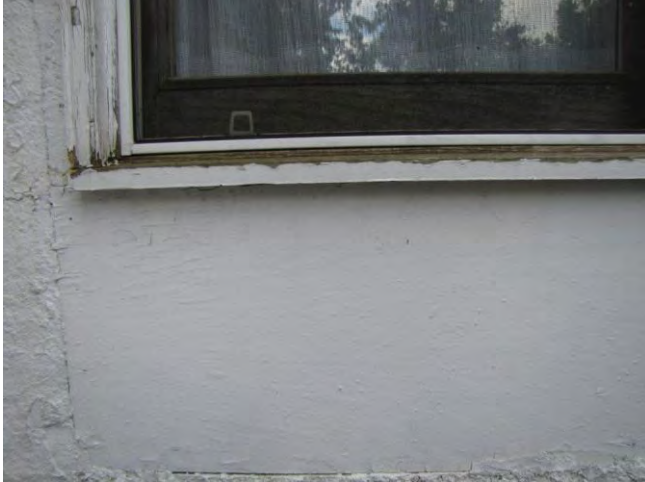
**Photo 9: Window**

Plywood is built into stucco and needs to be kept painted. Some wood deterioration is visible on the trim.

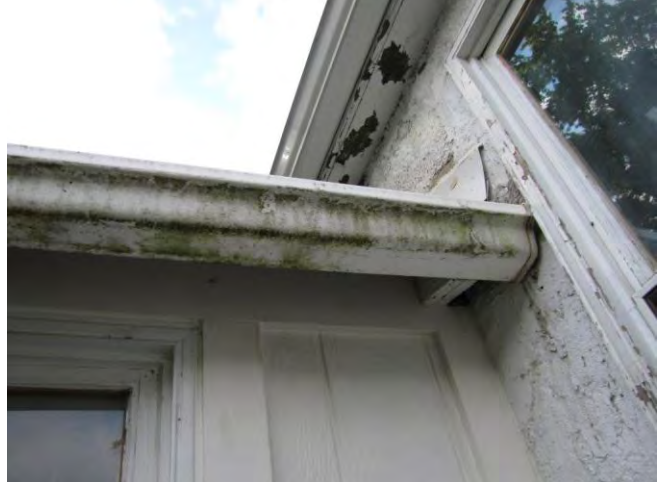
**Photo 10: Poor drainage at Eavestrough**

Ice damming may be occurring in this area affecting the bottom side soffit and interior building materials. As well the stucco is starting to deteriorate.

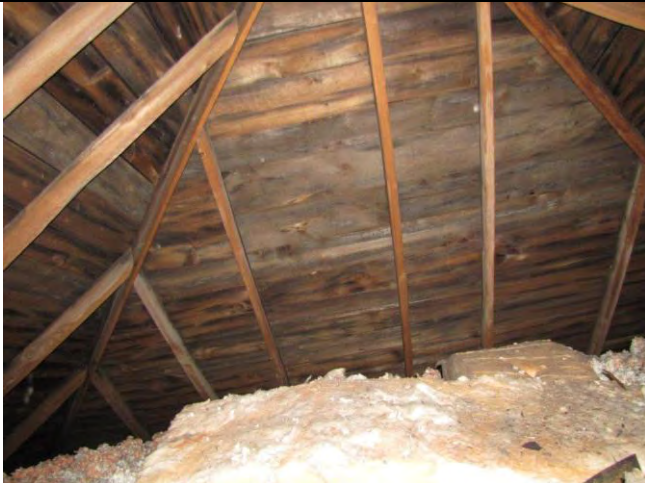
**Photo 11: Attic**

Mold growth was detected on swabs taken of the attic sheathing.

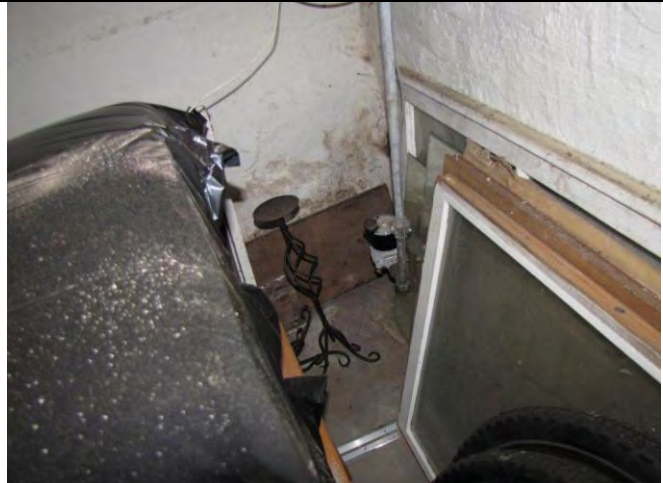
**Photo 12: Basement**

A strong musty odour is present upon descending into the basement. There is evidence of water intrusion and mold growth affecting this area of basement.

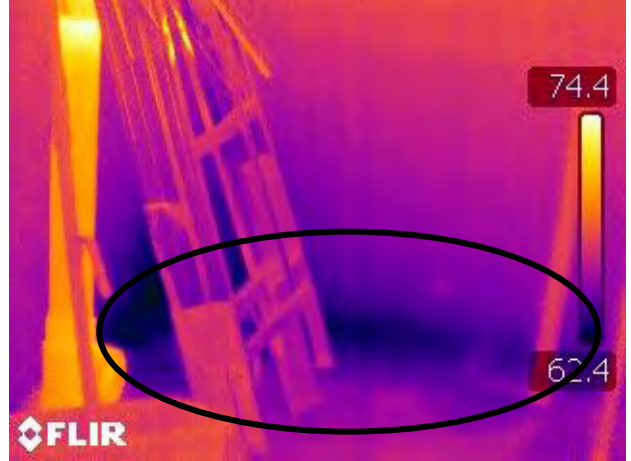
**Photo 14: Basement**

Moisture intrusion occurring at floor height.

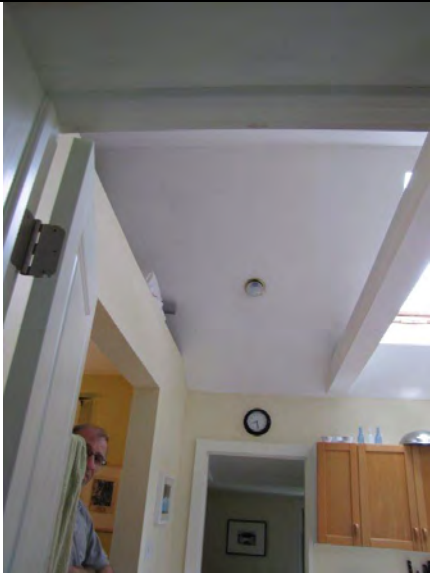
**Photo 15: Kitchen Cathedral Ceiling**

Most of the cathedral ceiling in the kitchen shows some heat loss.

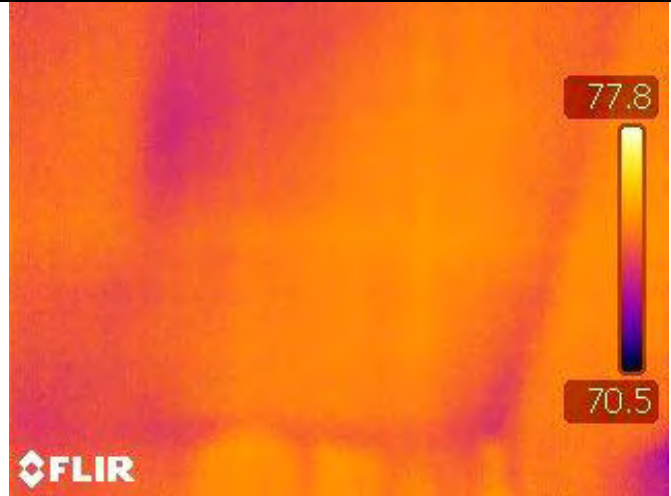
**Photo 16: Kitchen Cathedral Ceiling**

The heat loss may affect the roof in winter months causing ice damming because of insufficient ventilation.

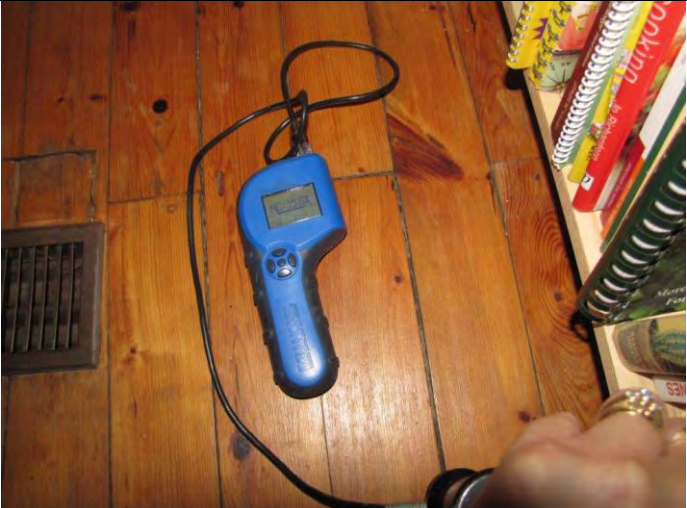
<p>The wood floor in this area including subfloor is moist up to 16% wood moisture content. A crawlspace is below with no access.</p>
--	--
