Heritage Impact Statement

277 Pinetree Way
Mississauga ON L5G 2R4

November 28, 2011

Report prepared by David W. Small

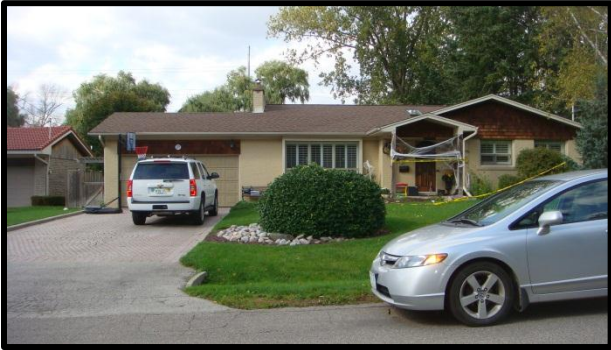
Front Elevation

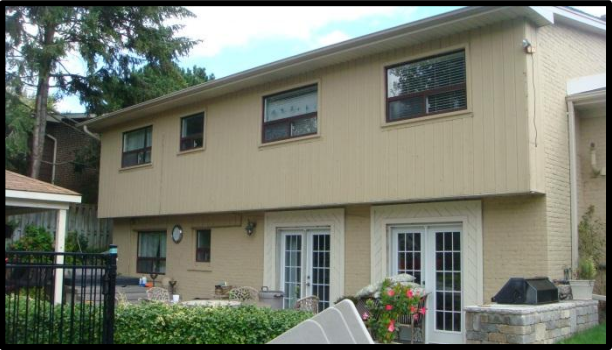
Rear Elevation

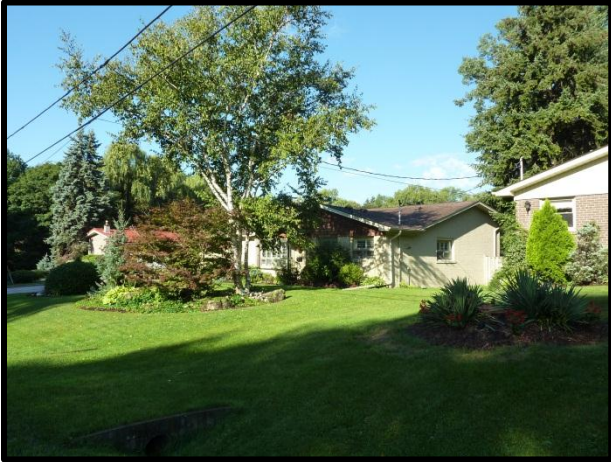
Right Side Elevation

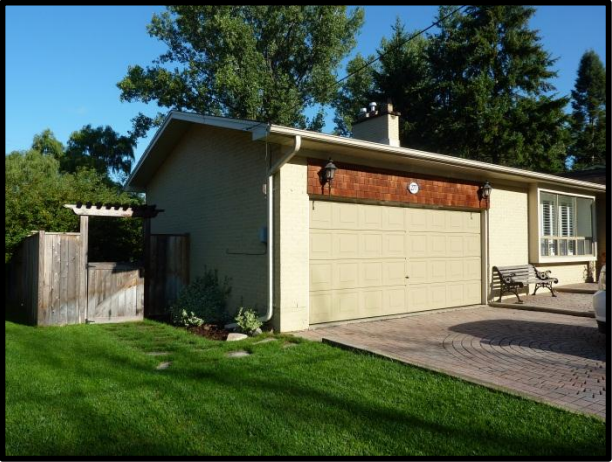
Left Side Elevation

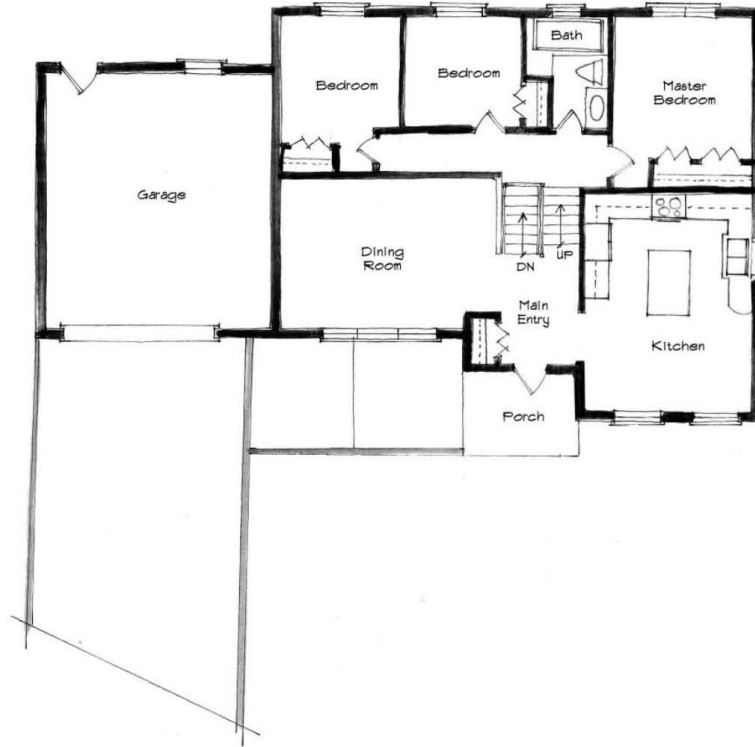
Ground/Second Floor Plan

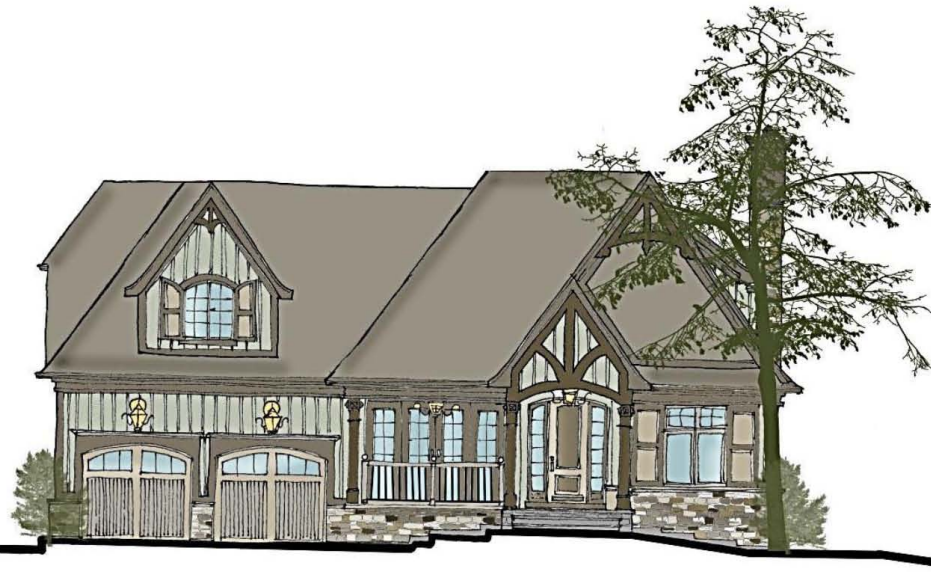
277 Pinetree Way
Streetscape Elevation

The proposed home at 277 Pinetree Way has been designed with similar massing characteristics of other homes on Pinetree Way and adjacent streets throughout the neighborhood. Although the massing of the proposed home does not represent the immediate adjacent neighbors the house has been designed in a manner in which it can successfully cohabitate with the existing dwellings.

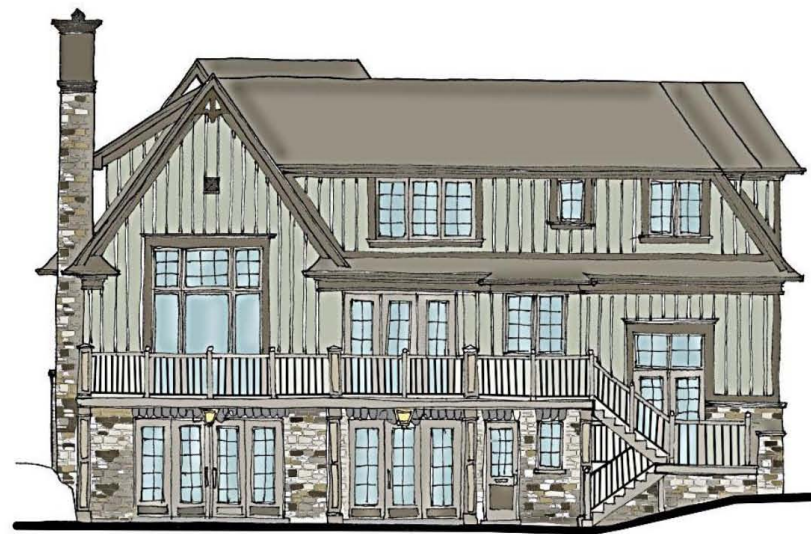
Rear Elevation

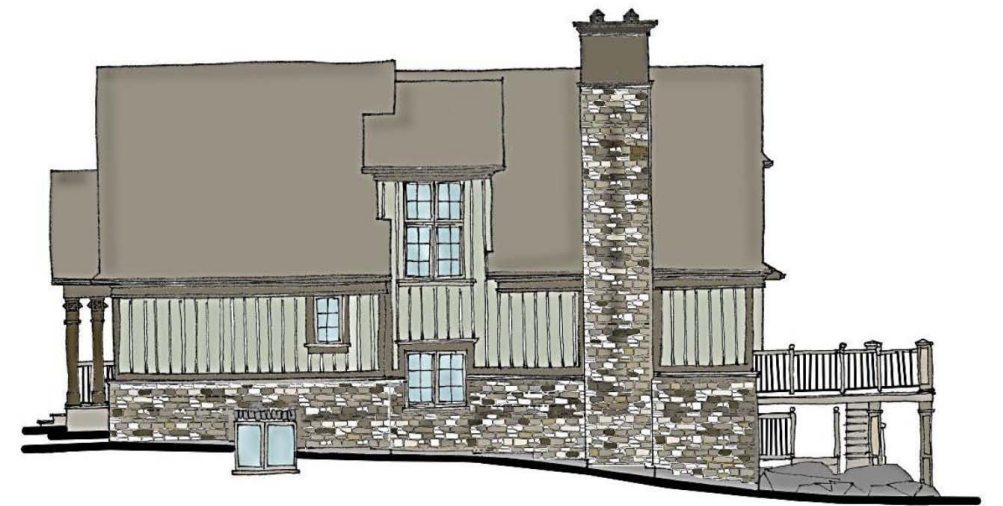
Right - Side Elevation

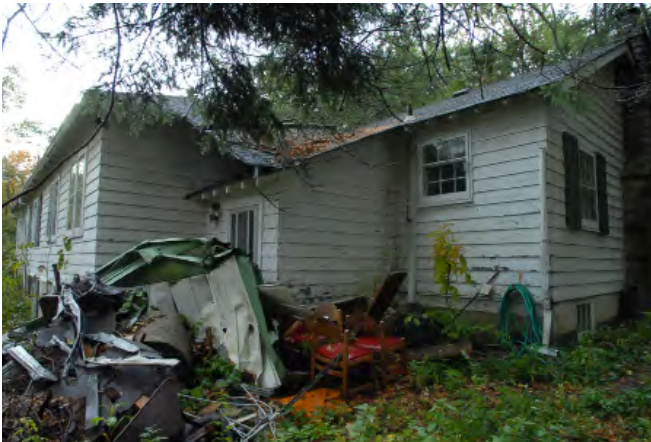
North East Corner (Note awkward roof condition at Rear Entry)

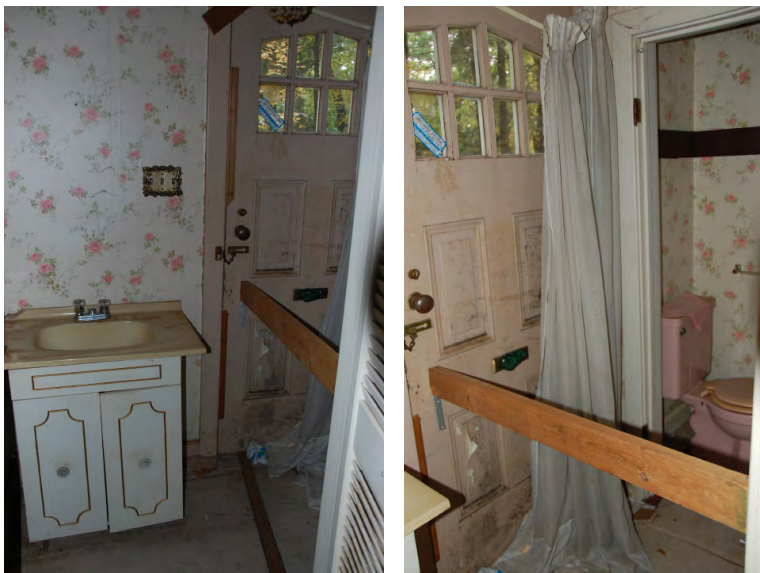
Entry Converted To Powder Room

One notable factor of the additions to the home is that the existing building was not well integrated into it. The original entry vestibule was oddly converted into a two piece washroom, and the parlour seems to have been used as a bedroom. The kitchen remained small and dark. It is unclear why the addition is a small step below the

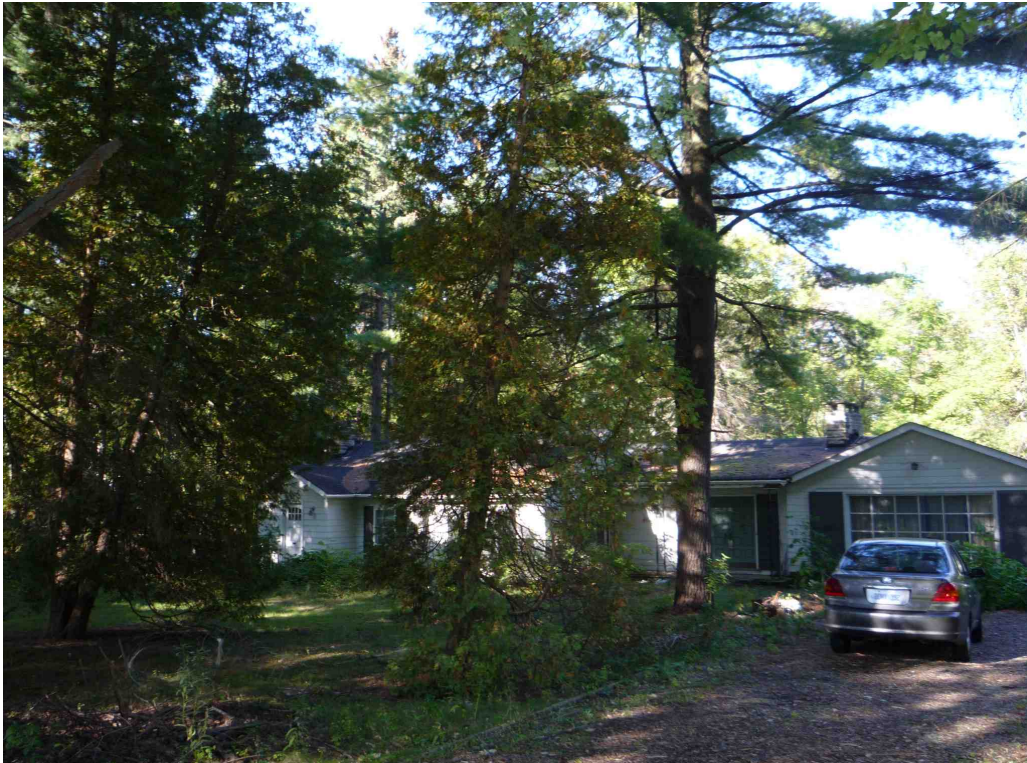
Photograph 1: View of front yard showing T100 and existing house and driveway to be demolished.
