# Cooksville Creek Flood Evaluation Study

## Task Force Meeting

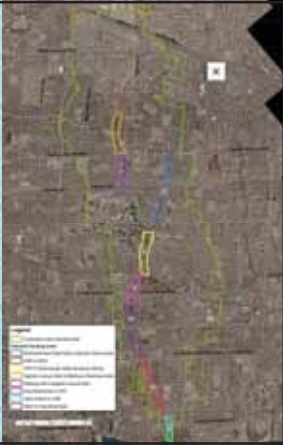
- 304 buildings may flood during the Regulatory storm
- Floodplain mapping completed 1975
  - Development pre-1975 did not consider floodplain (generally south of Hwy 403)
  - Development post-1975 was outside the Regulatory floodplain (generally north of Hwy 403)
- 94% of the watershed is developed

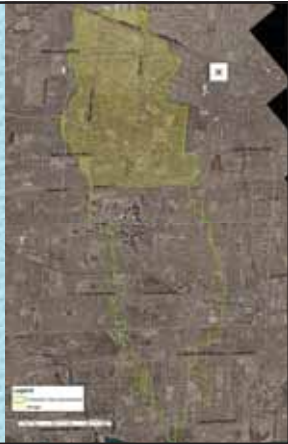
### Flood Remediation Measures

- Storage

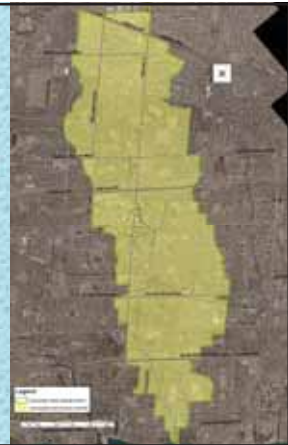
### Flood Remediation Measures

- Source and conveyance controls

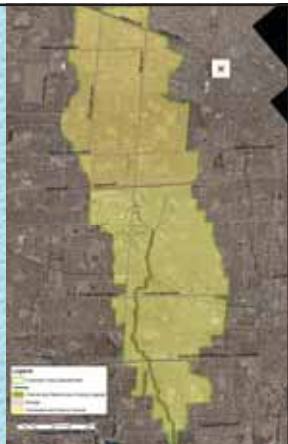
### Flood Remediation Measures

- Channel and watercourse crossing upgrades
- ▨ Storage
- Source and conveyance controls

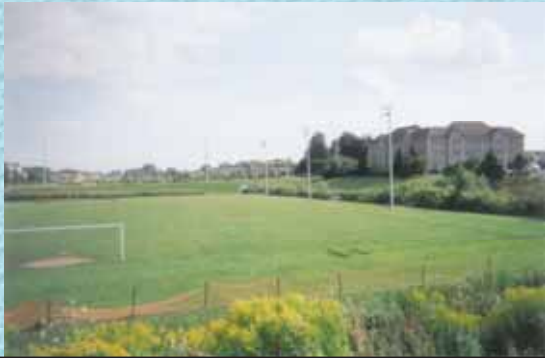
### PARK STORAGE – CITY OF HAMILTON

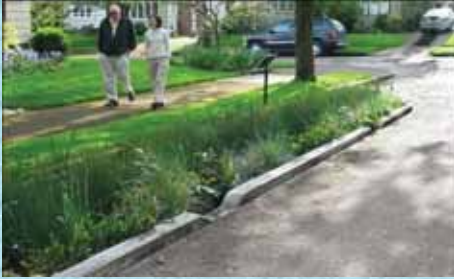
## CONVEYANCE CONTROL PROGRAM FOR EXISTING URBAN AREAS

Bioinfiltration Unit in the Road

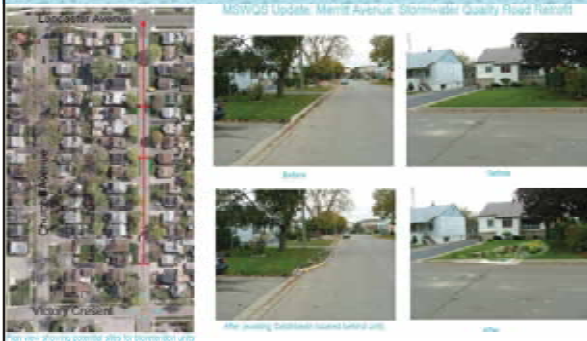
## CONVEYANCE CONTROL PROGRAM FOR EXISTING URBAN AREAS

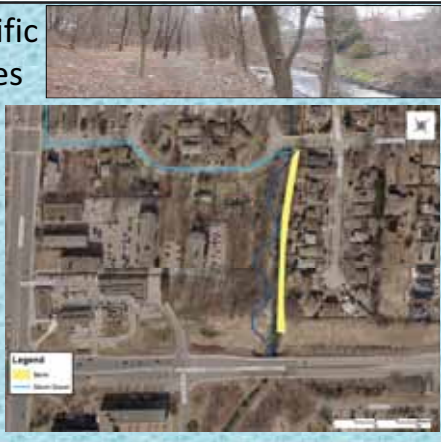
## Site Specific Measures

Paisley Boulevard East – berm and channel relocation

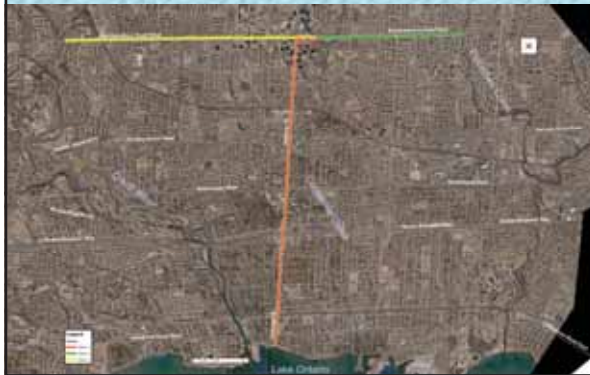
## TUNNEL
