# **Park 505 – Phase One: Fluvial Geomorphology Assessment**

## **FINAL REPORT**

Project No. P2019-364

**Re: Fluvial Geomorphology Study  
City of Mississauga – Park 505 Phase One Development**

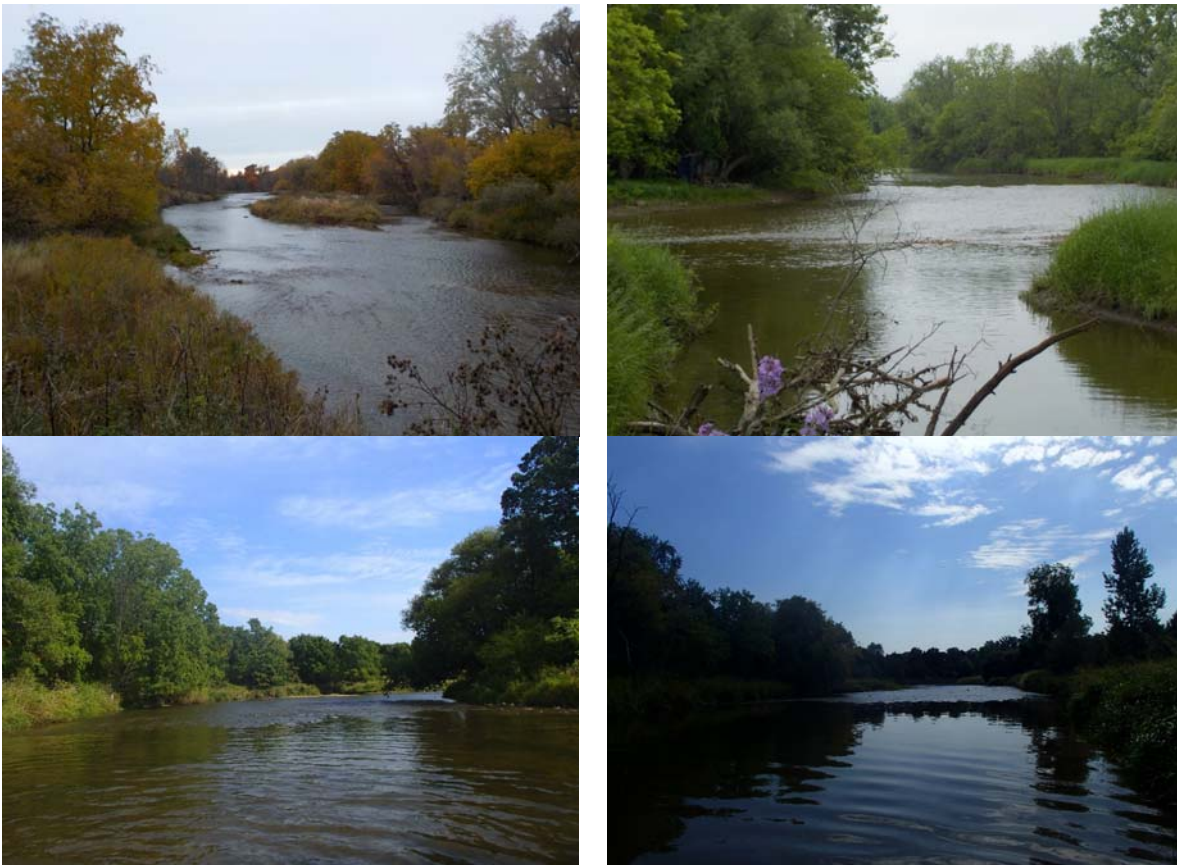
*Photo 1: Credit River representative photos. At existing pedestrian bridge near upstream end of reach (top left), at confluence with Fletcher's Creek (top right), at upstream proposed crossing (bottom left), at downstream proposed crossing (bottom right).*

The river in this reach can be characterized as a wide, meandering, gravel-bed river. There are several locations where the river flows coincident with the toe of the valley wall. Engineered erosion protection is present at several of these locations to mitigate potential toe erosion risks. Localized instances of bank erosion are present but, overall, the banks are well-vegetated, and the reach does not exhibit system-wide symptoms of instability.

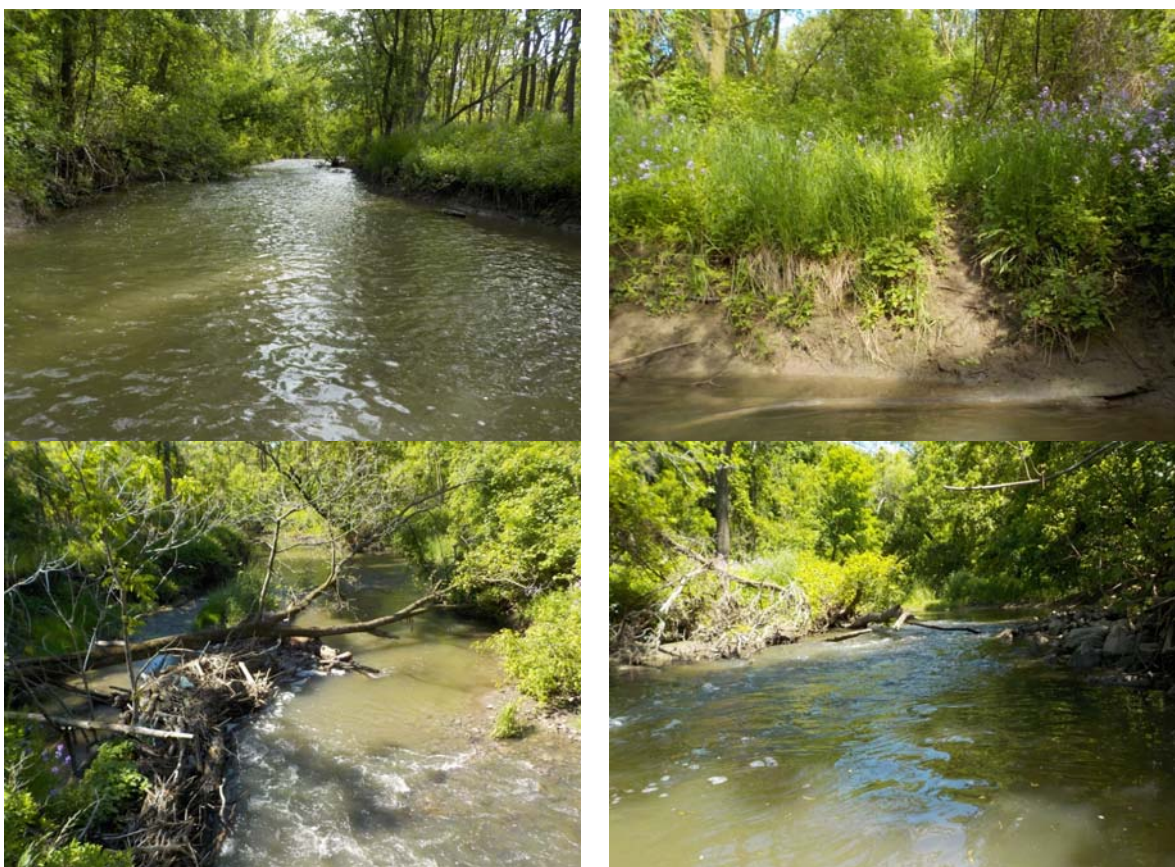
*Photo 2: Fletcher's Creek representative photos. At existing pedestrian bridge near upstream end of reach (top left), at confluence with Fletcher's Creek (top right), at upstream proposed crossing (bottom left), at downstream proposed crossing (bottom right).*

Fletcher's Creek exhibits geomorphic indicators consistent with river incision and widening processes. This condition is representative of watercourses in active adjustment and of watersheds that have been subject to significant land-use change. Woody debris and fine sediment deposition are present throughout the reach. The riffles' substrate composition is consistent with channel armouring processes (another indicator that the stream has undergone adjustment). Also, the oversized nature of the channel implies that the floodplain is not frequently accessed by flood flows, thus there is less energy dissipation (than in floodplain connected reaches) occurring during higher flows.

The proposed Park 505 crossing locations are illustrated in Map 5. Fletcher's Creek in the vicinity of the crossing has not changed significantly during the observed period of record, with only approximately 1 m difference between the centrelines of all years. This difference is within the uncertainty associated with delineating the historical centrelines. It is, thus, concluded that the stream has not changed locations considerably. This conclusion is corroborated by the topography at the proposed crossing location, which confines the channel alignment here. The confined setting should be considered when positioning the crossing abutments, as the creek flows coincident to the toe of the left bank. Field observations indicate that the bed and toe of the left bank are armoured with coarse material (Photo 2), which may mitigate potential erosion at this location.

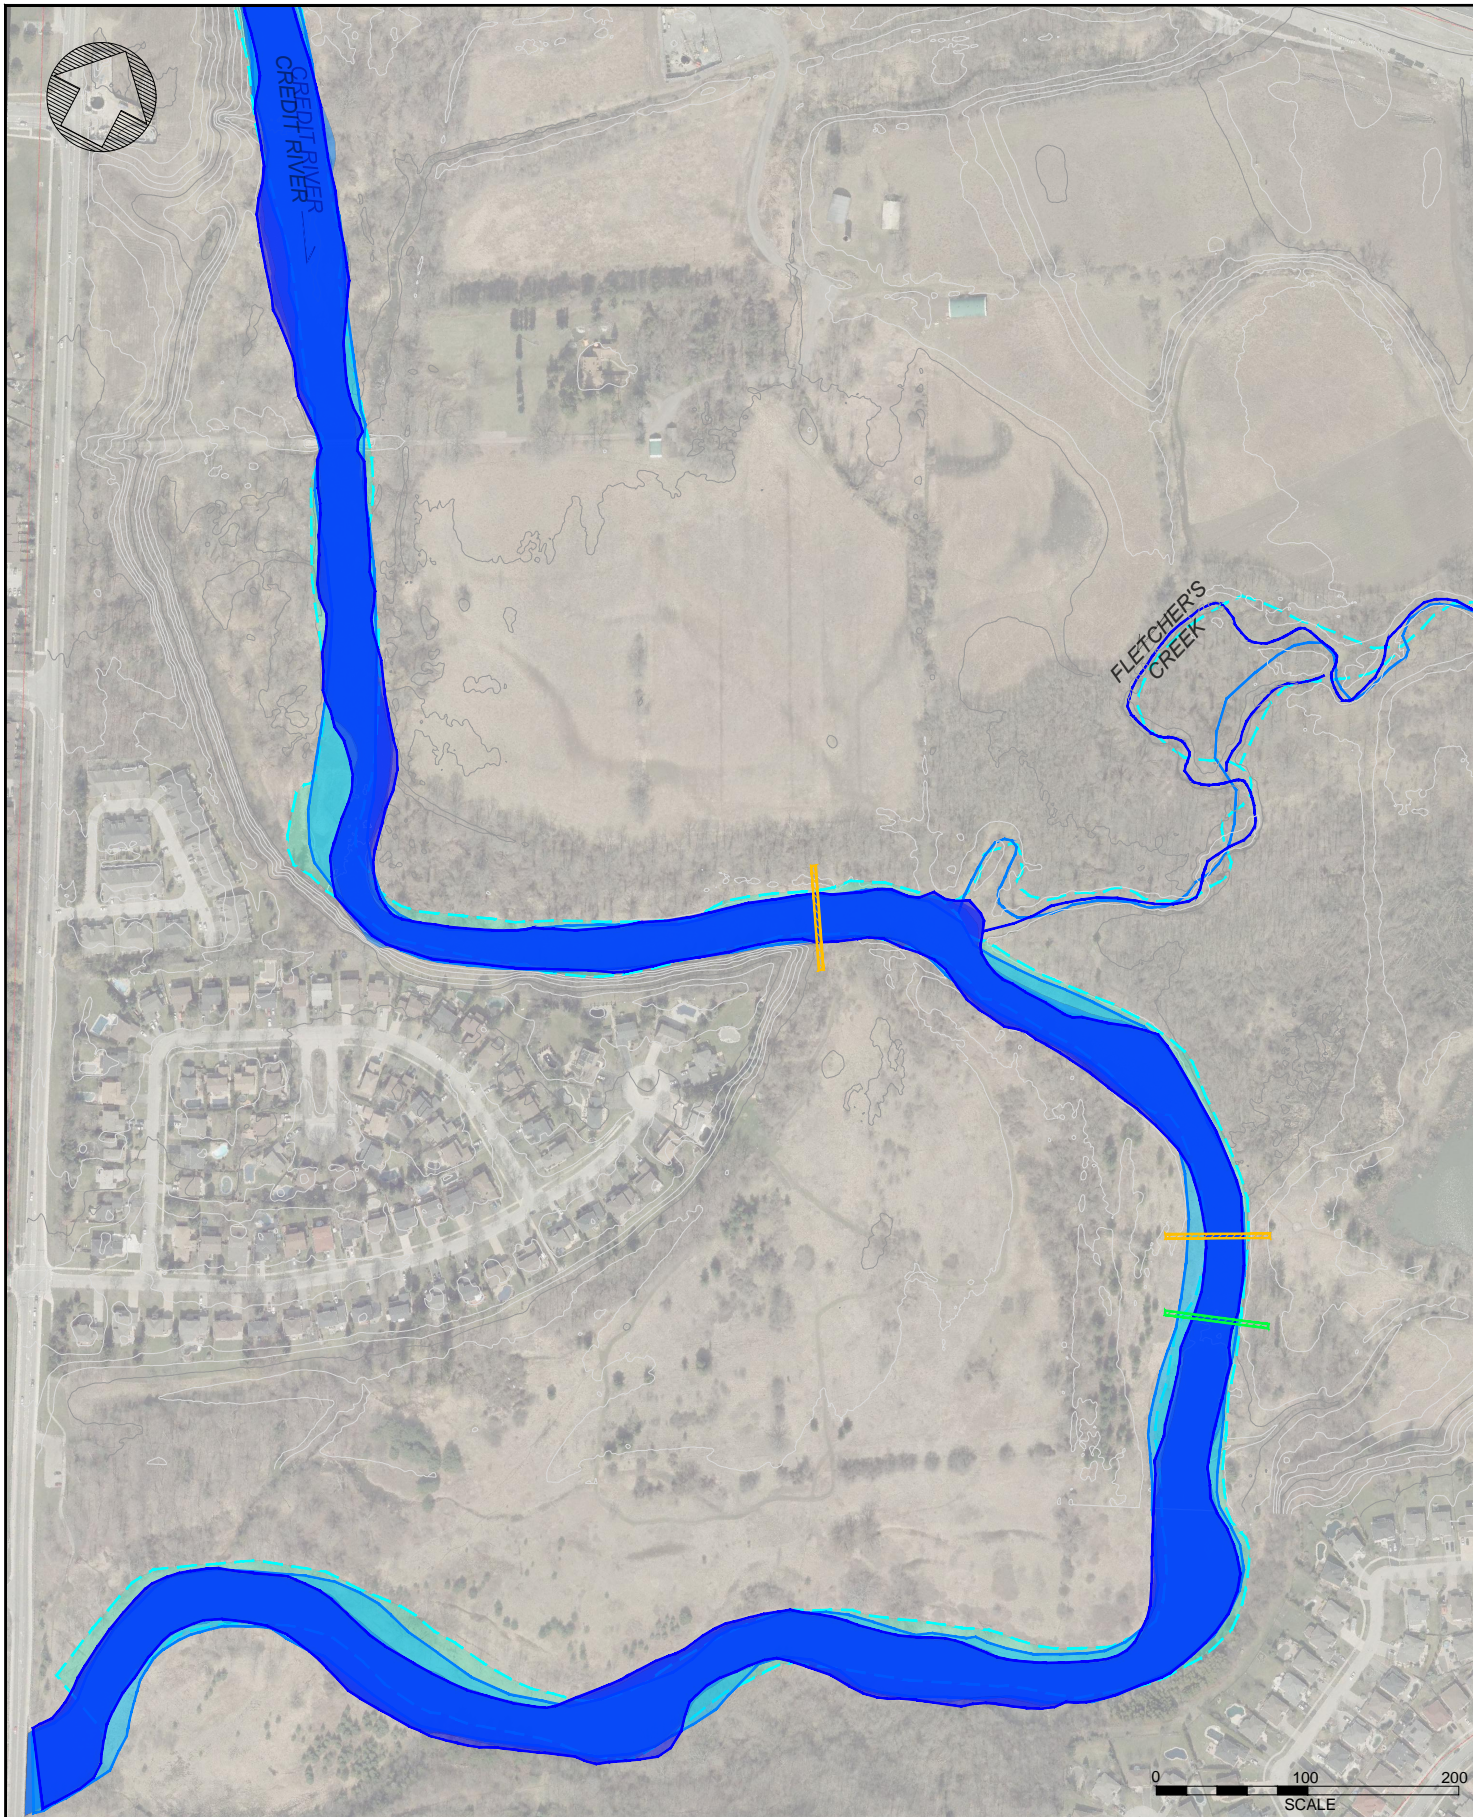
Credit River Historical Channel Alignments

The historical conditions were assessed, and a summary is included in Table 7. The delineated banks and centreline are illustrated in Map 3 and Map 4.

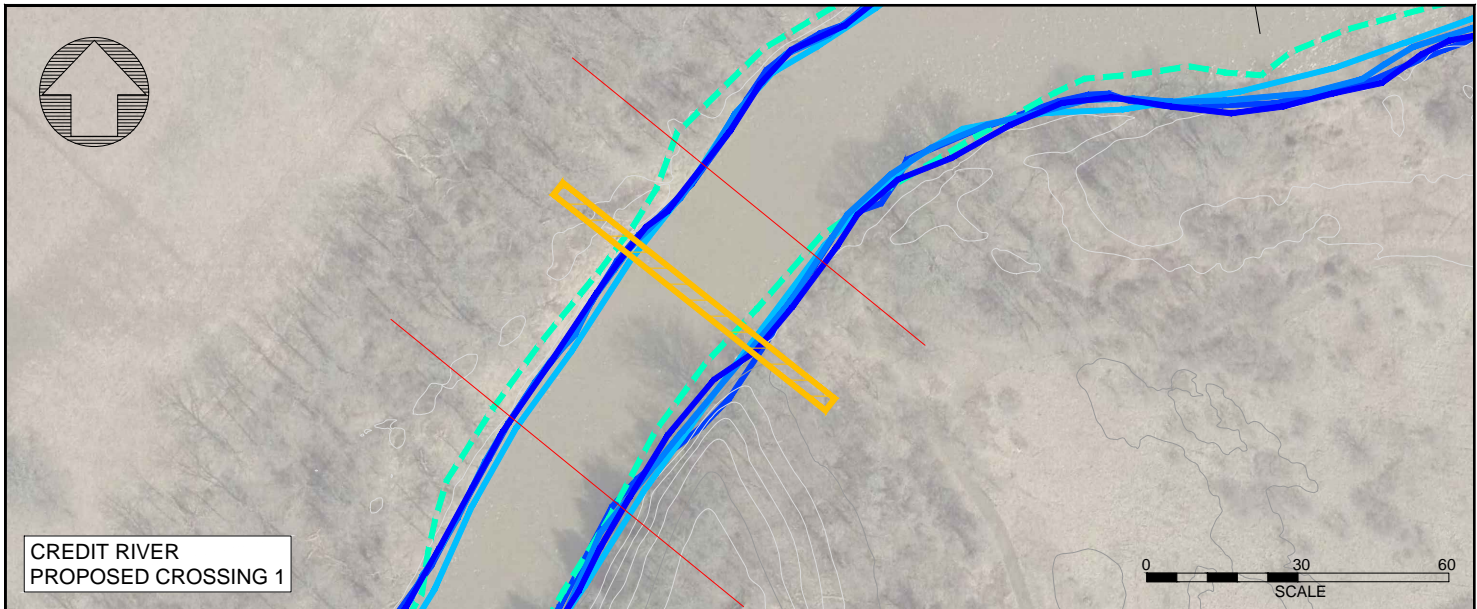
Map No.  
5

Proposed Crossing Locations

The upstream proposed crossing (Crossing 1) is located on a straight section of river immediately upstream of a riffle (XS-CR7). While bank erosion/migration potential was determined to be low here, abutments or piers should be set back from the top of banks by a minimum of 3.5 m (to account for uncertainty in the aerial photo delineation and the 100-year migration from Table 8). The crossing is immediately downstream of a valley wall contact location (on the right bank) and, as such, will have less impact on sediment transport continuity or floodplain obstruction on the right bank.

The downstream proposed crossing (Crossing 2) is located on a bend. Although lateral migration rates were assessed to be low in this location, locating crossings on bends is not recommended as these are naturally dynamic areas (as discussed above). If possible, the crossing location should be moved downstream to be closer to the downstream riffle (XS-CR10). Aerial photos revealed an area of localized bank erosion at XS-CR10 (shown on Map 5). This area is low-lying and experiences overbank flows (as illustrated in the 1980 photo). As such, the crossing should be situated approximately 25 m upstream of XS-CR10 (or approximately 55 m downstream of the original proposed location of Crossing 2), which is upstream of the low-lying area and exhibits historically stable banks. It is recommended that the abutments be set back a minimum of 3.5 m, remaining consistent with Crossing 1.
