**Sawmill Creek Erosion Control Project**  
**Folkway Drive to Erin Mills Parkway**  
**Municipal Class Environmental Assessment**  
**Virtual Public Information Centre**

# Sawmill Creek Erosion Control Project

- The city is initiating a **Municipal Class Environmental Assessment** (MCEA) under a Schedule B to investigate the causes, extent, and mitigating alternatives of the issues identified in this area.

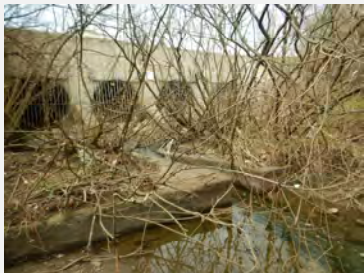
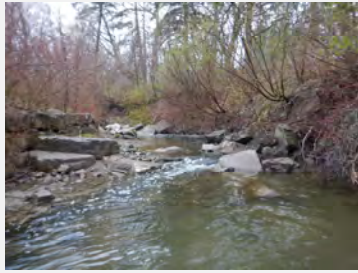
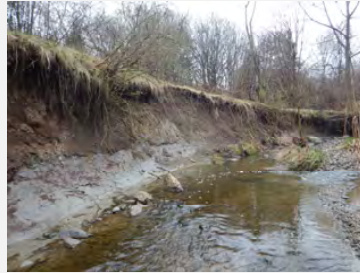
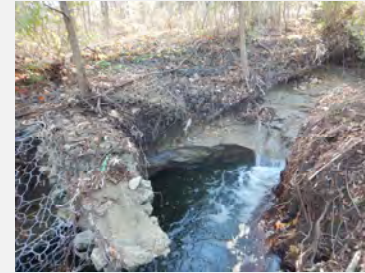
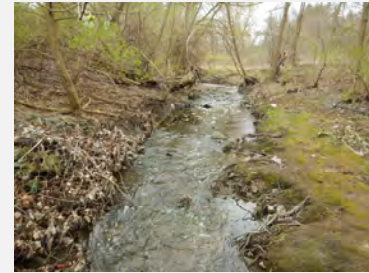
- Bank protection (gabions, concrete channel lining, large angular stone) occurred along ~39% of the total bank length (1,037 m).
- Bank protection conditions ranges from being in a deteriorated state (fallen gabions, cracked concrete) to being in fair condition.
- 19 weirs (gabion, concrete) situated across the channel; many are compromised.

- Sawmill Creek is a meandering channel with a pool-riffle bed morphology sequence through the study area.
- Bed morphology is partially influenced by the erosion control and grade control measures (weirs) implemented on the channel banks and bed. As such, the stream type through the study area is 'semi-structural control and alluvial'.
- 6 reaches were defined based on the channel bed profile and erosion control characteristics.
- The channel cross-section is generally well connected to the floodplain, with the exception of the downstream third portion of the channel which has incised into the floodplain setting, creating high steep channel banks.
- Erosion and evidence of channel adjustment through channel widening, scour pool development and outflanking/undermining of erosion and grade control measures is abundant through the entire channel within the study area.

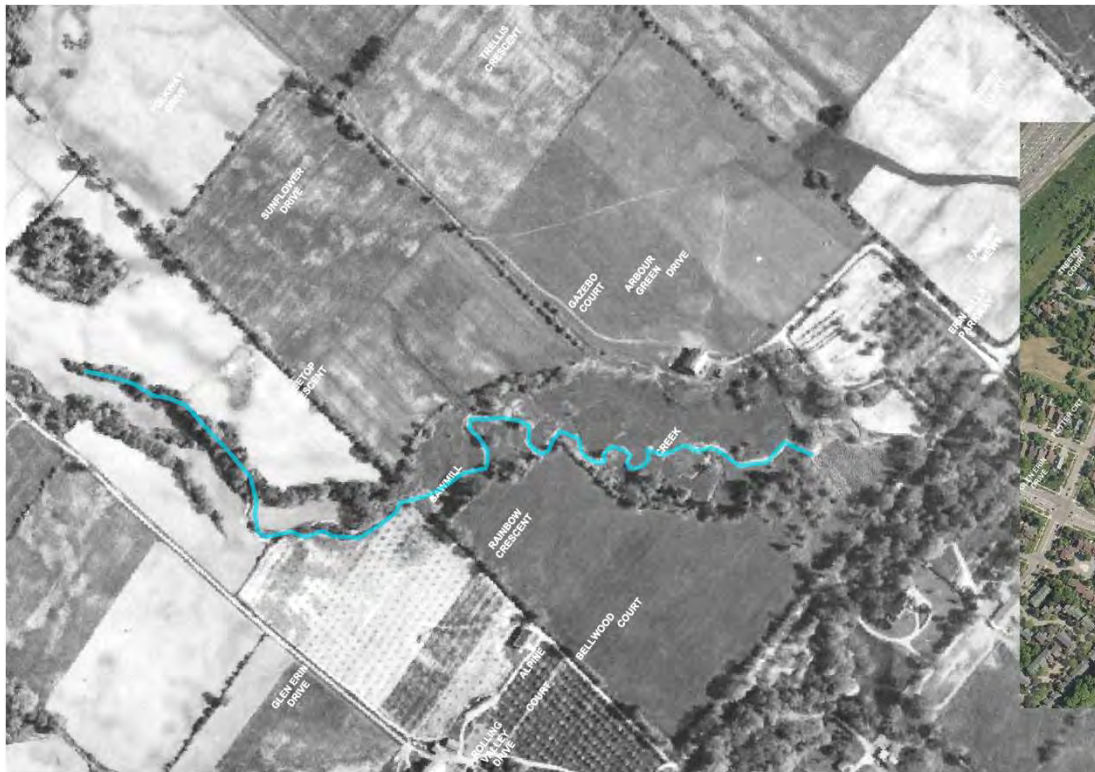
1954 Aerial Image  
(National Air Photo Library)

- Extensive urbanization has occurred within the study area during the 1970s
- Sawmill Creek has been re-aligned through the study area as a result of a channelization project conducted between 1975 and 1977
- Vegetation communities reflect historical changes of study area

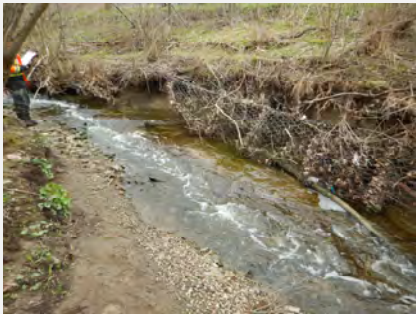
## ENGINEERED CHANNEL CONDITIONS

- 19 degraded / failing grade control weirs
- Failing / emptied gabion basket bank protection

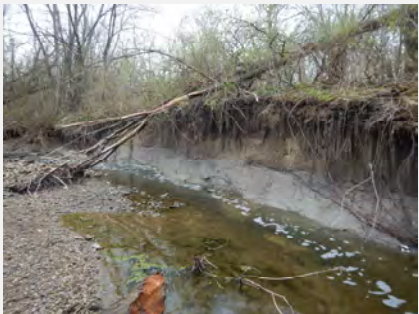
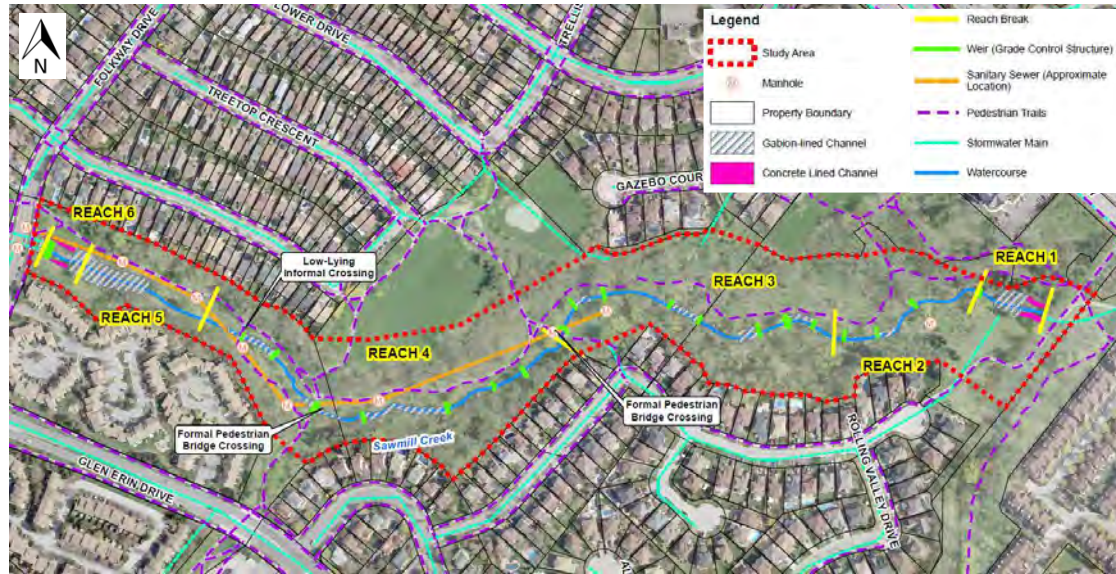
## CHANNEL BED AND BANK EROSION

- Channel has eroded into native underlying glacial till; difficult to maintain cover (i.e., substrate) once removed.

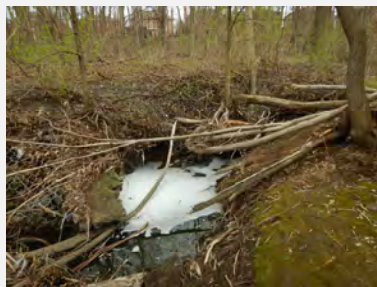
## DEBRIS ACCUMULATION

- Large woody debris has accumulated within the channel, causing channel bank erosion, inhibiting fish passage, and promoting accumulation of urban debris.

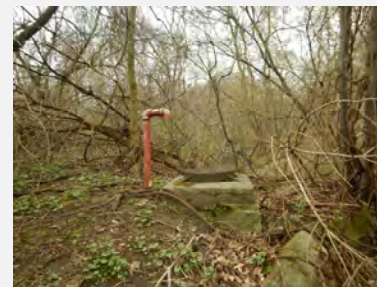
## INFRASTRUCTURE

- Sanitary sewer located beneath (~4 crossings) and in proximity to creek; associated manholes
- Pedestrian bridge crossings (2 formal; 1 low-lying). Fair to poor condition
- Erosion risk to multi-use trail where in proximity to channel

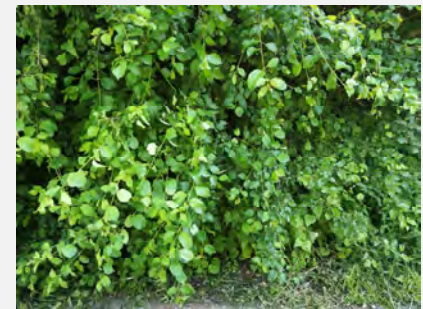
## INVASIVE SPECIES

- Invasive and non-native species such as common buckthorn, winged spindle tree, and garlic mustard.

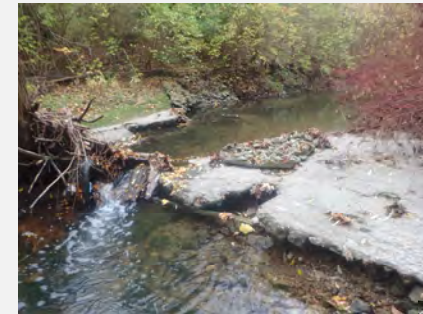
## AQUATIC HABITAT

- Issues of fish passage due to large drops, log jams, and accumulation of debris from failed bank hardening structures.

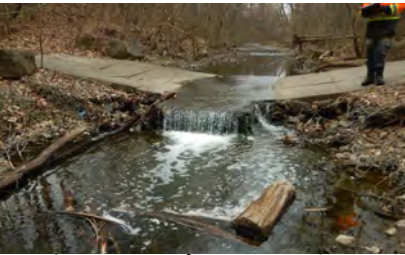
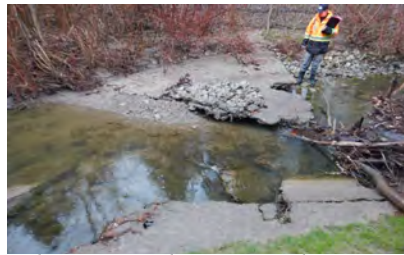
**CONTINUED DETERIORATION / FAILURE OF GABION EROSION CONTROL ON CHANNEL BANKS**

**CONTINUED FAILURE OF EROSION CONTROL ON CHANNEL BANKS & AT PEDESTRIAN BRIDGE CROSSINGS**

- Continuation of ongoing channel processes that are leading to the deterioration and failure of erosion control and grade control measures.
- Continued bank erosion and downcutting (scour) of the channel bed; exposure of underlying glacial till material
- Continued risk to existing infrastructure, due to ongoing processes, including bridges, sanitary sewer crossings and manholes, and pedestrian pathway, leading to eventual failure.

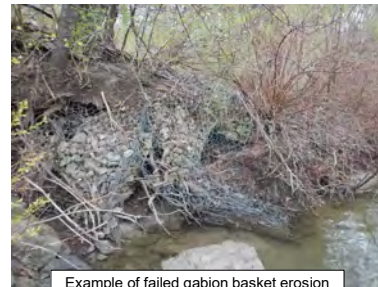
Example of failed gabion basket erosion control protection within the Study Area.

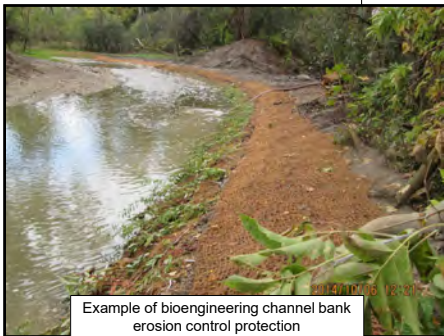
## TYPICAL RIFFLE AND EROSION CONTROL PROTECTION ASSOCIATED WITH FORMAL PEDESTRIAN BRIDGE CROSSINGS

- Replacement of the two deteriorated existing bridge crossings. Areas of erosion / undermining of bridge crossings would be addressed
- Removal of the failed or outflanked gabion grade control structures (weirs) and replacement with natural stone riffles
- Removal of dead or unhealthy trees and channel debris
- Placement of natural stone or woody material to provide erosion control in vulnerable locations (pathways, slopes, buried infrastructure) where they are currently exposed

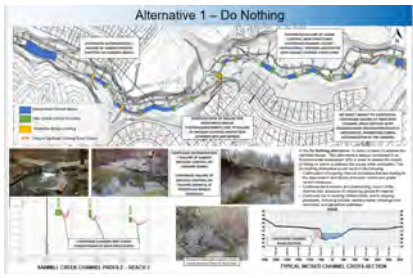
| Alternative | | Benefits | Challenges |
|---|---|---|---|
| <p>Alternative 1 – Do Nothing</p> | <b>Do Nothing</b> | <ul style="list-style-type: none"> <li>No near future construction disturbance</li> <li>No immediate costs</li> </ul> | <ul style="list-style-type: none"> <li>Channel will continue to incise in some locations; further channel bank erosion may compromise channel stability</li> <li>Bridges will continue to deteriorate</li> <li>Invasive vegetation will continue</li> </ul> |

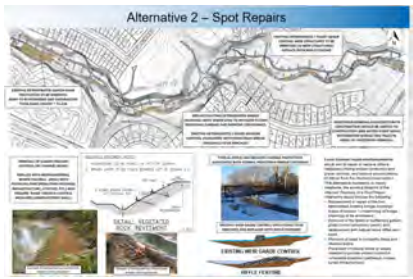
| Alternative | | Benefits | Challenges |
|---|---|---|---|
| <p>Alternative 2 – Spot Repairs</p> | <b>Spot Repairs</b> | <ul style="list-style-type: none"> <li>Makes repairs to portions of the project that have failed</li> <li>Would replace the deteriorated bridges</li> <li>Would have limited site disturbance</li> <li>Costs would be comparatively low</li> </ul> | <ul style="list-style-type: none"> <li>Does not address areas of channel incision</li> <li>Does not address erosion potential</li> <li>May require frequent future maintenance</li> </ul> |

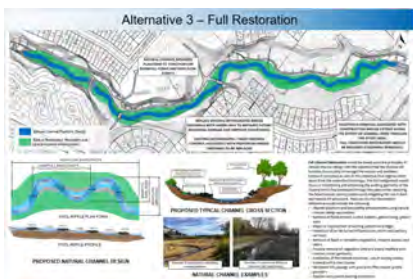
| Alternative | | Benefits | Challenges |
|---|---|---|---|
| <p>Alternative 3 – Full Restoration</p> | <b>Full Restoration</b> | <ul style="list-style-type: none"> <li>Addresses erosion concerns through natural channel design</li> <li>Would replace bridges</li> <li>Would remove invasive vegetation and restore with native vegetation</li> </ul> | <ul style="list-style-type: none"> <li>Would require site-wide disturbance to gain construction access</li> <li>Cost would be comparatively high</li> </ul> |

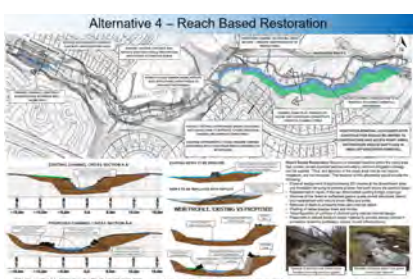
| Alternative | | Benefits | Challenges |
|---|---|---|---|
| <p>Alternative 4 – Reach Based Restoration</p> | <b>Reach Based Restoration</b> | <ul style="list-style-type: none"> <li>Provides focused improvements to areas of incision and to channel erosion</li> <li>Would have moderate site disturbance</li> <li>Would replace some invasive vegetation with native vegetation</li> <li>Would replace bridges</li> </ul> | <ul style="list-style-type: none"> <li>Would cause moderate site disturbance</li> <li>Cost would be comparatively moderate</li> </ul> |
