Report on
Geotechnical Slope Stability Assessment
Serson Creek
Lakeview Village, 800 Hydro Road
Mississauga, Ontario

Prepared For:
Lakeview Community Partners Limited

Project No. 18-519-102
July 19, 2019

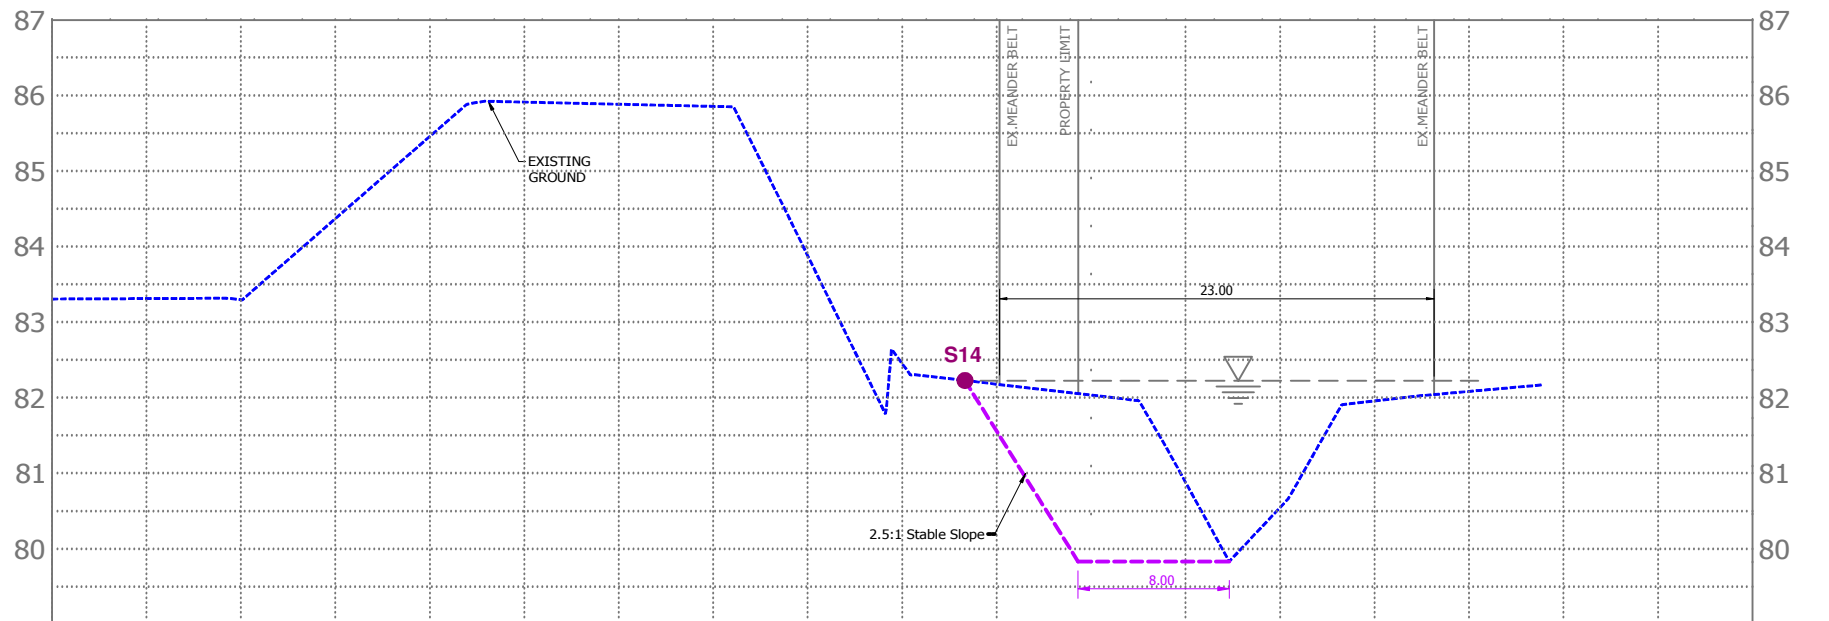
SECTION
N-N

The existing slope profiles at 14 Sections (A-A to N-N, see Figure 1 for locations) were provided to us by Urbantech, as presented on Figures 2 to 15.

The calculated factors of safety of the existing slopes at Sections A-A and N-N range from 1.23 to 1.43, which are less than the CVC's minimum acceptable value of 1.5. The existing slopes at Sections A-A and N-N are considered not stable in terms of long-term stability based on CVC's requirements.

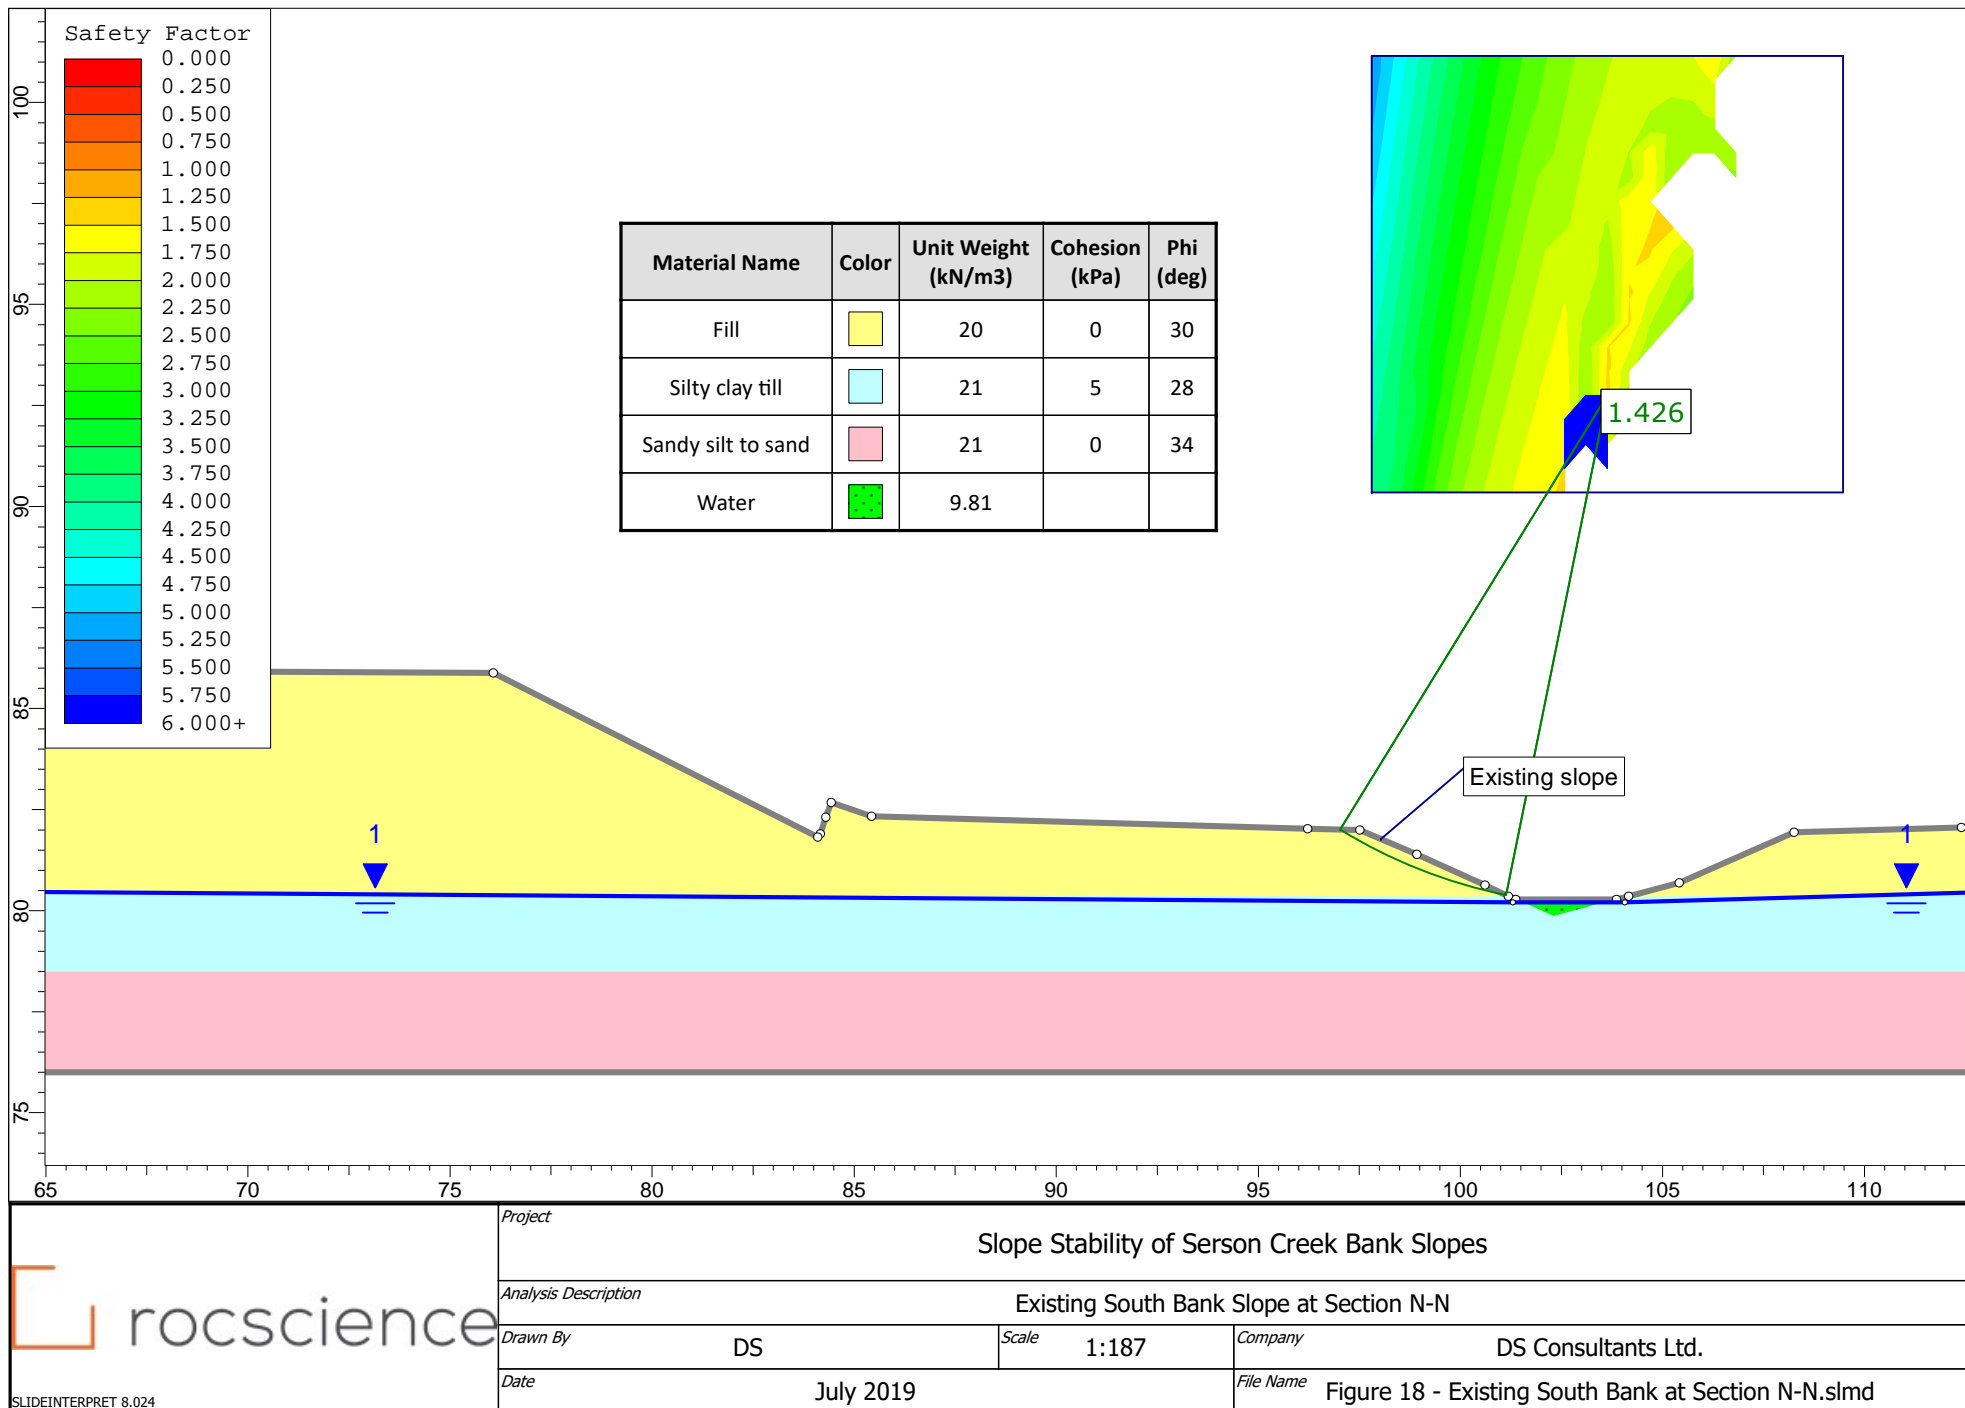
The existing slope profiles at Sections A-A to N-N (see Figure 1 for locations) are presented on Figures 2 to 15. Long-term stability analyses of the existing slopes at three typical Sections A-A, L-L and N-N have been carried out with the computer program SLIDE (Version 8) using the Simplified Bishop method, Simplified Janbu method and GLE/Morgenstern-Price method. The analysis results are presented in Figures 16 to 18 and are summarized on Table 2 below.

Slope Location	Approximate Steepness	Calculated Factor of Safety (FS)	Long-Term Stability
Section A-A (See Figure 16)	2H:1V	1.23	FS<1.5, Not stable
Section L-L (See Figure 17)	2.5H:1V	1.56	FS>1.5, Stable
Section N-N (See Figure 18)	2.2H:1V	1.43	FS<1.5, Not Stable

The calculated factor of safety of the existing slope at Section L-L is 1.56, which is greater than the CVC's minimum acceptable value of 1.5. The existing slope at Section L-L is considered stable in terms of long-term stability based on CVC's requirements.

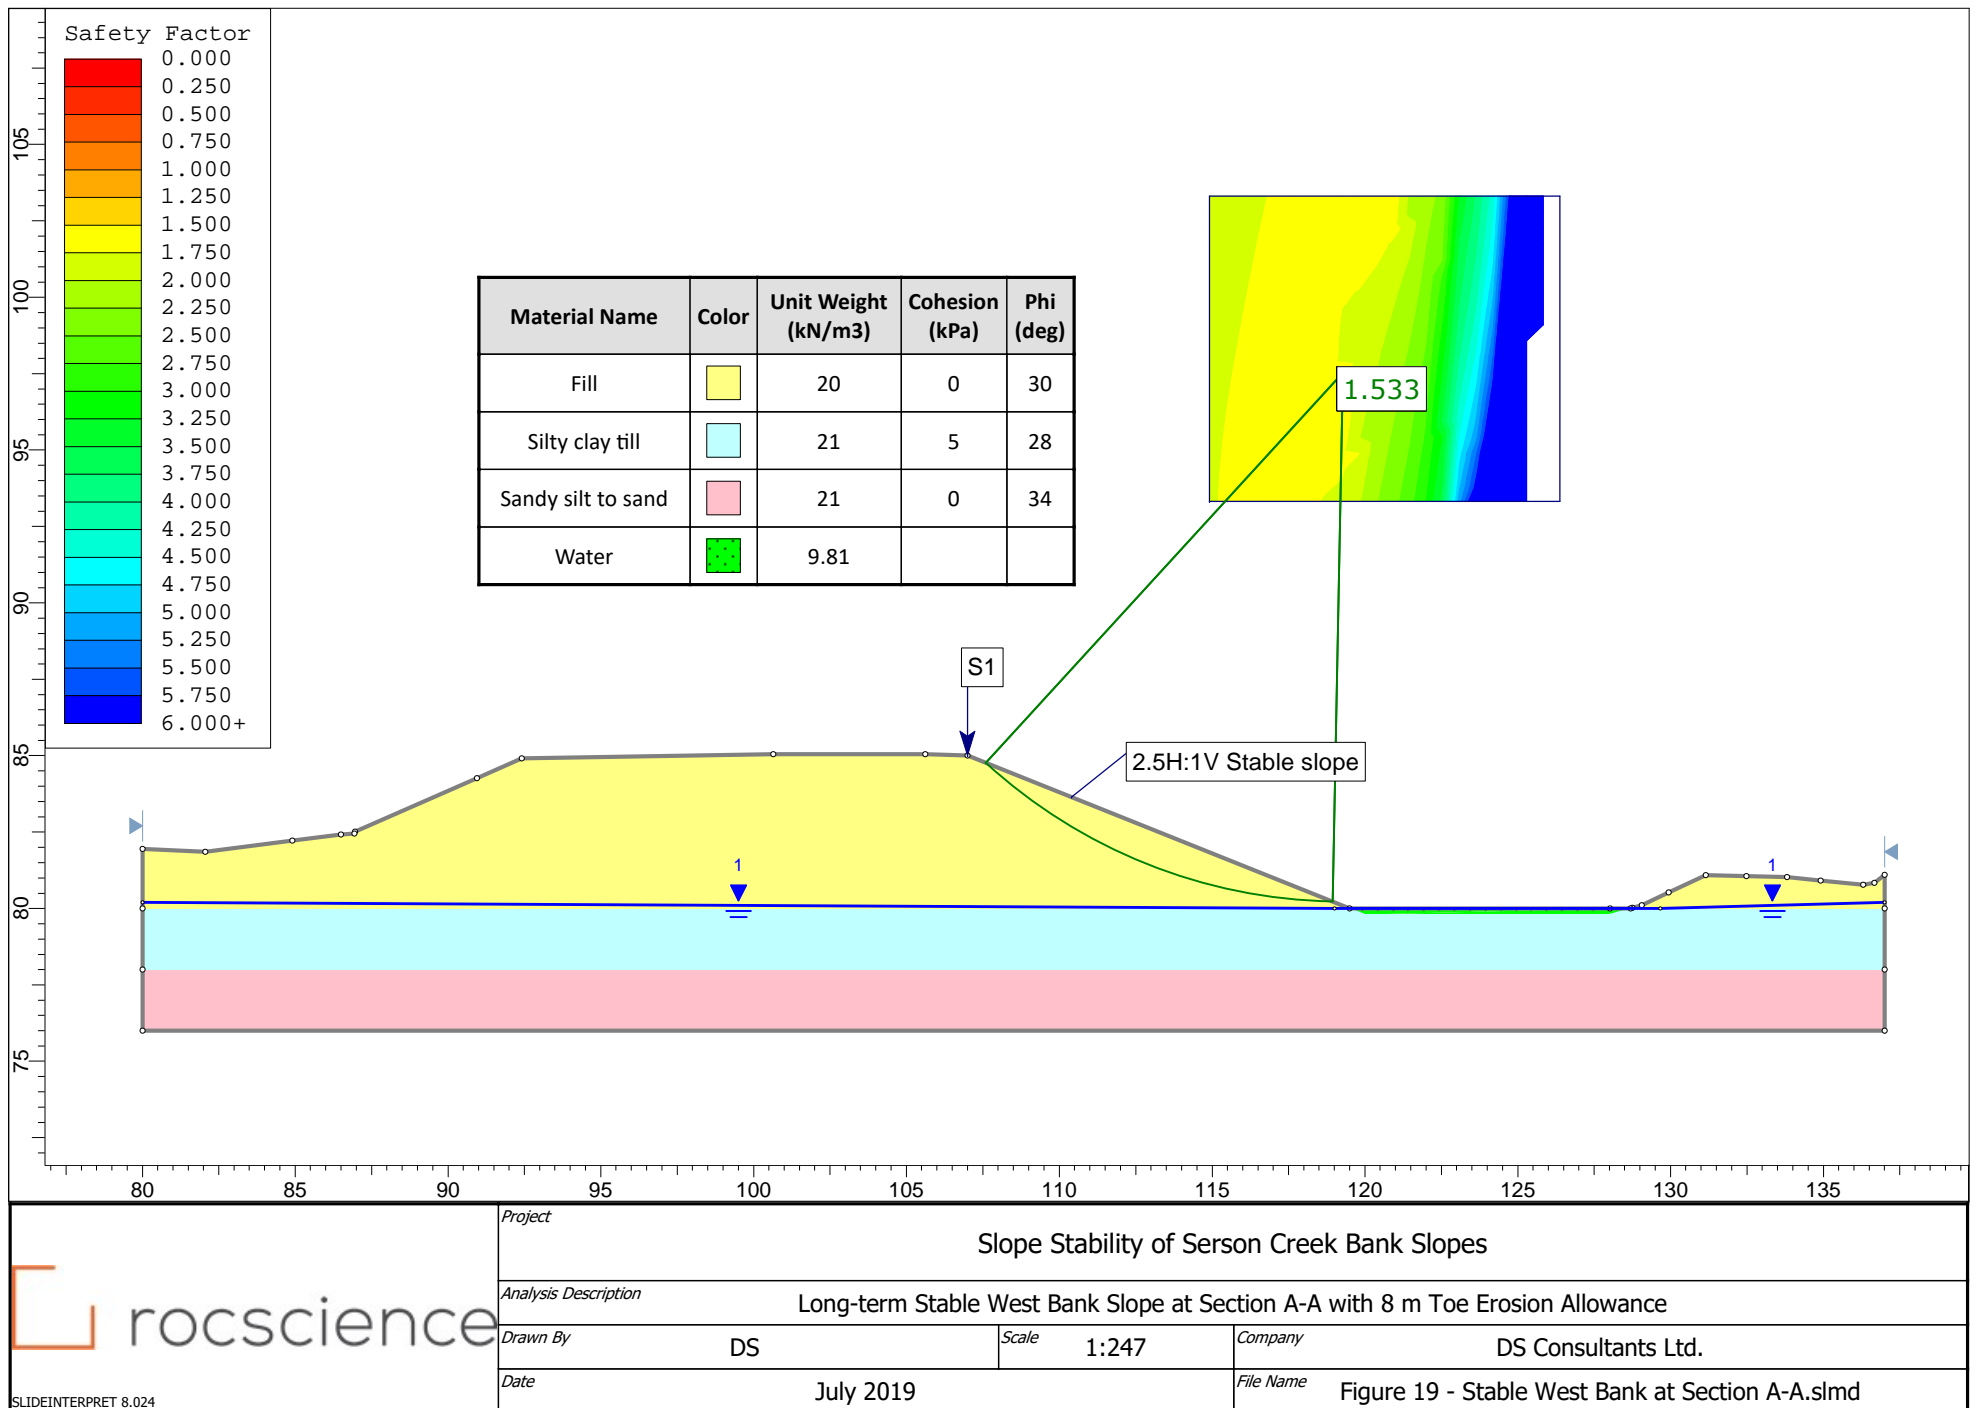
In order to determine the long-term stable slope, analysis of a 2.5H:1V slope with a toe erosion allowance of 8 m at Section A-A have been carried out, and the results are presented on Figure 19. The calculated factor of safety of the 2.5H:1V slope at Section A-A is 1.62, which is greater than the minimum acceptable value of 1.5. Similarly, stability analyses of stable slopes at Sections L-L and N-N are carried out, and the results are presented on Figures 20 and 21. Table 3 presents a summary of the results of long-term stable slopes.

Slope Location	Approximate Steepness	Toe Erosion Allowance (m)	Calculated Factor of Safety (FS)	Long-Term Stability
Section A-A (See Figure 19)	2.5H:1V	8.0	1.53	FS>1.5, Stable
Section L-L (See Figure 20)	2.5H:1V	8.0	1.57	FS>1.5, Stable
Section N-N (See Figure 21)	2.5H:1V	8.0	1.57	FS>1.5, Stable

The factor of safety values of the slopes as summarized on Table 3 are greater than the minimum required value of 1.5. Based on the analysis results, it can be concluded that a slope of 2.5H:1V with a toe erosion allowance of 8m is stable and acceptable in terms of long-term stability.

Based on the slope stability analysis results presented above, Points “S1”, “S12” and “S14” in Figures 19 to 21 represent the long-term stable top of slope (LTSTOS) at Sections A-A, L-L and N-N, respectively. Accordingly, Points “S1”, “S12” and “S14” are also shown in profile Figures (Figure 2, Figure 13 and Figure 15) at Sections A-A, L-L and N-N, respectively.

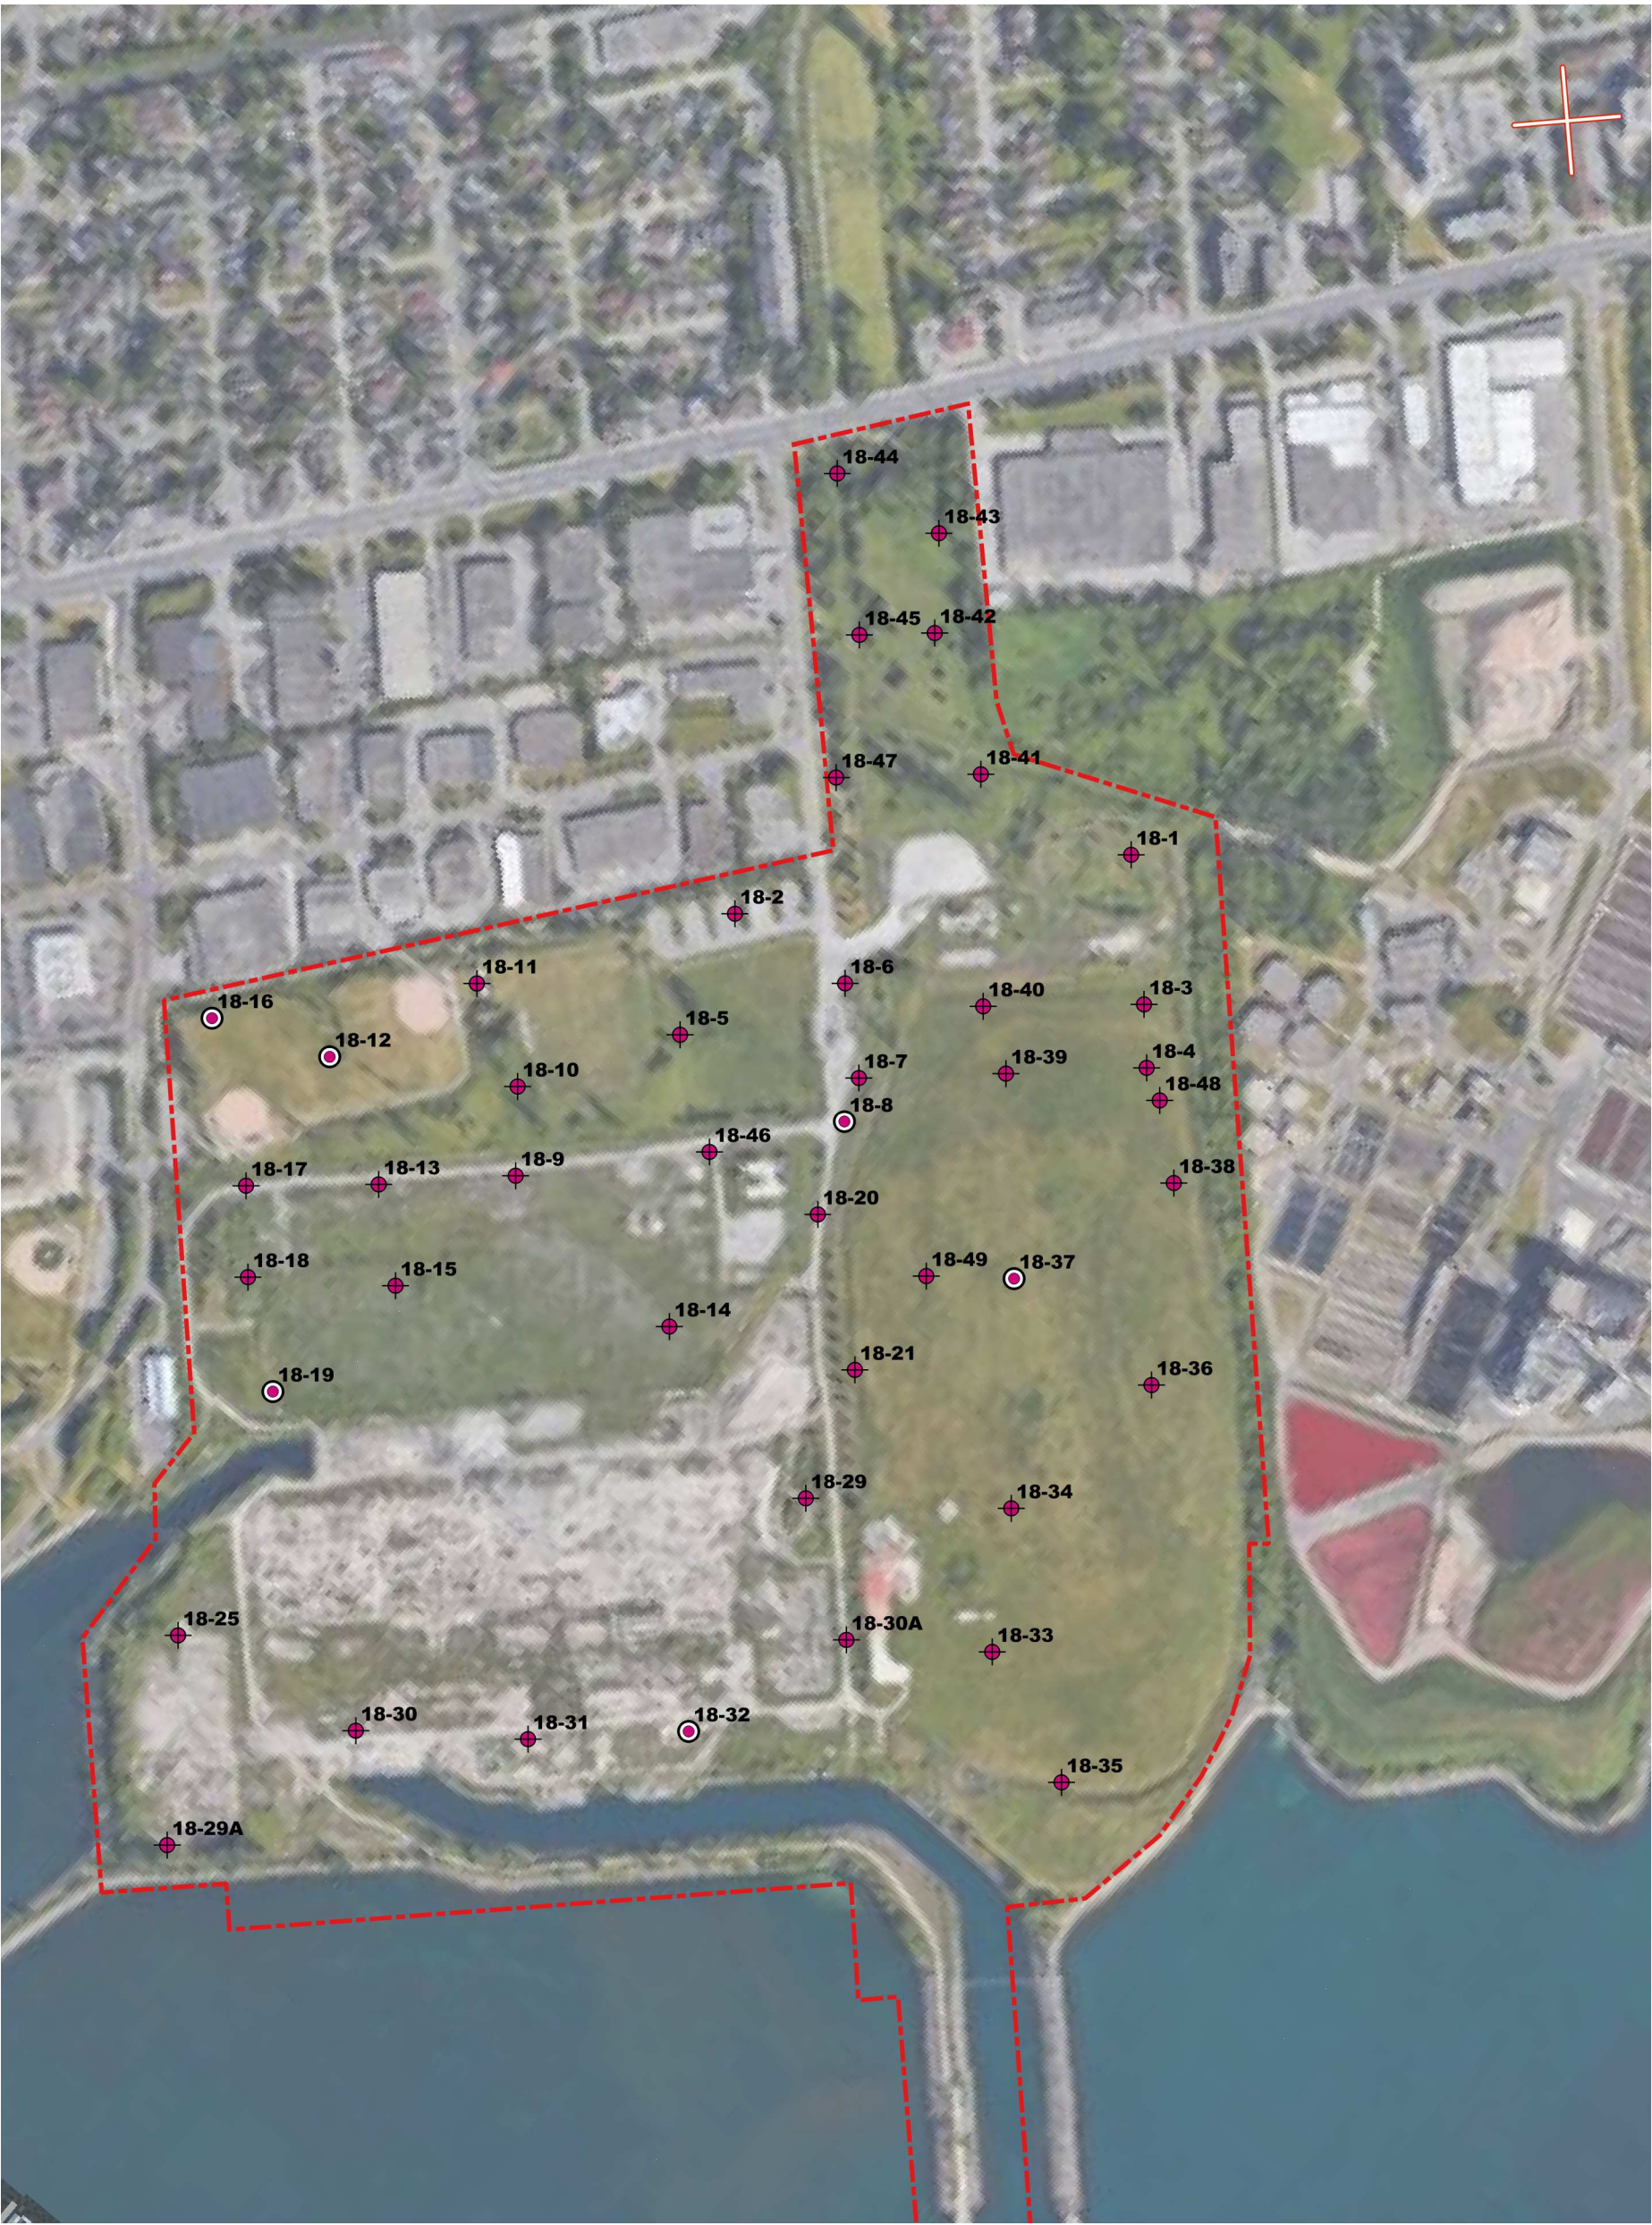
DS Consultants Ltd. carried out a preliminary geotechnical investigation, documented in the report No. 18-519-10, dated October 15, 2018. Nine (9) boreholes (BH18-01, BH18-03, BH18-04, BH18-36, BH18-38, BH18-41, BH18-42, BH18-43, and BH18-48) were drilled near the creek area. The borehole location plan and relevant borehole logs are attached in **Appendix A**. The subsurface information in these boreholes are used in this slope stability study.

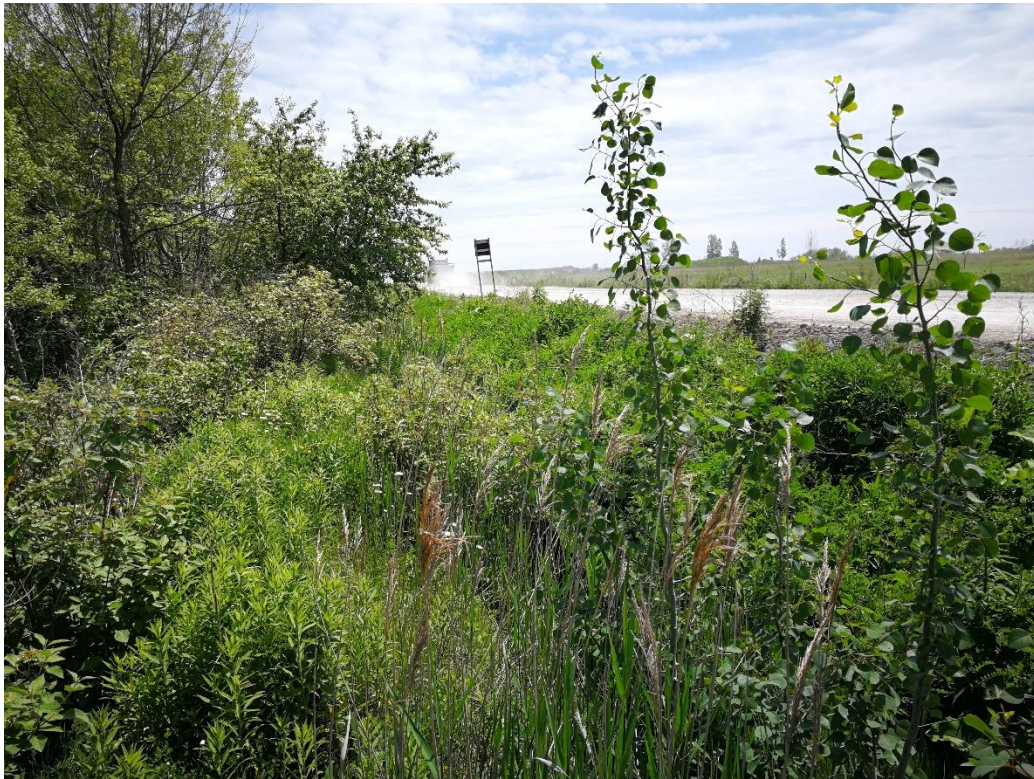
- The slope in Reach 3 area was generally 2 to 3 m in height, with steepness of 2H:1V to 3H:1V or flatter.
- The height of the west bank slope in Reach S2 area ranged from about 6 m near the bridge to about 3 m near the lake, decreasing toward south. The steepness of the slope was about 2H:1V to 3H:1V or flatter. At the south part, there was a ditch of 1 to 1.5 m in depth between the creek slope and the access road (see Photos B17 and B18 in **Appendix B**).

**Photo B17: Ditch between Creek and Road at south part of Reach S2 area
(looking south - downstream)**

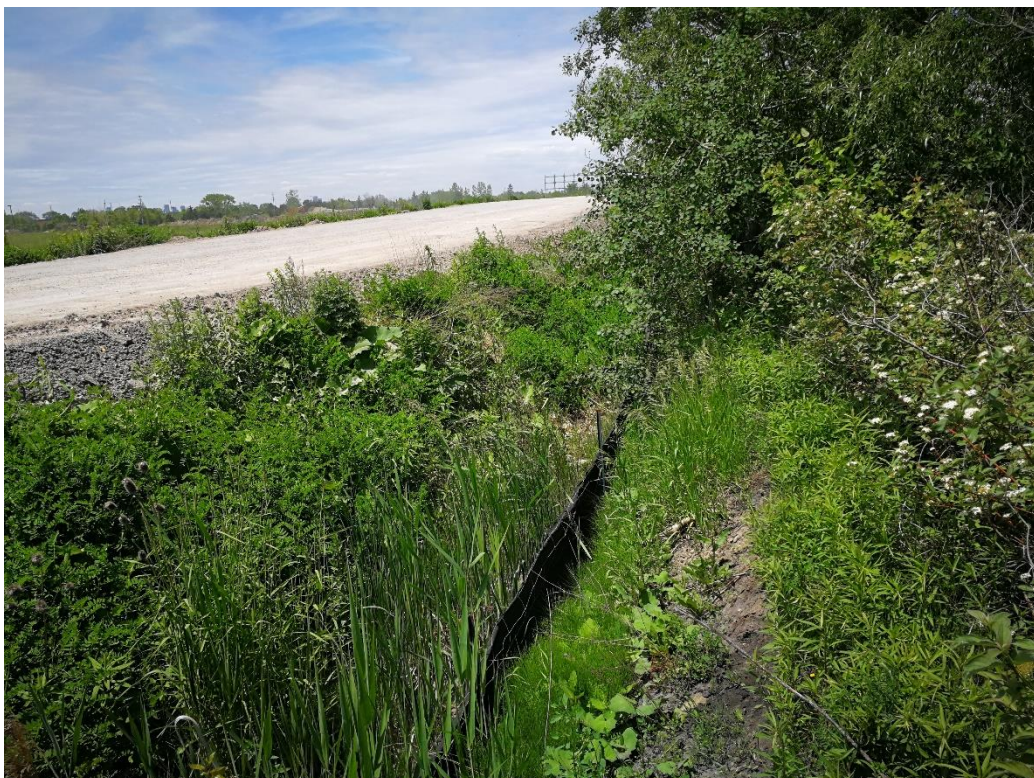
**Photo B18: Ditch between Creek and Road at south part of Reach S2 area
(looking north - upstream)**
