Mimico Creek Erosion Control Project (Rena Road and Etude Drive to Derry Road East)

Schedule 'B' Municipal Class Environmental Assessment

Online Public Engagement (June 3, 2021 - July 8, 2021)

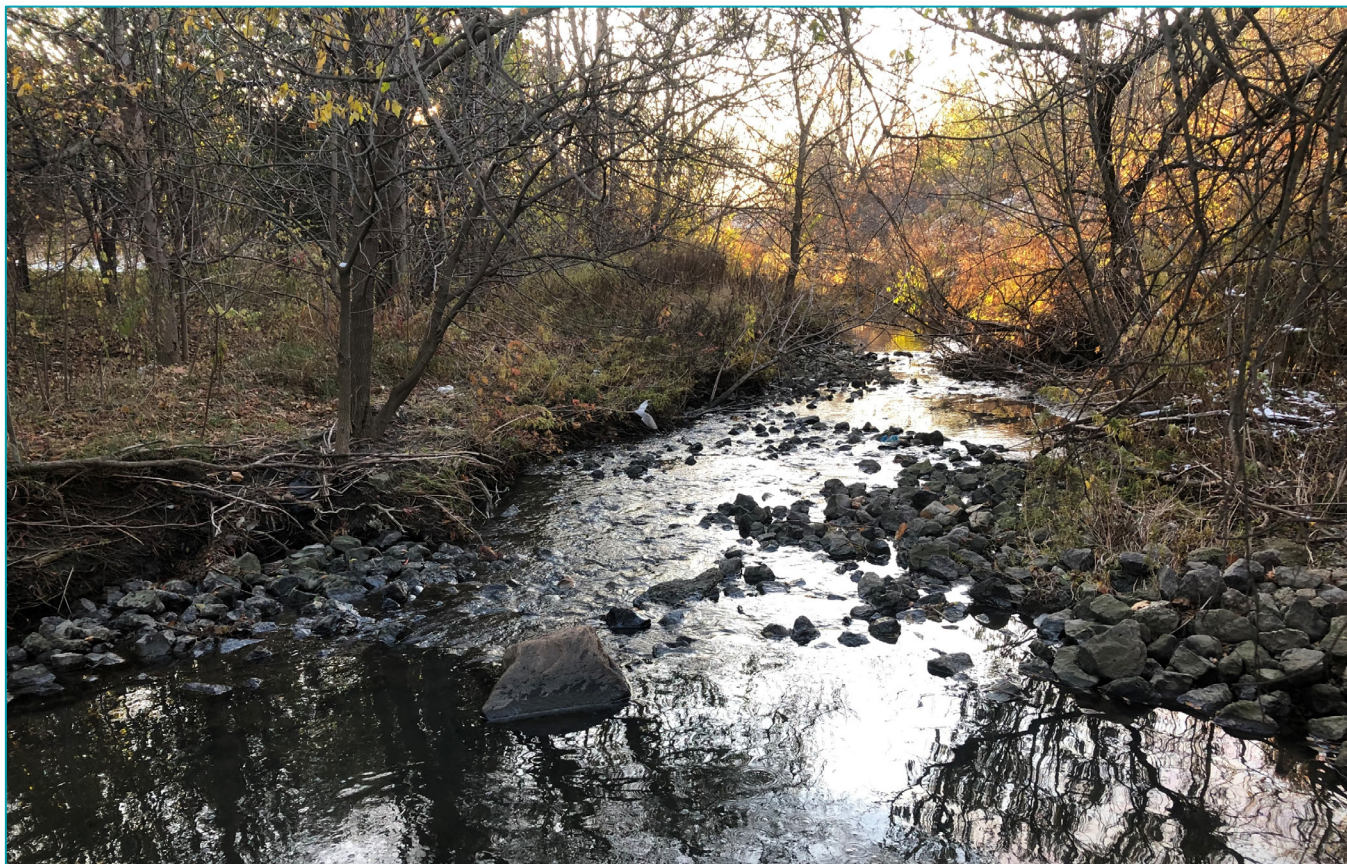
Photograph showing erosion in Mimico Creek West Branch

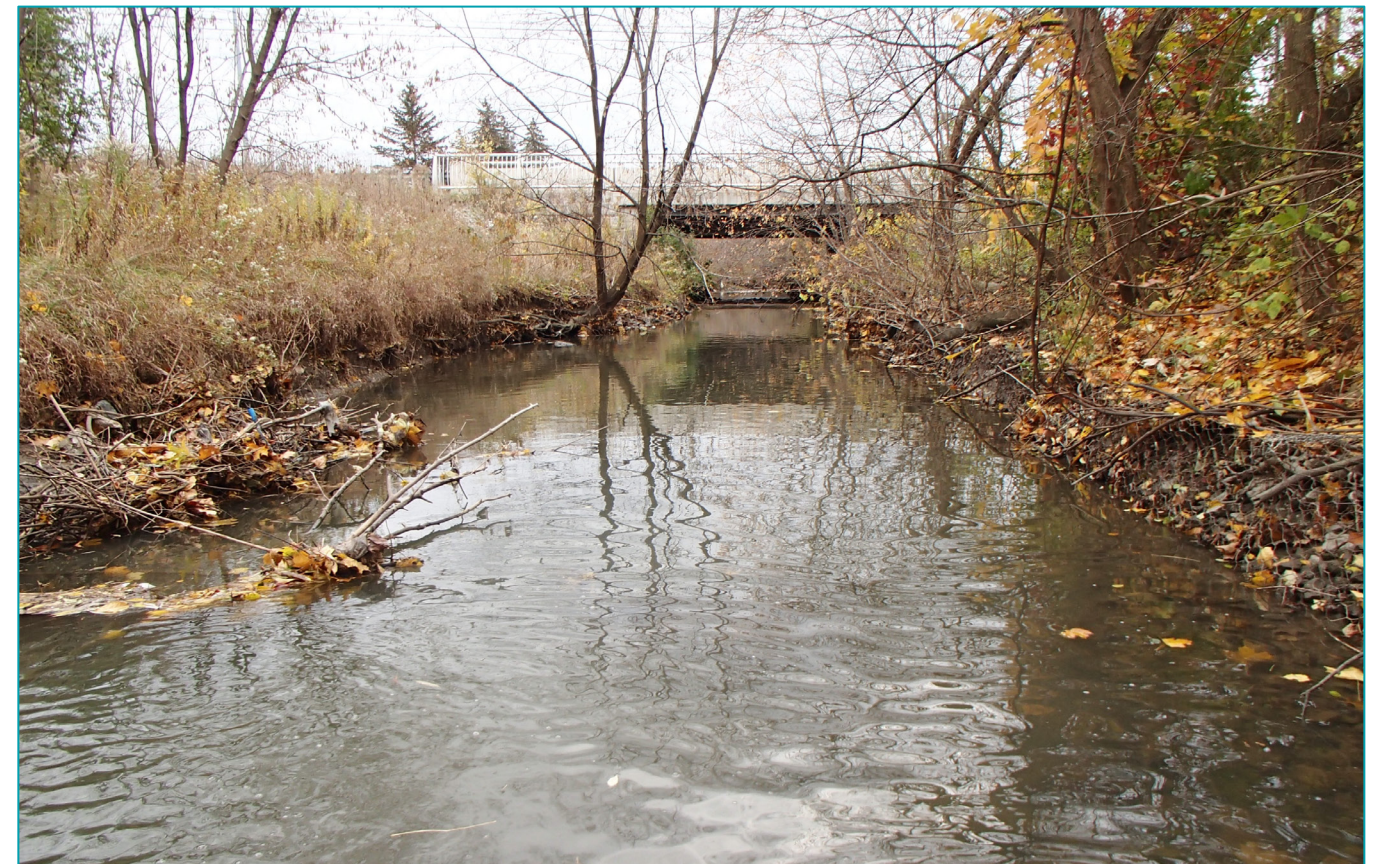
Photograph showing erosion in Mimico Creek East Branch

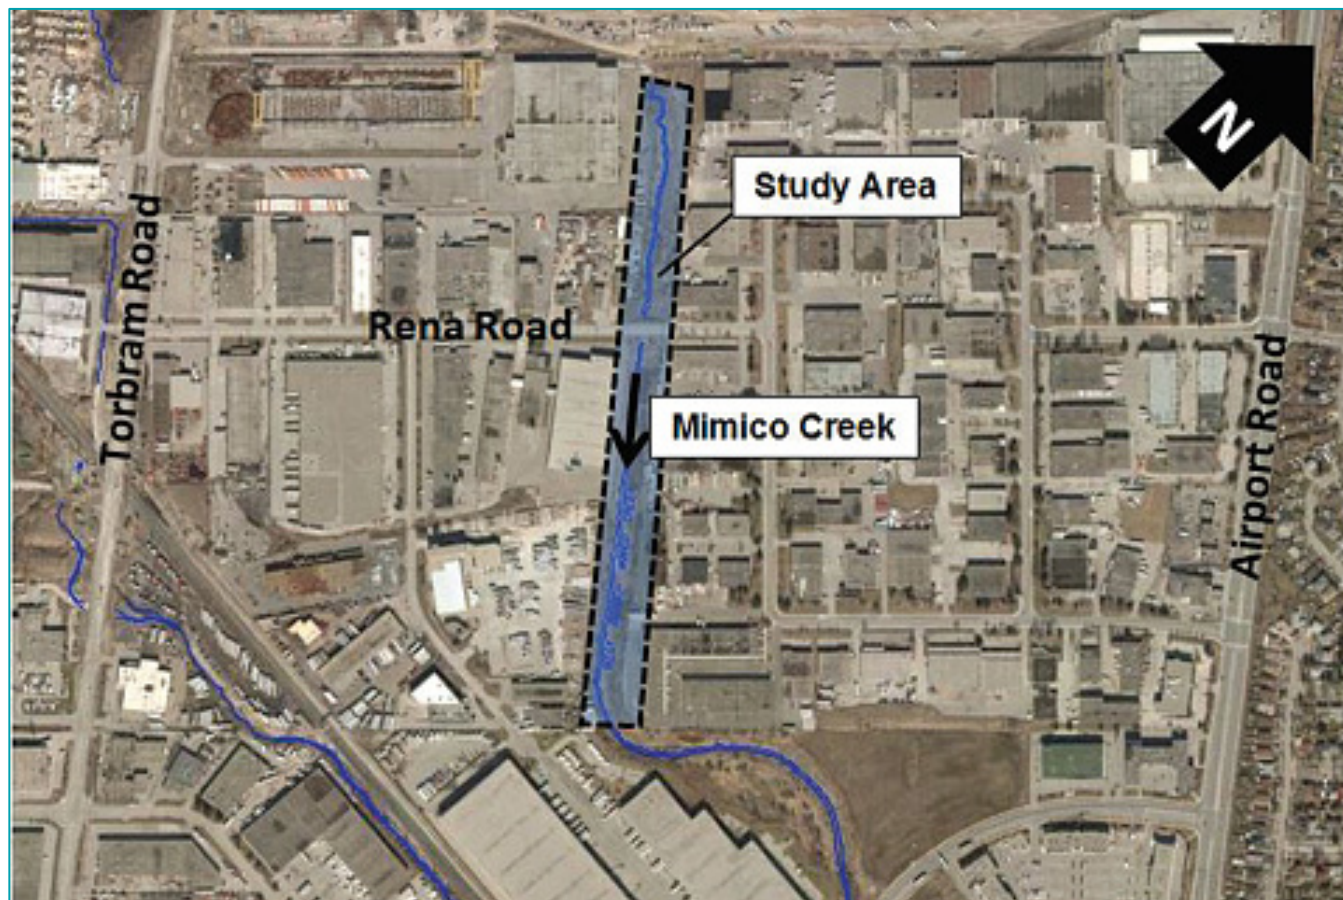
The West Branch study area extends from the Canadian National Railway tracks located approximately 300m north of Rena Road to approximately 650m south of Rena Road.

Mimico Creek West Branch Study Area

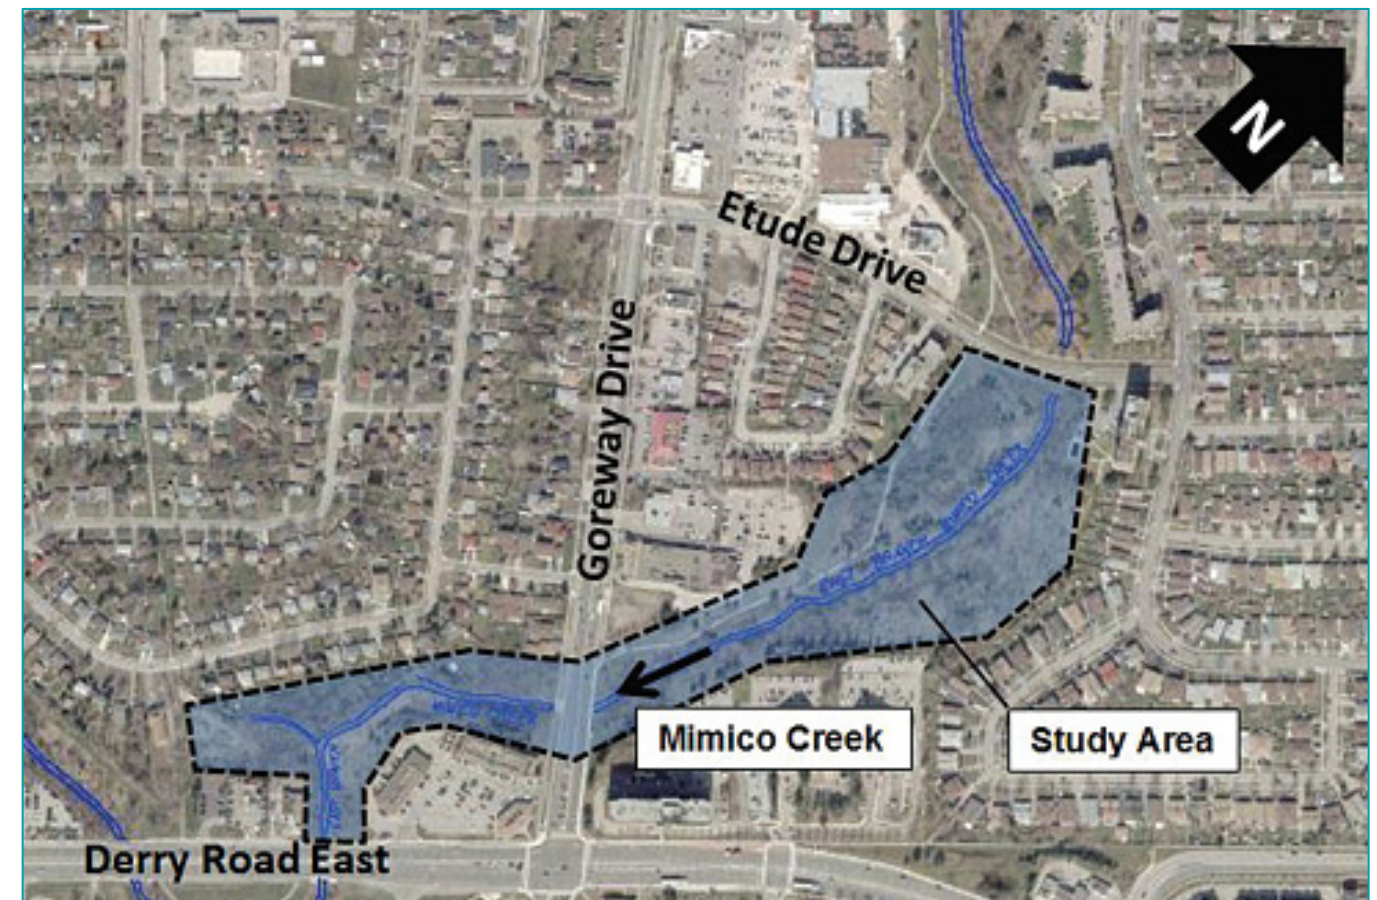
The East Branch study area extends from Etude Drive to Derry Road East, which is a distance of approximately 800 m.

Mimico Creek East Branch Study Area

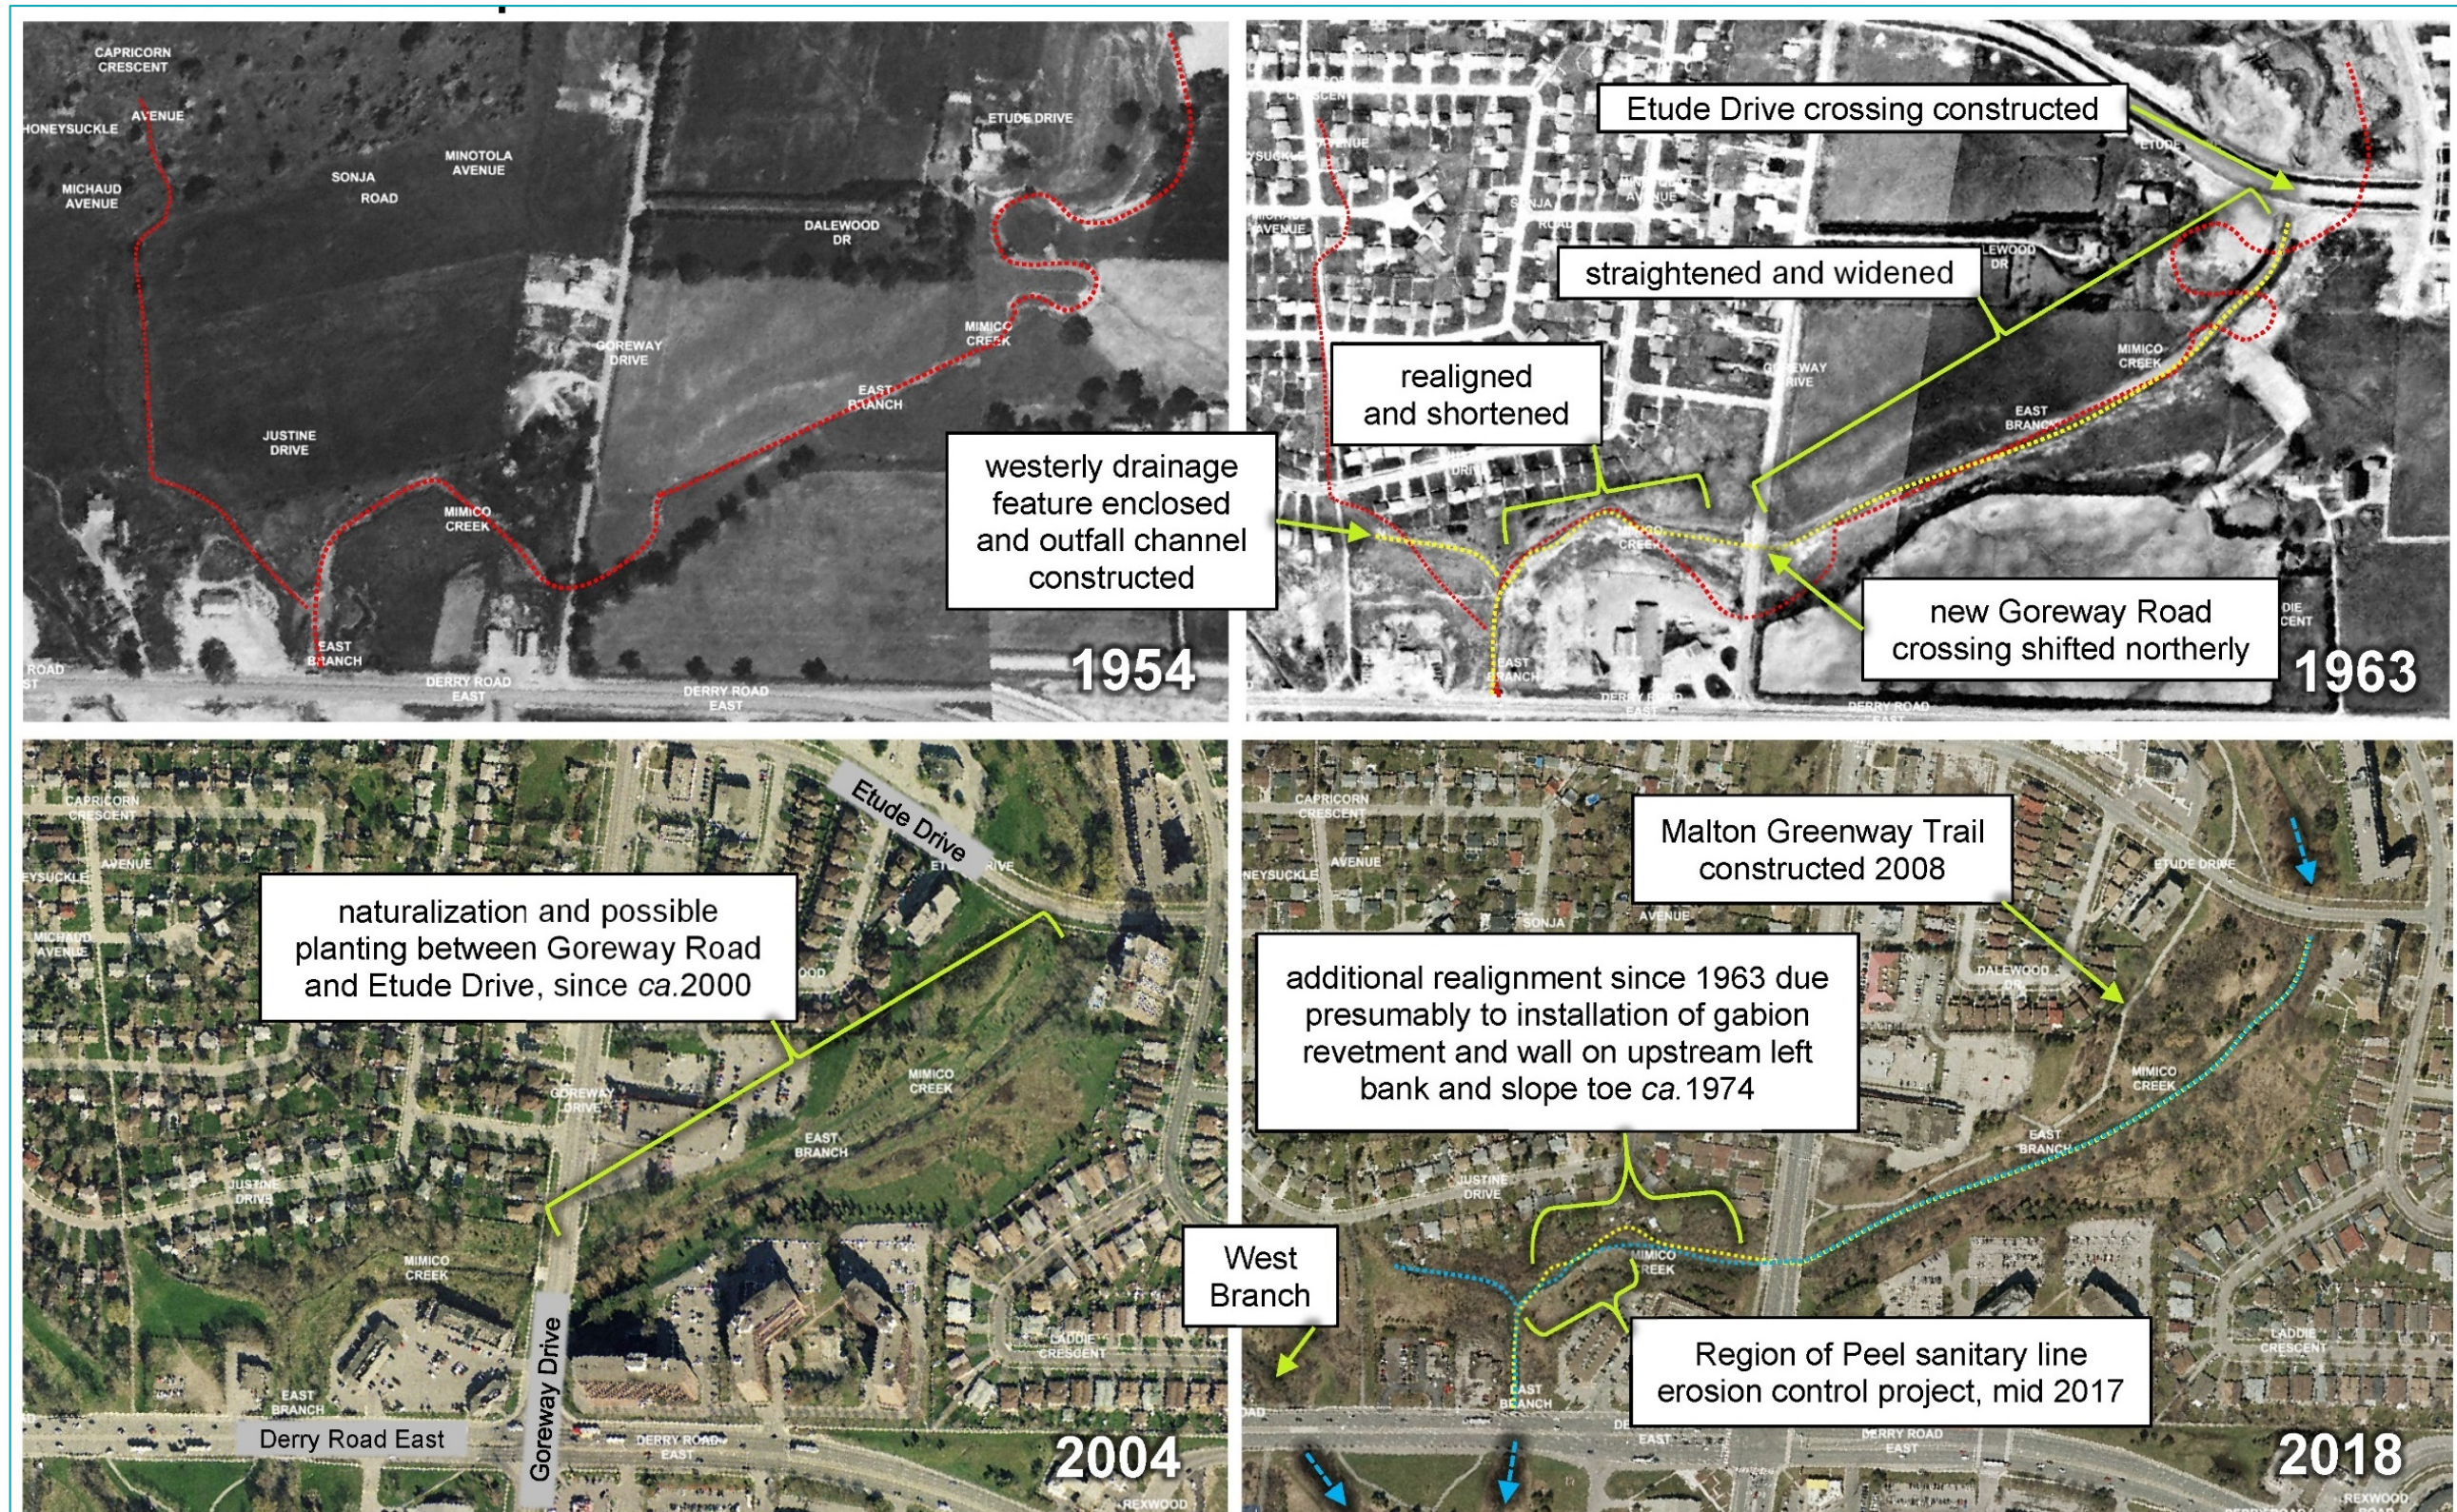
Historic Evolution of Mimico Creek East Branch Channel

1963: Urbanization of surrounding lands and channel realignment

2000s: Channel naturalization, tree planting, moderate levels of incision and widening, and development of Malton Greenway Trail (2008)

2018: Naturalization of entire riparian corridor

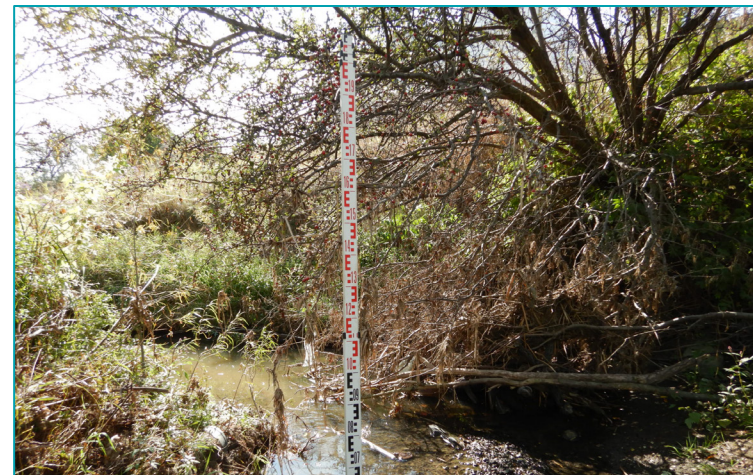
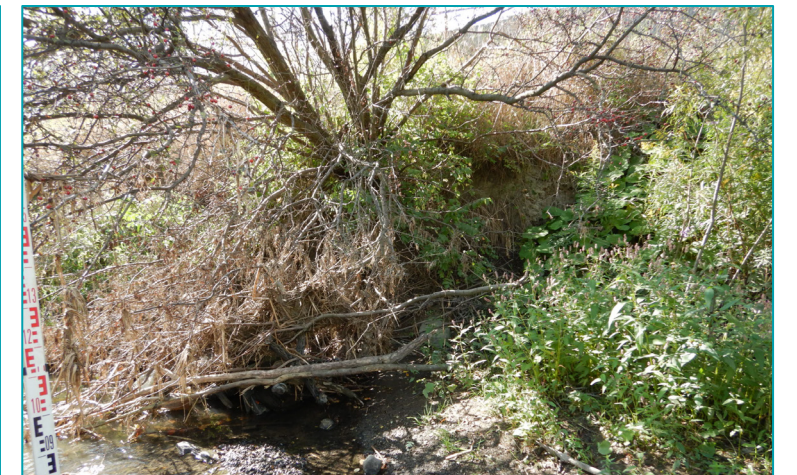
1 - Bank and slope erosion scar with vertical exposure and vegetation failure into the channel.

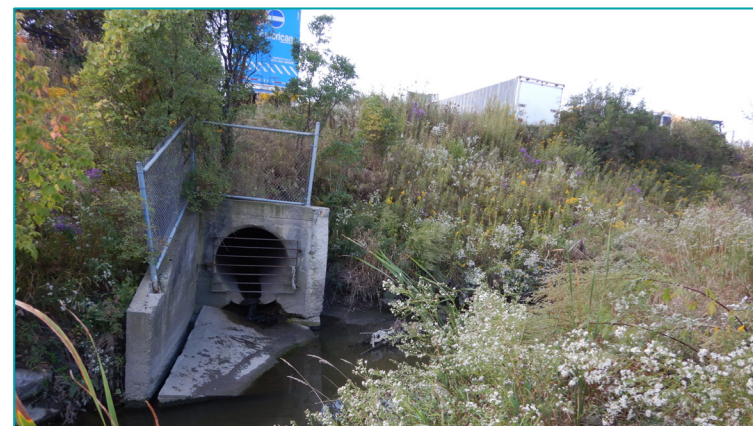
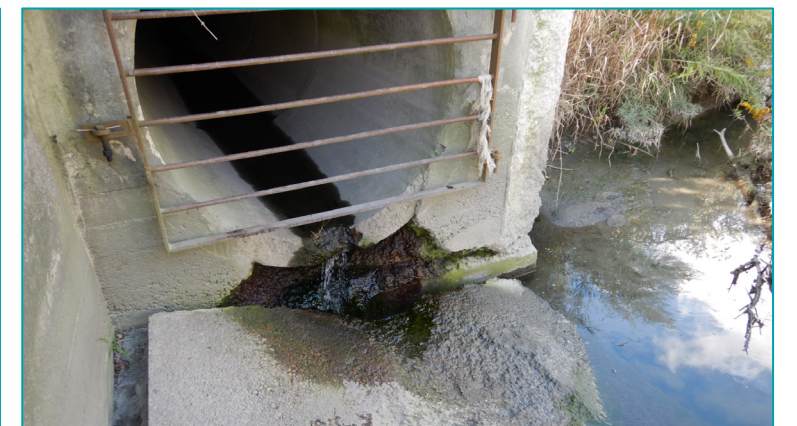
2 - The storm outfall and headwall structure has been exposed due to meander movement and widening. The northerly wingwall has failed and rests on the creek bed.

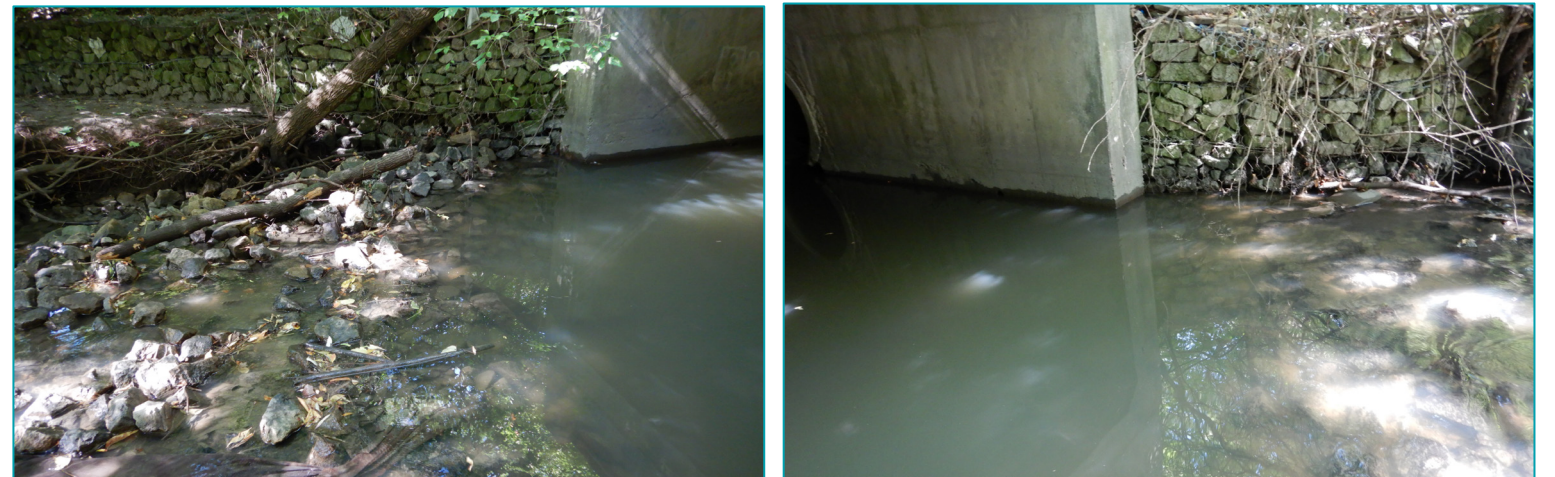
1 - The base or toe of each gabion has broken due to rusted wire and stone displacement has occurred.

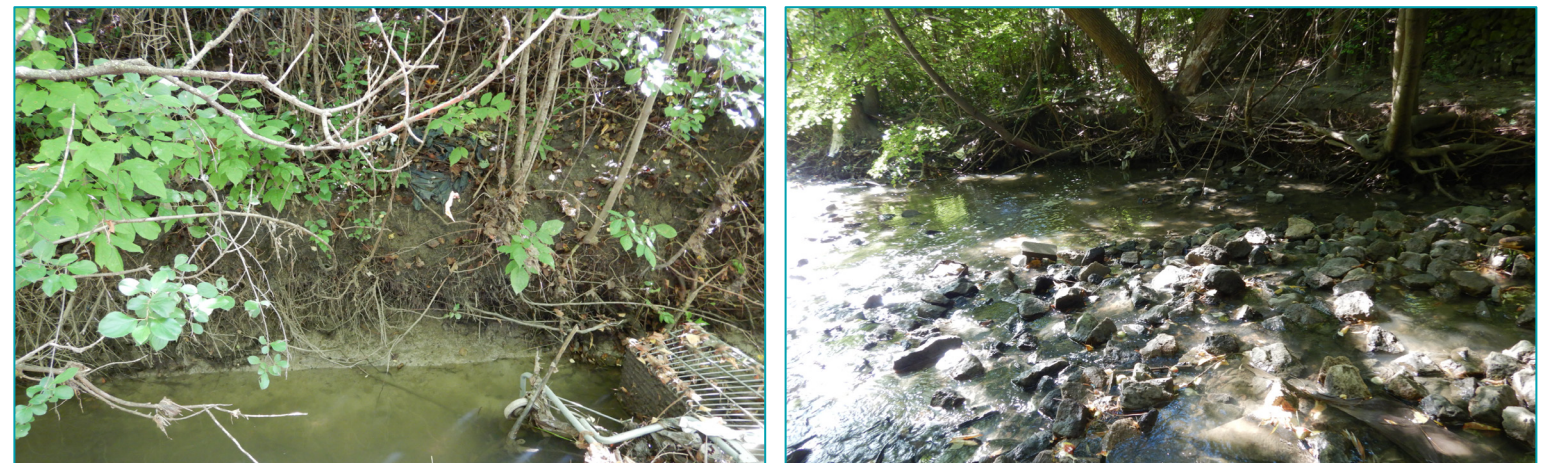
2 - Channel bank erosion has resulted in additional slope failure up the slope face and loss of vegetation.

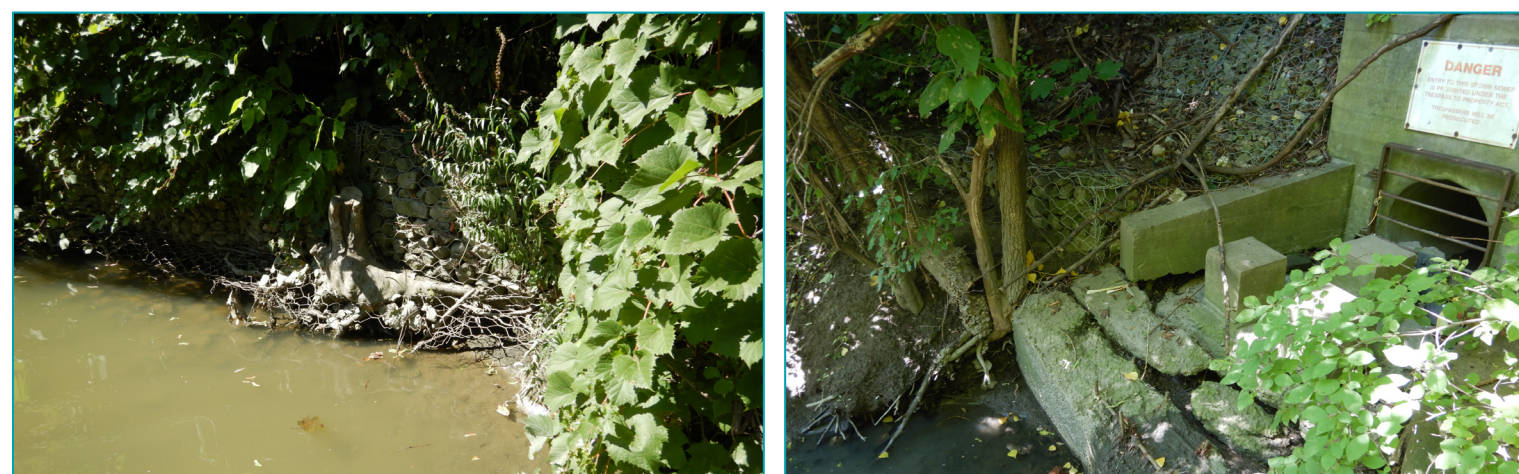
4 - The gabion wingwall is slightly undermined, and the base is sitting on soft saturated sediment.

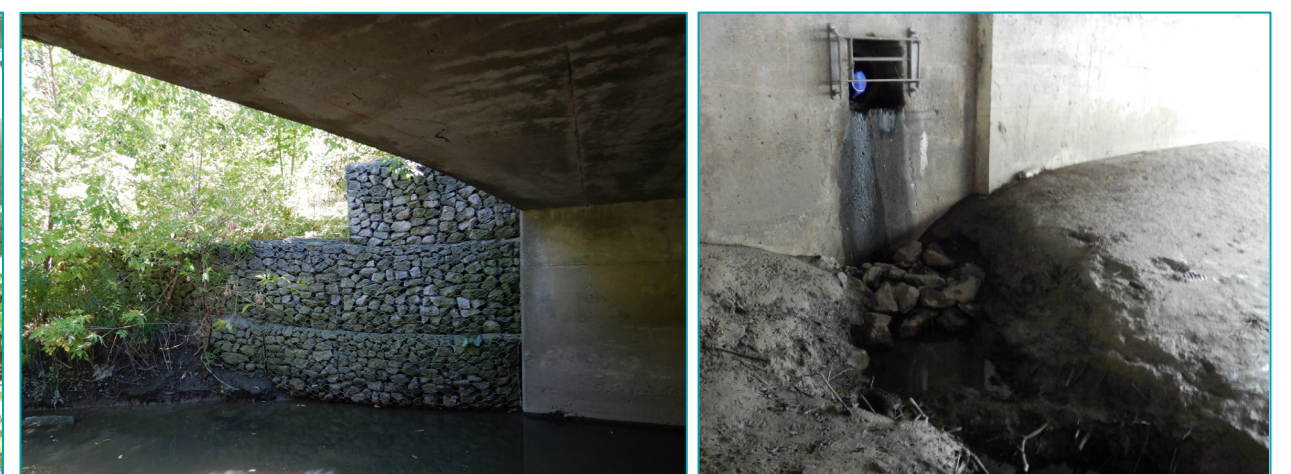
3 - Base row of gabions is failing along the low flow due to rusted wire. Erosion below the storm outfall.

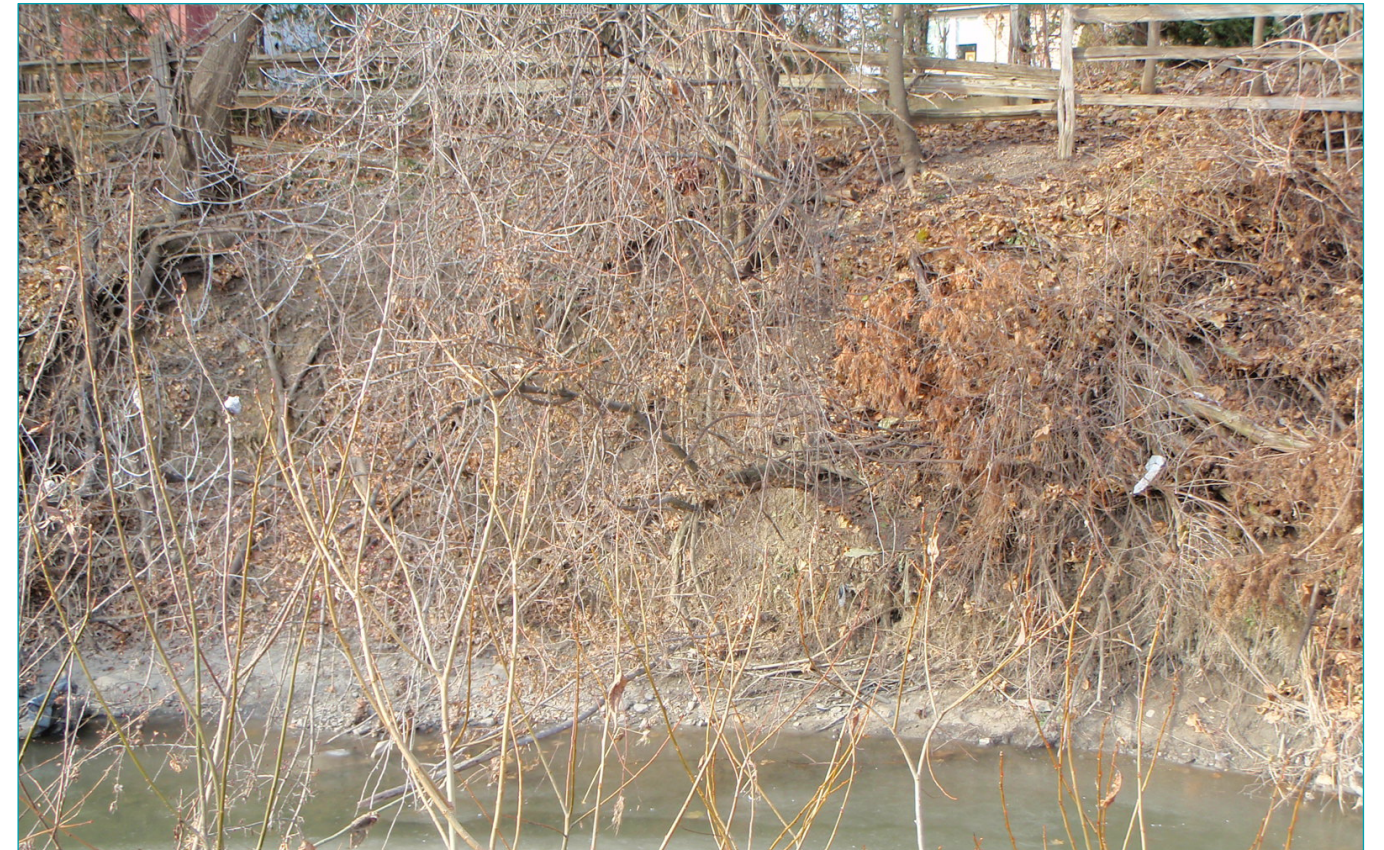
- The overall bank heights at the two investigated sites ranged from approximately 4 to 6 m high.
- The lower portions of the slopes along the outside of the meanders were identified as areas of erosion with surficial sloughing.

Photo showing slope erosion in Mimico Creek East Branch

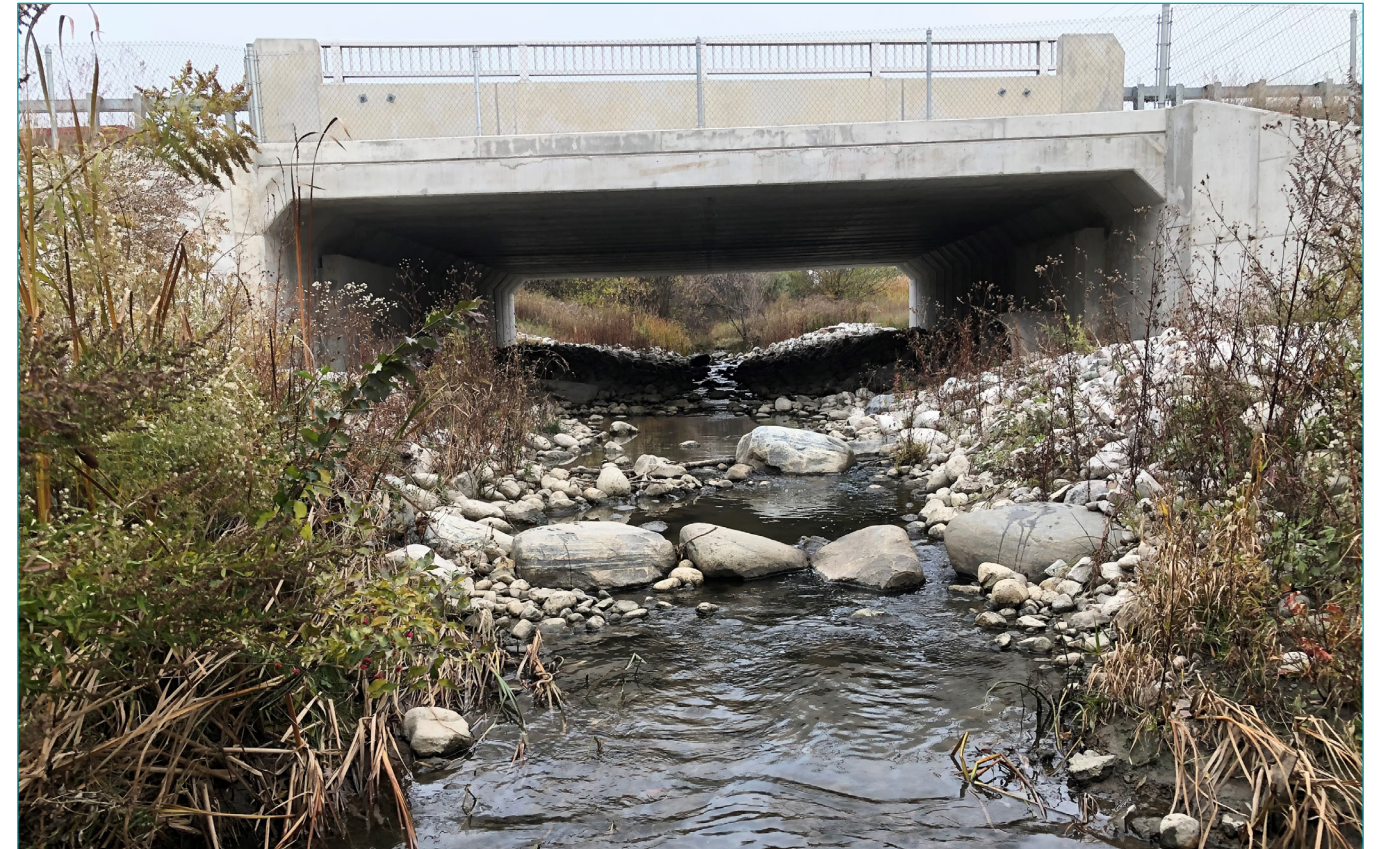
Photo showing low water levels in Mimico Creek West Branch that may impede fish passage

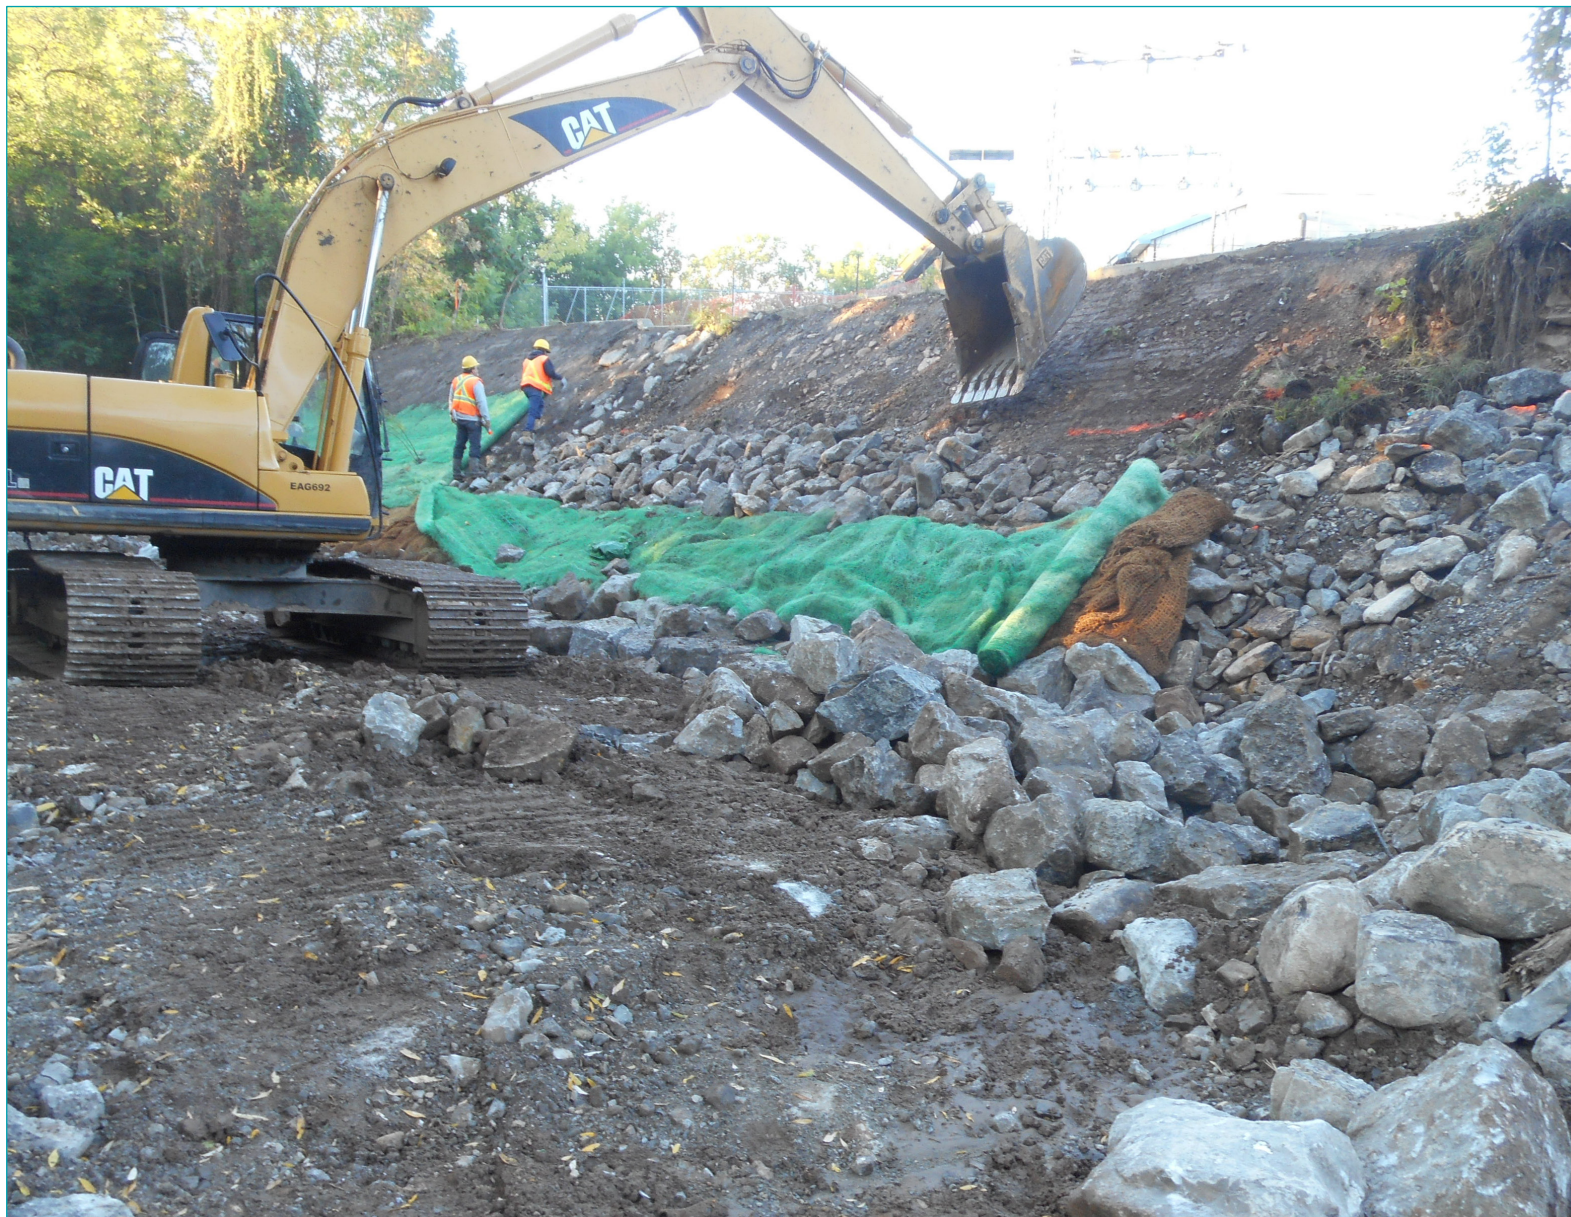
Typical creek bank stabilization with boulder revetment and vegetated banks

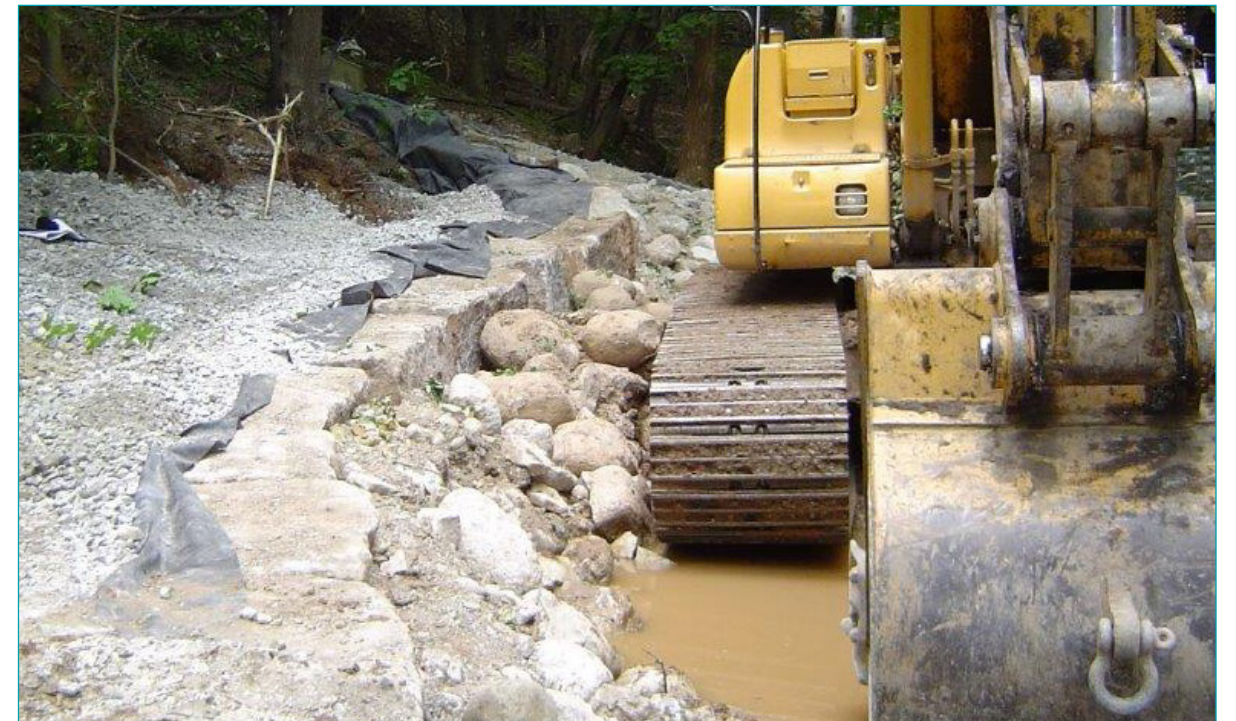
Boulder and armour stone bank stabilization

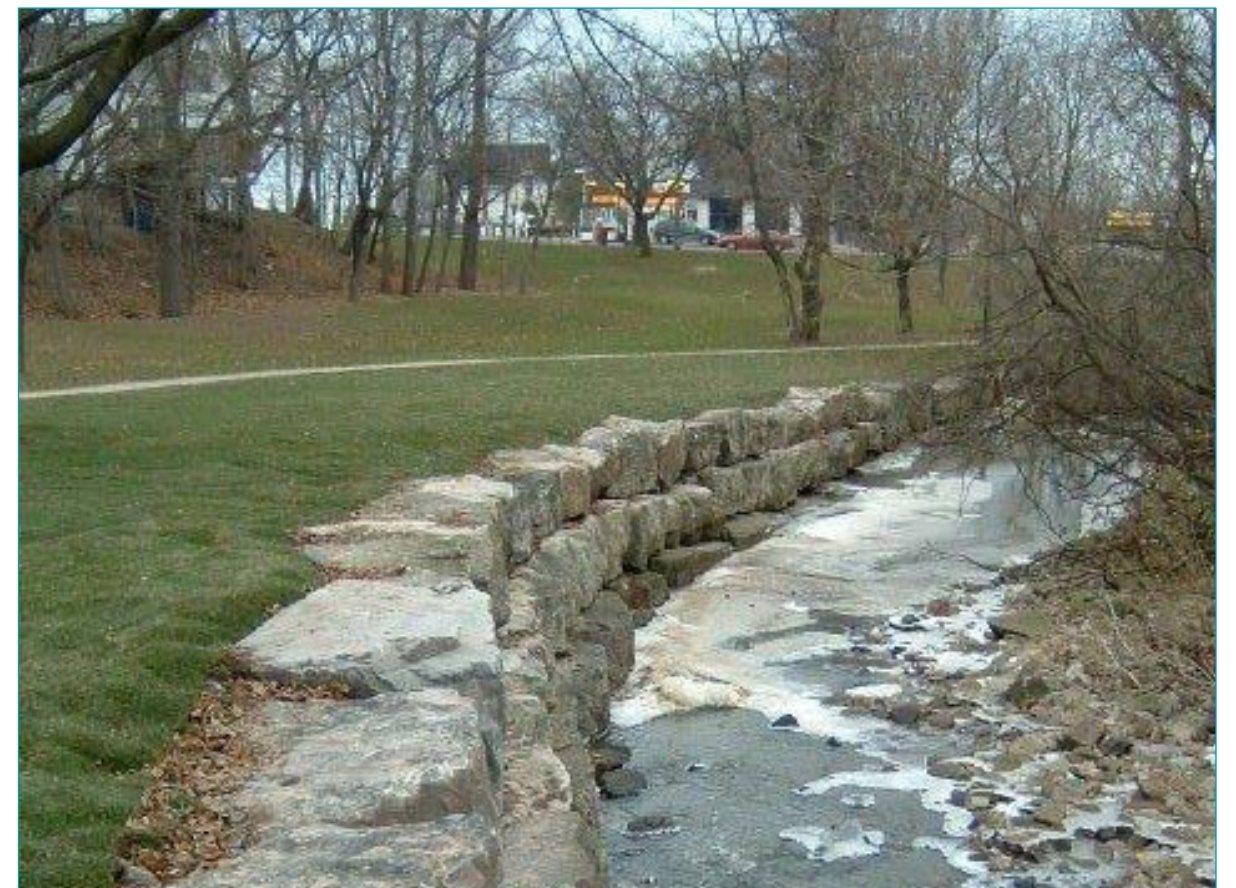
Rehabilitated creek bank with multiple rows of armour stone

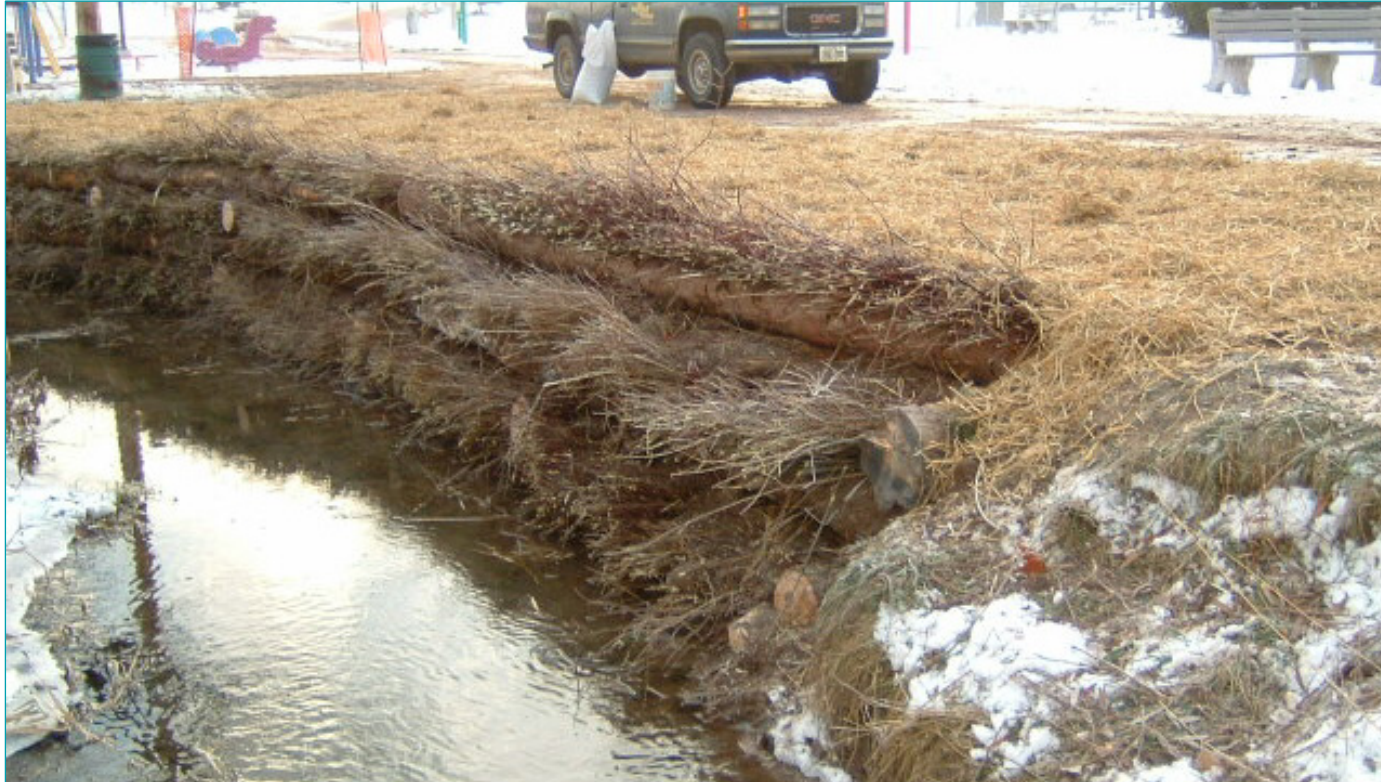
Timber crib bioengineered bank stabilization

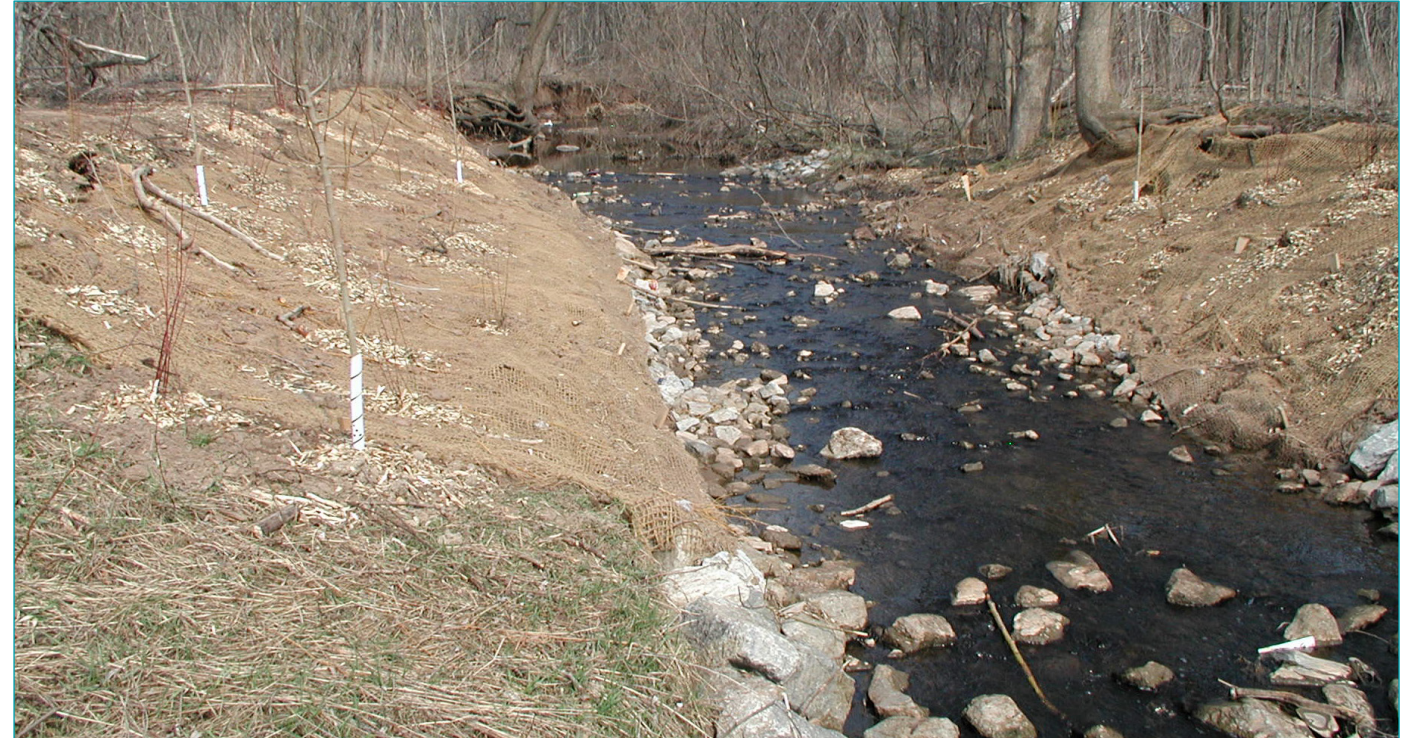
Localized erosion protection with minor regrading, stone and vegetated banks with erosion blanket
