Mimico Creek Erosion Control Project (Rena Road and Etude Drive to Derry Road East)

Schedule 'B' Municipal Class Environmental Assessment

Online Public Engagement (June 3, 2021 - July 8, 2021)

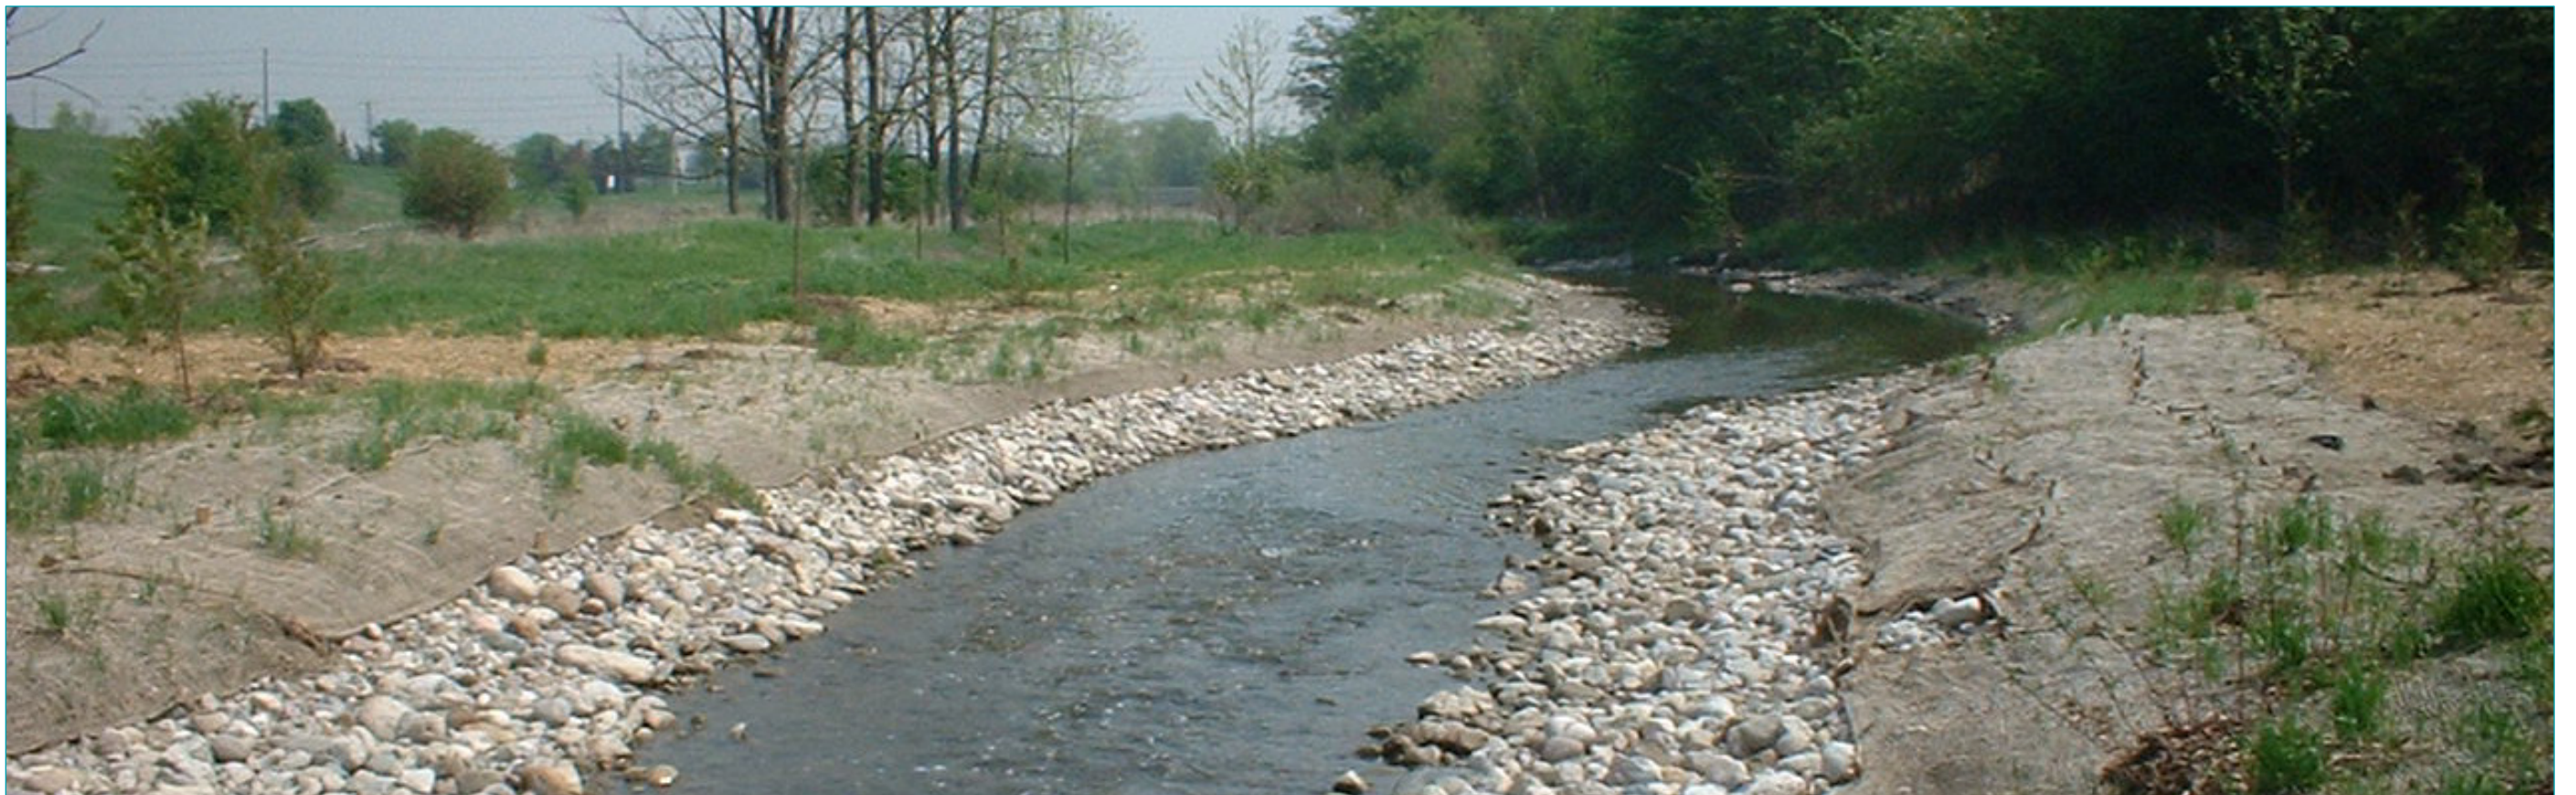
Full reconstruction and realignment of creek with natural stone pools and riffles, and vegetated banks

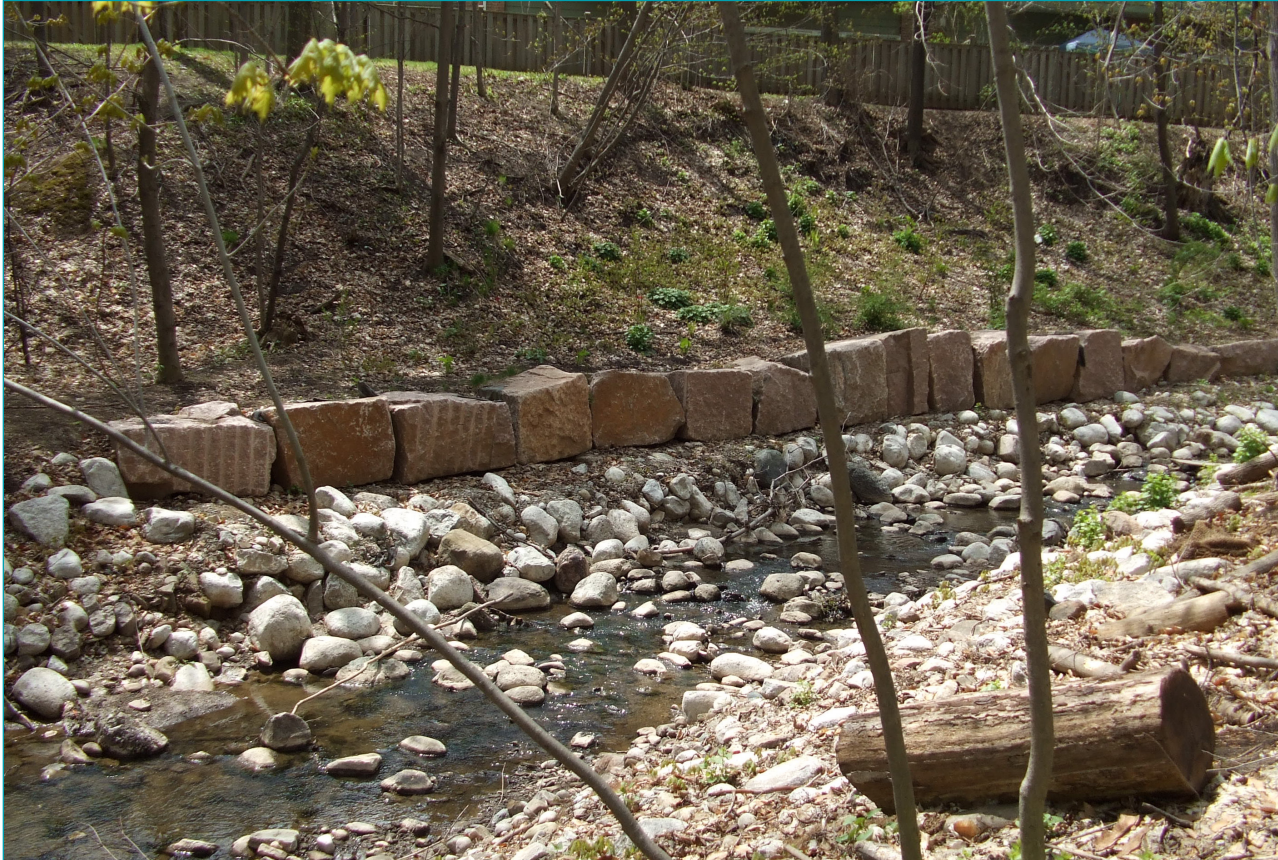
Creek with single row of armour stone

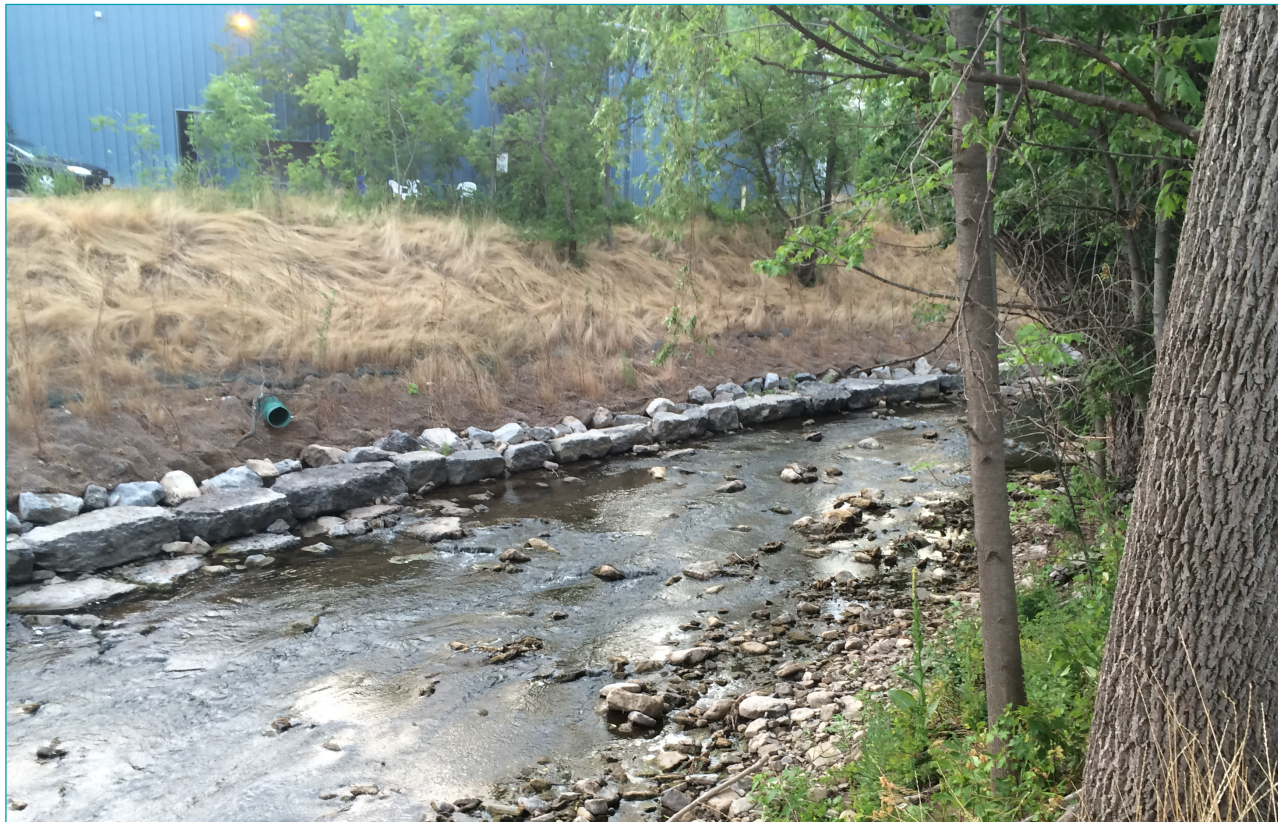
Boulder toe protection and vegetated banks

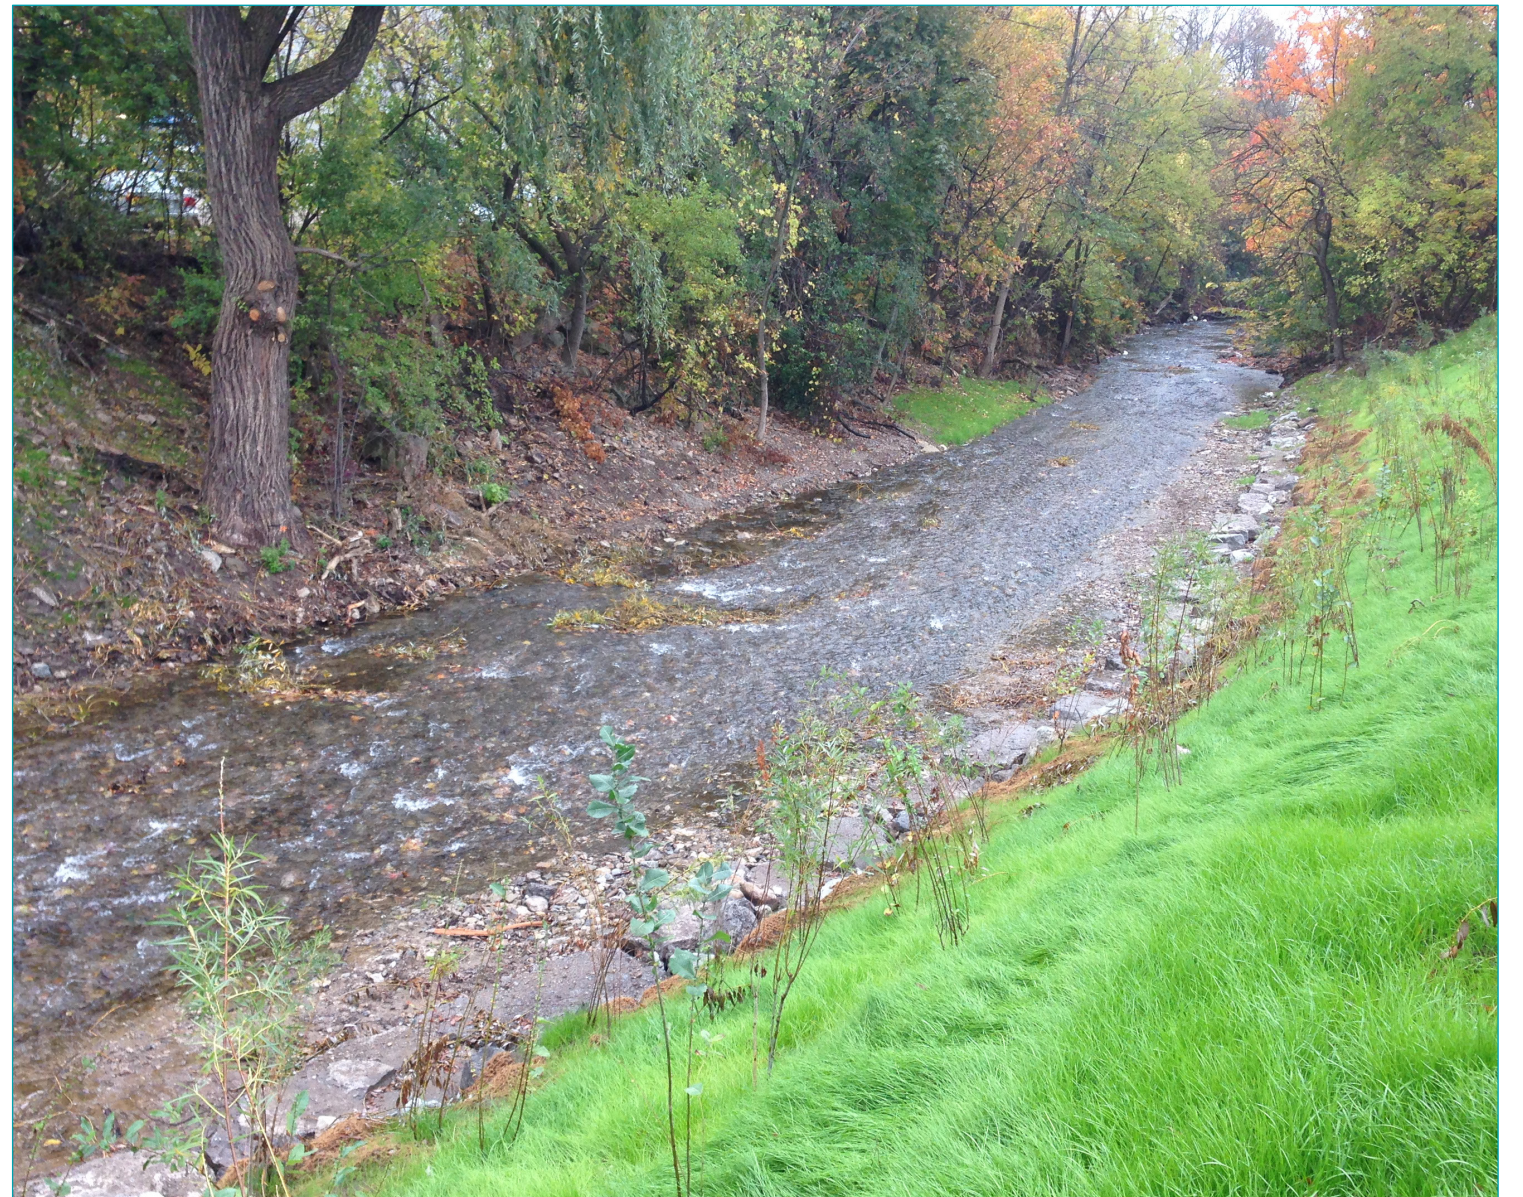
Rehabilitated creek with natural stone substrate, boulder toe protection and vegetated banks
