## Schedule B Class Environmental Assessment – Project File

### Loyalist Creek Erosion Control Project behind Thorn Lodge Drive

A project file submitted by:  
**Aquafor Beech Ltd.**

October 18, 2021

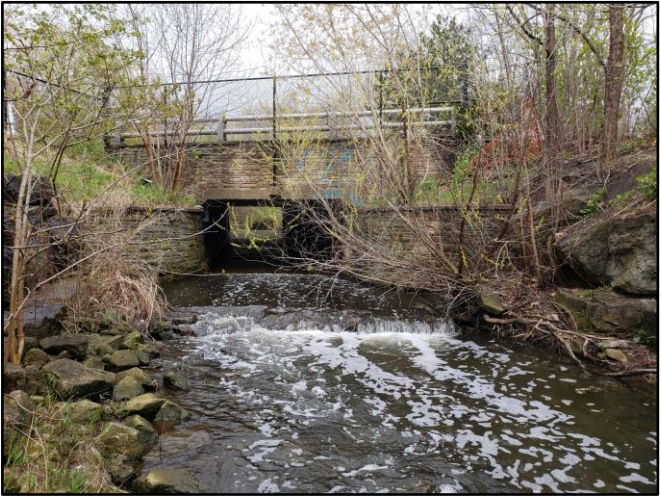
A. Upstream Thorn Lodge Drive culvert with brick-lined wingwalls in fair conditions.

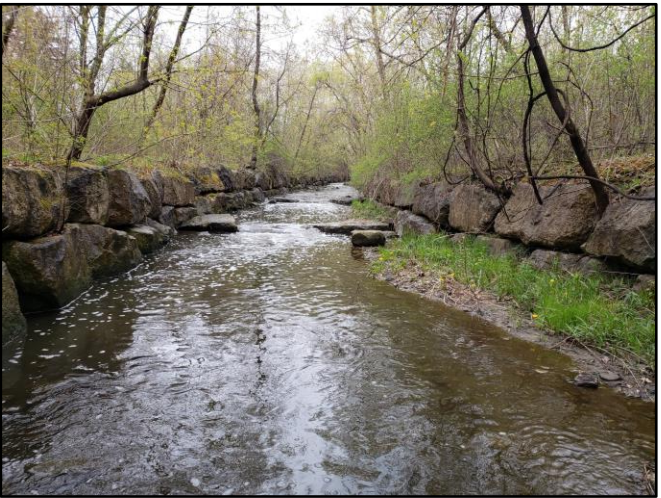
B. Section of armourstone retaining walls in fair conditions.

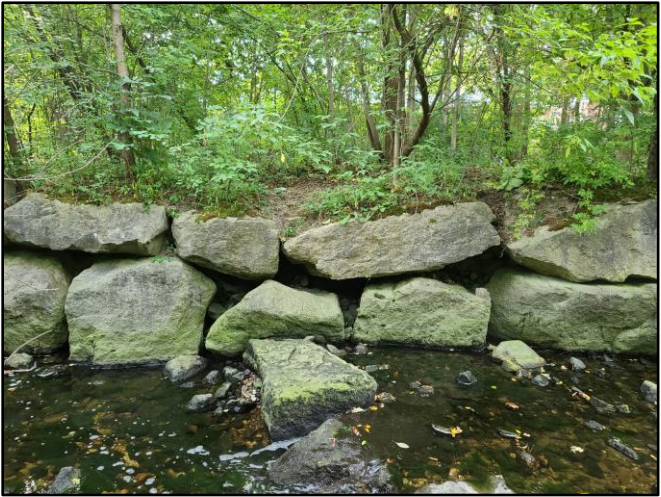
C. Section of armourstone retaining walls in poor conditions, with dislocated stone and loss of drainage material.

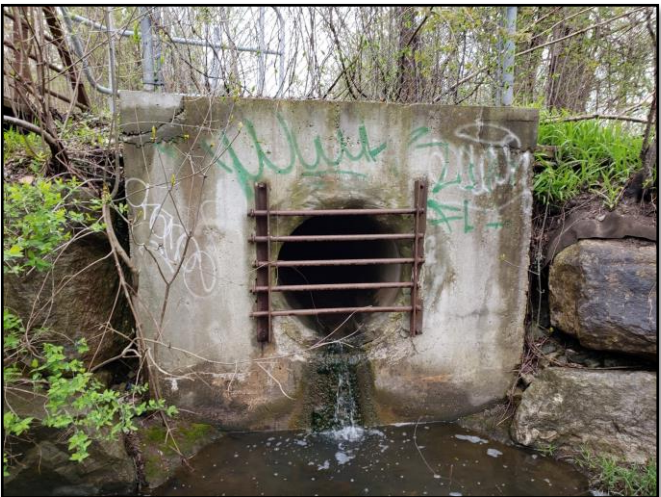
D. Existing deteriorated stormwater outfall immediately downstream of pedestrian bridge.

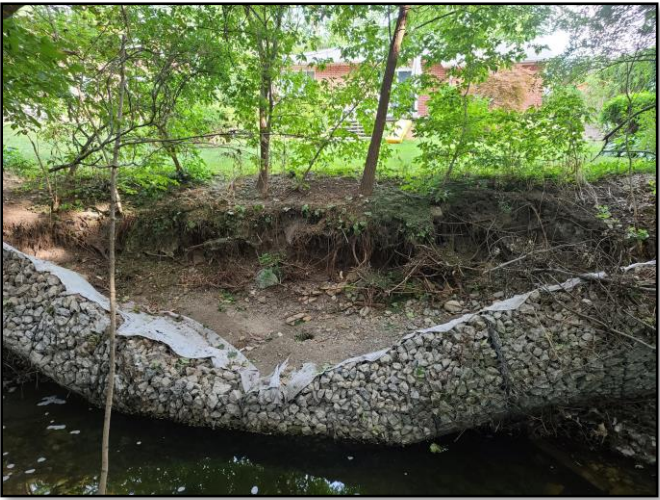
E. Failure of gabion baskets and loss of tableland in close proximity of private property.

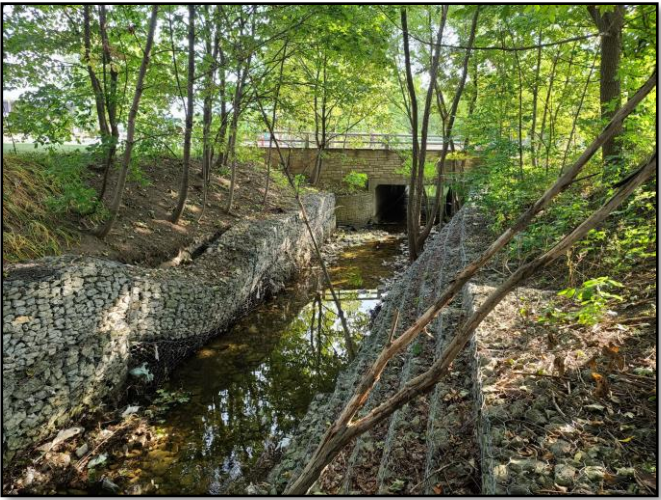
F. Failing gabion baskets with empty bottom, upstream of the downstream Thorn Lodge Drive culvert.

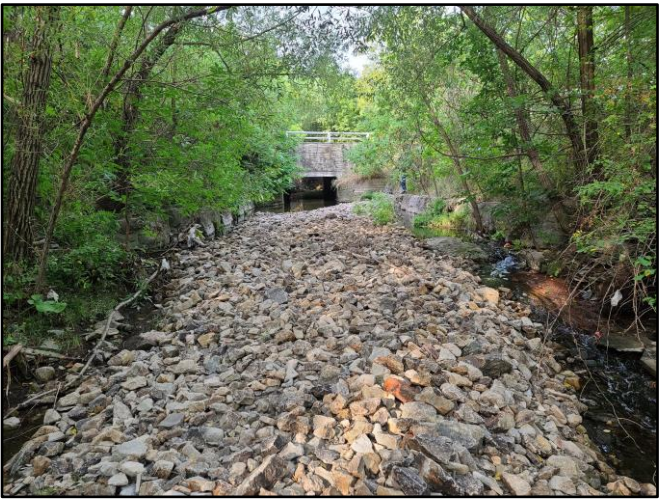
G. Large accumulation of engineered material, backwatering and impacting conveyance of culvert.

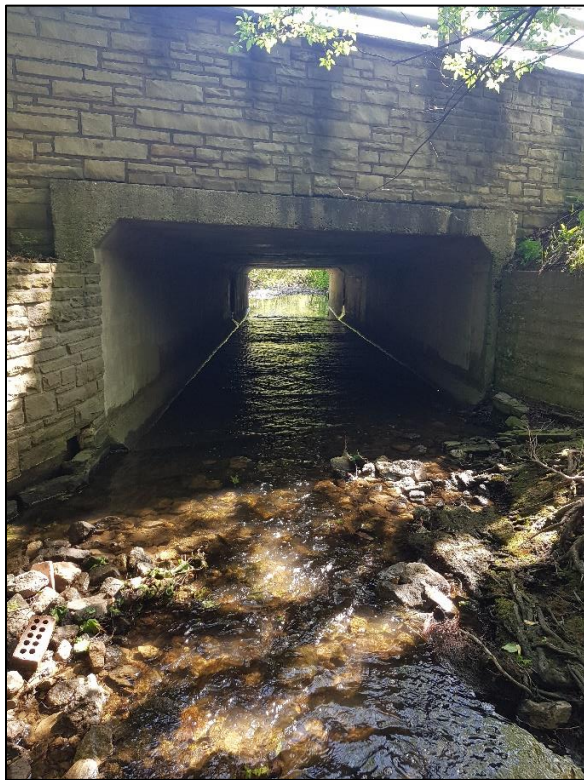
**Photo 1. Downstream extent at Erin Mills Pkwy, looking downstream.**

The downstream extent at Erin Mills Parkway is serviced by a closed bottom box culvert (Photo 1) where it continues upstream through a stepped gabion line corridor (Photo 2). At the time of investigation, flow was bounded by the gabion lined banks creating uniform channel characteristics defined by a mean stream width of 4 m and a mean depth at crossovers of 80 mm. Substrate consisted of angular stones (Photo 3) likely introduced during channelization works and by failing gabion baskets observed upstream (Photo 4). Smaller gravels and cobbles were observed in pool areas like that shown in Photo 4 and in deposition areas, while the majority of the habitat consisted of shallow riffles created by gabion knickpoints (Photo 5) and shallow, uniform runs (Photo 6) dominated by angular stones or rip rap. Habitat characteristics continued in this manner approximately 240 m upstream to a pedestrian bridge perpendicular to Liruma Road. Here, the creek became channelized by armourstone walls (Photo 7Photo 9). A storm sewer outlet was observed at the downstream side of the pedestrian bridge (Photo 8). Substrate and habitat remained fairly consistent throughout this reach, with riffles created artificially through armourstone ribs and angular stones observed throughout (Photo 9Photo 10). Some riffles could constitute as fish barriers to non-jumping species, with jumping heights ranging upwards to ~200 mm (Photo 10).

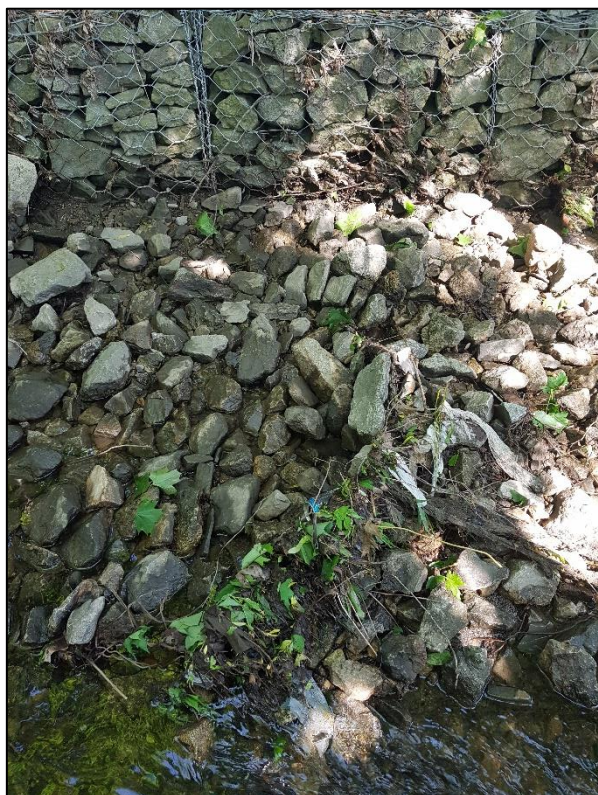
**Photo 3. Typical substrate and bank profile of Reach 2.**

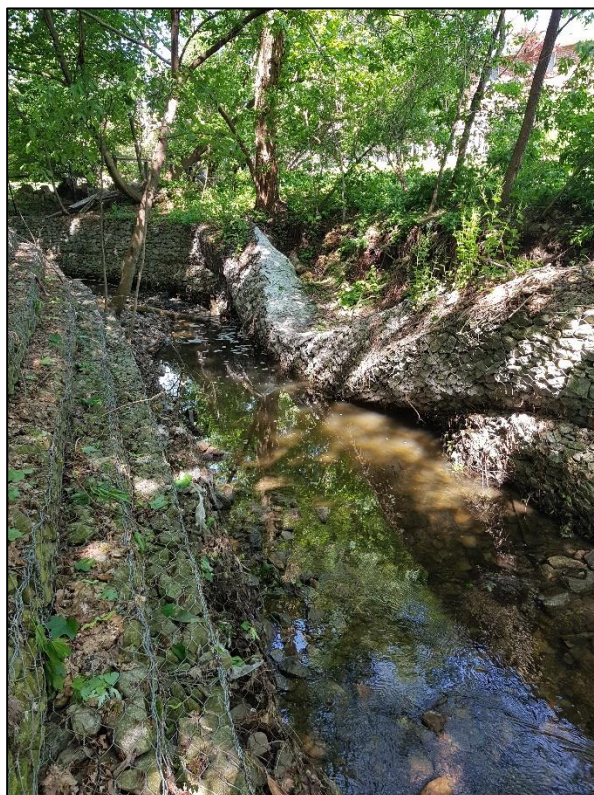
**Photo 4. Failing gabion bank, north bank.**

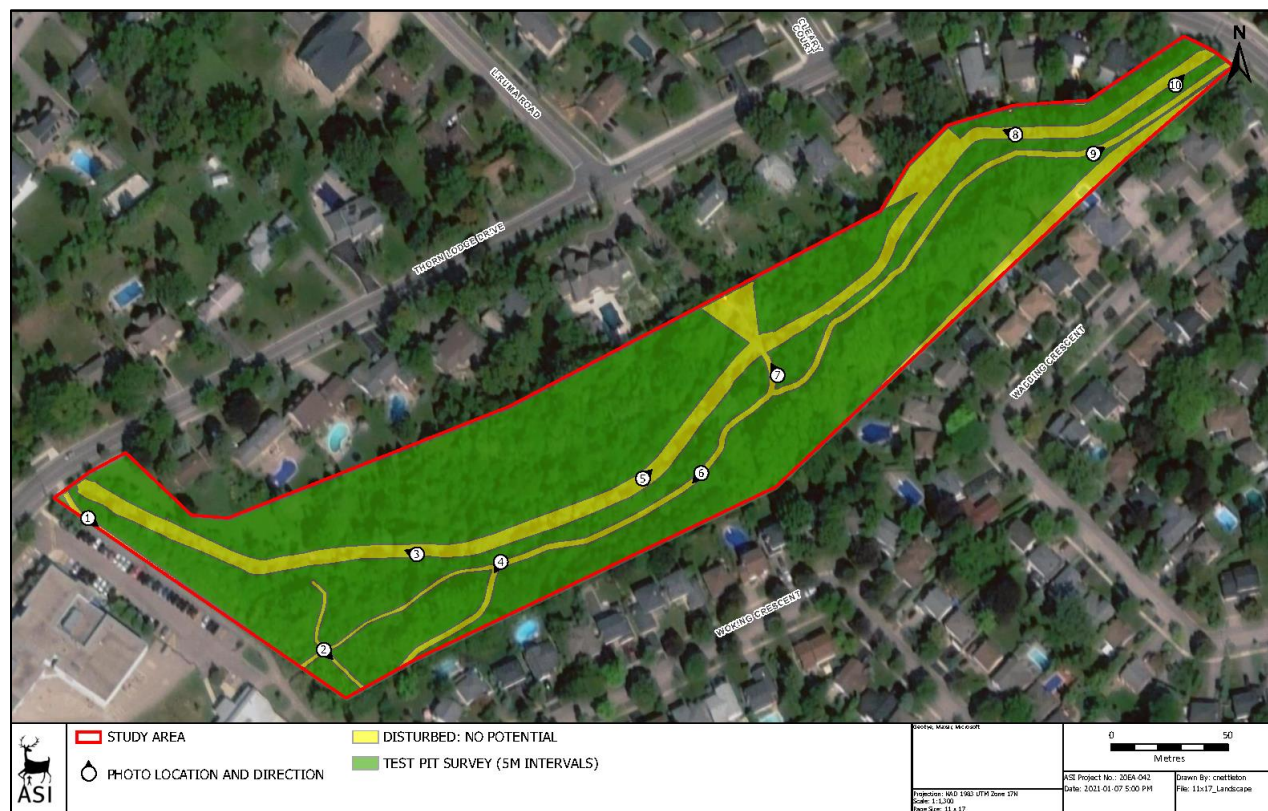
**Figure 3-11. Results of the Stage 1 Archaeological Assessment. (ASI, 2021)**

The Stage 1 background study determined that one previously registered archaeological site (AjGv-76 – Pre-Contact Indigenous; Euro-Canadian) is located within one kilometer of the study area. The assessment also indicated that part of the study area exhibits archaeological potential and will require Stage 2 assessment by test pit survey at five-meter intervals, prior to any proposed impacts to the property, to be undertaken at the detailed design stage. A summary of the assessment results is shown in Figure 3-11 and the full archaeological report is included in Appendix E.

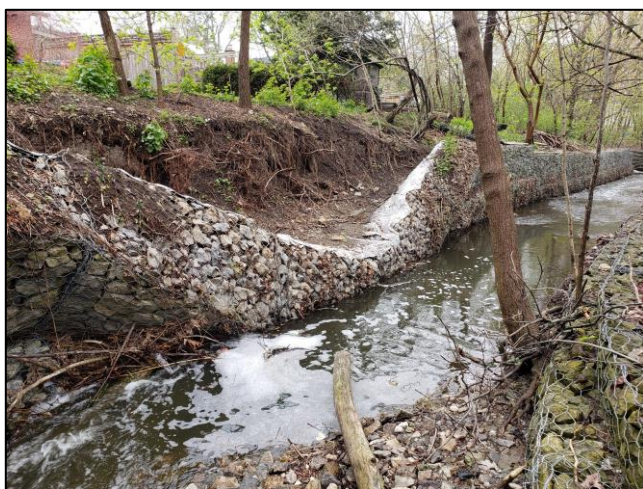
**Figure 4-1. The Most Failed Section of Gabion Baskets within Study Area.**

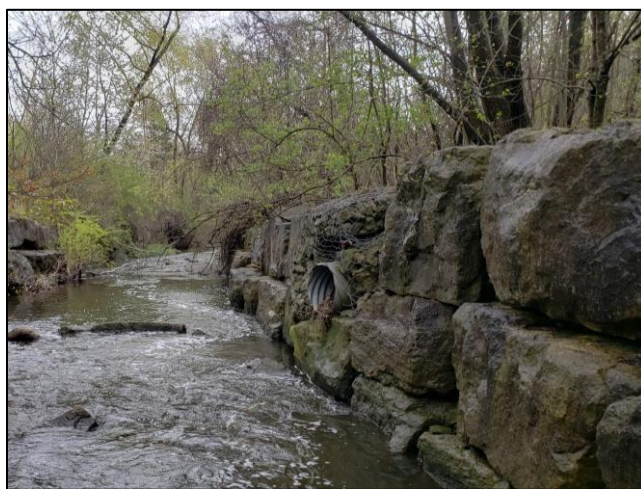
**Figure 4-2. Deteriorated Stormwater Outlet Inset within Gabion Baskets Surrounded by Armourstone.**

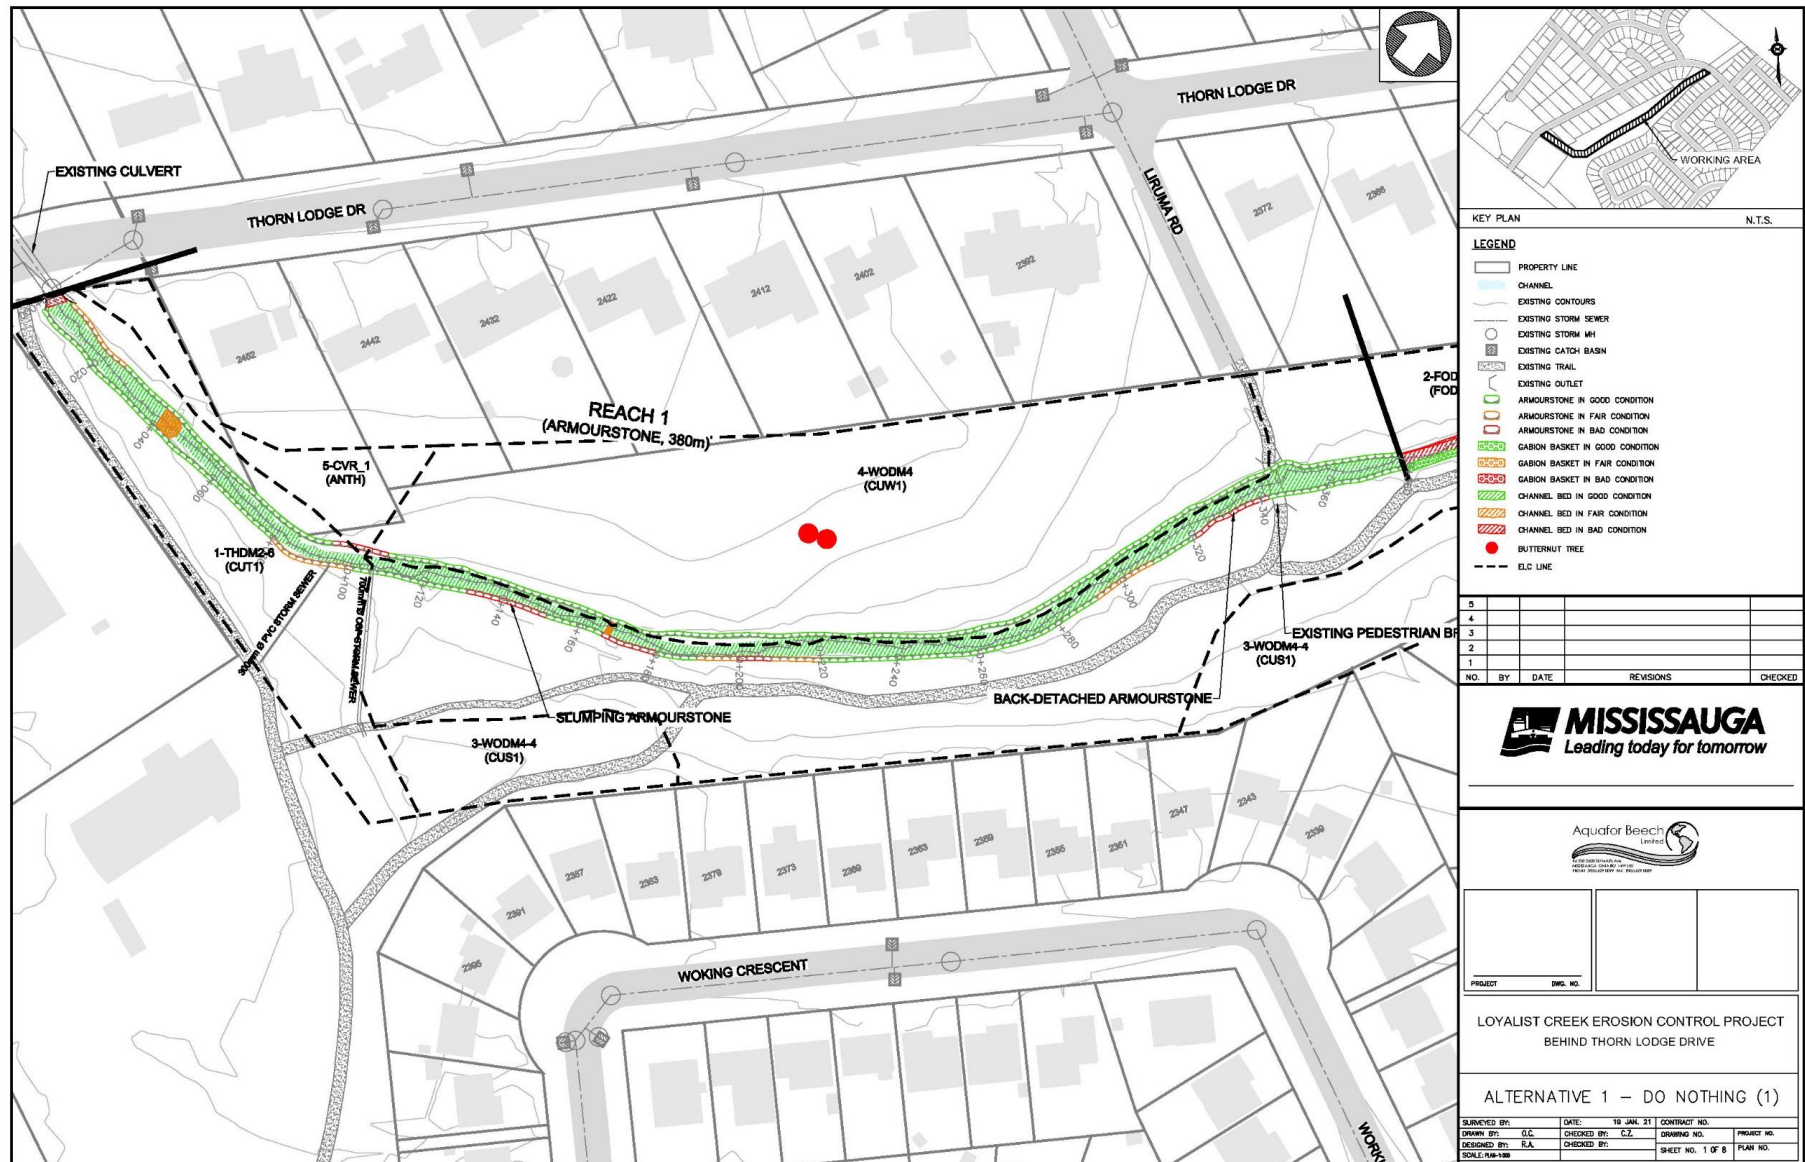
Figure 4-3. Alternative No. 1 – Do Nothing (1 of 2).

Figure 4-1 and Figure 4-2 included below depict the most failed section of the gabion baskets and the deteriorated stormwater infrastructure within the study area. Color coding in Figure 4-3 and Figure 4-4 highlight the various conditions of the existing creek banks and bed throughout the corridor, which will be used to as a reference point when defining the priority of restoration locations, extent and types of restoration measures, and appropriate channel planform configurations.

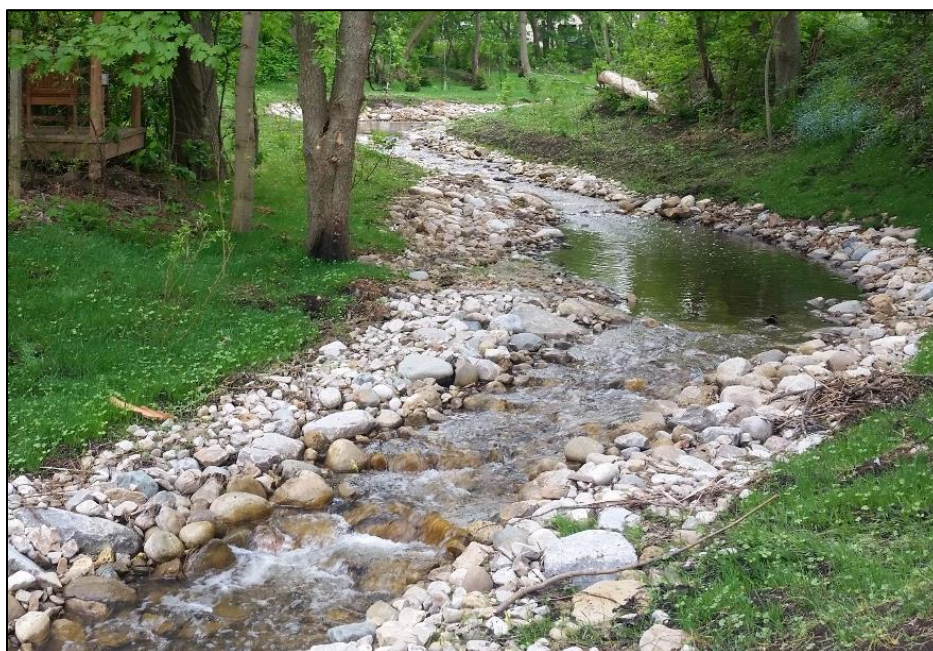
**Figure 4-9. An Example of Natural Channel Restoration.**

An example of natural channel restoration is shown in Figure 4-9, and the preliminary design planform of Alternative 4 is illustrated in Figure 4-10. The implementation of this option would have a relatively high cost as well, as illustrated in Table 4-4 below.

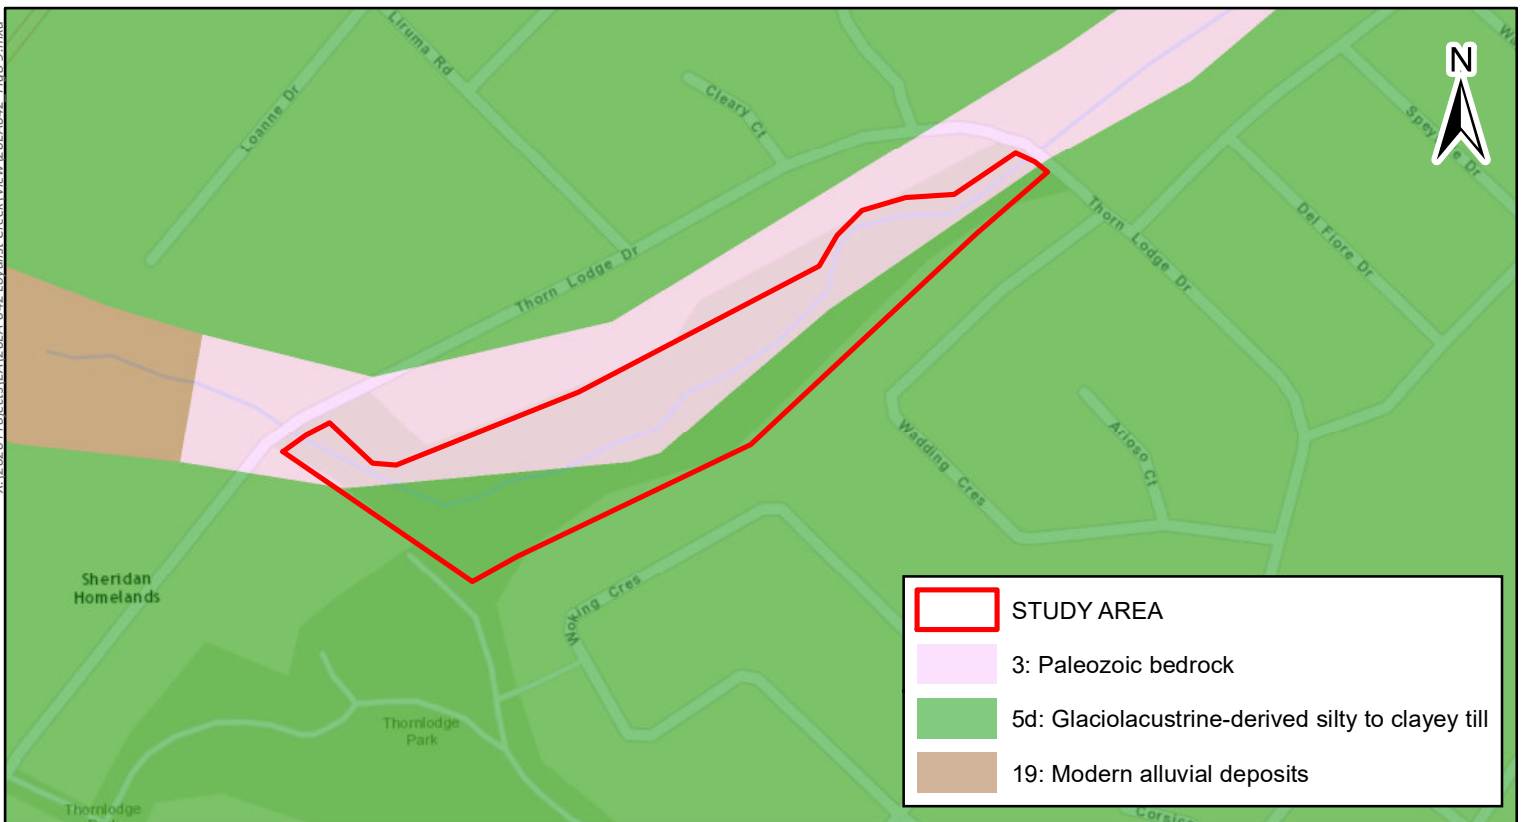
Figure 8: Study Area - Surficial Geology

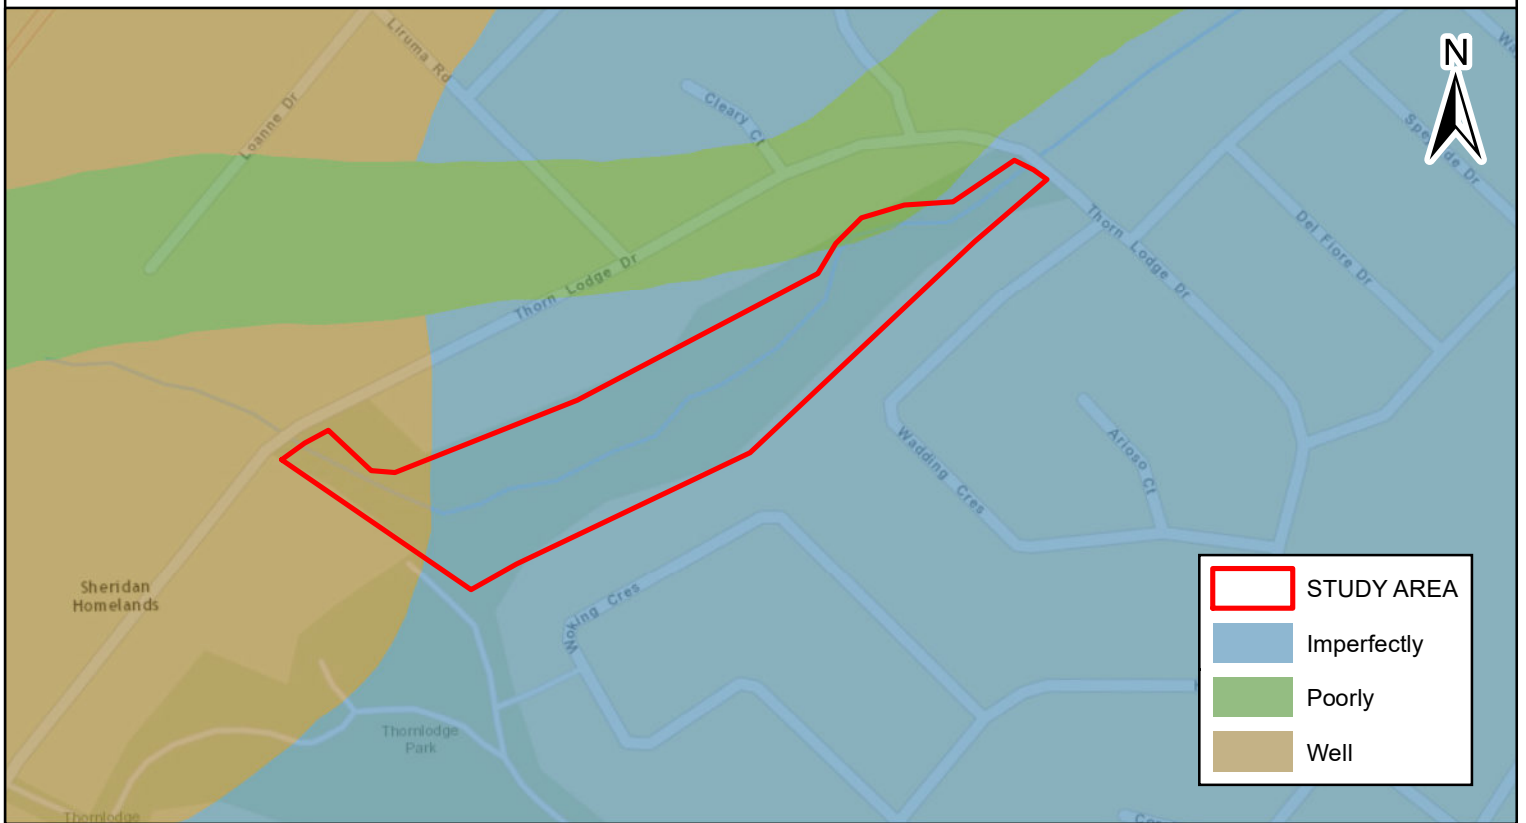
Figure 9: Study Area - Soil Drainage

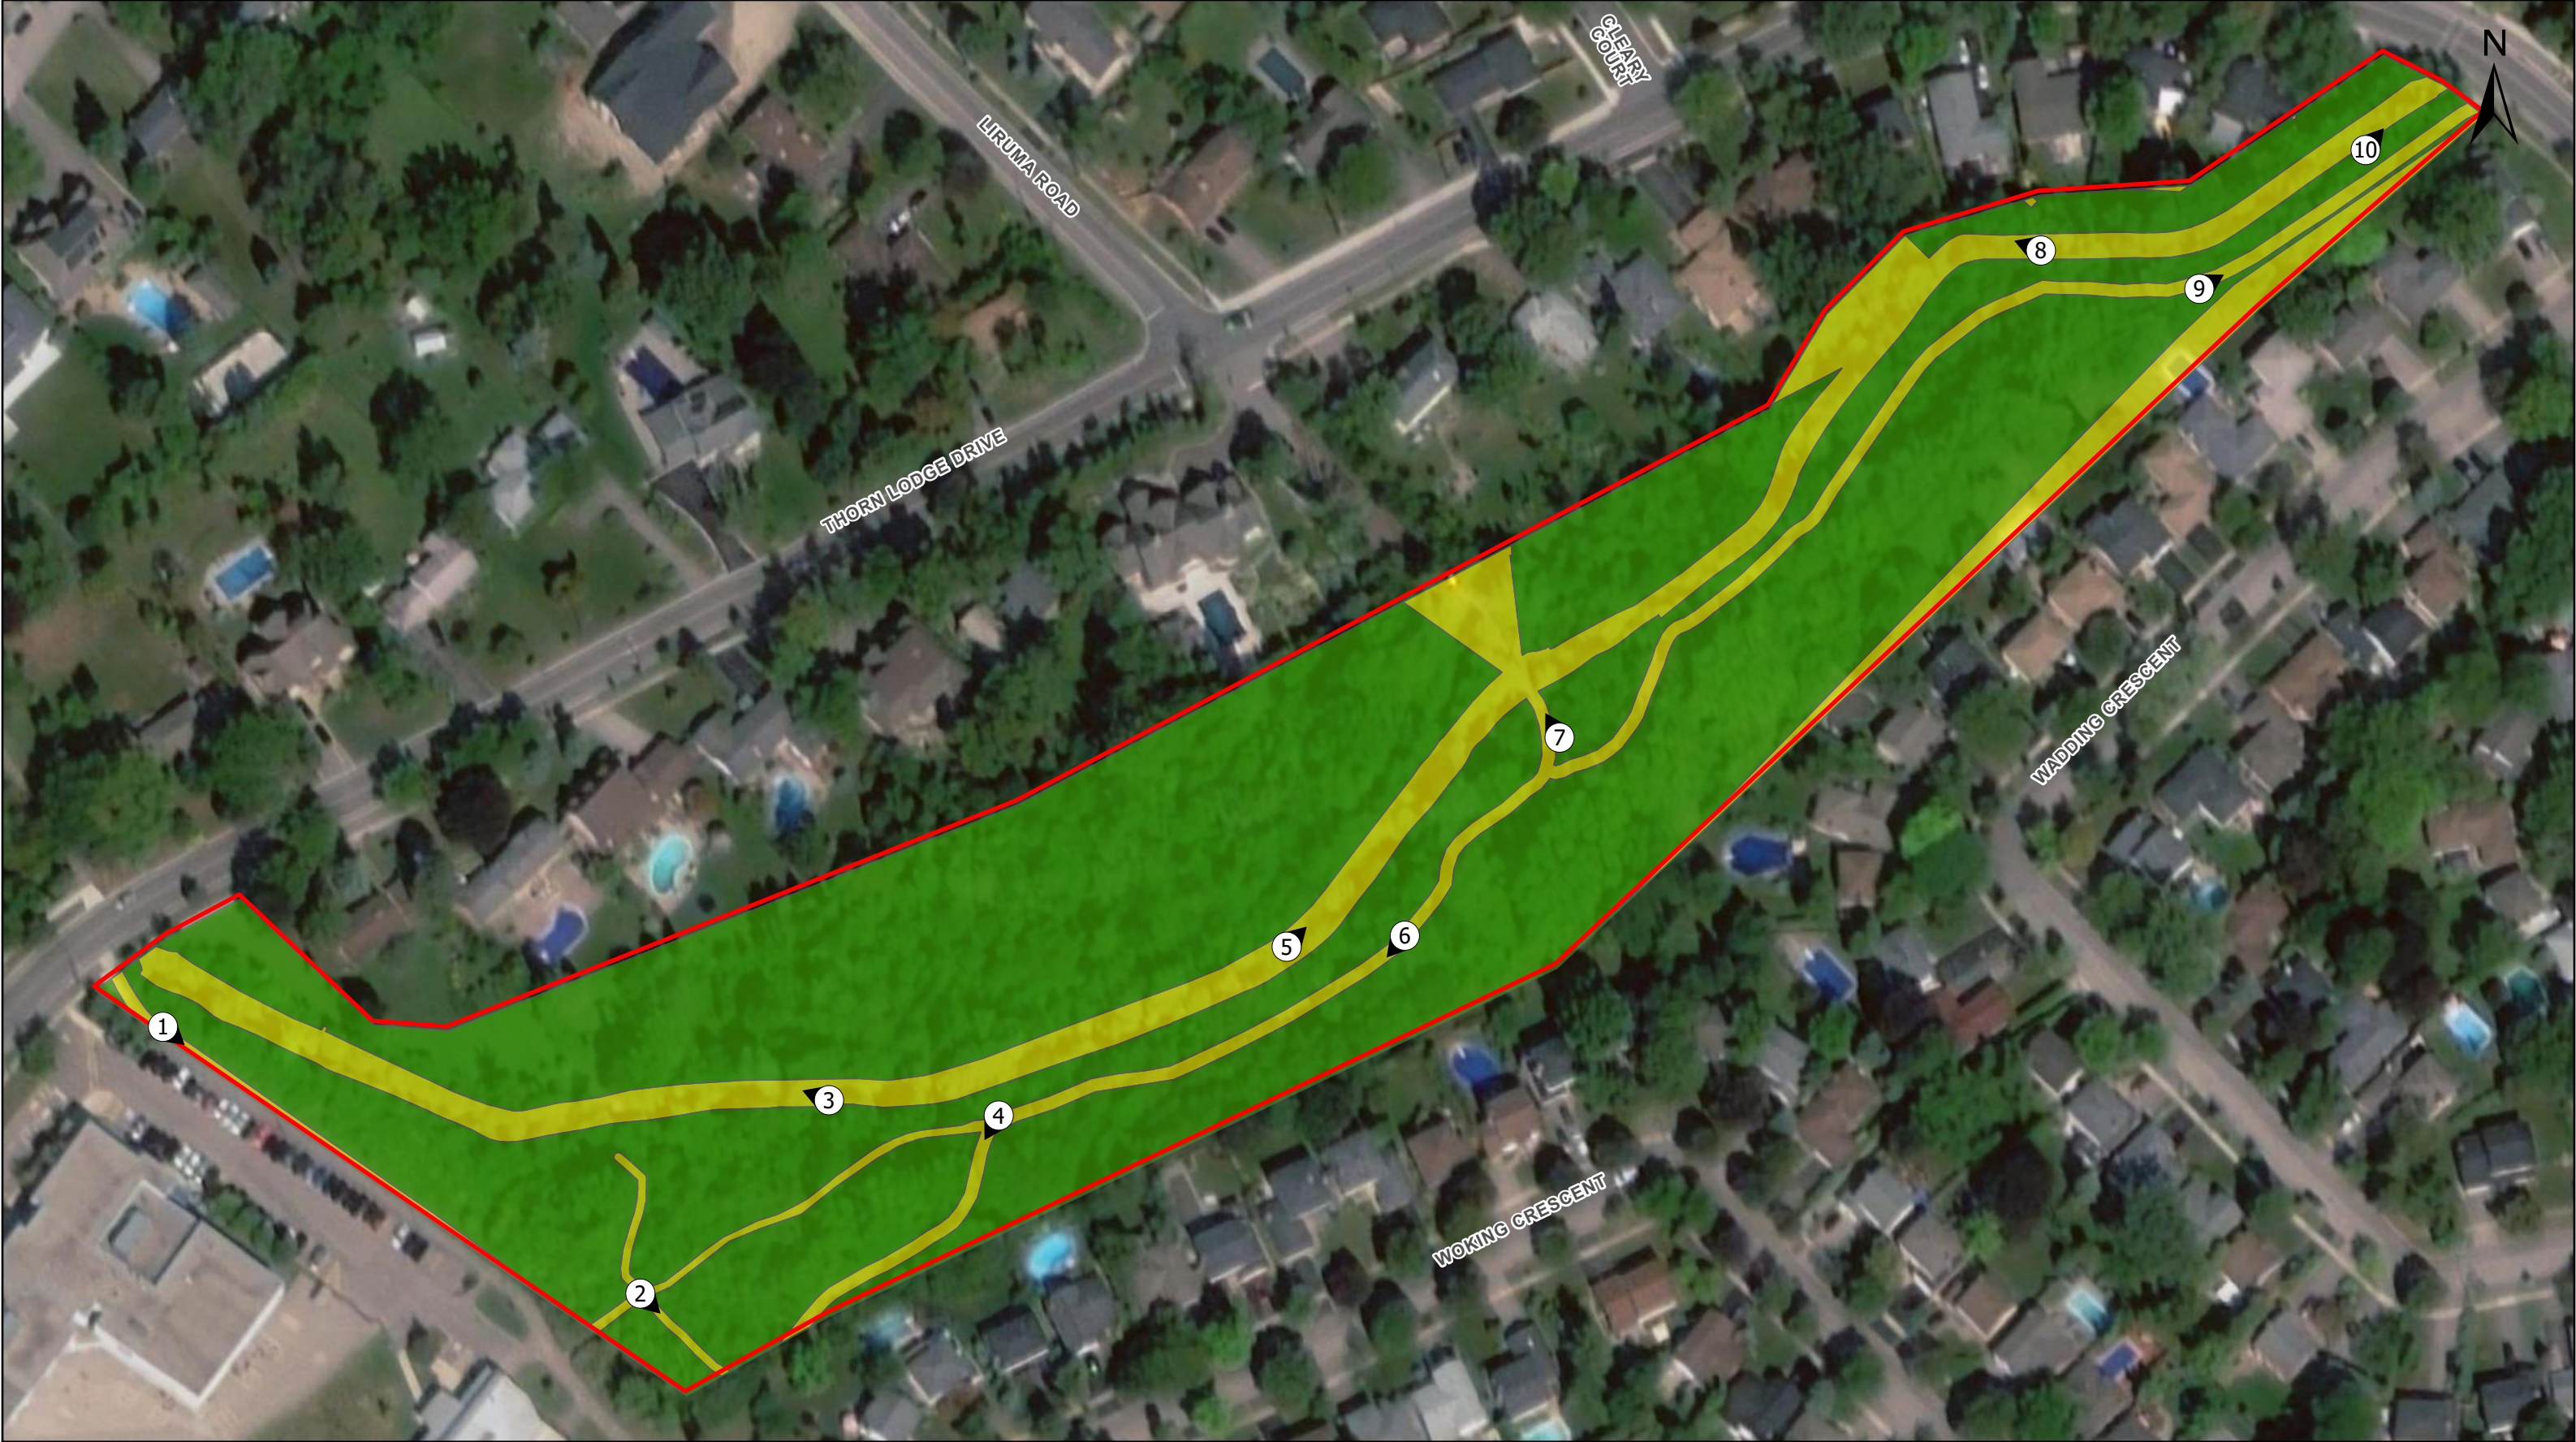
STUDY AREA	  DISTURBED: NO POTENTIAL	  TEST PIT SURVEY (5M INTERVALS)	GeoEye, Maxar, Microsoft		  0 50 Metres	
	  PHOTO LOCATION AND DIRECTION	Projection: NAD 1983 UTM Zone 17N Scale: 1:1,300 Page Size: 11 x 17			ASI Project No.: 20EA-042 Date: 2021-01-07 5:00 PM	Drawn By: cnettleton File: 11x17_Landscape

Figure 10: Loyalist Creek - Results of Stage 1

The property inspection determined that the Study Area exhibits archaeological potential. These areas will require Stage 2 archaeological assessment prior to any development. According to the S & G Section 2.1.2, test pit survey is required on terrain where ploughing is not viable, such as wooded areas, properties where existing landscaping or infrastructure would be damaged, overgrown farmland with heavy brush or rocky pasture, and narrow linear corridors up to 10 metres wide (Plates 1, 4, 6, 9; Figure 10: areas highlighted in green).

The remainder of the Study Area has been subjected to deep soil disturbance events, including the channelization of Loyalist Creek, additions of retaining walls, ditches, culverts, storm sewer outfall, and residential construction, and according to the S & G Section 1.3.2 do not retain archaeological potential (Plates 1, 3, 5, 7-8, 10; Figure 10: areas highlighted in yellow). These areas do not require further survey.

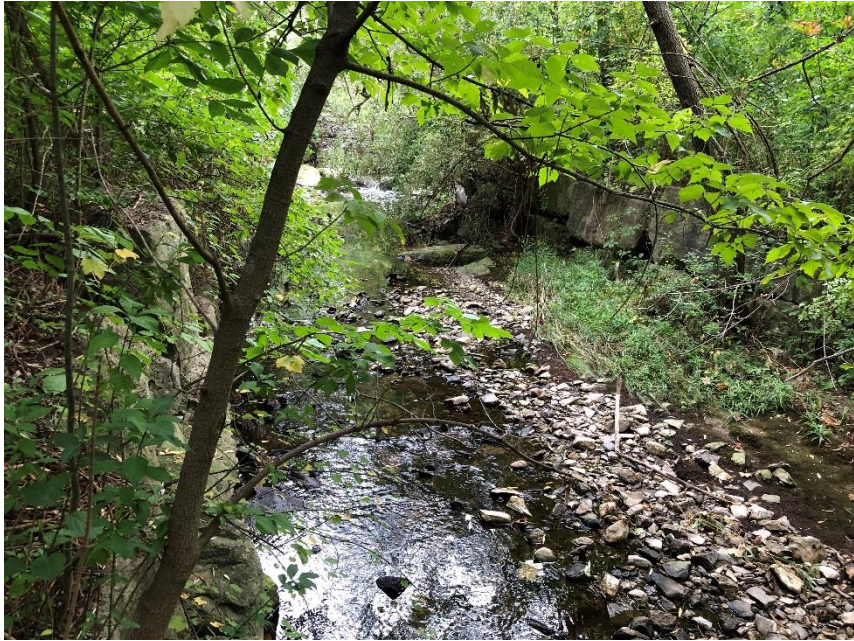
Plate 3: View of Loyalist Creek; Creek has been disturbed from channelization, no potential

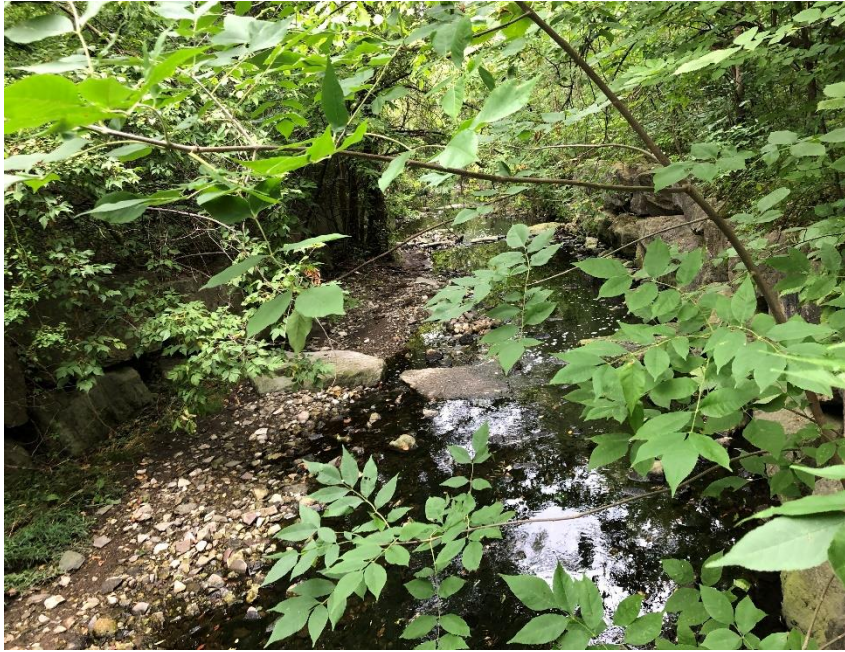
Plate 5: View of Loyalist Creek; Creek has been disturbed from channelization, no potential

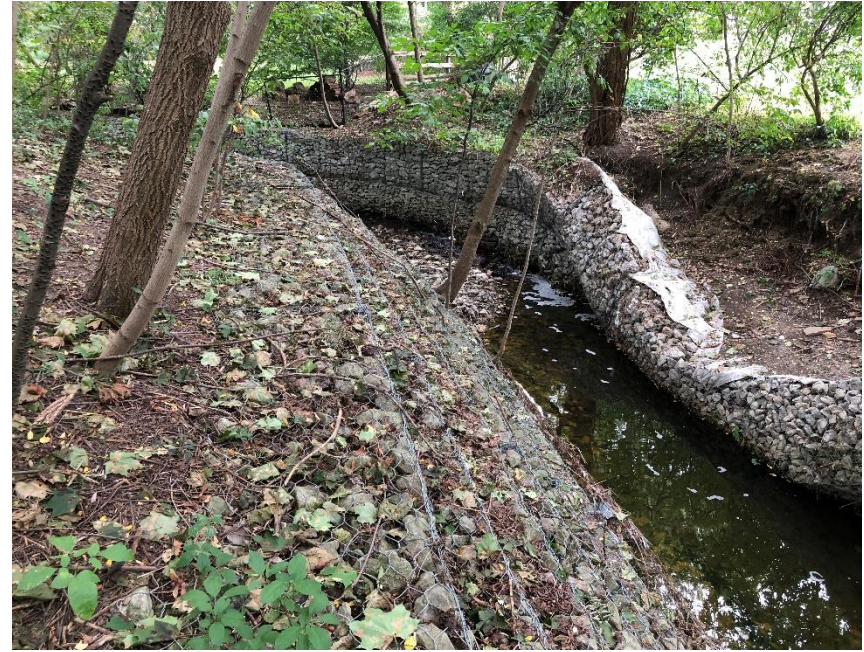
Plate 8: View of Loyalist Creek; Creek has been disturbed from channelization, no potential

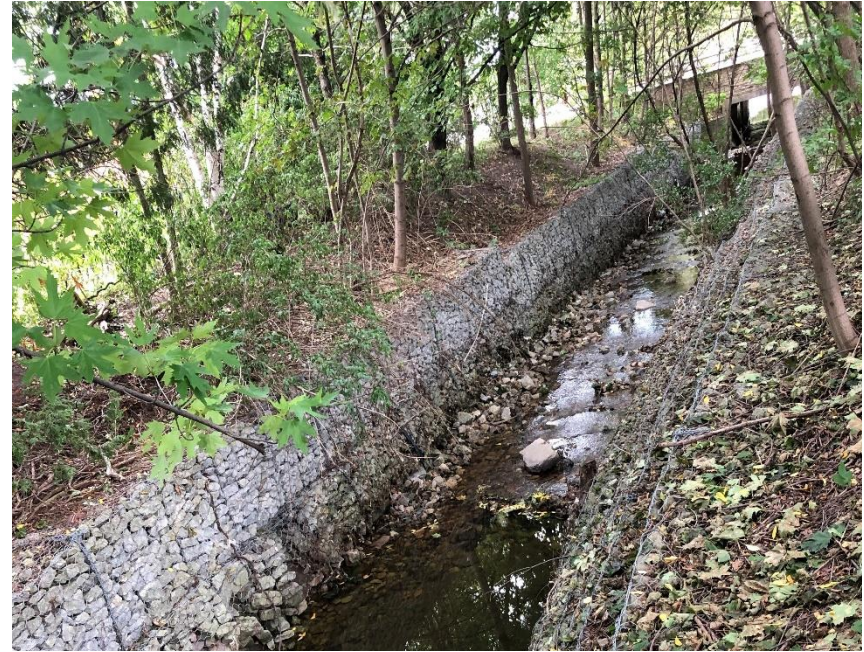
Plate 10: View of Loyalist Creek; Creek has been disturbed from channelization, no potential

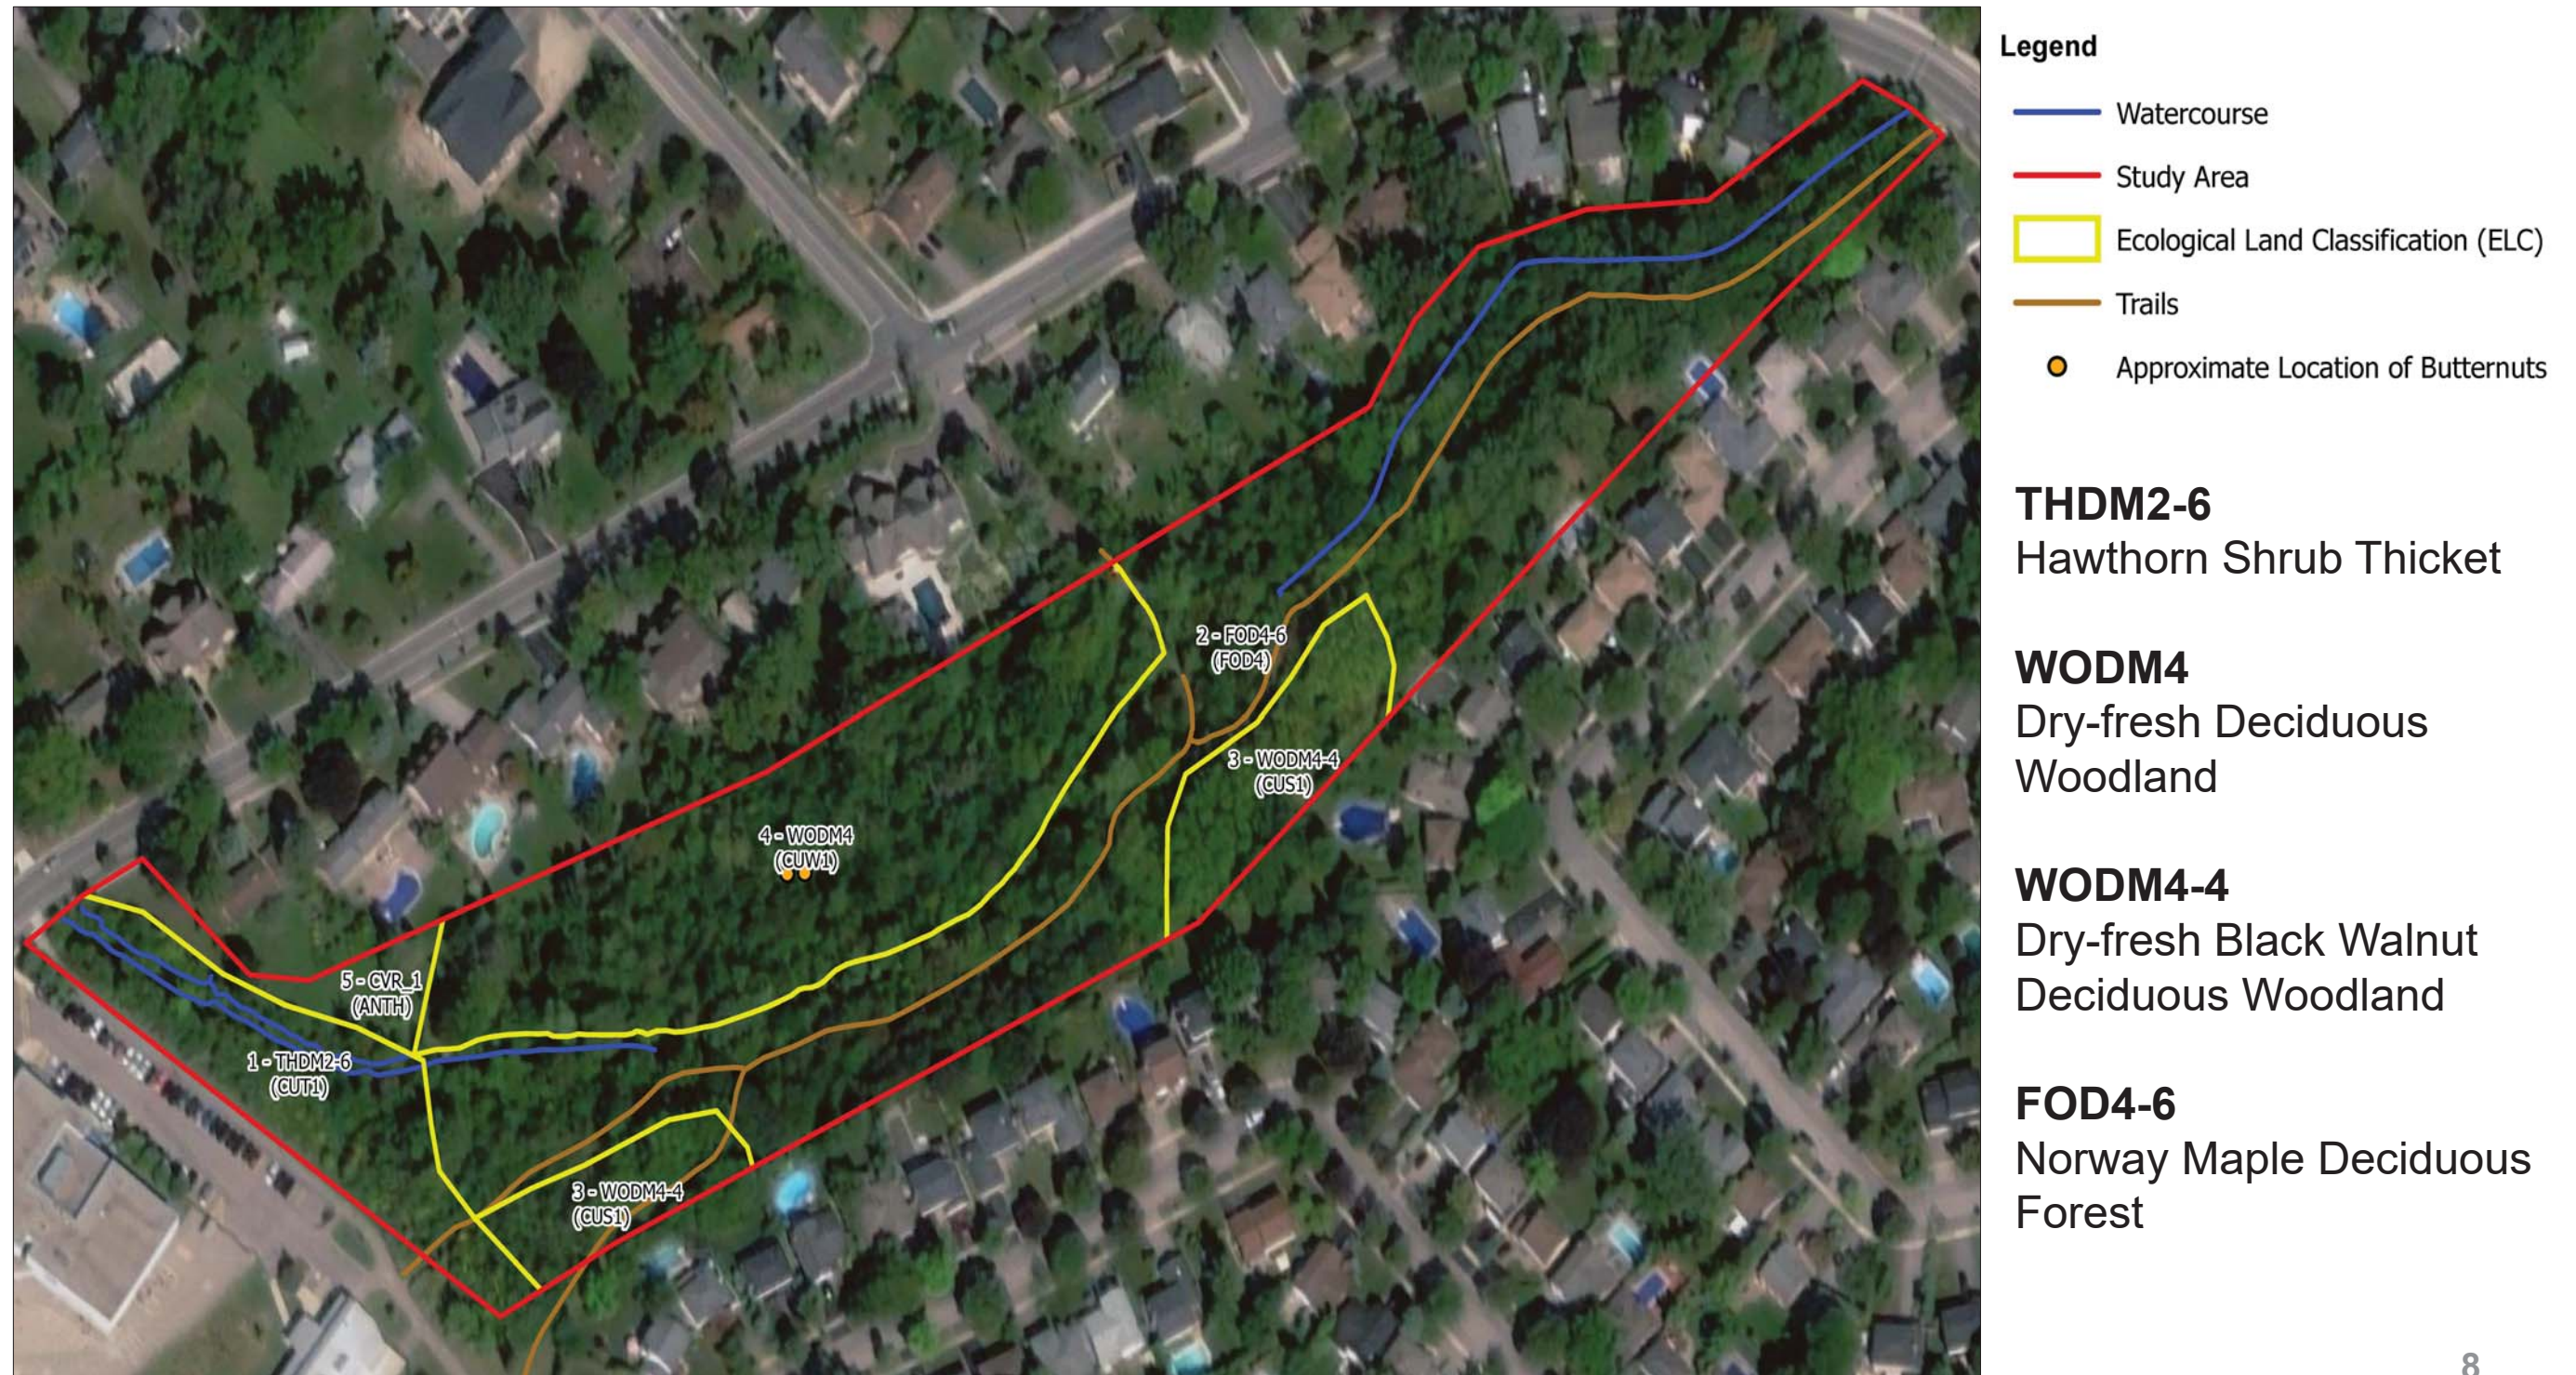
Ecological Land Classification (ELC) is a standard practice used to describe, identify, classify and map vegetation communities on the landscape. Community types found within the study area range from cultural thickets to woodlands as shown in the map below.

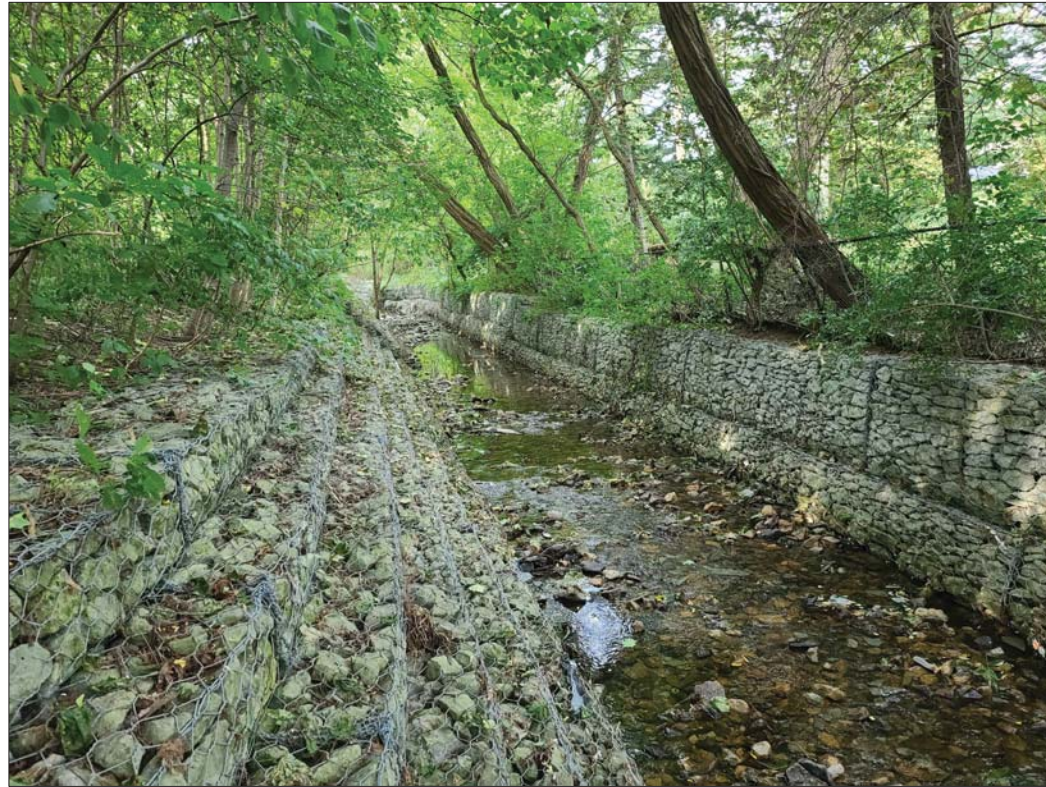
The study assessed aquatic habitat and fisheries within Loyalist Creek to define existing conditions.

- Fish were not observed within the study area during the field investigation. However, past fish community studies provided fish collection records within the subwatershed.
- No major fish barriers were observed within the site.
- Aquatic habitat is generally in poor conditions, demonstrating characteristics of a channelized, urban-impacted and stormwater fed watercourse.
- Aquatic habitat potentially supports localized communities or vagrant species, and could be improved through restoration by adding more in-water cover and allowing the river to return to a more natural meandering pattern.
