## Schedule B Class Environmental Assessment – Project File

### Loyalist Creek Erosion Control Project behind Thorn Lodge Drive

A project file submitted by:  
**Aquafor Beech Ltd.**

October 18, 2021

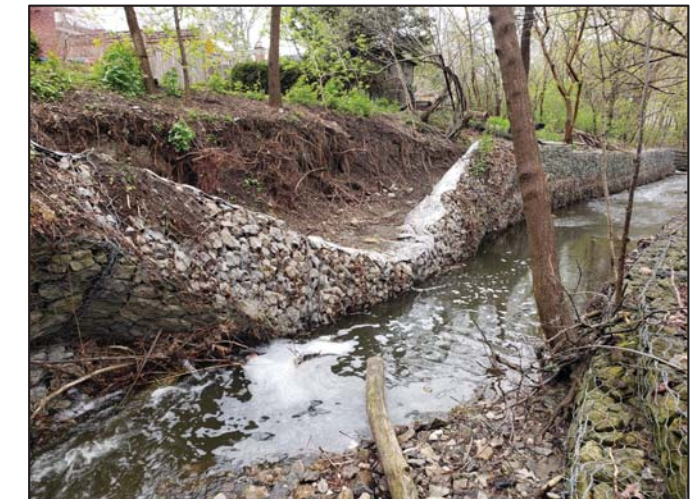
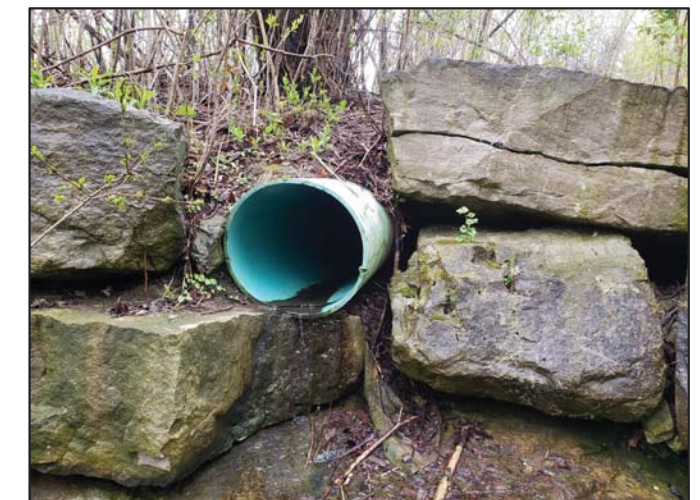
Existing Conditions / Do Nothing

**Description:** This alternative would involve leaving the existing creek, particularly the gabion baskets which line both banks, to continue failing. Existing risks associated with eroding of streambanks, deteriorated storm outfalls, loss of tableland within private properties, and public safety will remain. Habitat conditions would continue to degrade due to erosion.

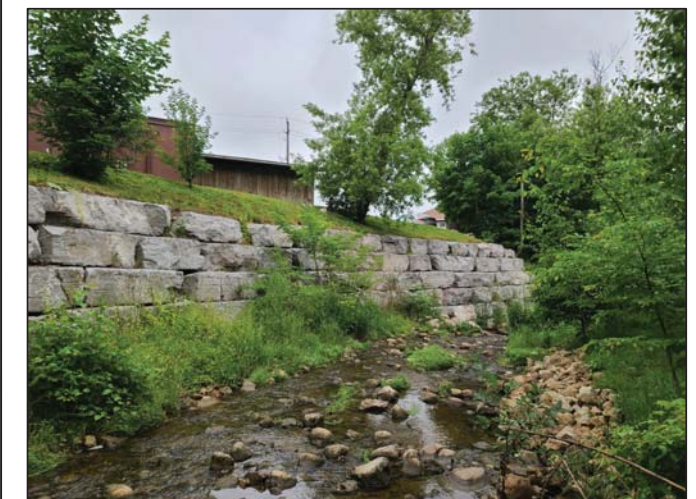
Engineered Channel Restoration

**Description:** This Alternative would involve a continuous restoration of the Loyalist Creek throughout the study area, replacing all existing bank and bed structures with armourstones. The existing channel width and alignment will be maintained. This alternative will require moderate disruption to the natural environment and adjacent properties, and provide long-term erosion protection to the watercourse. However, the creek will still runs through private properties, which may cause risks to the properties again in the long term. Improvement to the aquatic and terrestrial habitats is relatively low as minimal in-water and riparian vegetation could be planted. The lifespan of these works are generally defined as long, however, long-term maintenance or repair after significant rainfall will typically required to meet lifespan expectations.
