**PHASE ONE ENVIRONMENTAL SITE ASSESSMENT
900 MISSISSAUGA HEIGHTS DRIVE,
MISSISSAUGA, ONTARIO**

Prepared for: **Norman Lee & Associates Ltd.**
28 Fulton Way Unit 8-100,
Richmond Hill, Ontario
L4B 1J5

File No 1-18-0001-41
February 23, 2021

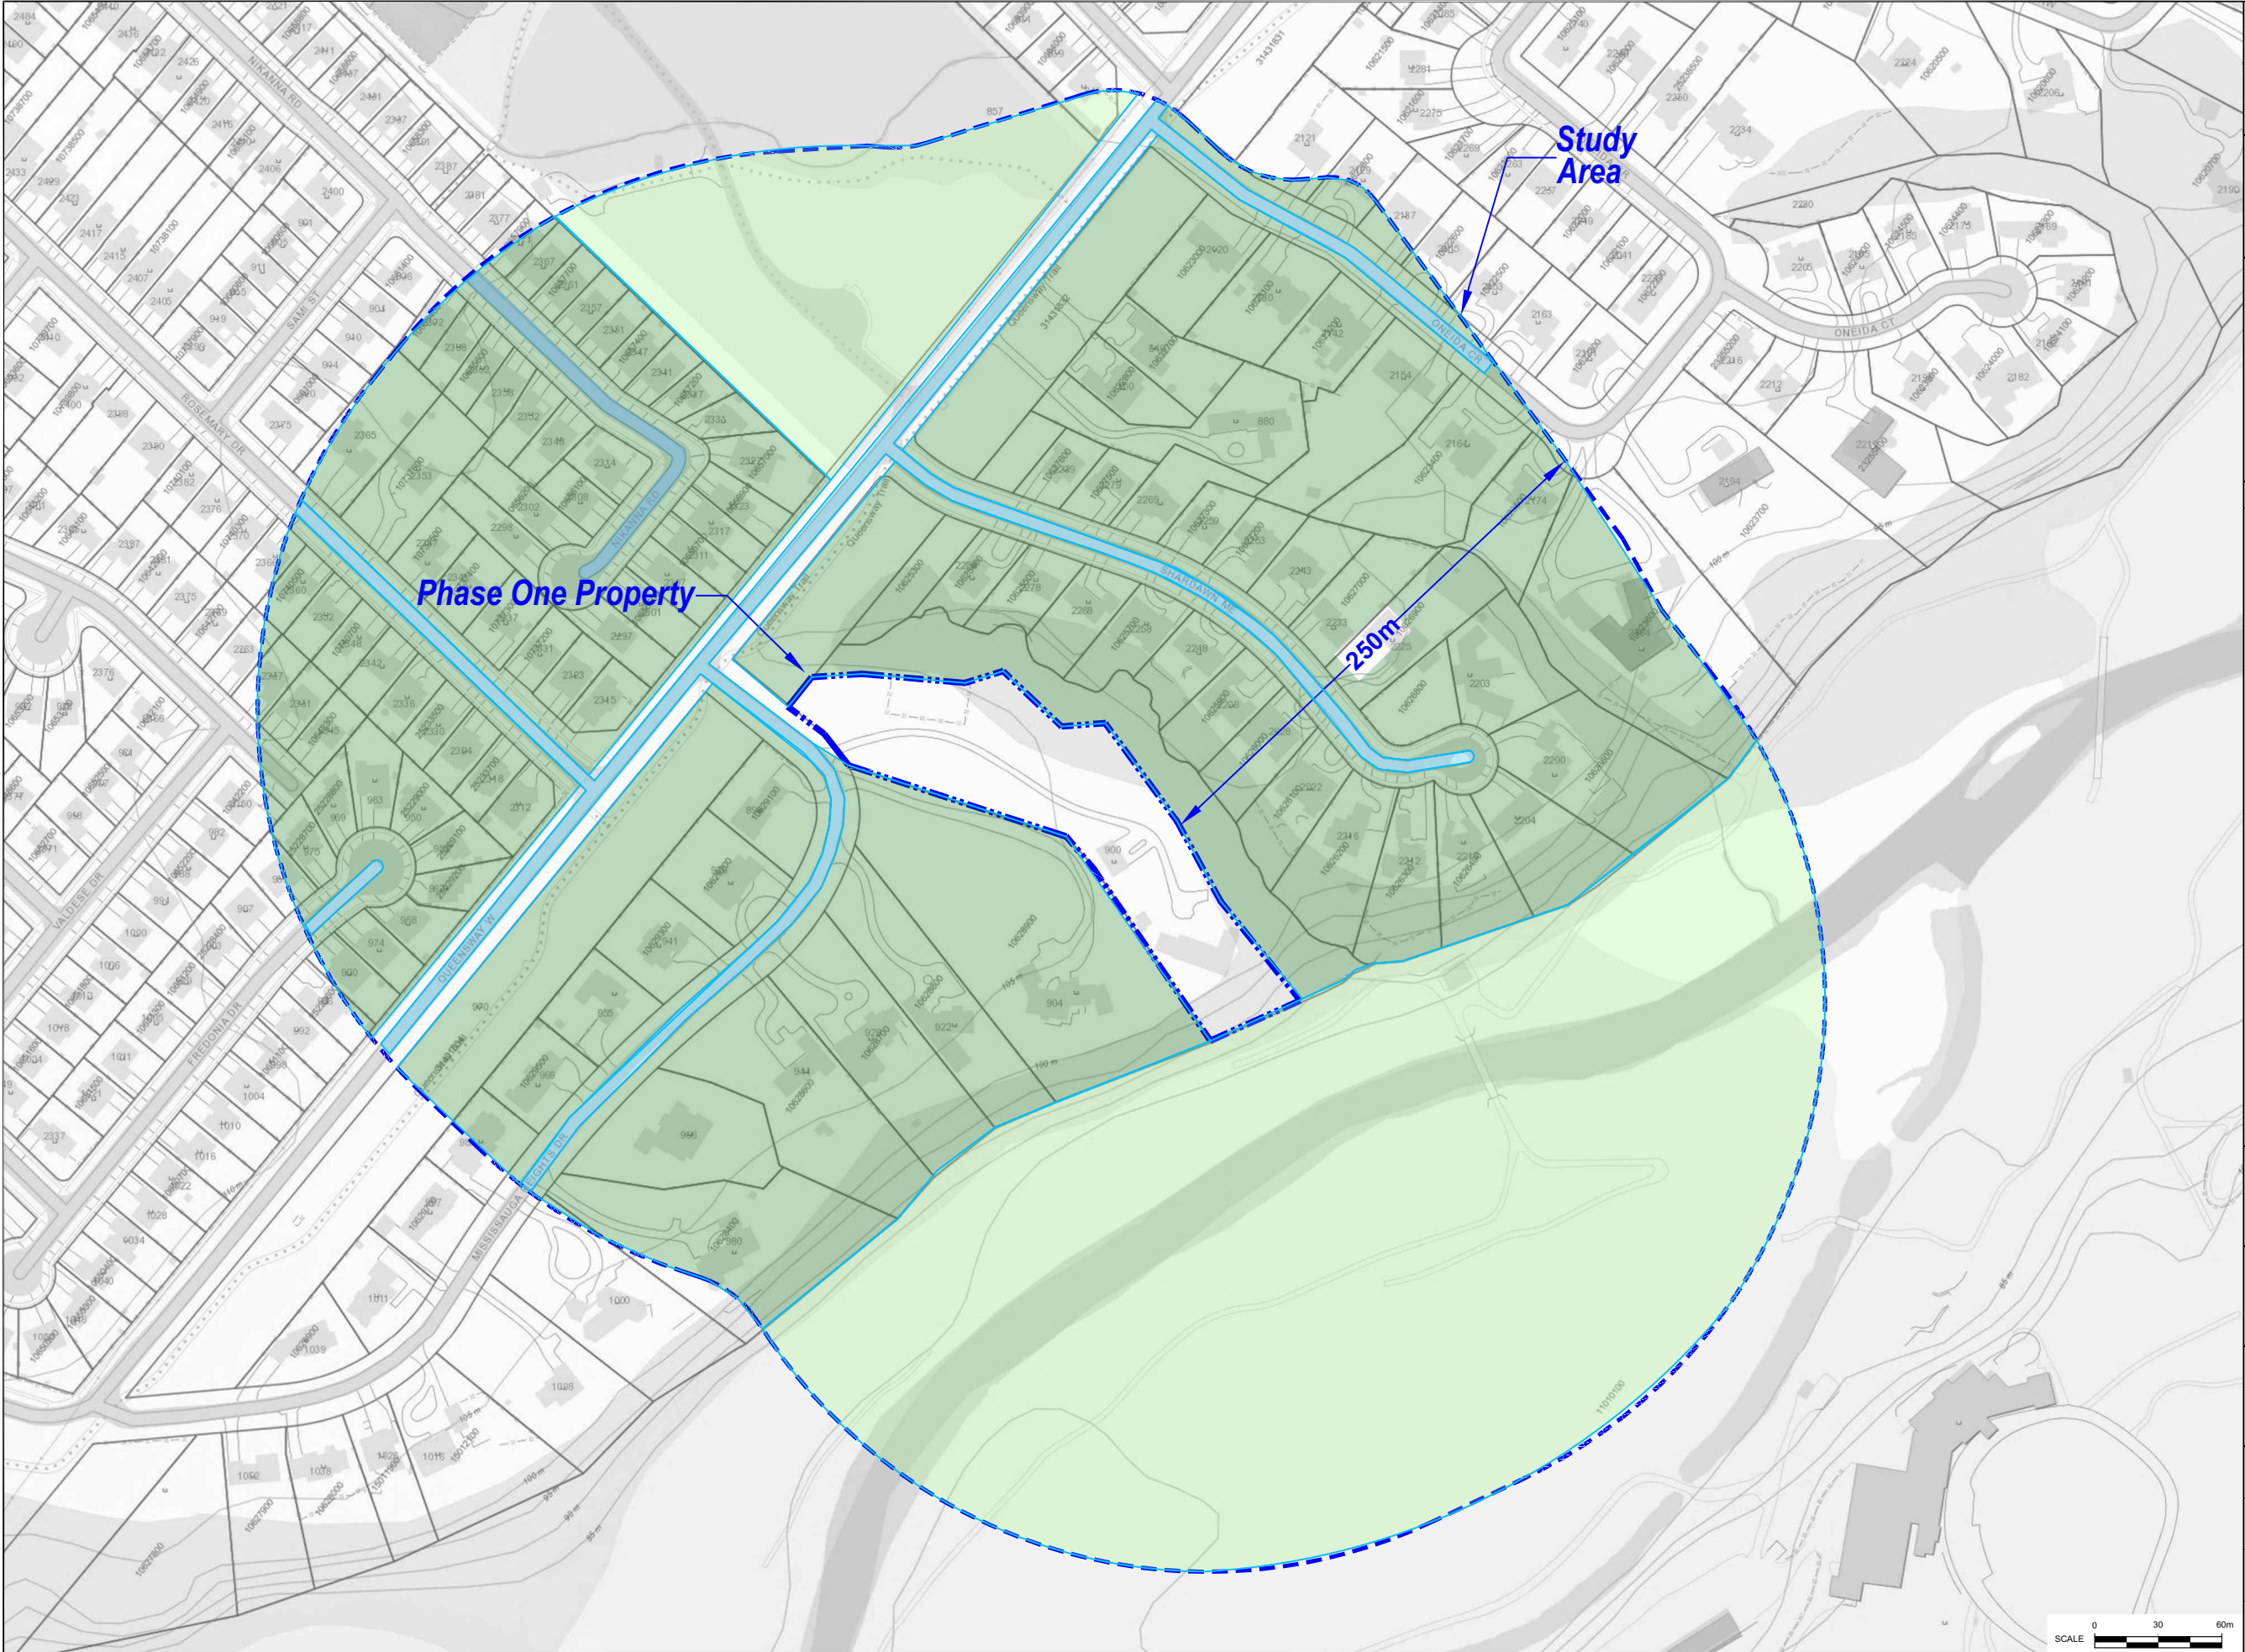
Designed By: TM	File No.: 1-18-0001-41
Drawn By: SSK	Scale: As Shown
Reviewed By: BW	Figure No.: 4
Date: February 2021

ADJACENT PROPERTY LAND USES

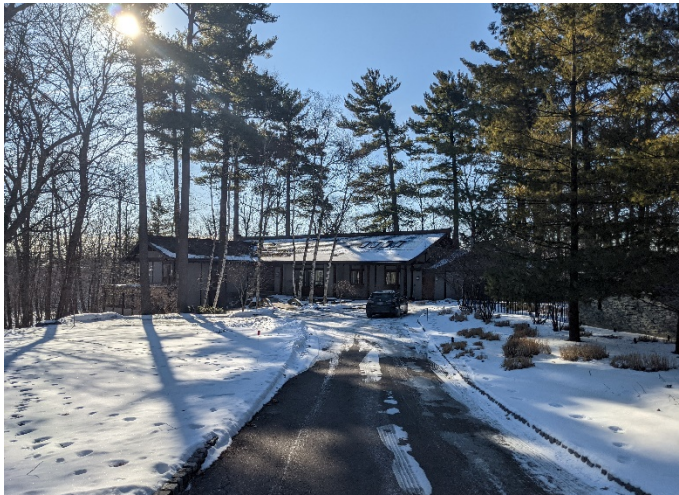
Photograph 1

Location: Phase One Property (900 Mississauga Heights Drive)
Viewing: Southwest
Description: Viewing the residential dwelling on the south portion of the Property

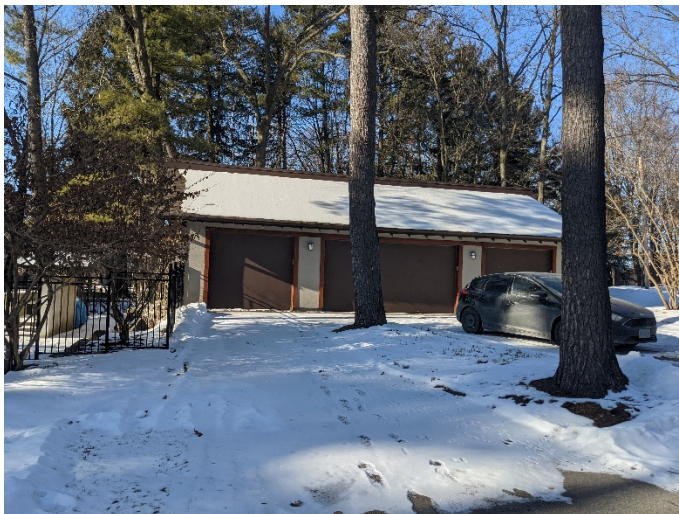
Photograph 2

Location: Phase One Property (900 Mississauga Heights Drive)
Viewing: West
Description: Viewing the Detached garage located in the centre of the Property

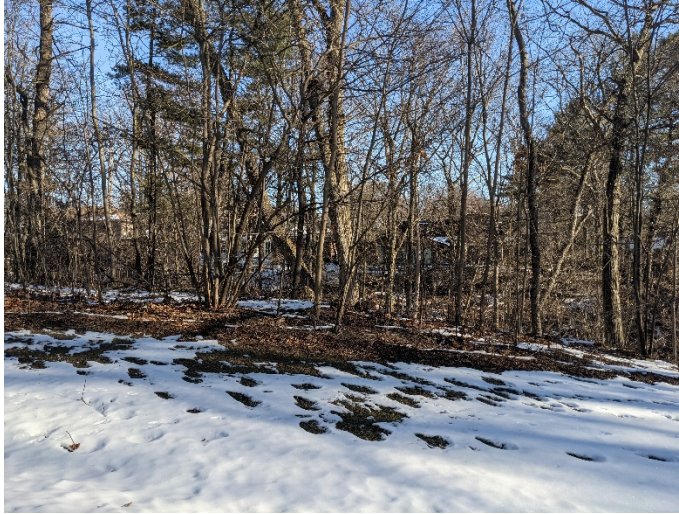
Photograph 3

Location: Phase One Property (900 Mississauga Heights Drive)
Viewing: South
Description: Viewing southern property boundary with Mississauga Golf and Country Club beyond.

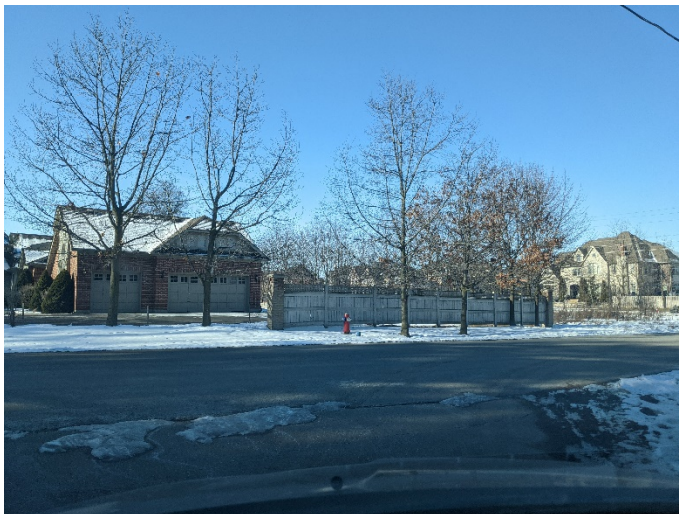
Photograph 4

Location: Phase One Property (900 Mississauga Heights Drive)
Viewing: East
Description: Viewing the eastern property boundary and residential dwellings beyond

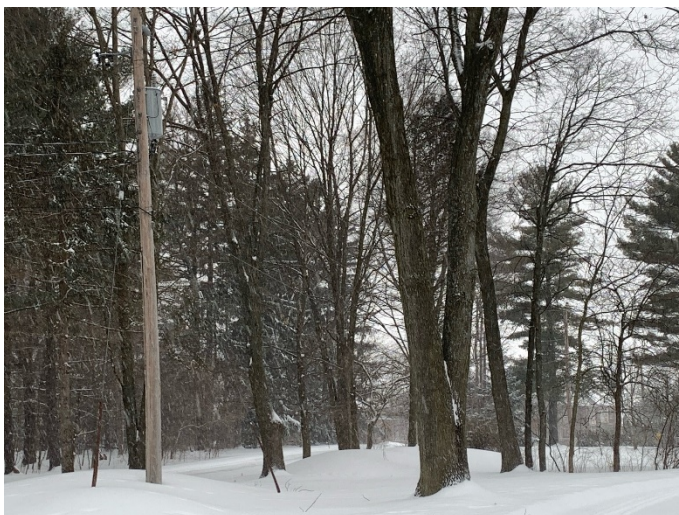
Photograph 6

Location: Phase One Property (900 Mississauga Heights Drive)
Viewing: Northwest
Description: Viewing the pole mounted transformer located on the centre of the Property.

Location of PCA	PCA	APEC (YES/NO)	Details
Phase One Property Central portion of the Property	#55 – Transformer Manufacturing, Processing and Use	Yes	Site Reconnaissance: A pole mounted transformer was identified on the Property. The PCA has the potential to cause an APEC on the Property.
Phase One Study Area Approximately 100 m south of the Property	#40 – Pesticides (including Herbicides, Fungicides and Anti-Fouling Agents) Manufacturing, Processing, Bulk Storage and Large-Scale Applications.	No	Aerials: 1954 to present there appears to be a golf course on the adjacent property to the south The PCA is downgradient of the Property.
Phase One Study Area Approximately 150 m north of Property	#40 – Pesticides (including Herbicides, Fungicides and Anti-Fouling Agents) Manufacturing, Processing, Bulk Storage and Large-Scale Applications.	No	Aerials: 1954 to 1966 there appears to agricultural land use on the properties to the north. The PCA is cross gradient of the Property.
