Phase I Environmental Site Assessment

128 Lakeshore Road East, Port Credit, Ontario

February 12, 2021 Pinchin File: 287305 FINAL

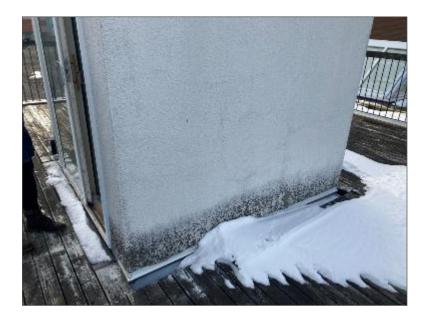
A comprehensive inspection for mould, which would require intrusive testing, was not performed as part of this Phase I ESA. Water-damaged wall finishing was observed in the roof stairway access of the Site Building. The Site Representative advised Pinchin that they were not aware of the source of the water staining. Water damage/staining observed on building materials (i.e., ceiling tiles) should be removed/replaced in accordance with industry standards and routinely monitored for changes. In addition, consideration should be given to investigating and repairing the source of the damage. Additionally, suspect mould growth was observed on the exterior stucco wall finishing adjacent to the rooftop patio access door.

Photo 12 – Suspect mould observed on rooftop patio.

The extent of the suspect mould growth and water damage within wall/ceiling cavities was not assessed as part of this Phase I ESA. In order to further assess the potential presence of mould, a mould survey would be required.

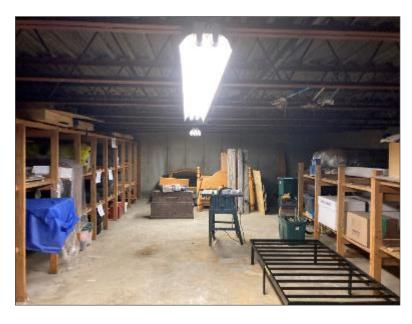
Photo 13 – Basement storage room.

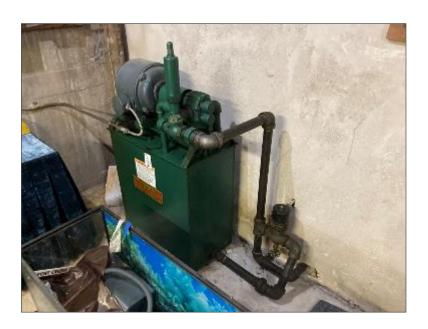
Hydraulic oil is stored within a steel reservoir located within the passenger elevator/mechanical room located adjacent to the passenger elevator and within a steel reservoir located adjacent to the freight elevator. Review of available maintenance logs and hydraulic oil loss records back to 2014 for the passenger elevator did not identify any significant oil losses from the system. No maintenance logs or hydraulic oil loss records were available for the out-of-use freight elevator. No staining was observed surrounding the steel reservoirs.

Based on the lack of staining surrounding the reservoir of the freight elevator and the fact that the elevator was reportedly decommissioned in 2014, it is Pinchin's opinion that this hydraulic freight elevator is unlikely to result in potential subsurface impacts at the Site.

However, given the year of construction of the original portion of the Site Building (i.e., approximately 1923), there is a potential that the hydraulic freight elevator observed on-Site may contain PCBs.

Photo 15 – Hydraulic reservoir for out-of-use freight elevator.

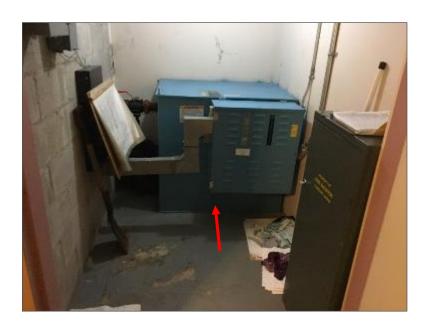
Photo 16 – Basement passenger elevator maintenance room, showing steel reservoir.

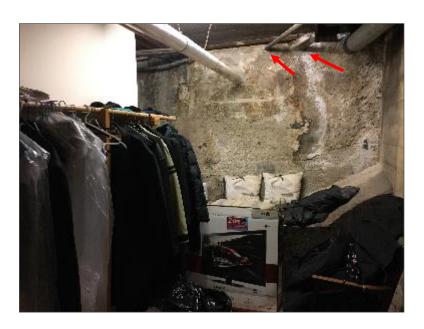
No aboveground storage tanks (ASTs) were observed on-Site, and none were reported by the Site Representative. However, cut-off vent and fill pipes were observed entering the basement along the northeast wall of the basement storage room adjacent to the furnace room. Additionally, a suspect vent pipe was observed on the exterior northeastern wall of the Site Building. The location of the exterior vent pipe correlates to the observed interior location of the vent and fill pipes. It is Pinchin's opinion that an AST was historically located in the basement of the Site Building. No staining was observed on the floor of the storage room or in the garden adjacent to the exterior pipe. It is Pinchin's opinion that this potential historical AST is unlikely to result in potential subsurface impacts at the Site.

Photo 17 – Storage room, showing suspect vent and fill pipes.

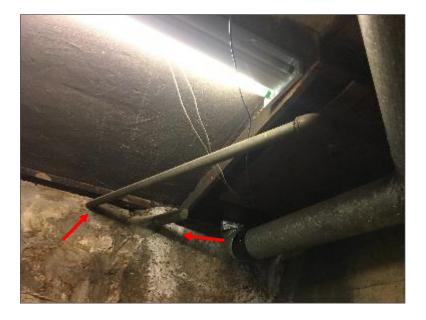
Photo 18 – Suspect vent and fill pipes in basement storage room.

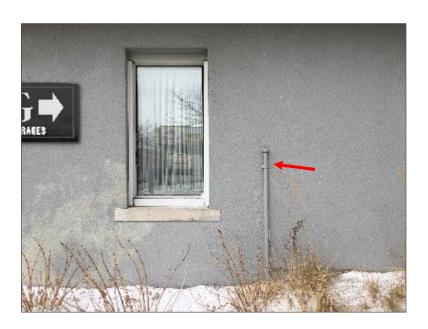
Photo 19 – Suspect vent pipe on Site Building northeast exterior wall.

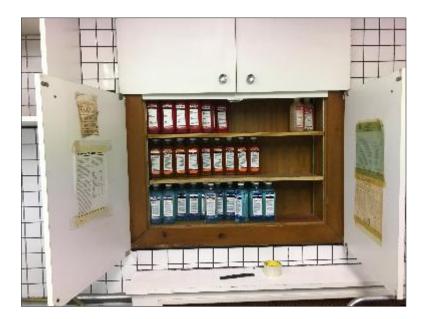
Topic	Findings
Chemicals	Chemicals typically used for general purpose cleaning and building maintenance (e.g., window cleaners, bleach, paints, deodorizers, etc.) were noted on-Site at the time of the Site reconnaissance. Chemicals observed on-Site were stored within manufacturer-supplied containers in various locations within the Site Building.
	Hydraulic oil stored in a steel reservoirs was observed in the passenger elevator maintenance room in the basement and adjacent to the out-of-use freight elevator in the basement.
	Metasyn Accelerated stored in 475-mL glass bottles (approximately 13) was observed on wooden shelves in the preparation room.
	Metaflow stored in 475-mL glass bottles (approximately 15) was observed on wooden shelves in the preparation room.
	Syncav stored in 475-mL glass bottles (approximately 26) was observed on wooden shelves in the preparation room.
	Two approximately 500-mL plastic bottles of Hexyethylphenoform were observed on wooden shelves in the preparation room.

No spills or evidence of historical spills (i.e., staining) were observed in the chemical storage areas noted above. The interior concrete floor slabs were observed to be in good condition (i.e., no cracking or pitting) and the chemicals appeared to be stored in an orderly fashion. No floor drains or catch basins were present in the vicinity of the chemical storage areas.

Photo 20 – Ground floor preparation room chemical storage.

Pinchin notes that the waste embalming fluid is considered a hazardous waste and should be properly disposed of as opposed to being poured down the drain.
