# 2935 & 2955 MISSISSAUGA ROAD

FUNCTIONAL SERVICING REPORT APRIL 28, 2021 PROJECT 20-697

PREPARED BY Greck and Associates Limited 5770 Highway 7, Unit 3 Woodbridge, ON L4L 1T8

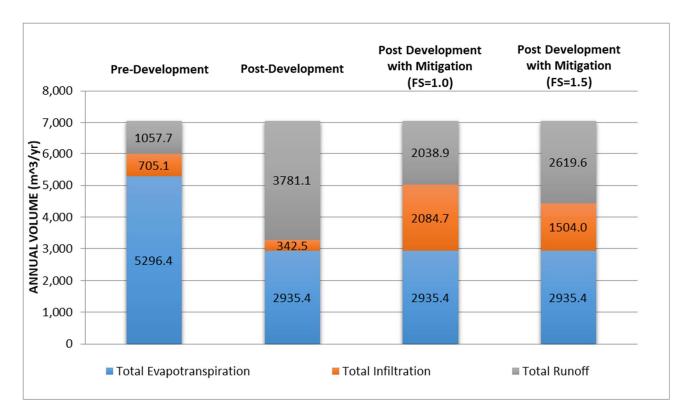
FIGURE 8.1: WATER BALANCE SUMMARY

Based on an annual impervious surplus factor of 726mm per year, the annual infiltration volume towards the infiltration chambers equates to 1742m³ per year with a total site-wide infiltration of 2085m³. However, a factor of safety of 1.5 was applied to the total infiltrated chamber volume, in the event that infiltration does not occur as efficiently, due to soil saturation, partially full chambers from previous rainfall events, or unexpected insitu soil conditions. This equates to an annual chamber infiltration volume of 1161m³ for a total site-wide infiltration of 1504m³, therefore exceeding pre-development conditions.

A summary of the infiltration volumes is provided in **Figure 8.1**.

As such, the application of the infiltration chambers achieves a net increase in overall infiltration, which meets CVC's criteria of maintaining pre-development infiltration levels. For water balance calculations, please see **Appendix G**.

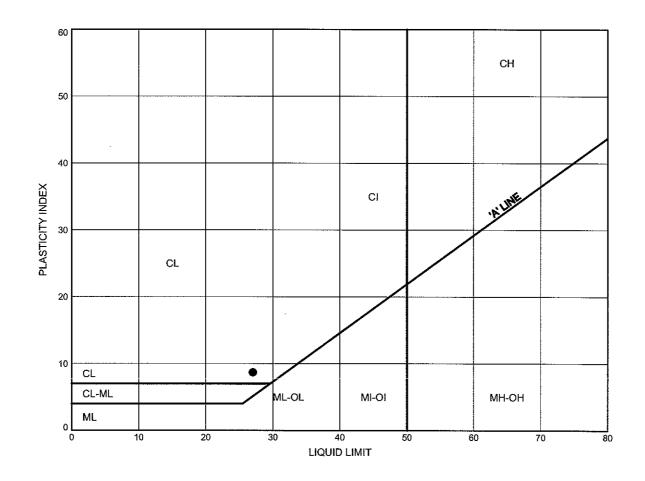
SYMBOL	BOREHOLE	DEPTH (m)	ELEVATION (m)
•	1603	0.9	97.2

Liguid Limit (WL) = 27.0
Plastic Limit (WP) = 18.3
Plasticity Index (IP) = 8.7
Natural Water Content (WN) = 16

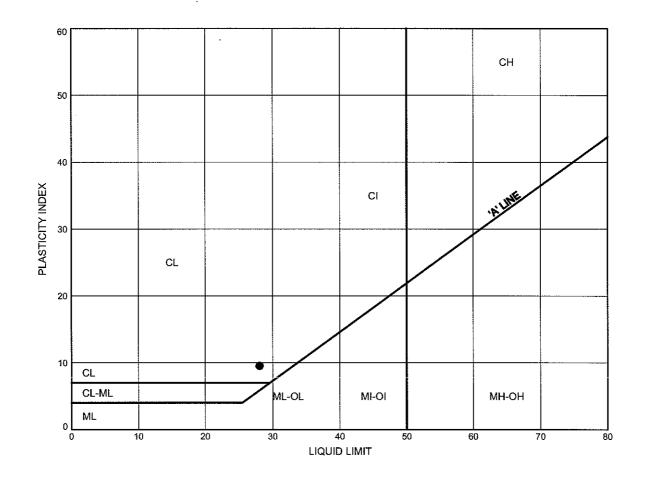
SYMBOL	BOREHOLE	DEPTH (m)	ELEVATION (m)
•	1605	0.9	97.2

Liguid Limit (WL) = 28.0
Plastic Limit (WP) = 18.5
Plasticity Index (IP) = 9.5
Natural Water Content (WN) = 16

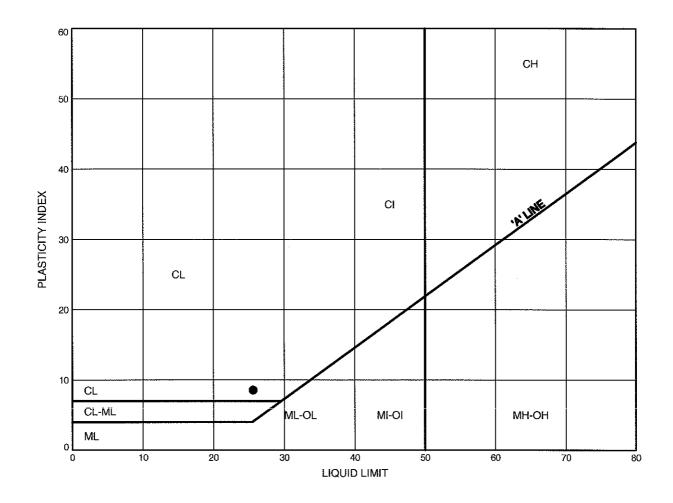
SYMBOL	BOREHOLE	DEPTH (m)	ELEVATION (m)
•	1607	0.9	97.1

Liguid Limit (WL) = 25.6Plastic Limit (WP) = 17.1Plasticity Index (IP) = 8.5Natural Water Content (WN) = 16

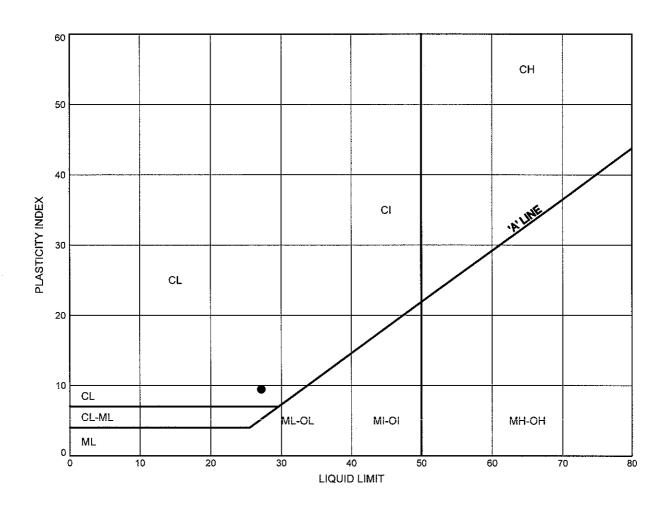
SYMBOL	BOREHOLE	DEPTH (m)	ELEVATION (m)
•	1611	0.3	97.8

Liguid Limit (WL) = 27.1 Plastic Limit (WP) = 17.7 Plasticity Index (IP) = 9.4 Natural Water Content (WN) = 13

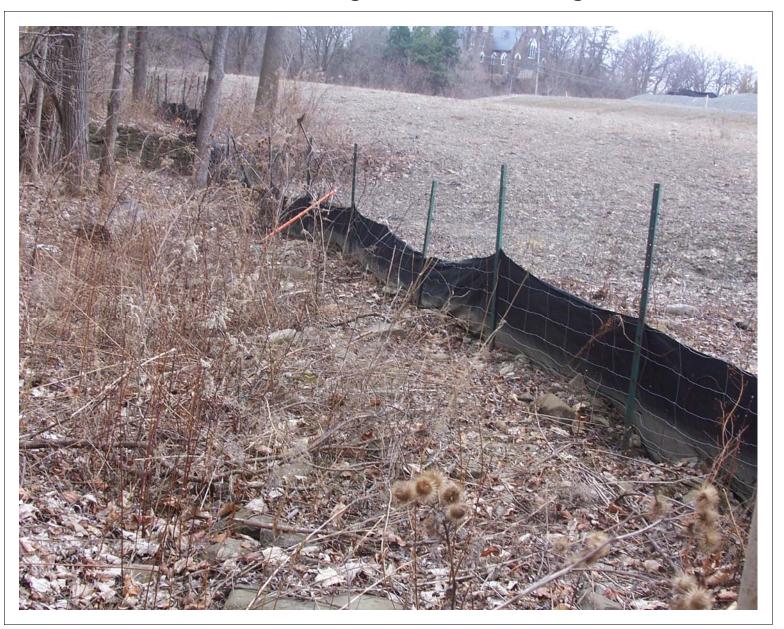
Photograph A: Looking from west side of the fence towards the site. Relatively 'recent' graded fill located on the east side of the fence.

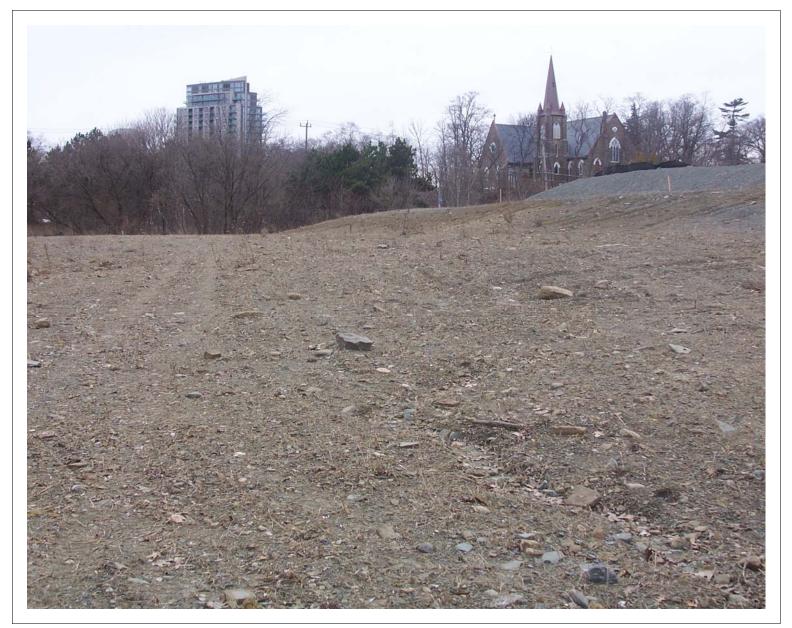
Photograph B: Another view (looking north) of the relatively 'recent' fill area, no significant vegetation cover / growth.

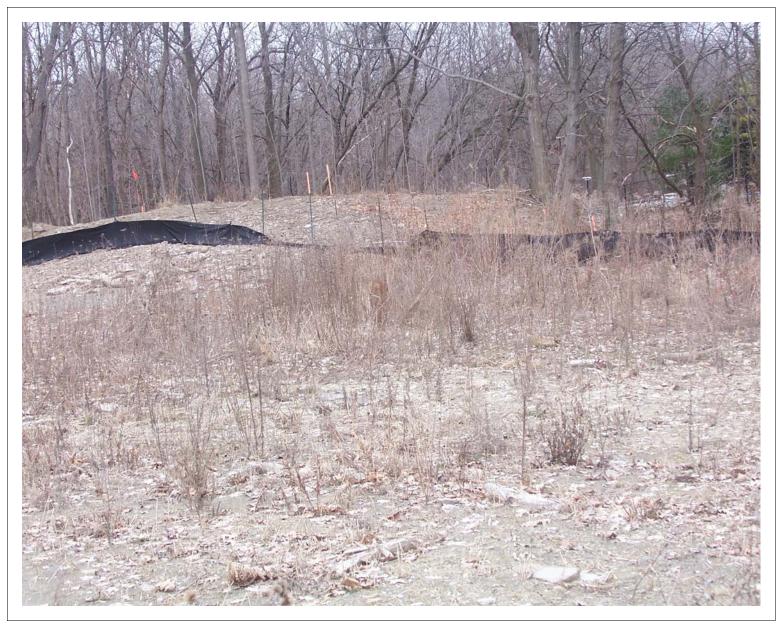
Photograph C: A view of southern portion of the site (inside the silt fence). This area includes patchy vegetation growth, and does not appear to include 'recent' fill.

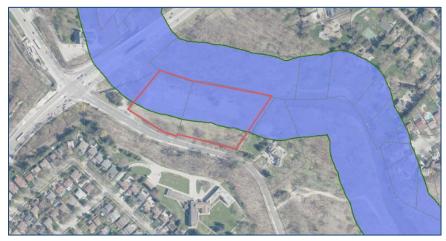
Map A. Greenbelt (dark green outline) with Urban River Valley (blue shading) (MNRF, 2020).

Section 3.2.6 (1.b.) states that municipalities, conservation authorities, other agencies and stakeholders should promote and undertake appropriate planning and design to ensure that external connections and Urban River Valley areas are maintained and/or enhanced. Section 3.3 is not applicable to this Project Site as it refers to parkland, open space, and trails.

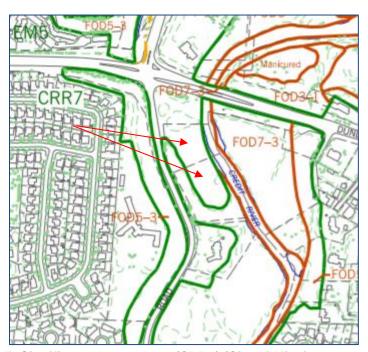
Map E. Significant Natural Area (CRR7) (City of Mississauga, 2017)

The Project Site does not include provincially designated features such as significant woodland, wetlands, Area of Natural and Scientific Interest (ANSIs) or Environmentally Significant/Sensitive Areas (ESAs). The natural area located adjacent to the site is identified as a Significant Natural Area (CRR7) as part of the NAS (City of Mississauga, 2017) (**Map E**) and partly within the Greenbelt's Urban River Valley.

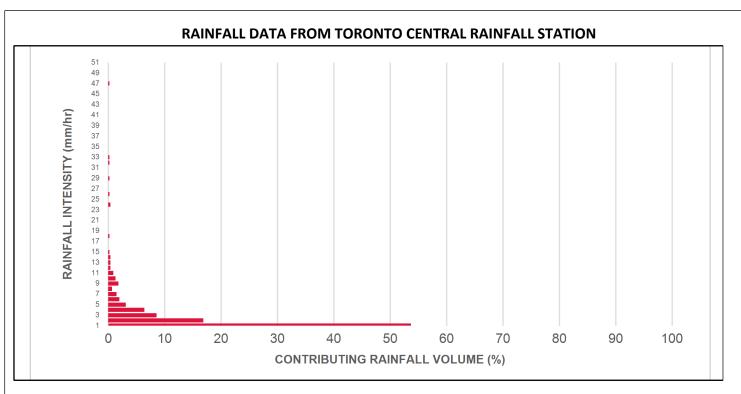
## STORMCEPTOR® ESTIMATED NET ANNUAL SEDIMENT (TSS) LOAD REDUCTION

43	0.0	99.7	10.76	646.0	538.0	47	0.0	68.9
44	0.0	99.7	11.01	661.0	550.0	47	0.0	68.9
45	0.0	99.7	11.26	676.0	563.0	46	0.0	68.9
46	0.0	99.7	11.51	691.0	575.0	46	0.0	68.9
47	0.2	99.9	11.76	706.0	588.0	46	0.1	69.0
48	0.0	99.9	12.01	721.0	600.0	46	0.0	69.0
49	0.0	99.9	12.26	736.0	613.0	46	0.0	69.0
50	0.0	99.9	12.51	751.0	626.0	46	0.0	69.0
				Estimated Net A	Annual Sedim	ent (TSS) Loa	d Reduction =	69 %

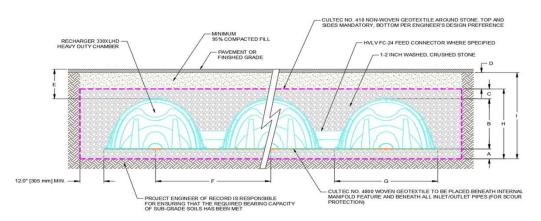
## **LOG OF BOREHOLE 1612**

8 units of the CULTEC Recharger 330XLHD chambers (or approved equivalent) occupying an area of 32.7m<sup>2</sup>, is proposed on the southwest corner of the development, which provides 19.5m<sup>3</sup> of subsurface storage. Erosion control and infiltration chamber sizing calculations are provided in **Appendix G**.
