PHASE ONE ENVIRONMENTAL SITE ASSESSMENT

Portion of 30 Queen Street East
Mississauga, Ontario

AUGUST 2020

128-P-0015492-0-01-222-SG-R-0001-00

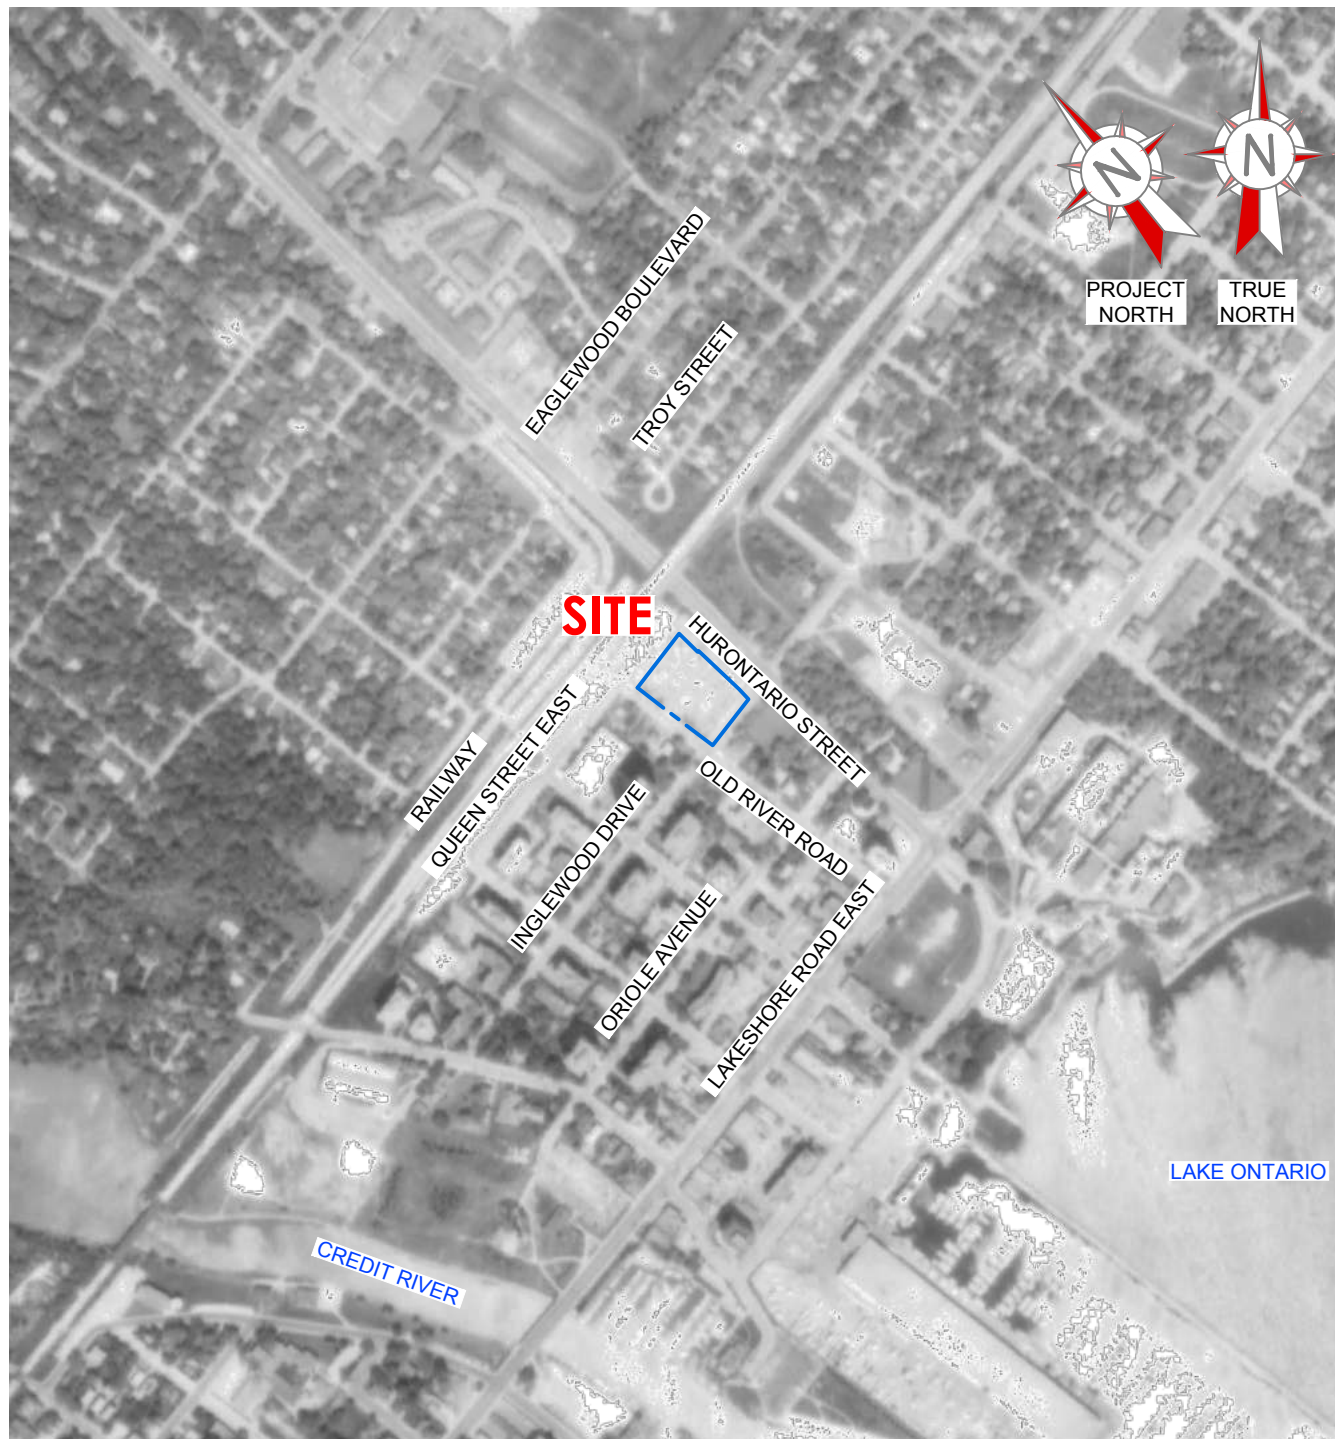
1-REFERENCES : 1980 Aerial Photograph, Reference No.A25451-117.

9	1980	1:7,500	The Site appears to be vacant, with the previously observed buildings structures removed. In general, the surrounding properties generally appear similar to the 1974 aerial photograph.
10	1989	1:7,500	The Site and surrounding properties generally appear similar to the 1989 aerial photograph.
11	2005	1:7,500	The Site and surrounding properties generally appear similar to the 1989 aerial photograph.
12	2015	1:7,500	The Site appears to be developed as parking lot. The Site is bordered to the north and east by a parking lot and railway line or roadway, respectively. The Site is bounded to the south by a roadway and vacant land located beyond. The Site is bordered to the west by a roadway and building structures located beyond.
Not proprietary	2019	Variable	The Site and surrounding properties generally appear similar to the 2015 aerial photograph.

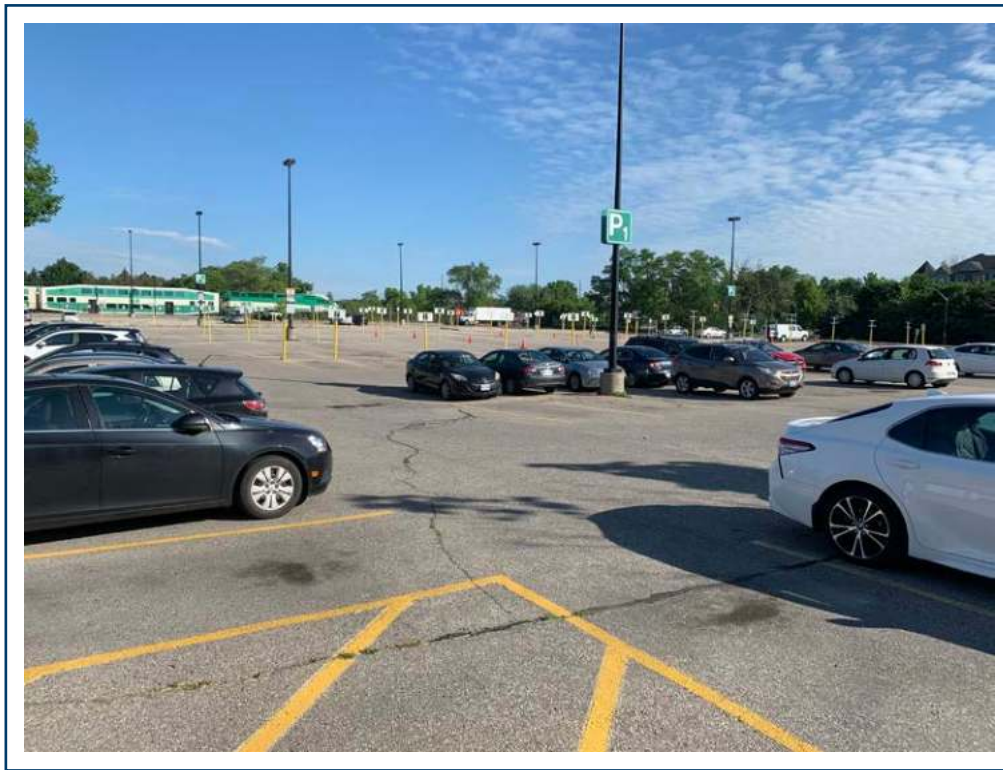
PHOTOGRAPH 1 — View of the Site, facing northeast.

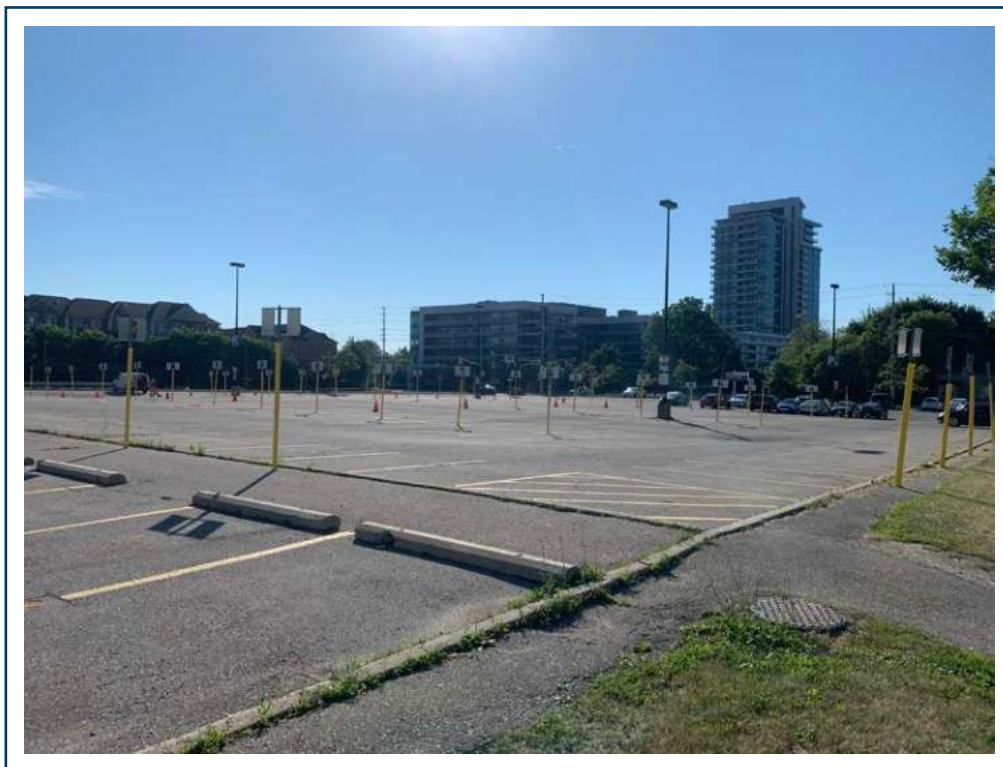
PHOTOGRAPH 2 — View of the Site, facing southeast.

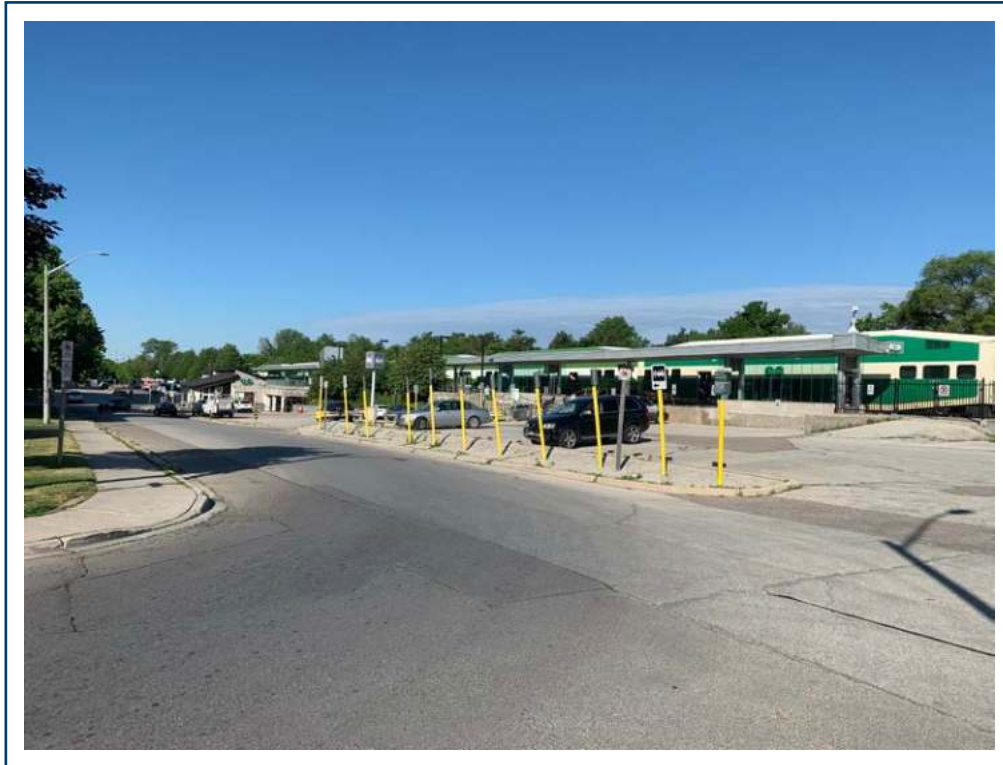
PHOTOGRAPH 3 — View of the GO Station, rail line and additional parking from the northwest corner of the Site, facing northwest.

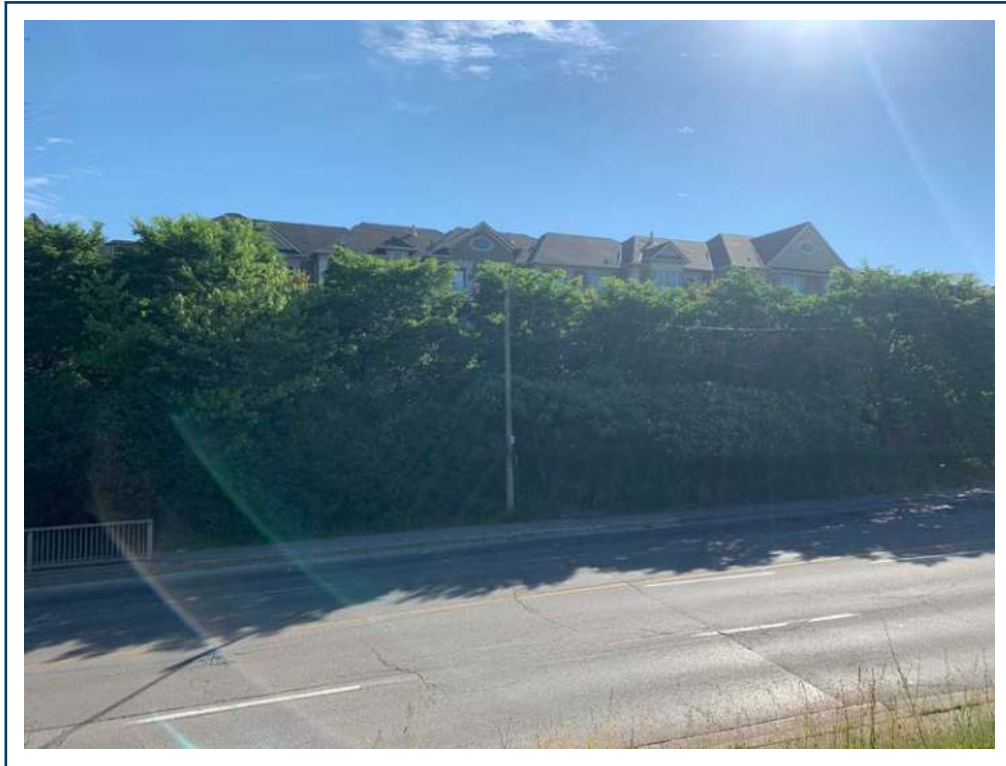
PHOTOGRAPH 5 — Residential townhouses and landscaped areas located to the east in the former area of the railway spur and coal storage, facing east. Note Hurontario Street is at much lower elevation than Site due to underpass of rail line.
