Natural Heritage Report

Southdown District Stormwater Servicing and Environmental Management Plan

Natural Environmental Conditions Report

PECG Project #
131129

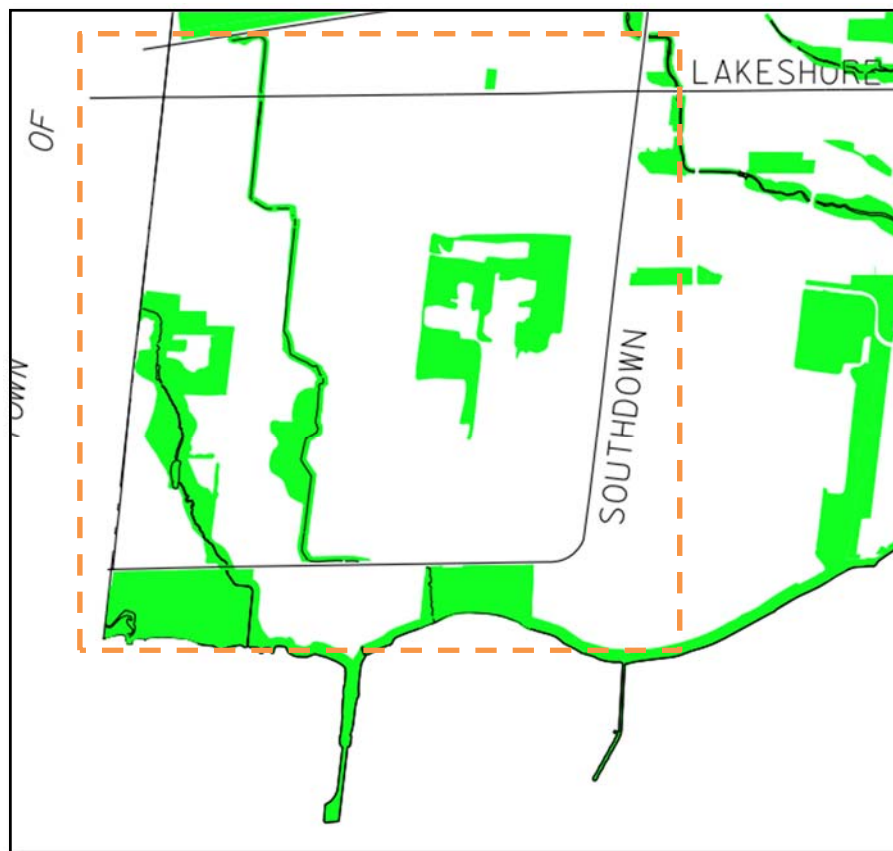
Map B. City of Mississauga Official Plan – Schedule 1A

Section 6, Value the Environment, of the OP provides the environmental policies for the City. Areas designated as part of the Urban System – Green System are depicted on OP Schedule 1a and are depicted for the project study area on **Map B**.

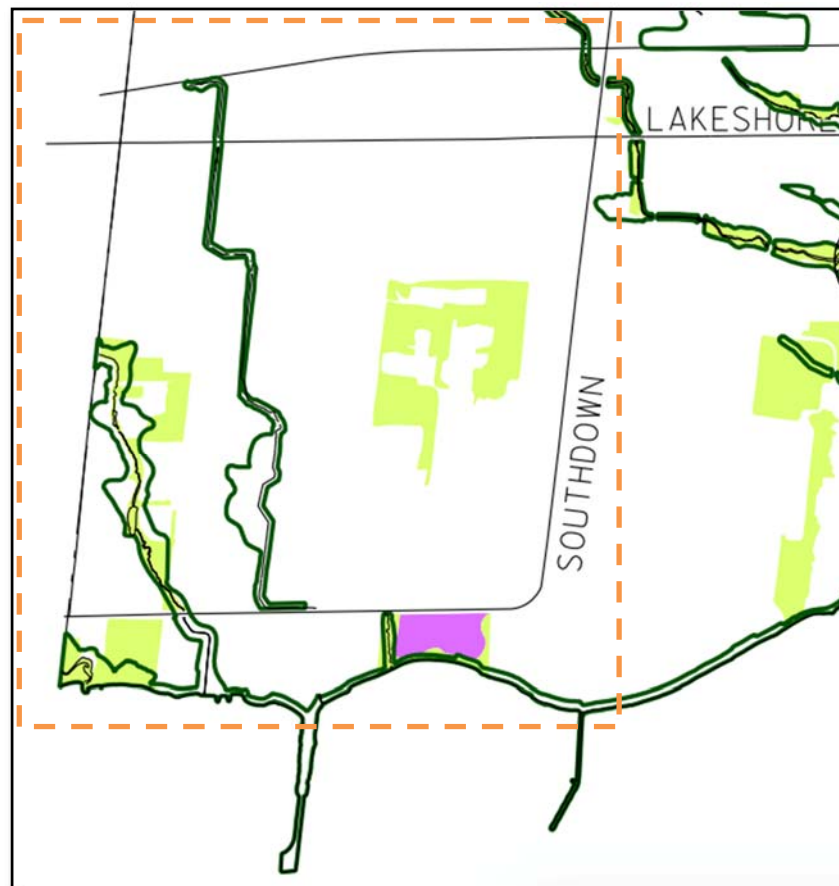
Map C. City of Mississauga OP Schedule 3 – Natural System

As mapped on OP Schedule 3, designated Significant Natural Areas [shown in light green on **Map C** below] occur within the study area. Natural Hazards are shown on **Map C** below in dark green and are associated with shoreline areas, Arrowhead and Clearview Creeks. The City's OP states that Natural Hazard lands are generally unsafe and development and site alteration will generally not be permitted due to the naturally occurring processes of erosion and flooding associated with river and stream corridors and the Lake Ontario Shoreline. A designated Special Management Area is shown in purple on **Map C** below. Special

Management Areas are defined in the OP (Section 6.3.15) as lands adjacent to or near Significant Natural Area or Natural Green Space and will be managed or restored to enhance and support the Significant Natural Area or Natural Green Space.

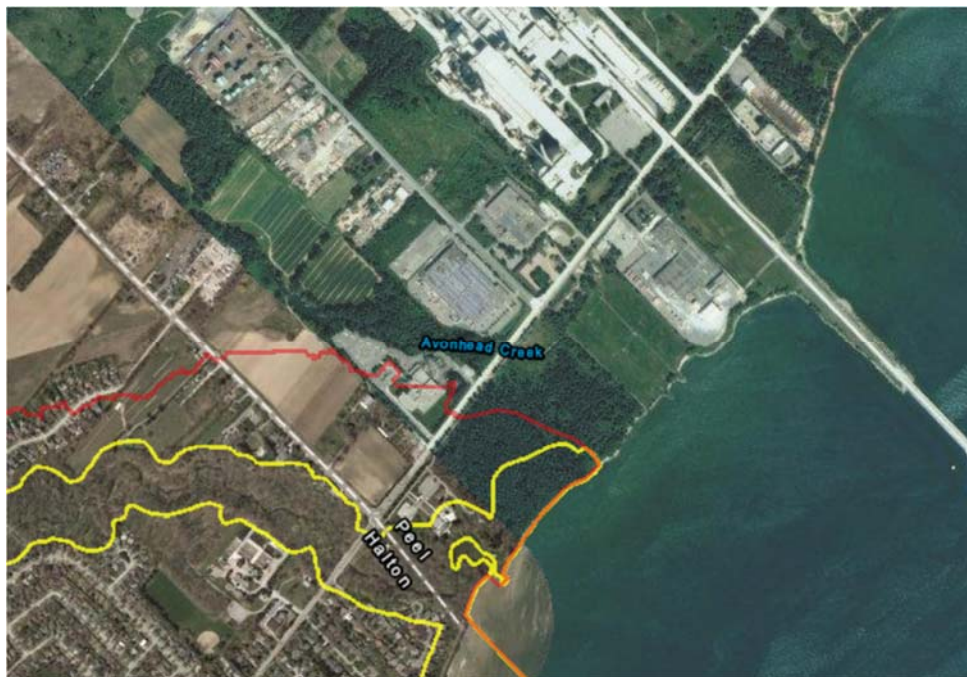
Map D. Conservation Halton – Regulated Area (shown in yellow)

The study area contains lands within the CH Regulated Area, associated with Joshua Creek and the Lake Ontario Shoreline, therefore there is a requirement for a permit under Ont. Regulation 162/06 for development within these areas. **Map D** below shows CH's Regulated Area with the Subject Area.

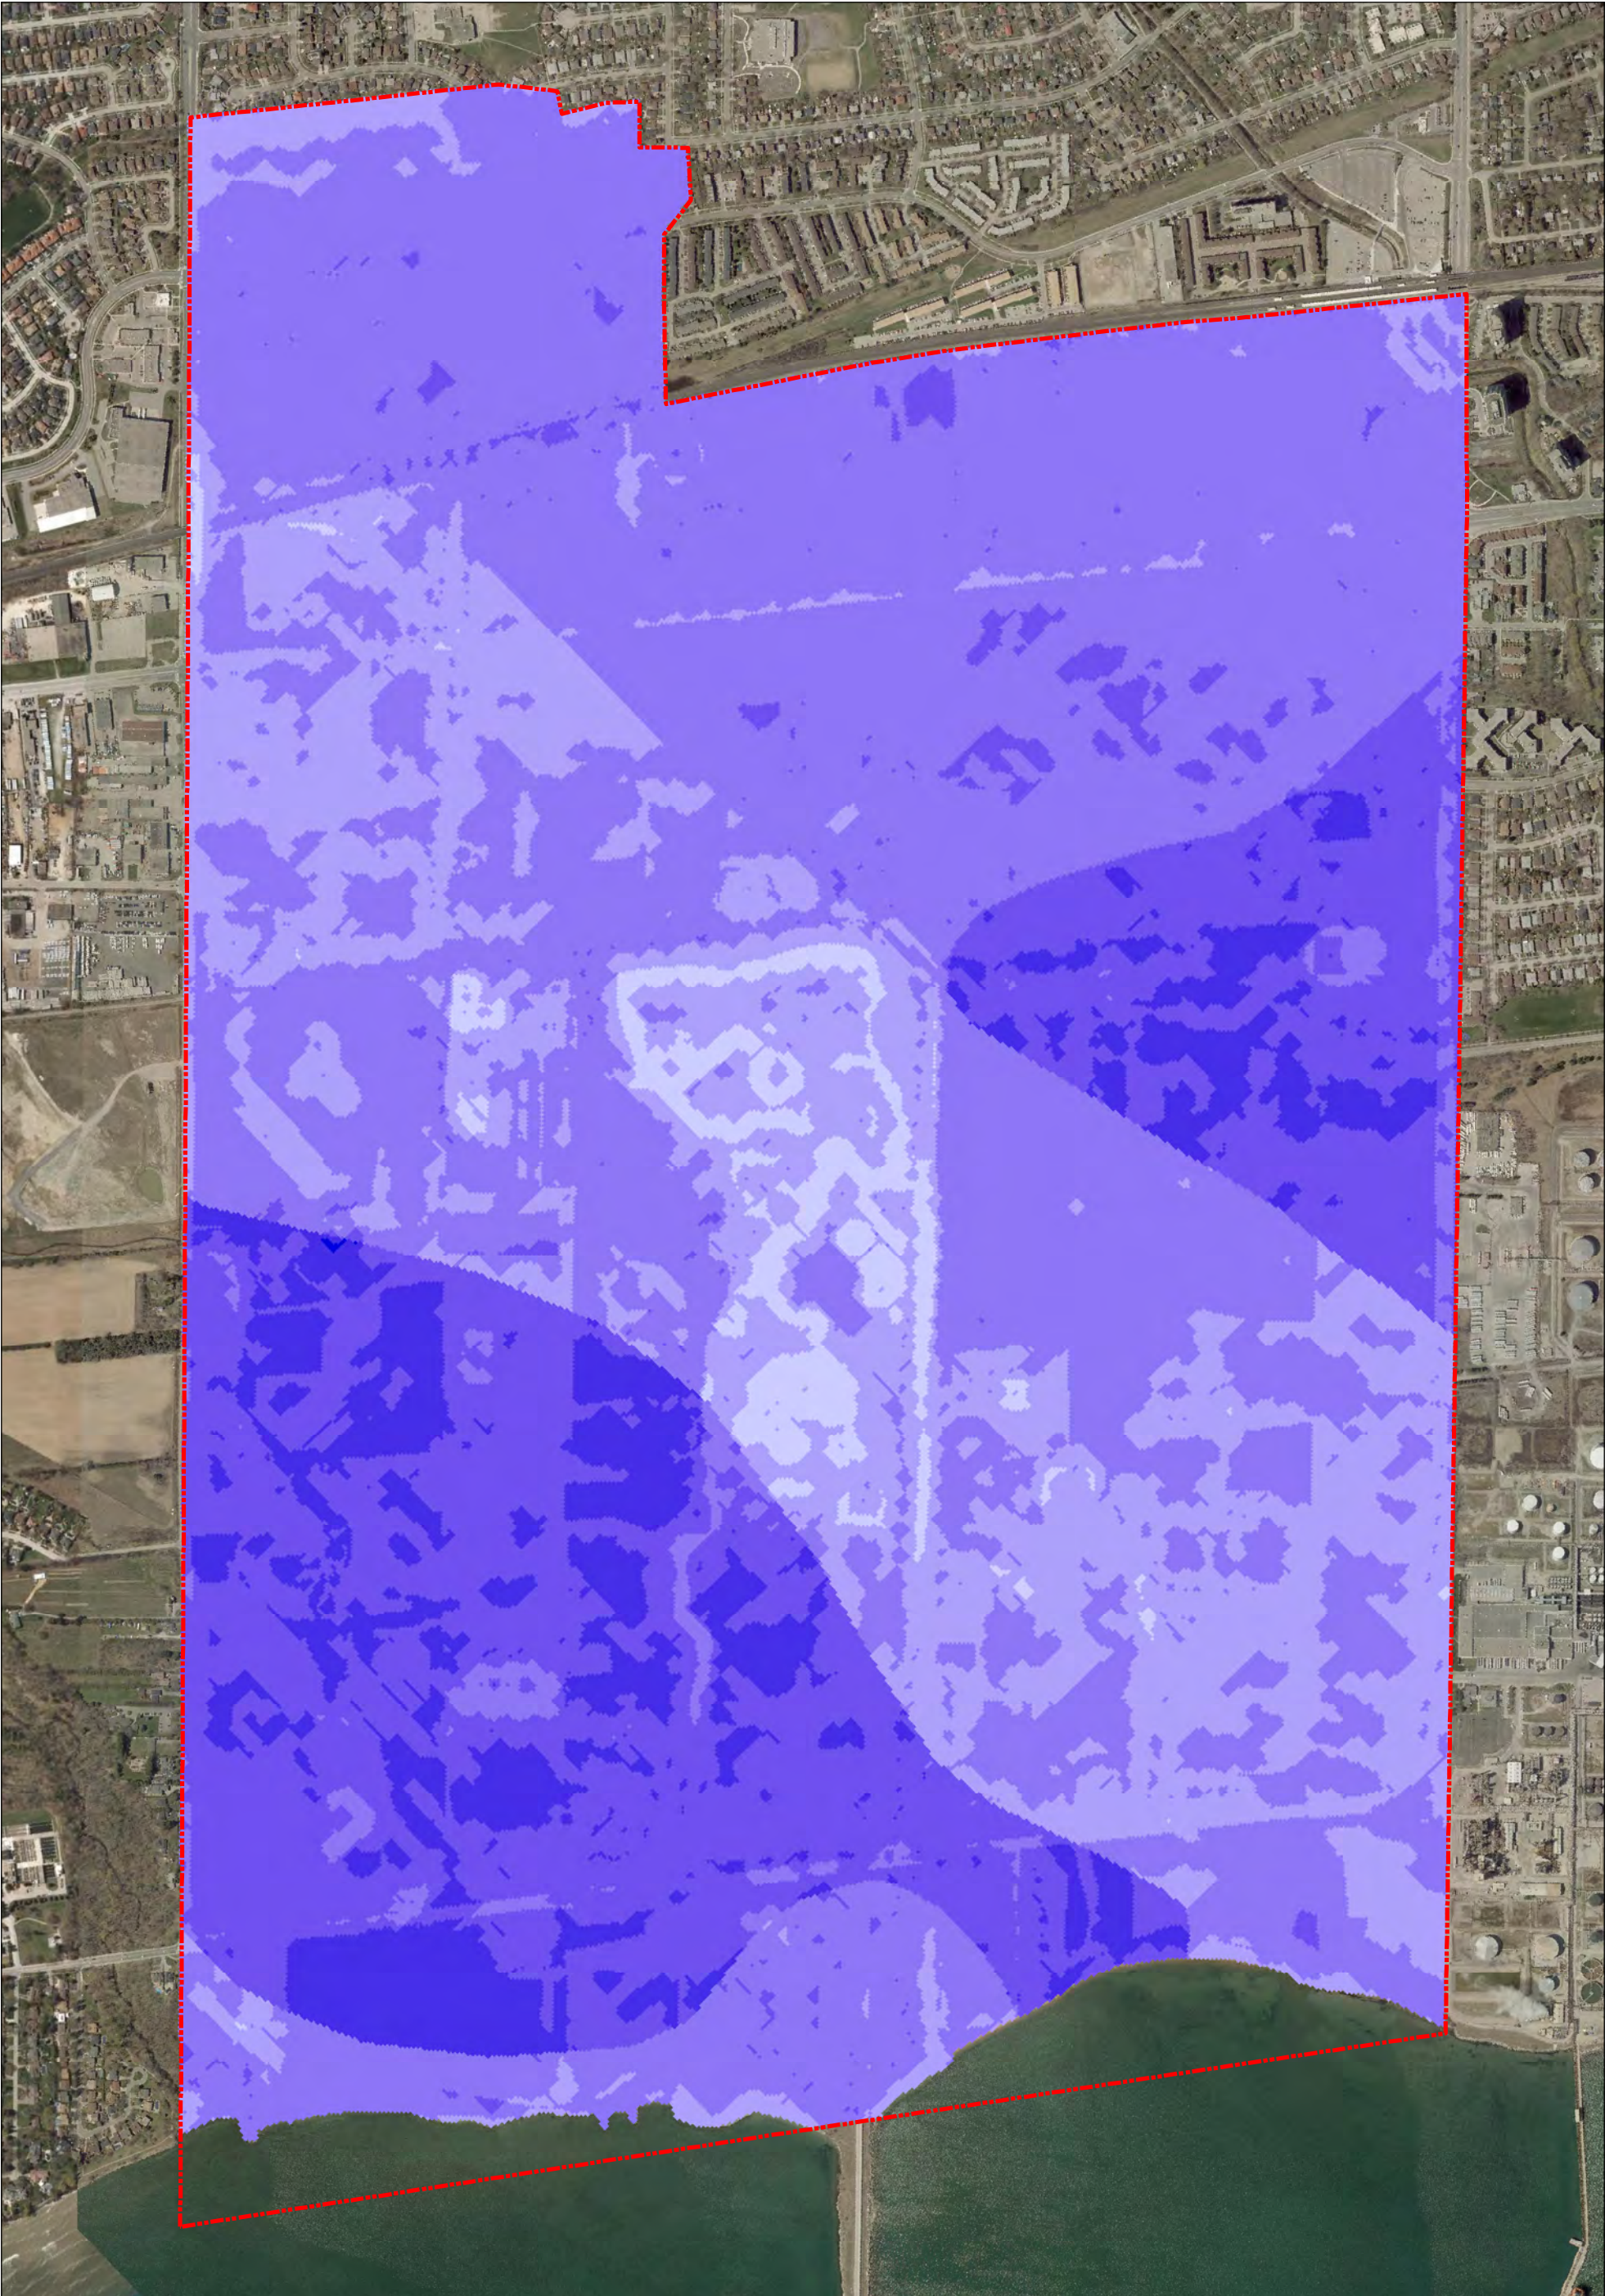
TITLE:
Potential Infiltration

Potential Infiltration (mm/yr)

The average annual water surplus was then partitioned using infiltration factors (MOEE, 1995). This approach takes into consideration three factors: topography/slope, soil type, and land cover. Water will infiltrate more easily through sands compared to clays, on flat slopes compared to steep slopes, and through naturally vegetated soils compared to agricultural crops or urban areas. The method developed by Bernard (1932) and described by the MOEE (1995) was used to determine the infiltration factors across the property, based on the topography, vegetation, and surficial geology.

Based on the results of the water balance most of the infiltration is expected in the areas associated with coarse grained glaciolacustrine deposits. It is recommended that Low Impact Development (LID) strategies should be implemented in these regions of the site where infiltration is expected to be high, and which are also outside of the HVA region indicated in **Appendix A**. Consideration should be given to maintaining the pre-to-post water balance of the natural areas present within the site boundary (**Figure 5**). Potentially effective LID measures include infiltration trenches, redirection of roof runoff, and/or permeable pavement. Other factors, such as the depth to the water table, should also be considered when selecting appropriate LID mitigation measures for the site.

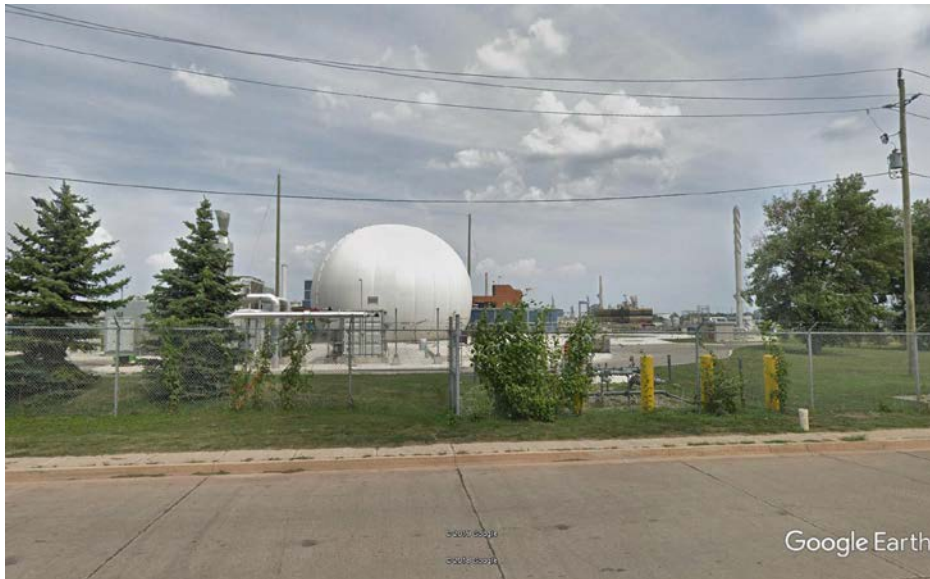
Image 3: View of disturbances associated with paved roadways, extant structures, and underground utilities.

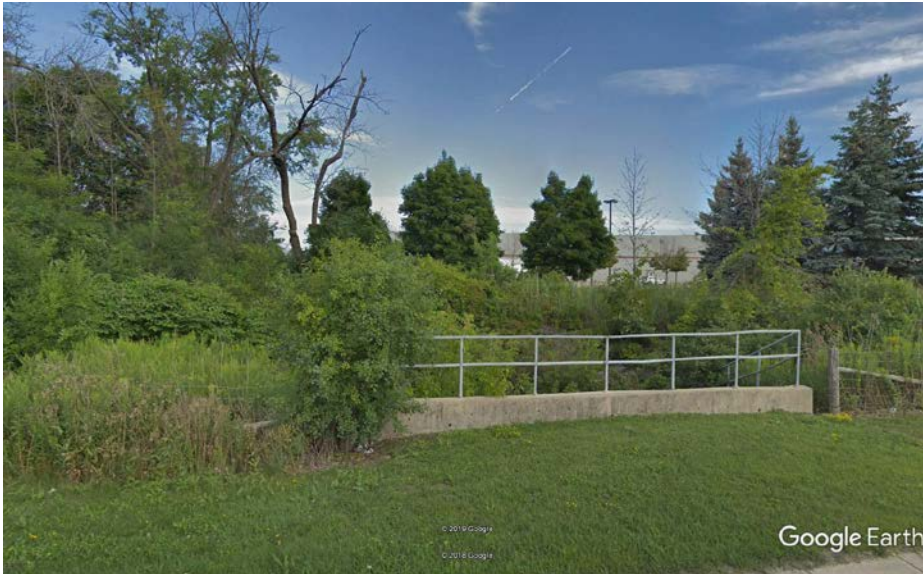
Image 9: View of disturbances associated with a culvert and the permanently wet area associated with Clearview Creek.

Physiographic features of no or low archaeological potential encountered within the study area include permanently wet areas consisting of drainage ditches, Avonhead Creek, Clearview Creek, Lakeside Creek, and Lake Ontario (*see Maps 9-10; Image 9*). On-site confirmation and

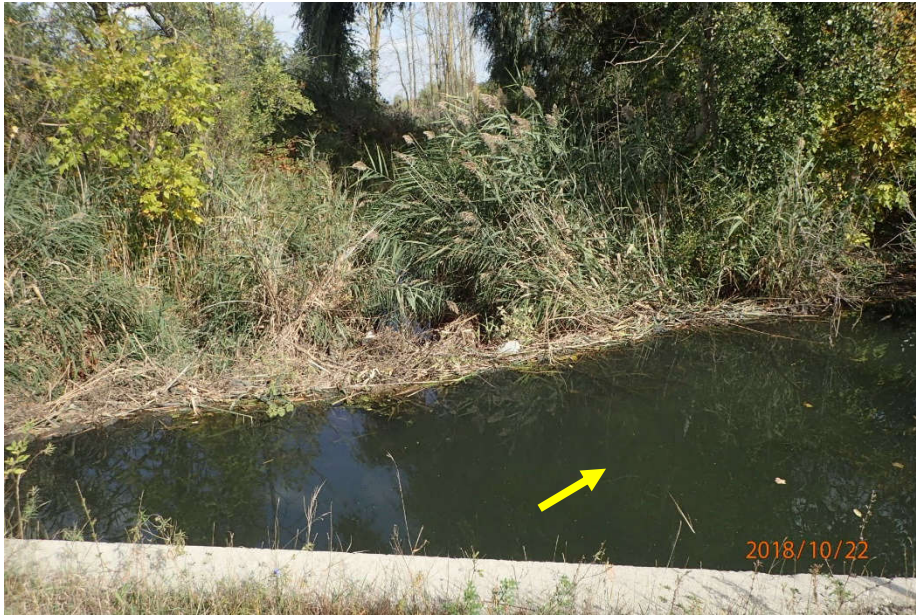
Photo 1

Reach CC-4 – Clearview Creek, from Winston Churchill to the online agricultural pond.

The culvert at Winston Churchill Boulevard conveying flows from Clearview Creek was near capacity due to a beaver dam located immediately downstream of the structure.

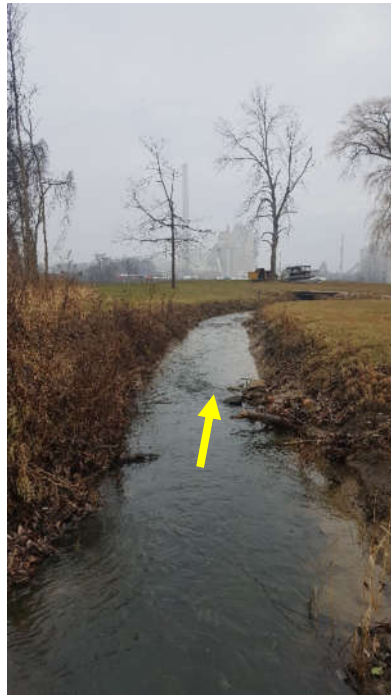
Photo 2

Reach CC-4 – Clearview Creek, from Winston Churchill to the online agricultural pond.

The channel showed evidence of having been modified within the reach, including this segment near 555 Winston Churchill Boulevard where the creek was straightened.

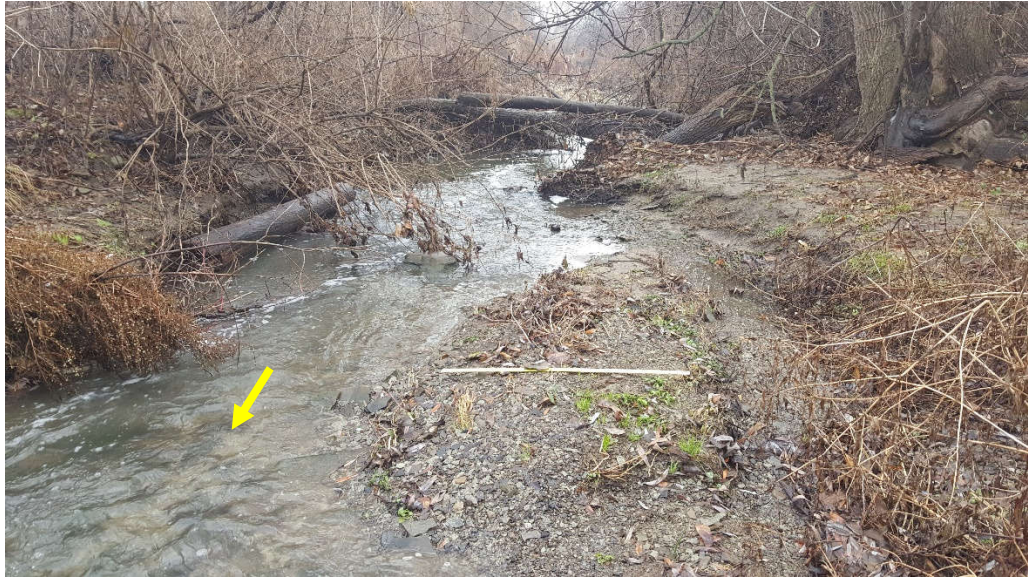
Reach CC-4 – Clearview Creek, from Winston Churchill to the online agricultural pond.

Within a small wooded area upstream of the online agricultural pond, evidence of aggradation, including the deposition of material in the overbank zone, was observed.

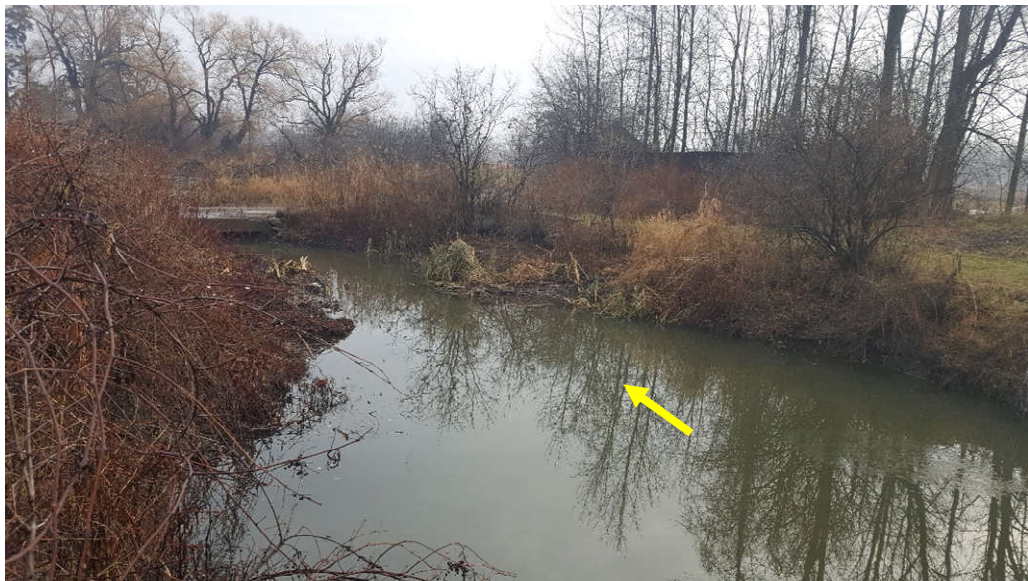
Photo 4

Reach CC-5 – Clearview Creek, agricultural pond between Winston Churchill Boulevard and Lakeshore Road

An undersized culvert was impeding flows directly upstream of the agricultural pond, functionally changing this segment of channel as it acted as a depositional environment with poor hydraulic efficiency.

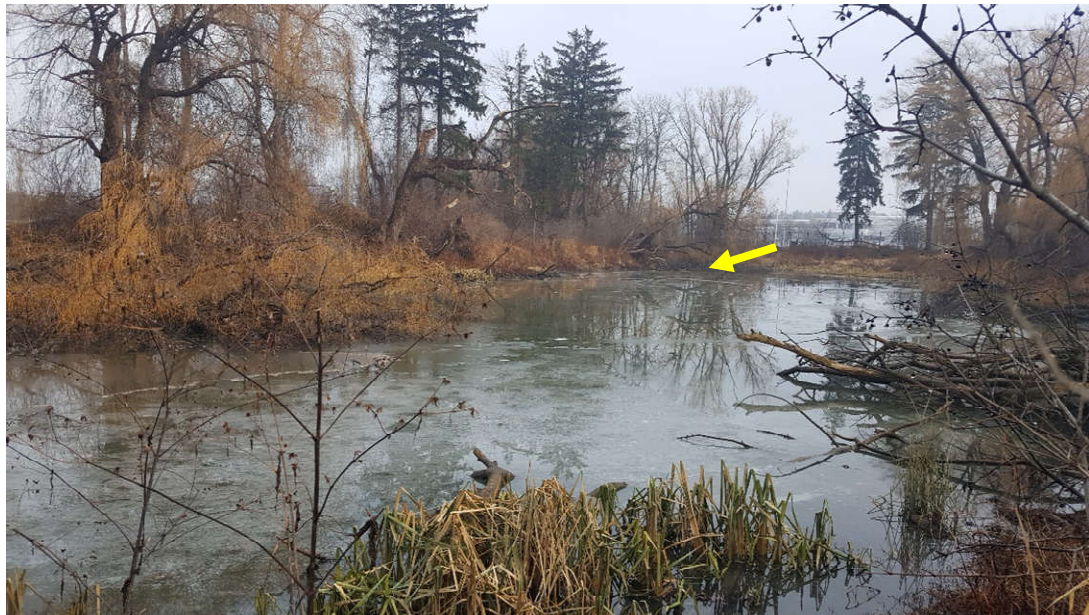
Reach CC-5 – Clearview Creek, agricultural pond between Winston Churchill Boulevard and Lakeshore Drive

The agricultural pond was surrounded by a narrow wooded riparian buffer, and a significant accumulation of sediment was observed within the feature.

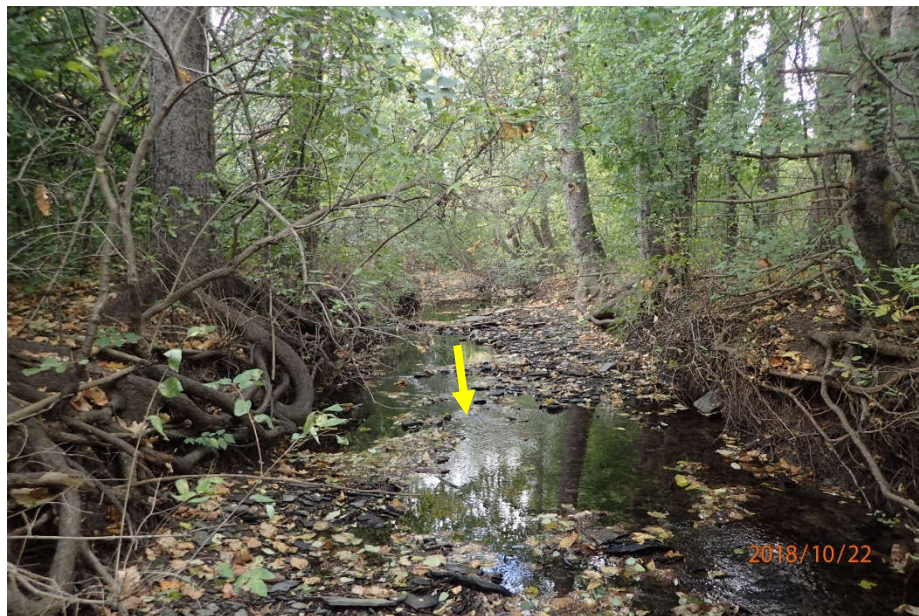
Reach CC-6: Clearview Creek, from the online Agricultural Pond to 40 m upstream of Lakeshore Road

Riffle-pool morphology was observed within Reach CC-6, with roughly 30% of the channel composed of riffles and 10% pools.

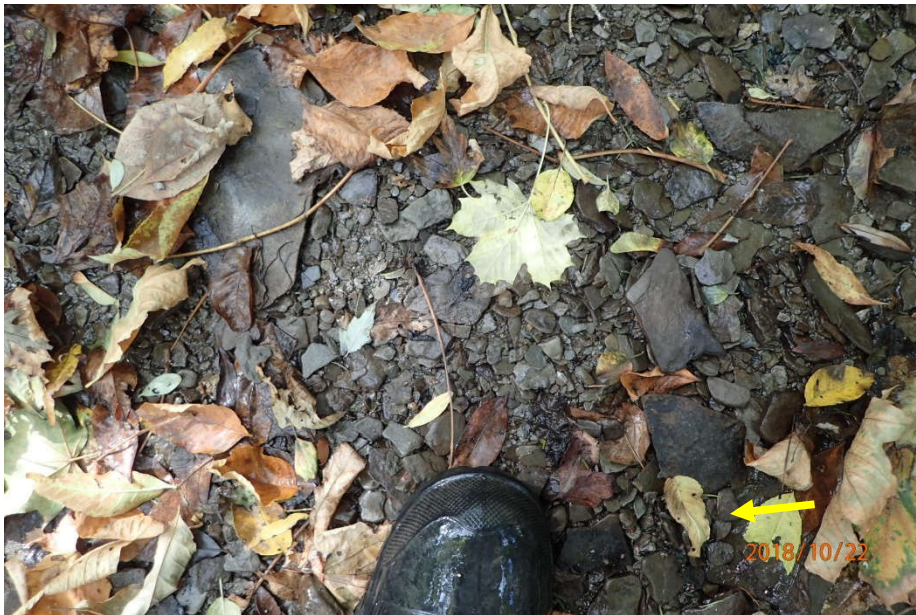
Photo 7

Reach CC-6: Clearview Creek, from the online Agricultural Pond to 40 m upstream of Lakeshore Road

Bed material in the channel consisted of gravel, cobble, till and small boulders within the riffles, and gravel, cobble, and till within the pools.

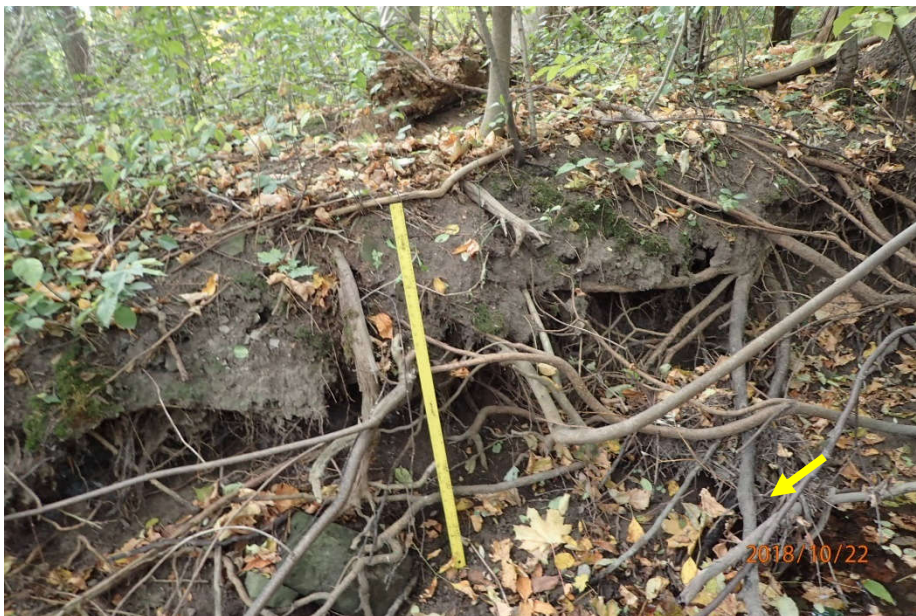
Photo 8

Reach CC-6: Clearview Creek, from the online Agricultural Pond to 40 m upstream of Lakeshore Road

Channel banks were composed of a clay, silt and sand mixture, and their angles ranged from 60 to 90 degrees, with undercuts measured up to 0.43 m.

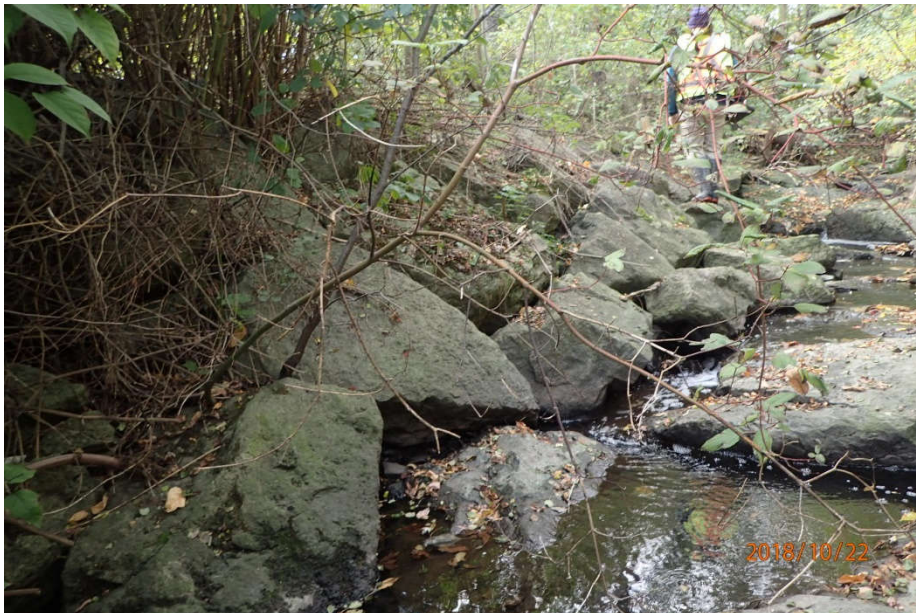
Photo 9

Reach CC-7: Clearview Creek, from 40 m upstream of Lakeshore Road to Lake Ontario

Immediately upstream of the crossing at Lakeshore Road the channel was lined with boulders and armourstone, forming a cascade.

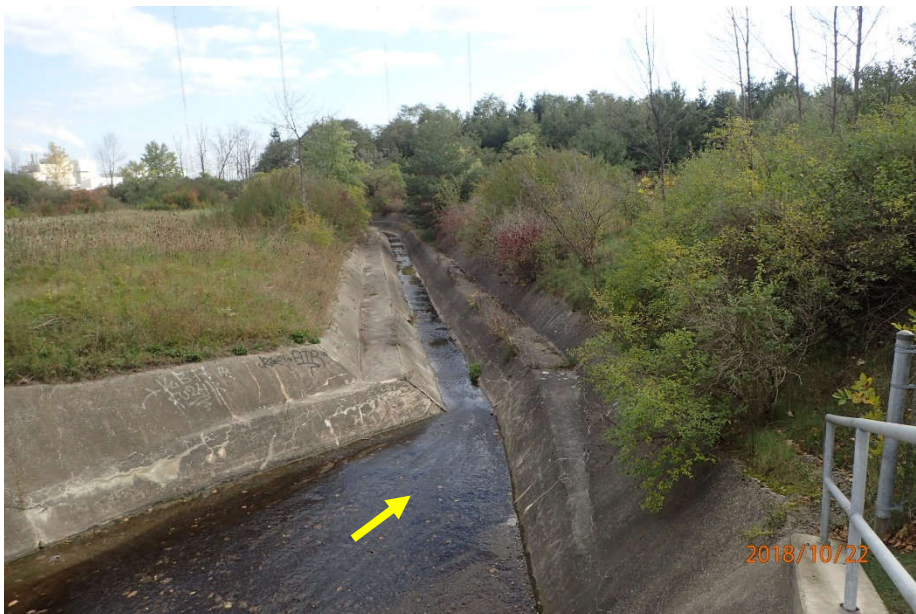
Photo 10

Reach CC-7: Clearview Creek, from 40 m upstream of Lakeshore Road to Lake Ontario

Downstream of Lakeshore Road the reach was a two-tiered concrete engineered channel. Although there was no bank vegetation, the channel was flanked on either side by a wide riparian buffer.

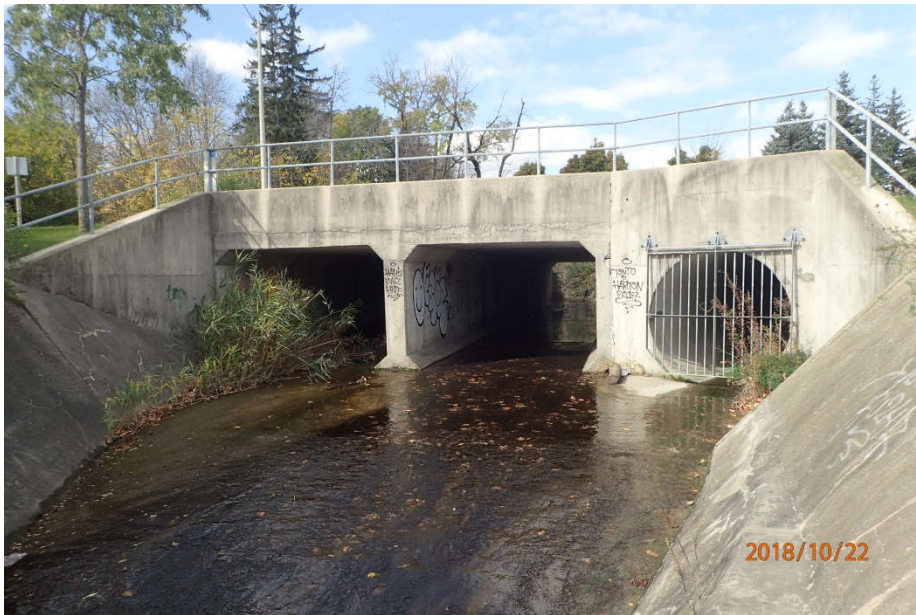
Photo 11

Reach CC-7: Clearview Creek, from 40 m upstream of Lakeshore Road to Lake Ontario

The crossing at Lakeshore Drive was a double box culvert, with an additional circular culvert discharging flows diverted from Avonhead Creek into the channel.

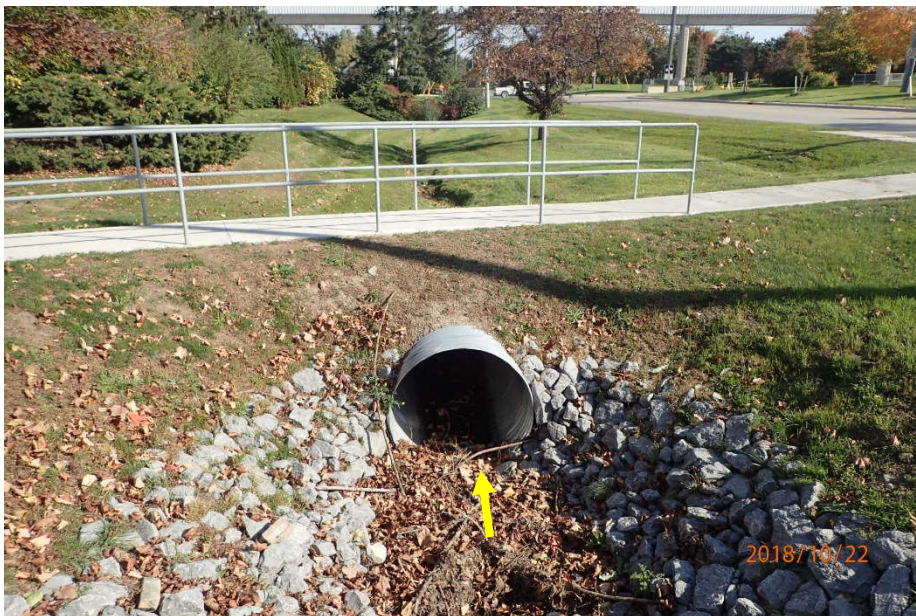
Photo 12

Reach R-2: Avonhead Creek from pedestrian bridge east of MJ Manufacturing to crossing at Lakeshore Road.

Reach 2 of Avonhead Creek was a roadside drainage ditch that ran parallel to Lakeshore Road for approximately 260 m.

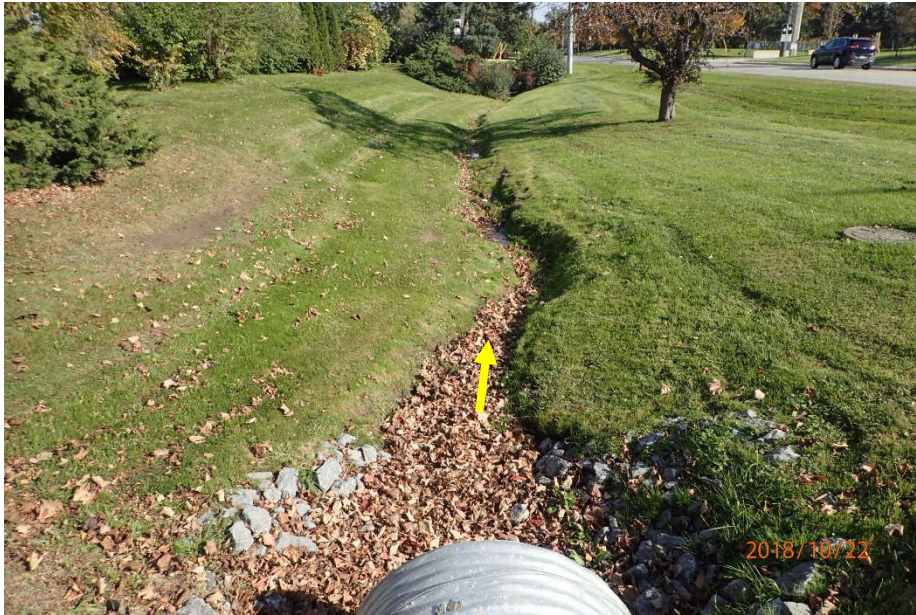
Photo 13

Reach R-2: Avonhead Creek from the pedestrian bridge east of MJ Manufacturing to the crossing at Lakeshore Road.

Bank angles ranged from 30 to 60 degrees and were covered by turf grass, as was much of the channel bed.

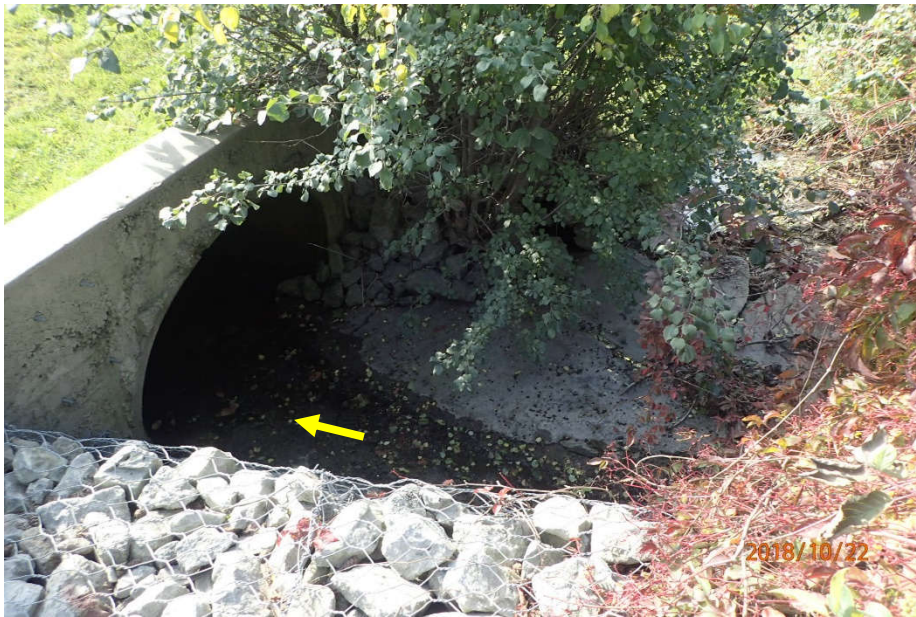
Photo 14

Reach R-2: Avonhead Creek from the pedestrian bridge east of MJ Manufacturing to the crossing at Lakeshore Road.

The culvert at Lakeshore Road, the downstream extent of Reach 2, marked the last point in which flow from Avonhead Creek was conveyed at the surface before discharging into Lake Ontario.

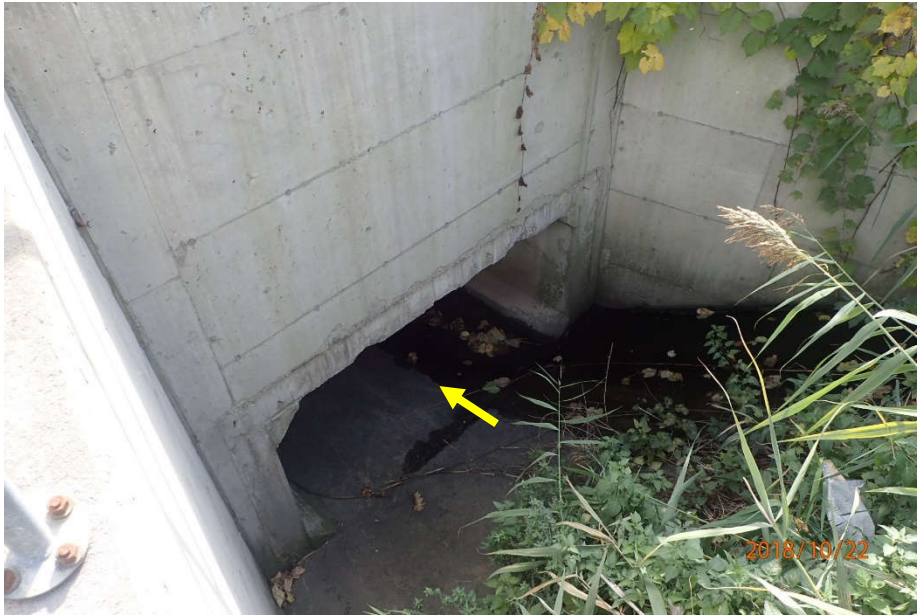
Photo 15

Reach R-14: Avonhead Creek, Assessed within the ROW of Royal Windsor Drive.

Avonhead Creek at Royal Windsor Drive was approximately 5 m below the road grade and was conveyed through a single box culvert.

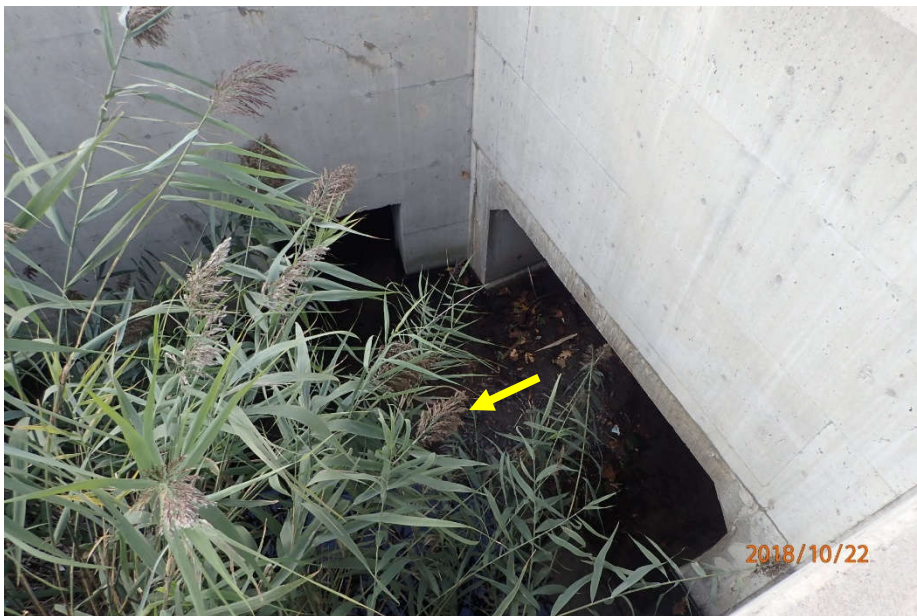
Photo 16

Reach R-14: Avonhead Creek, Assessed within the ROW of Royal Windsor Drive.

Where assessed Reach 14 was an engineered, straightened channel which was inaccessible due to surrounding railings and fences.

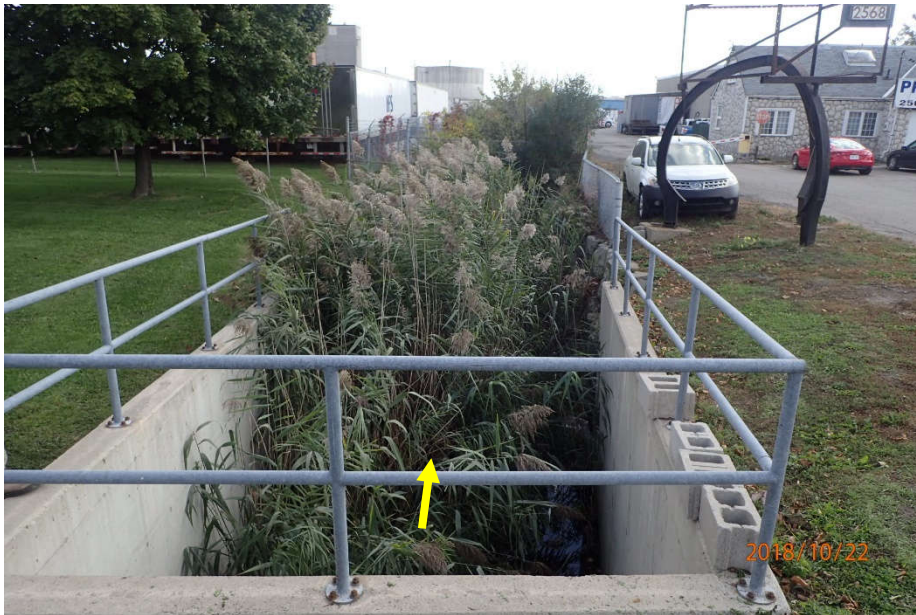
Photo 17

Reach R-14: Avonhead Creek, Assessed within the ROW of Royal Windsor Drive.

Substrate on the channel bed facilitated the establishment of Phragmites.

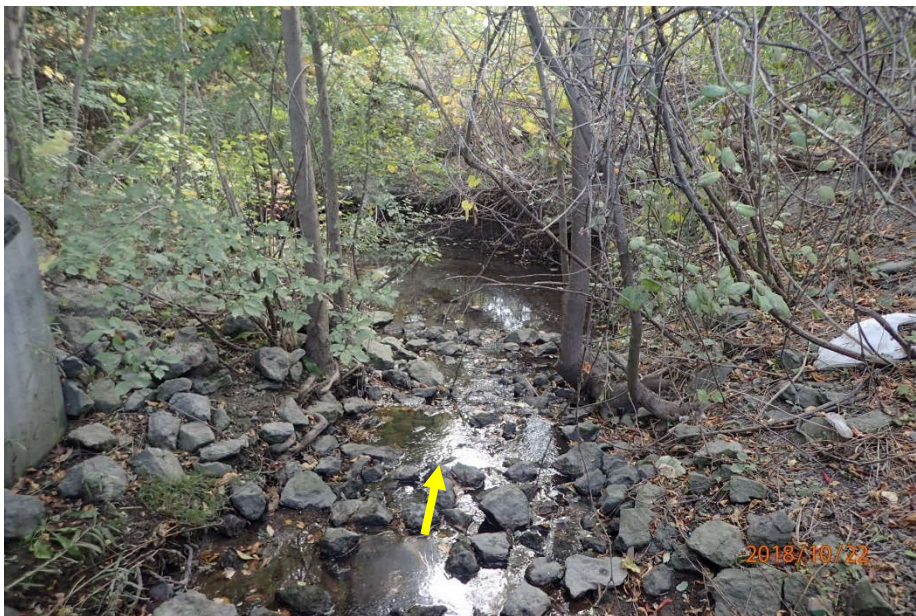
Photo 18

Reach LC-1: Lakeside Creek, from the crossing at Lakeshore Road to Lake Ontario

Photograph taken facing downstream from the culvert at Lakeshore Road West. The coarse material at this location was installed to prevent bed scour at the outlet of the culvert conveying flows under Lakeshore Road West.

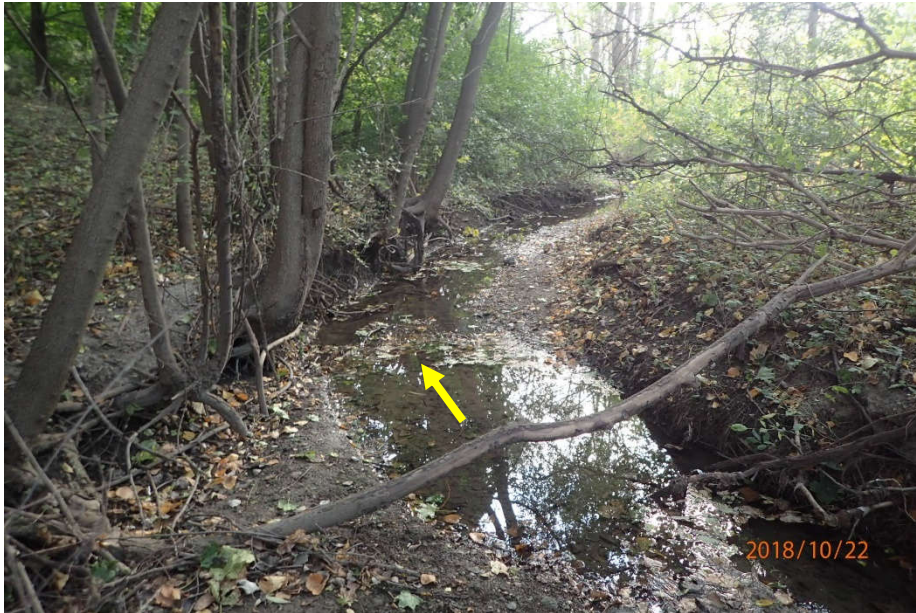
Photo 19

Reach LC-1: Lakeside Creek, from the crossing at Lakeshore Road to Lake Ontario

Reach LC-1 was a mixed-load meandering channel that occupied an unconfined valley.

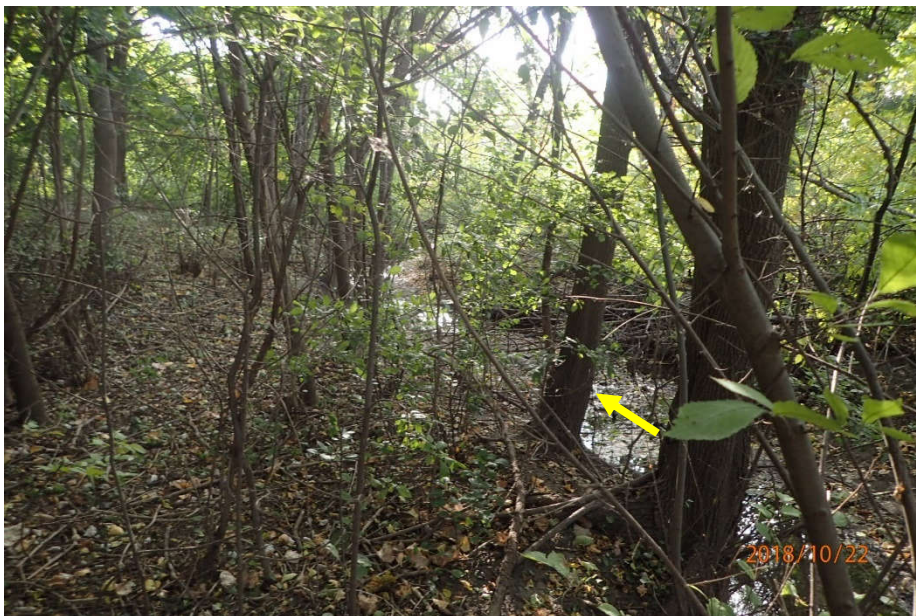
Photo 20

Reach LC-1: Lakeside Creek, from the crossing at Lakeshore Road to Lake Ontario

The channel had a continuous riparian buffer composed predominately of deciduous trees that spanned more than 10 times the channel width.

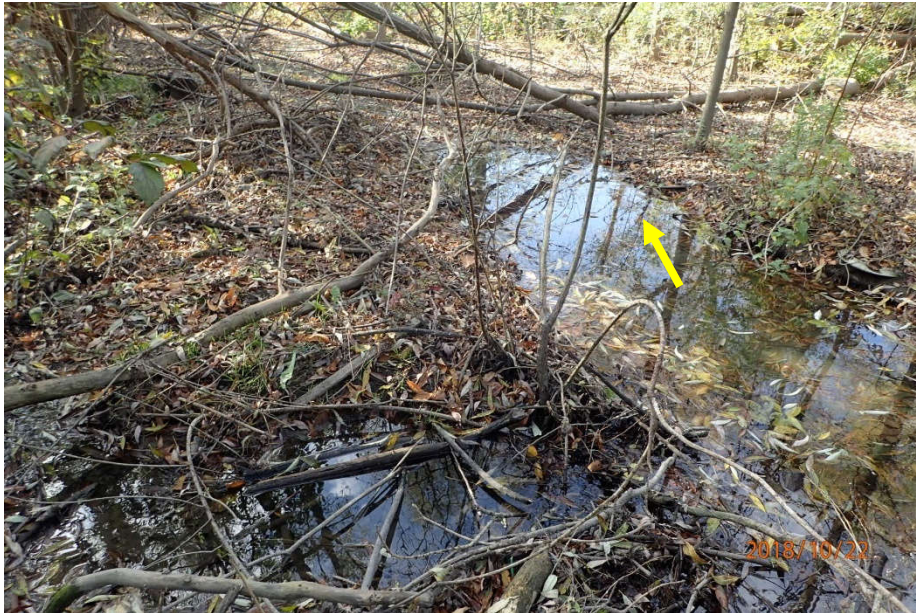
Reach LC-1: Lakeside Creek, from the crossing at Lakeshore Road to Lake Ontario

A low density of woody debris was observed within the channel and on its banks. No distinct debris jams were observed within the reach.

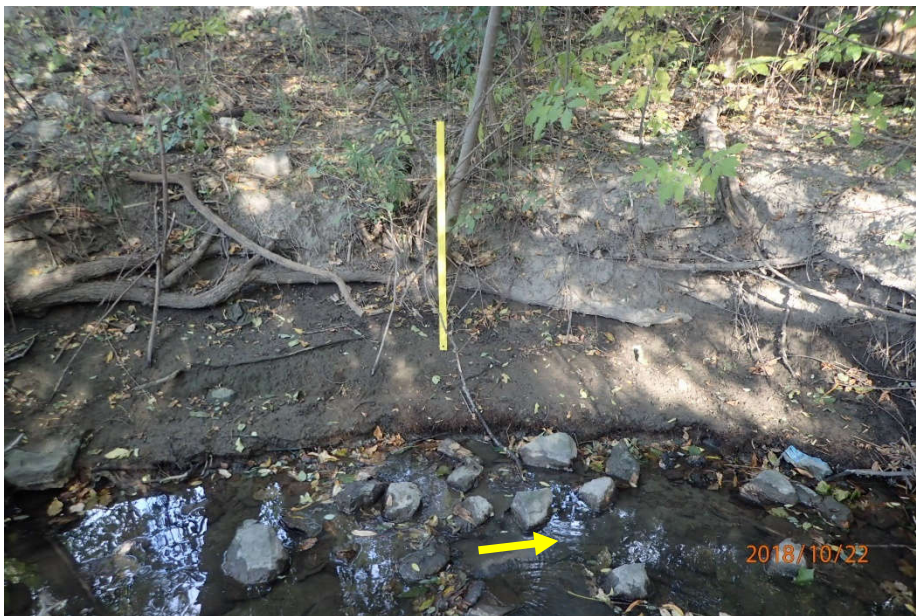
Photo 22

Reach LC-1: Lakeside Creek, from the crossing at Lakeshore Road to Lake Ontario

The banks were composed of clay, silt, and sand, and their angles generally ranged from 60 to 90 degrees.

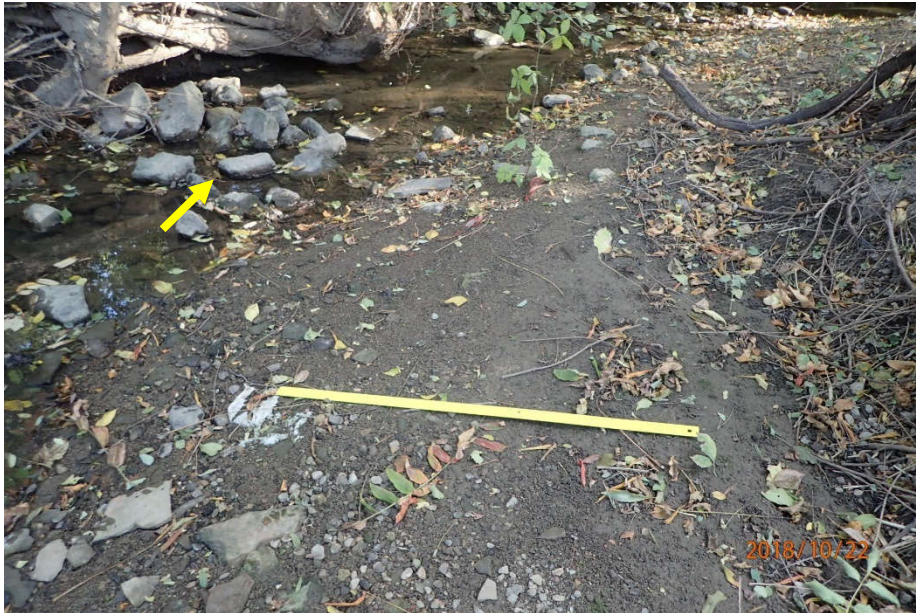
Reach LC-1: Lakeside Creek, from the crossing at Lakeshore Road to Lake Ontario

Point bar development was observed within the reach, with deposited material generally consisting of small gravels and sand.

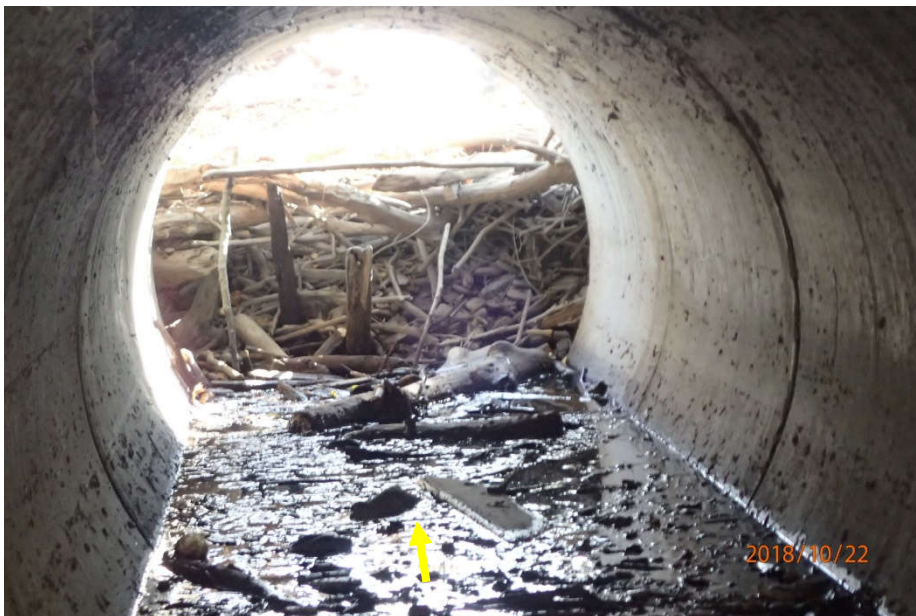
Photo 24

Reach LC-1: Lakeside Creek, from the crossing at Lakeshore Road to Lake Ontario

The culvert located at the boardwalk marking the downstream extent of the reach was severely blocked, causing backwatering within Reach LC-1.
