Natural Heritage Report

Southdown District Stormwater Servicing and Environmental Management Plan

Natural Environmental Conditions Report

PECG Project #
131129

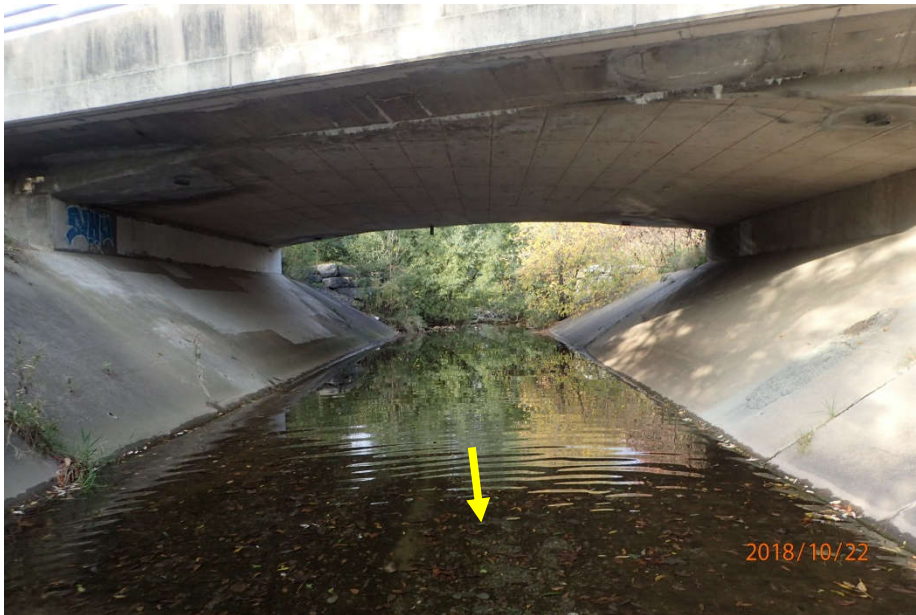
Photo 25

Reach SC-1: Assessed within the ROW of Bromsgrove Road

Reach SC-1 was a straight engineered concrete channel. The concrete on the channel bed was overlaid by a thin layer of silt, sand and gravel.

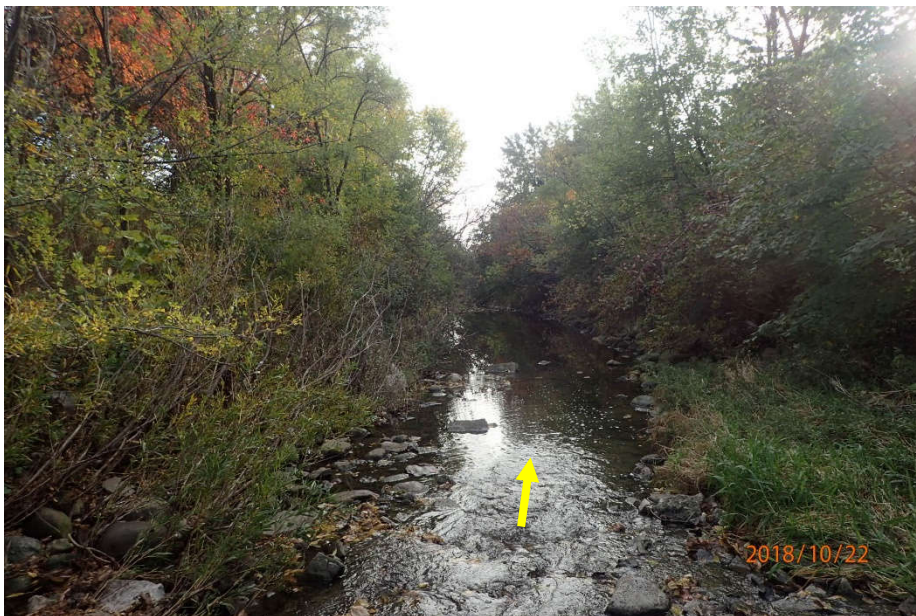
Photo 26

Reach SC-1: Assessed within the ROW of Bromsgrove Road

The channel had a continuous riparian buffer composed predominately deciduous trees that extended 1 to 4 times the channel width.

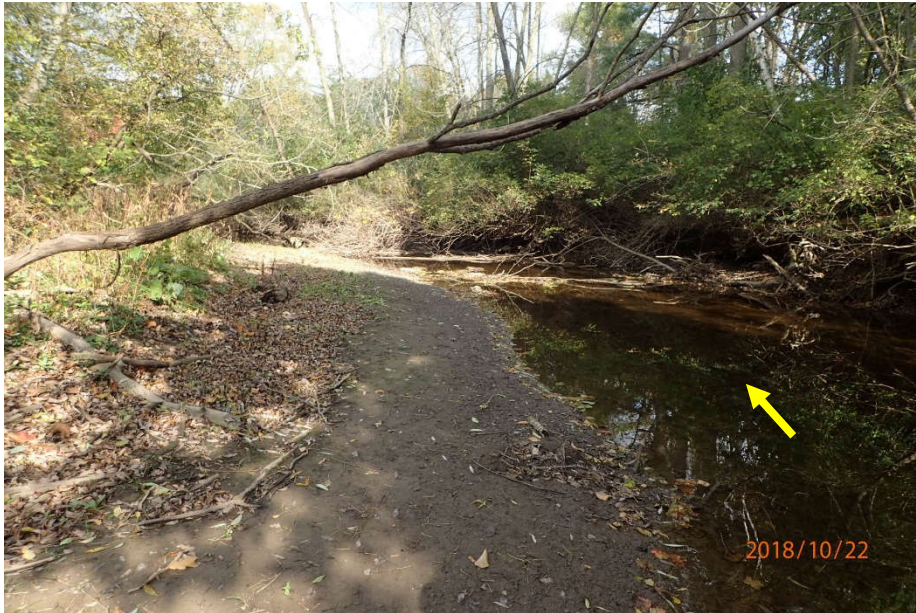
Photo 27
Reach JC-1 : From municipal boundary to Lake Ontario

Reach JC-1 had a fragmented, forested riparian buffer consisting of mature deciduous trees. Point bar formation and erosion at outside meander bends were noted upstream of the subject site.

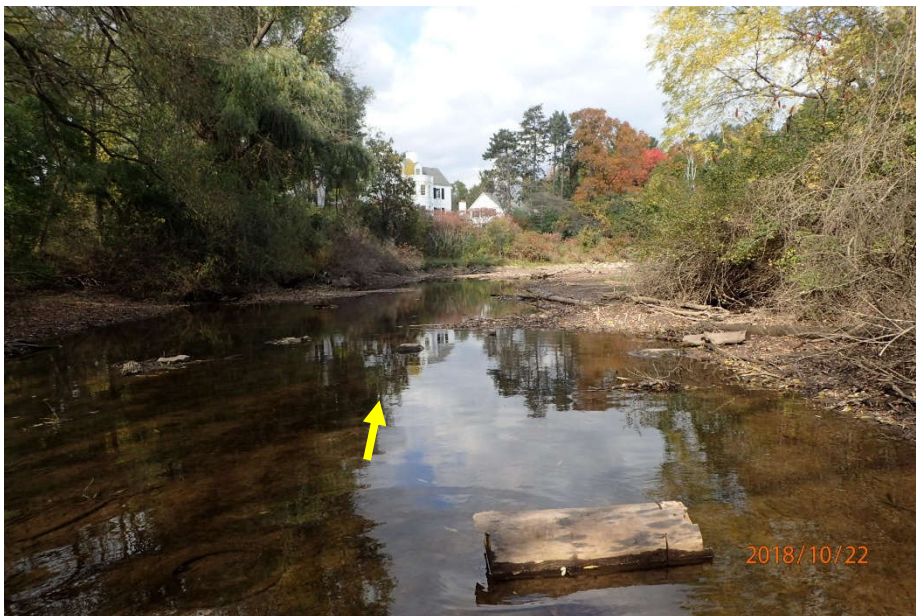
Photo 28
Reach JC-1 : From municipal boundary to Lake Ontario

Bed material in the channel consisted of clay, silt, and sand. No riffle-pool development was observed.

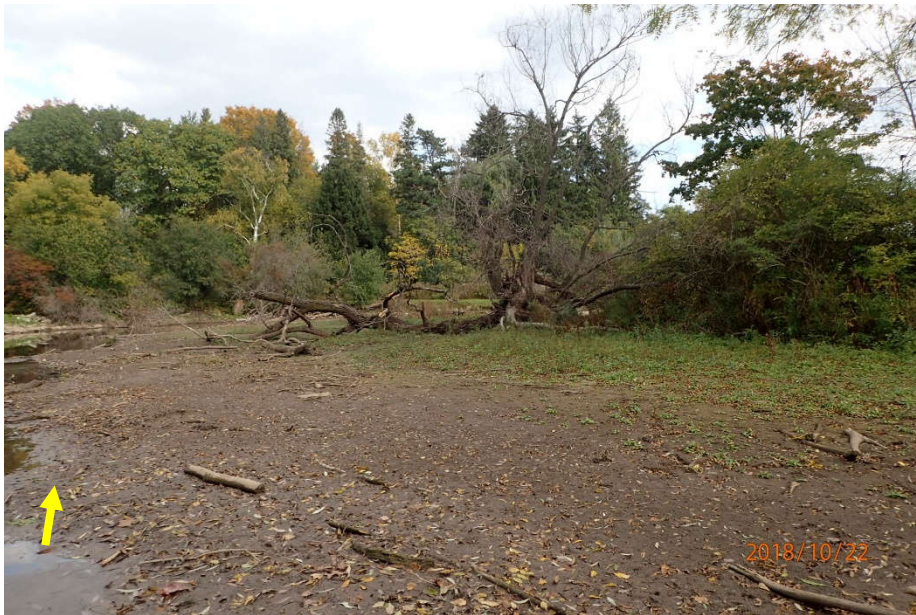
Photo 29
Reach JC-1 : From municipal boundary to Lake Ontario

Near Lake Ontario the channel had an oversized bankfull channel, likely because this area becomes a backwater site for the Lake during period of elevated water levels.

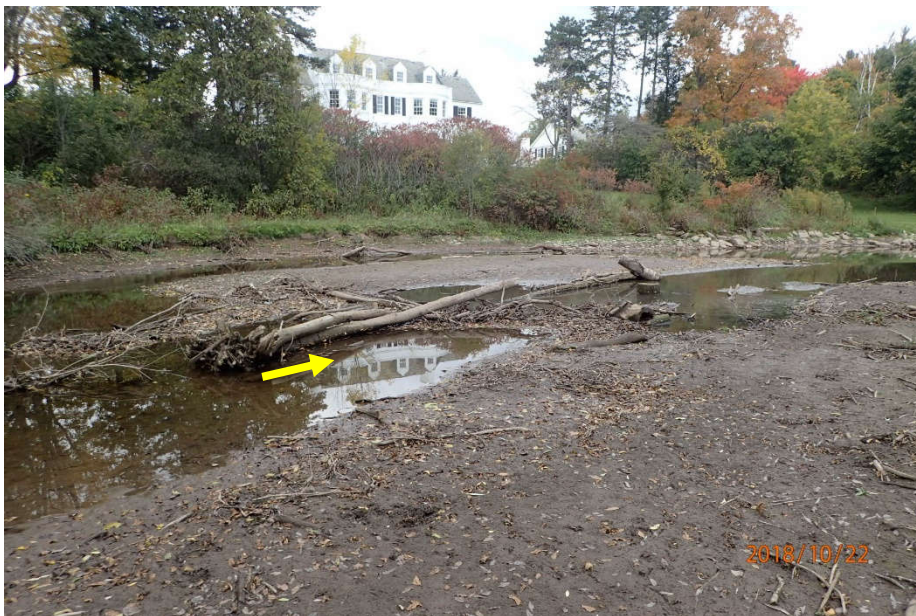
Photo 30
Reach JC-1 : From municipal boundary to Lake Ontario

Sparse large woody debris was observed within both the channel and at the banks. There was limited erosion in this portion of the reach.

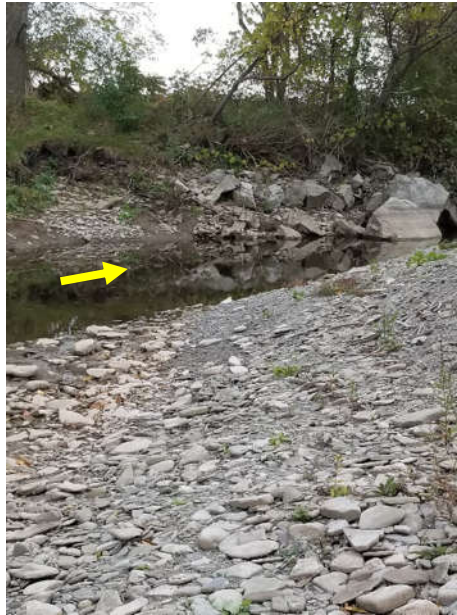
Photo 31
Reach JC-1 : From municipal boundary to Lake Ontario

Cobbles from the beach at Lake Ontario lined the channel as it approached the lakeshore, and the channel's width was reduced significantly

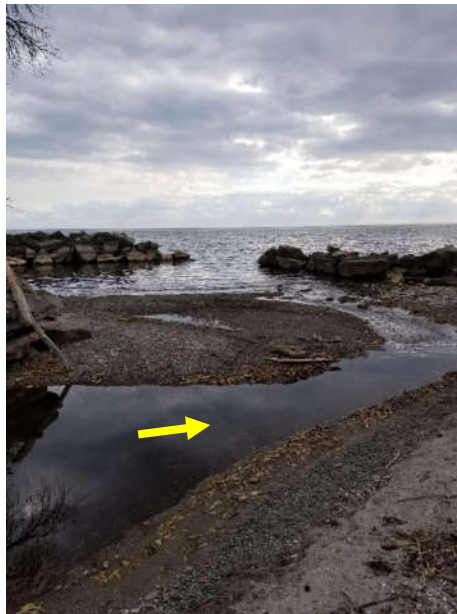
Photo 32
Reach JC-1 : From municipal boundary to Lake Ontario

The reach discharged into Lake Ontario through a relatively small channel given the size of the watershed, likely contributing to the backwater effect and depositional material observed upstream.

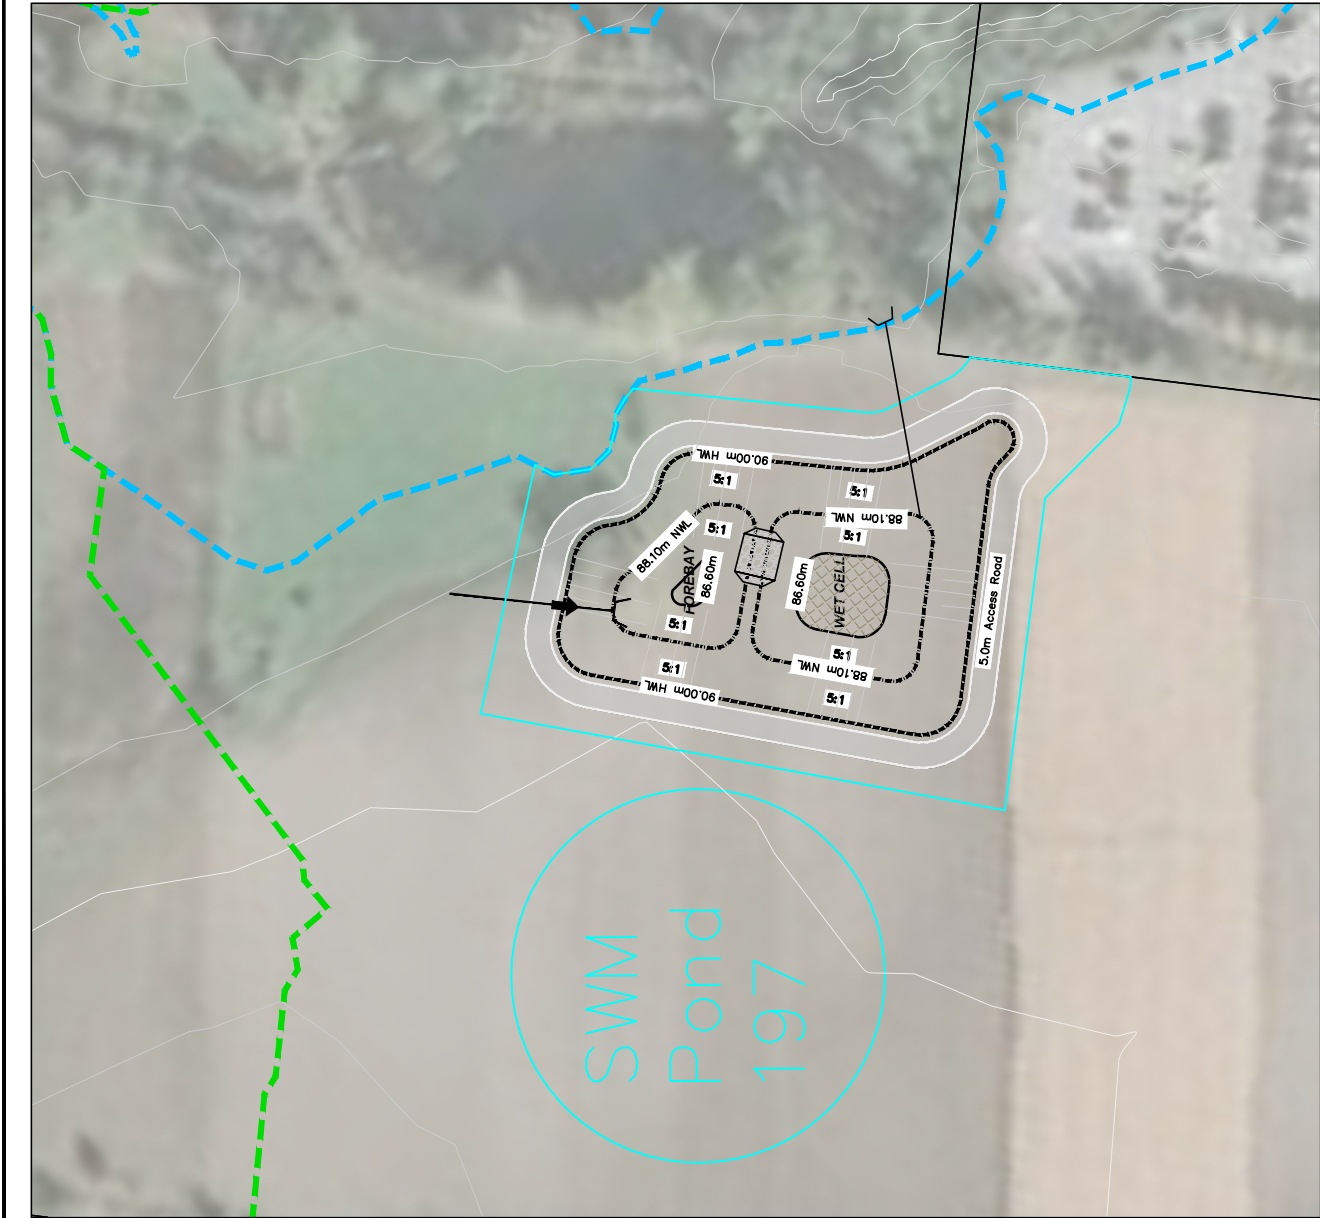
POND CHARACTERISTICS	STAGE / STORAGE INFORMATION							
	Elevation (m)	Stage (m)	Area 1 (m ²)	Area 2 (m ²)	Total Area (m ²)	Avg. Area (m ²)	Incremental Storage (m ³)	Cumulative Storage above Permanent Pool (m ³)
Base of Pond:	86.60	0.00	42.1	256.0	298.1		0.0	
N.W.L.:	88.10	1.50	549.6	997.7	1,547.4	922.7	1,384.1	0
Increment for Volume:		3.40	3,781.2		3,781.2	2,664.3	5,062.2	
Required Permanent Pool Volume:		3.70	4,179.0		4,179.0	3,980.1	1,194.0	
Permanent Pool Volume Provided:

DESCRIPTION	REQUIRED STORAGE	PROVIDED STORAGE
PERMANENT POOL EL.86.60 – EL.88.10	943 m ³	1,384 m ³
ACTIVE POOL EL.88.10 – EL.90.00	4,849 m ³	5,062 m ³

POND GEOMETRIC DATA	
ITEM	DATA
DRAINAGE AREA	8.84 HA
POND BLOCK AREA	0.77 HA
PERMANENT POOL ELEV.	88.10m
BOTTOM OF POND ELEV.	86.60m
HWL	90.00m
FREE BOARD ELEV.=ACCESS RD ELEV.	90.30m
POND SLOPES	5:1

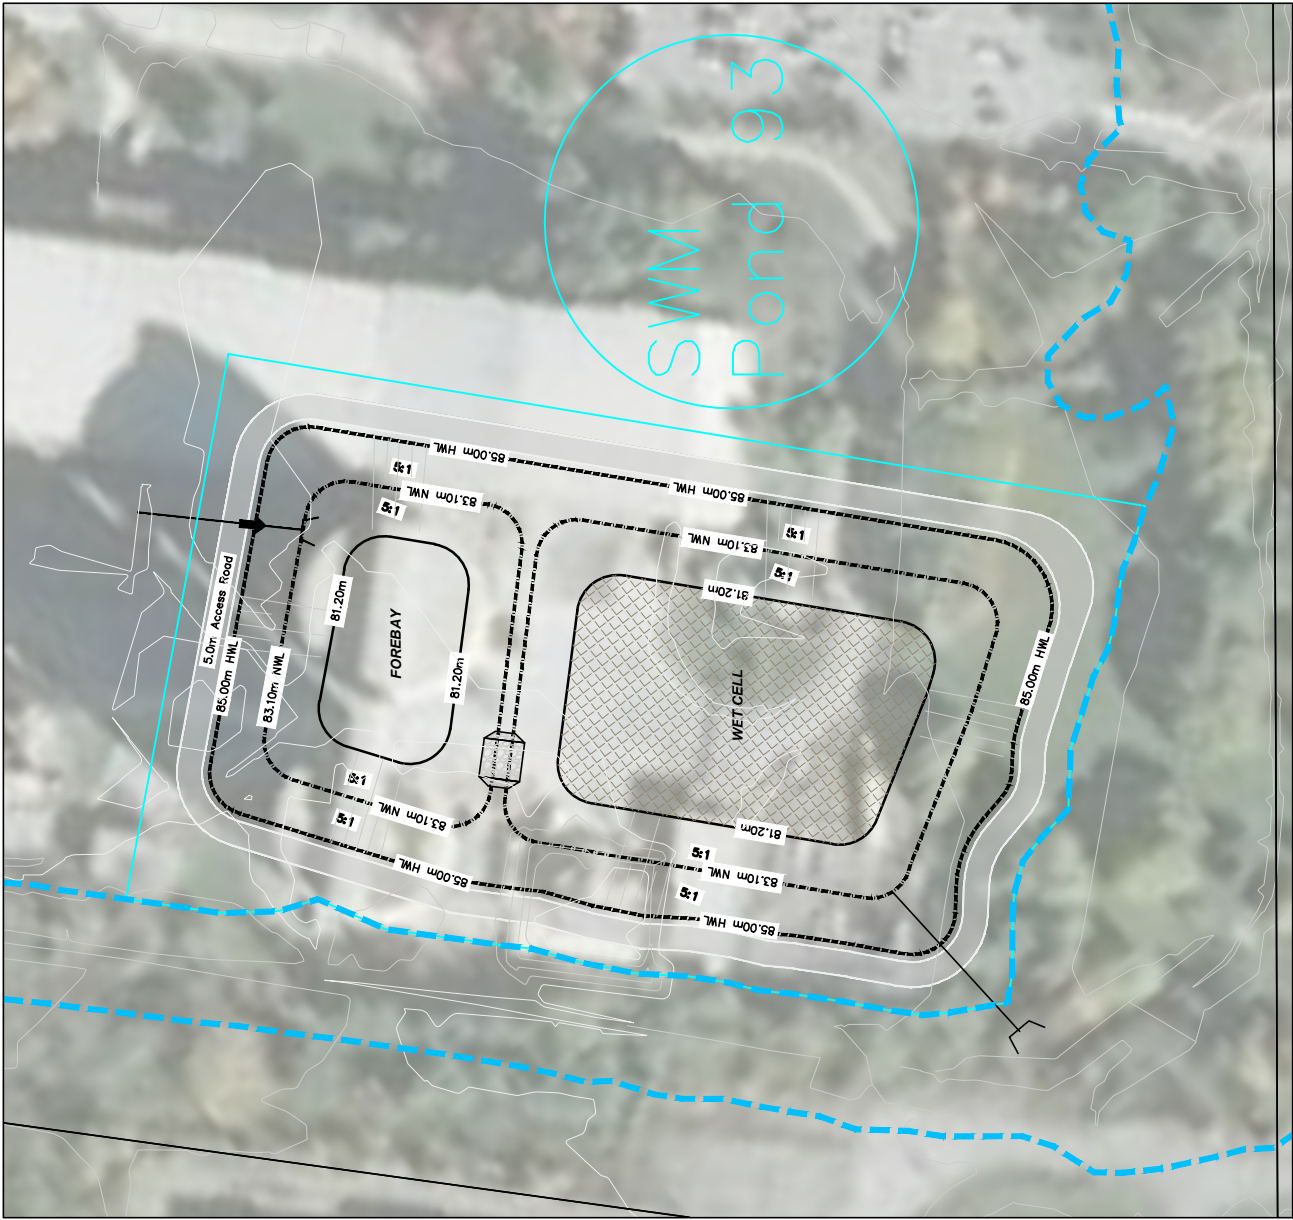
POND CHARACTERISTICS	STAGE / STORAGE INFORMATION							
	Elevation (m)	Stage (m)	Area 1 (m ²)	Area 2 (m ²)	Total Area (m ²)	Avg. Area (m ²)	Incremental Storage (m ³)	Cumulative Storage above Permanent Pool (m ³)
Base of Pond:	81.20	0.00	1,114.9	3,123.6	4,238.5		0.0	
N.W.L.:	83.10	1.90	2,736.6	5,600.1	8,336.7	6,287.6	11,946.5	0
Increment for Volume:		3.80	12,754.3		12,754.3	10,545.5	20,036.5	20,036
Required Permanent Pool Volume:		4.10	13,447.2		13,447.2	13,100.8	3,930.2	23,967
Permanent Pool Volume Provided:

DESCRIPTION	REQUIRED STORAGE	PROVIDED STORAGE
PERMANENT POOL EL.81.20 – EL.83.10	7,465 m ³	11,946 m ³
ACTIVE POOL EL.83.10 – EL.85.00	14,348 m ³	20,036 m ³

POND GEOMETRIC DATA	
ITEM	DATA
DRAINAGE AREA	69.98 HA
POND BLOCK AREA	1.91 HA
PERMANENT POOL ELEV.	83.10m
BOTTOM OF POND ELEV.	81.20m
HWL	85.00m
FREE BOARD ELEV.=ACCESS RD ELEV.	85.30m
POND SLOPES	5:1

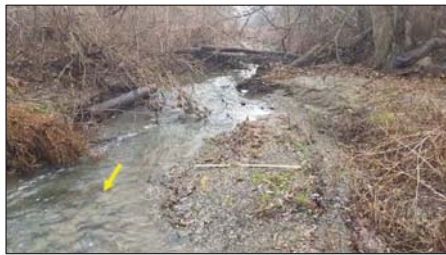
Clearview Creek downstream of Winston Churchill Blvd: meandering channel through sparse vegetation on private lots

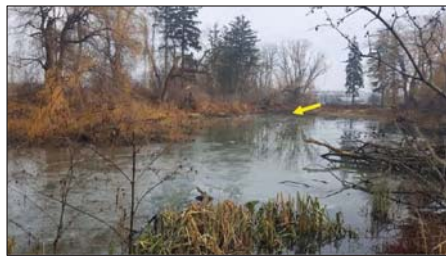
Clearview Creek: online agricultural pond

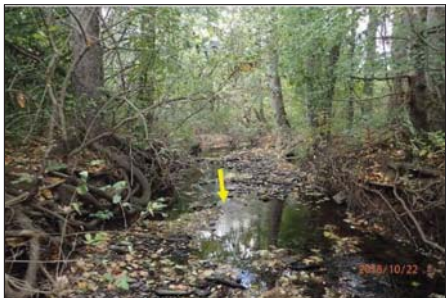
Clearview Creek upstream of Lakeshore Rd: meandering natural channel through mature riparian vegetation

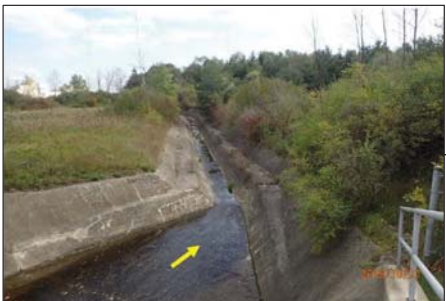
Clearview Creek downstream of Lakeshore Rd: concrete engineered channel

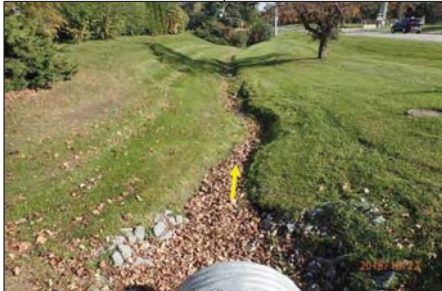
Avonhead Creek upstream of Lakeshore Road: grass-lined channel

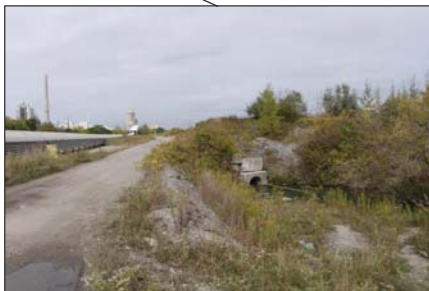
Avonhead Creek downstream of Lakeshore Road: piped to outlet at Lake Ontario

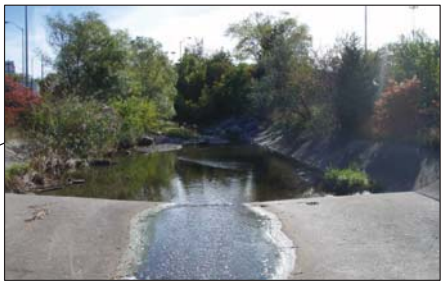
Sheridan Creek at CNR: concrete engineered channel

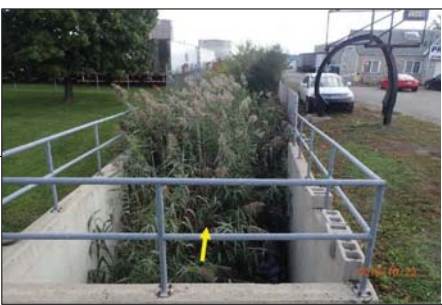
Avonhead Creek downstream of Royal Windsor Drive: narrow straightened channel/swale

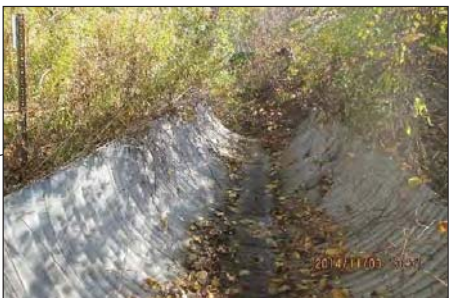
Avonhead Creek through concrete plant: CSP and concrete lined channel

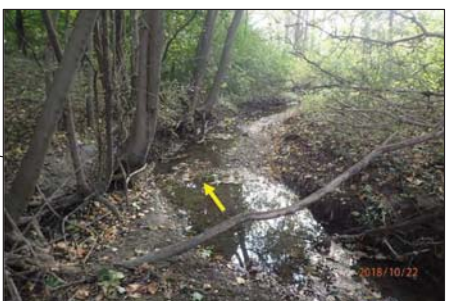
Lakeside Creek downstream of Lakeshore Road: natural channel through mature riparian vegetation

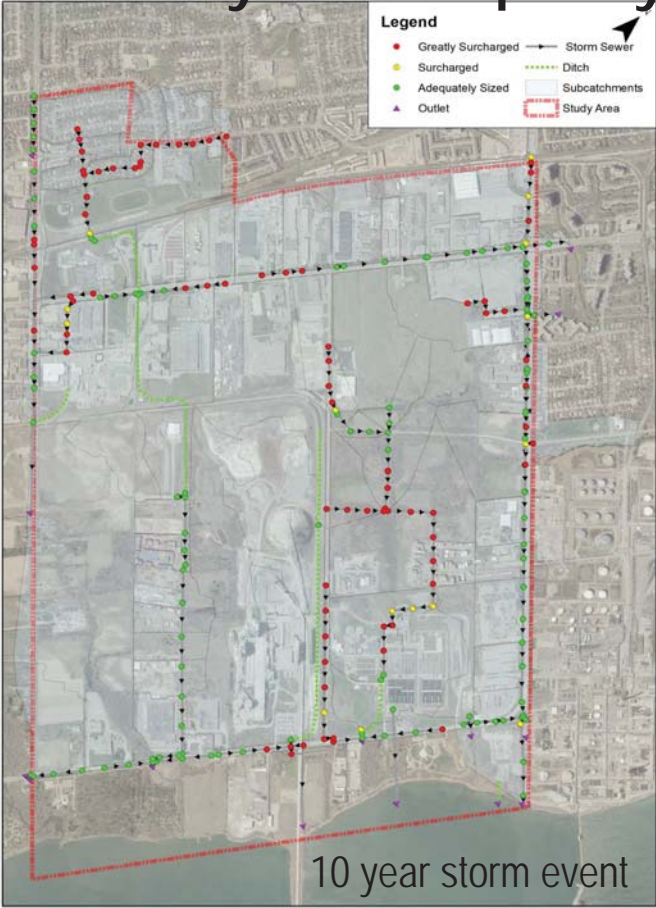
Minor System Capacity

Storm sewer segments illustrated in green are big enough to meet the City’s capacity standards under the current landuses. Sewer segments illustrated in red are undersized which may cause stormwater to “backup” and pond on the road.

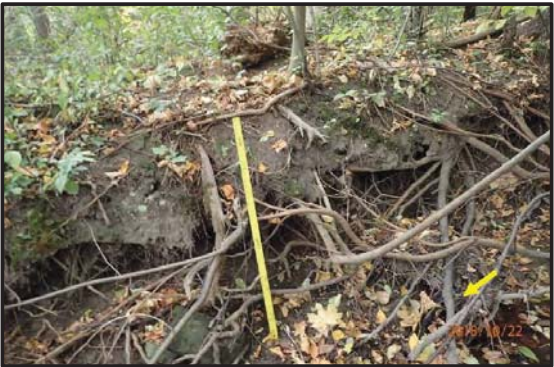
Long-term erosion hazards were estimated through meander belt mapping

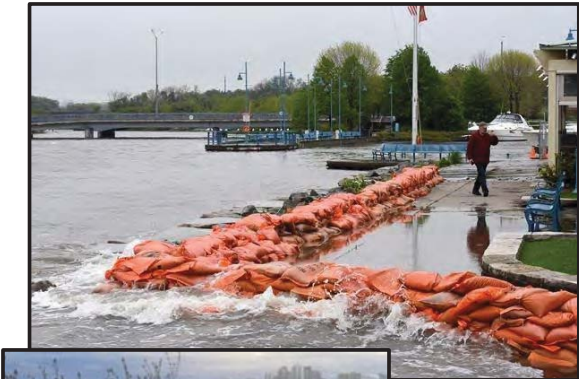
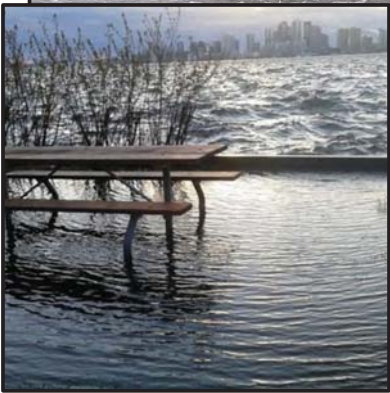
Shoreline hazards defined through Conservation Authority regulation mapping

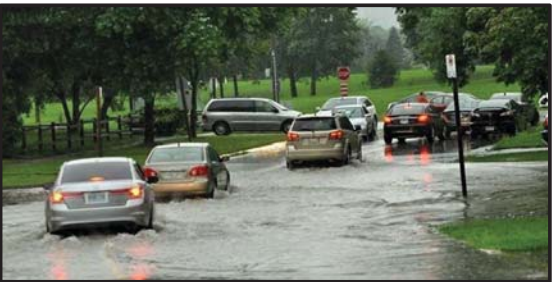
Flood hazards along the study area watercourses identified through computer modelling

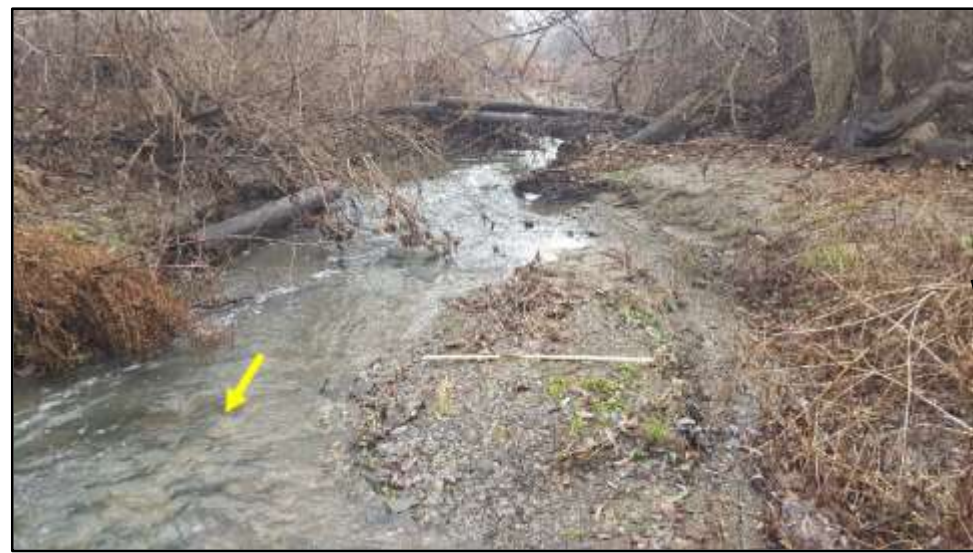
Clearview Creek downstream of Winston Churchill Blvd: meandering channel through sparse vegetation on private lots

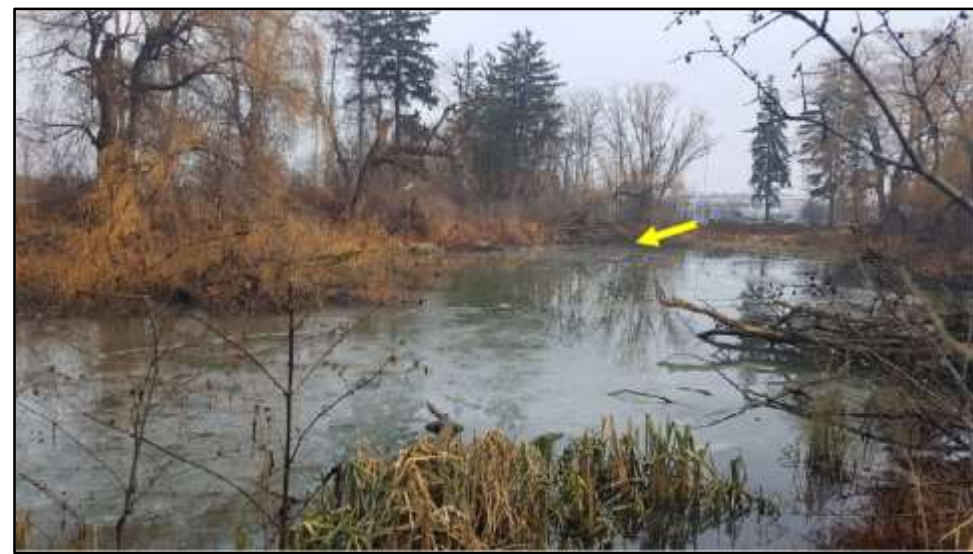
Clearview Creek: online agricultural pond

- Realignment and reconstruction of channel west of Winston Churchill Boulevard (62 m wide corridor)
- Replacement of the concrete channel south of Lakeshore Road with a natural channel (62 m wide corridor)
- Removal of the online pond north of Lakeshore Road
- Cost: \$19.1 Million

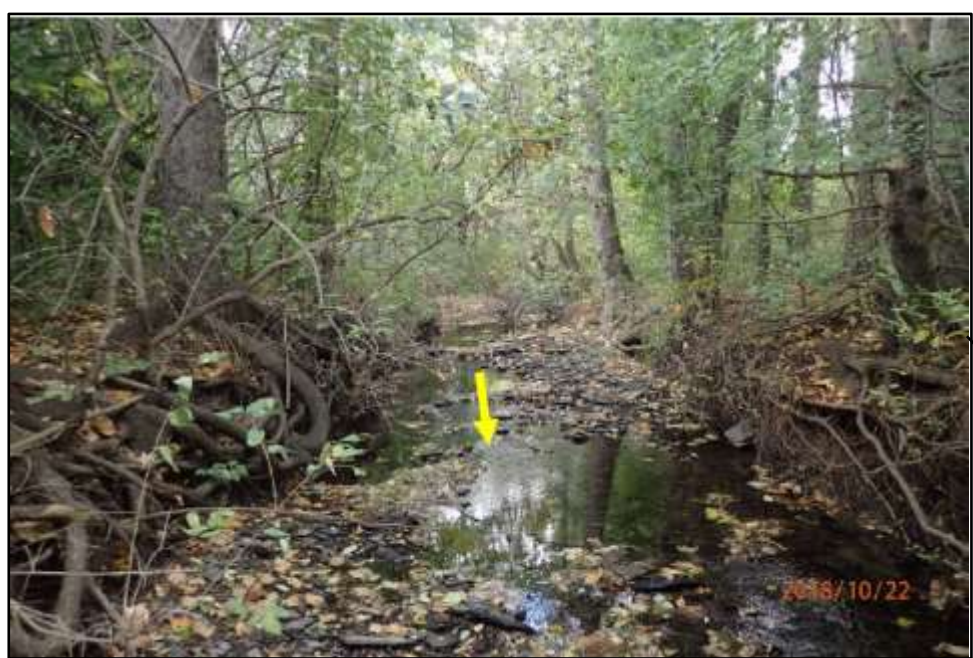
Clearview Creek upstream of Lakeshore Rd: meandering natural channel through mature riparian vegetation

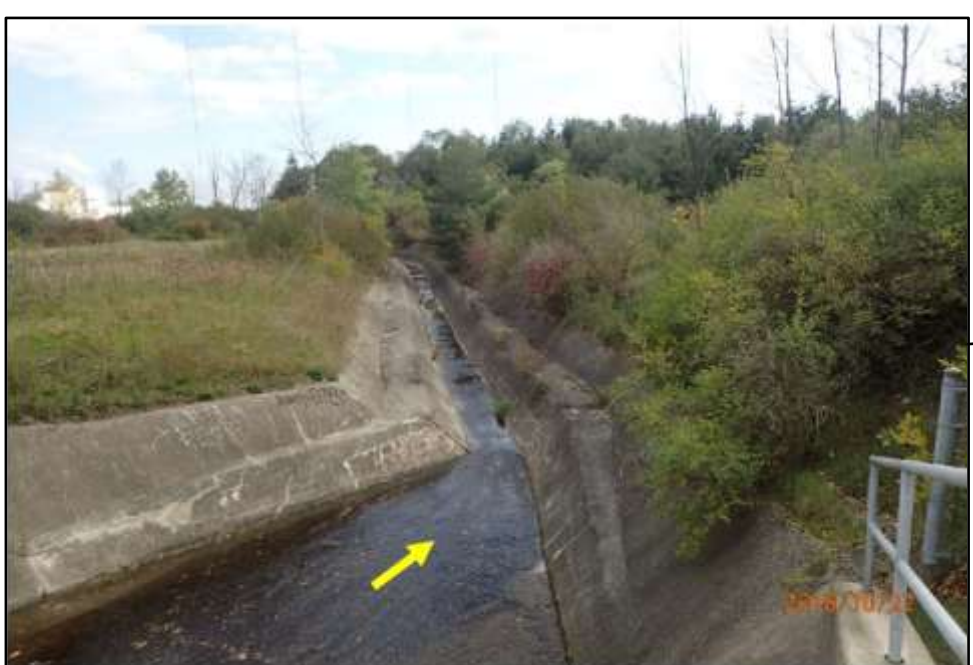
Clearview Creek downstream of Lakeshore Rd: concrete engineered channel

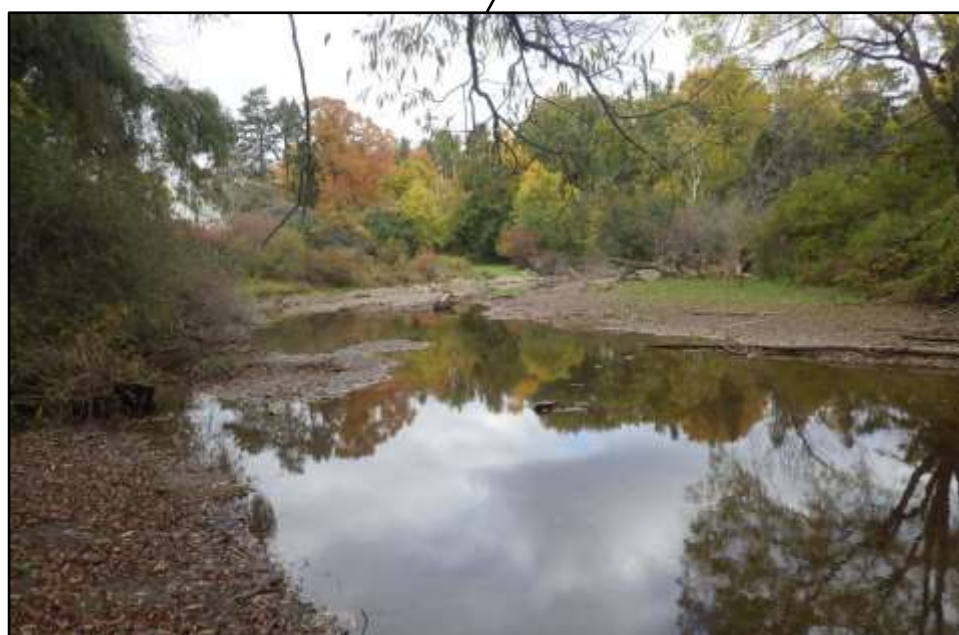
Joshua Creek: outlet to Lake Ontario

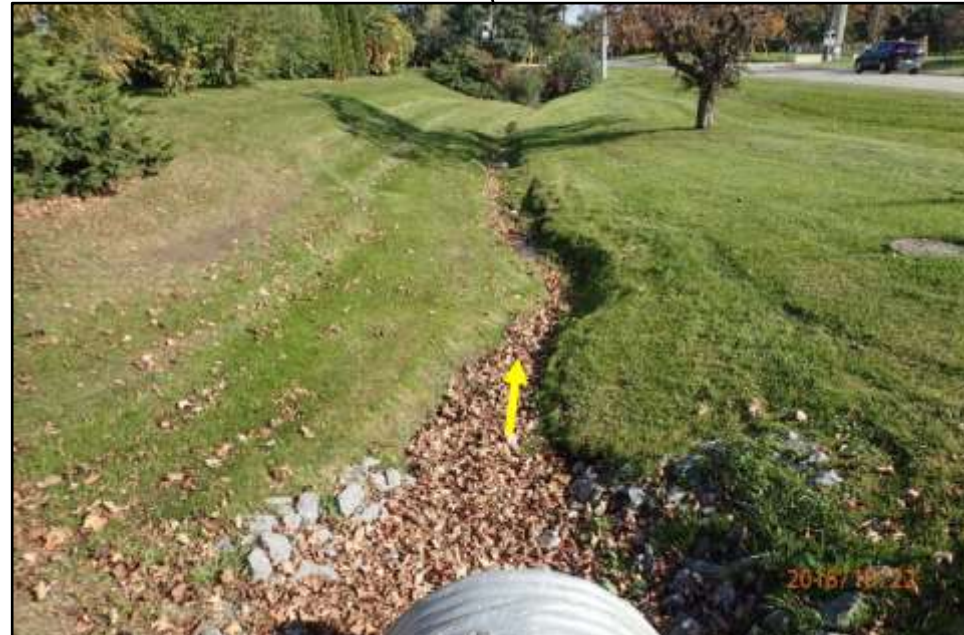
Avonhead Creek upstream of Lakeshore Road: grass-lined channel

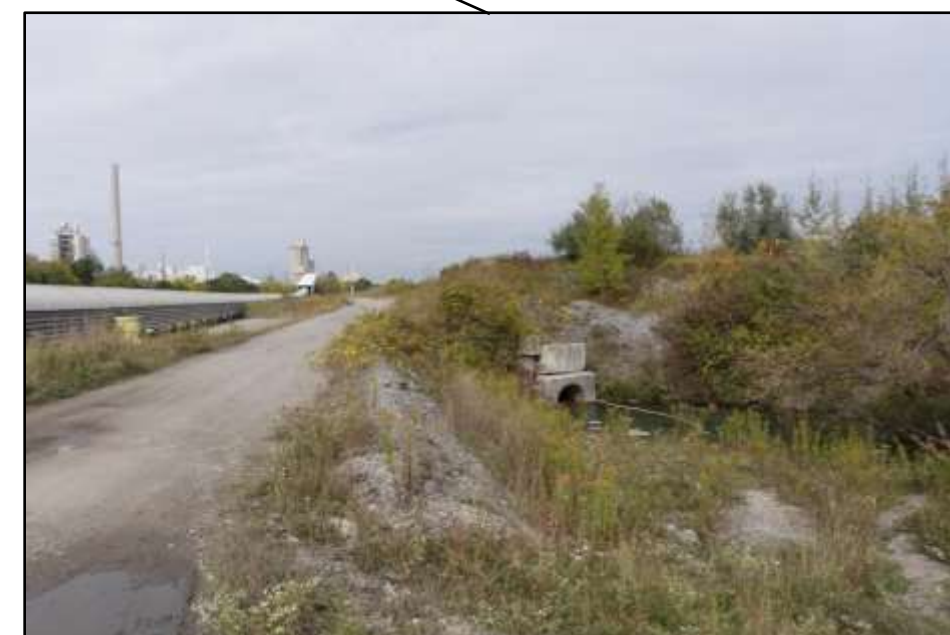
Avonhead Creek downstream of Lakeshore Road: piped to outlet at Lake Ontario

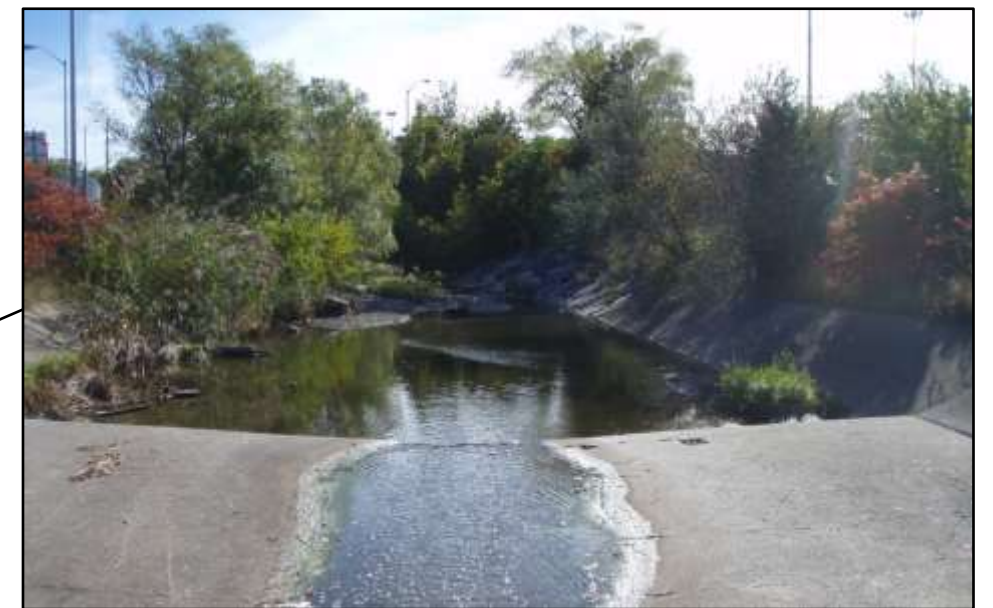
Sheridan Creek at CNR: concrete engineered channel

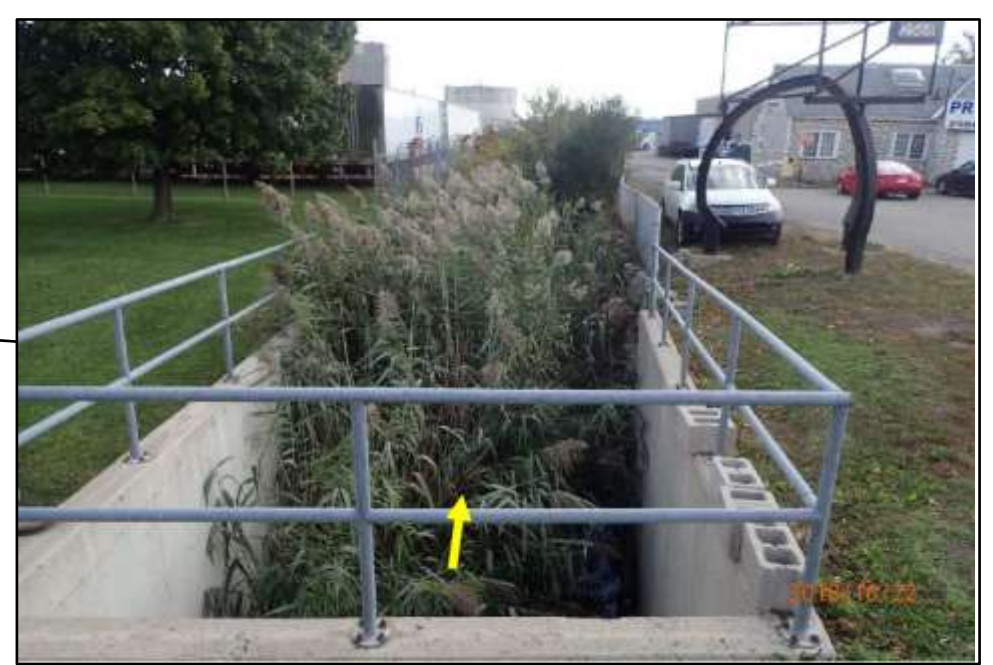
Avonhead Creek downstream of Royal Windsor Drive: narrow straightened channel/swale

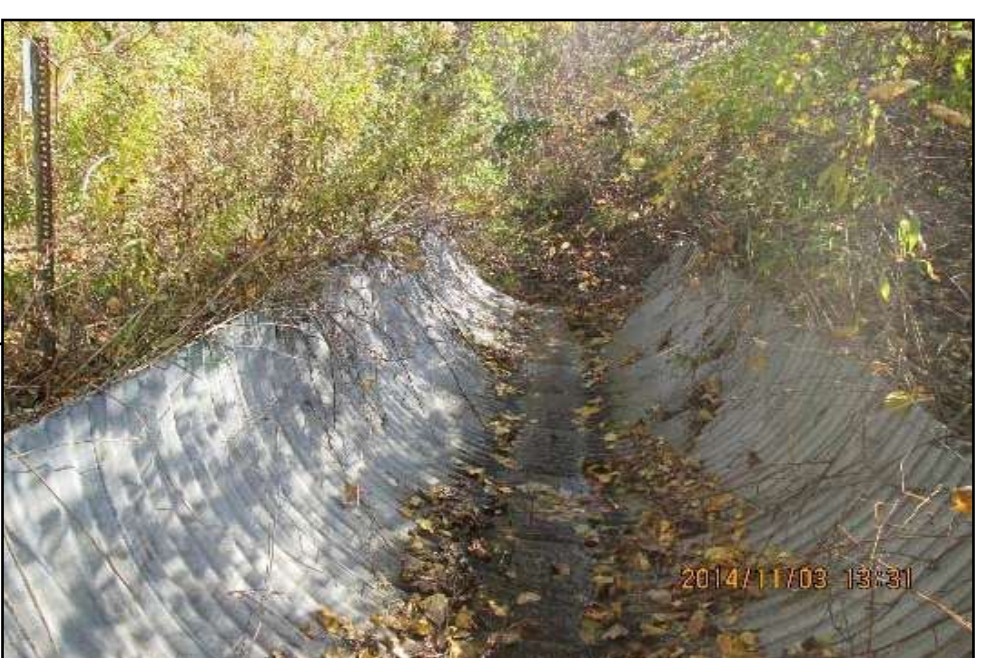
Avonhead Creek through concrete plant: CSP and concrete lined channel

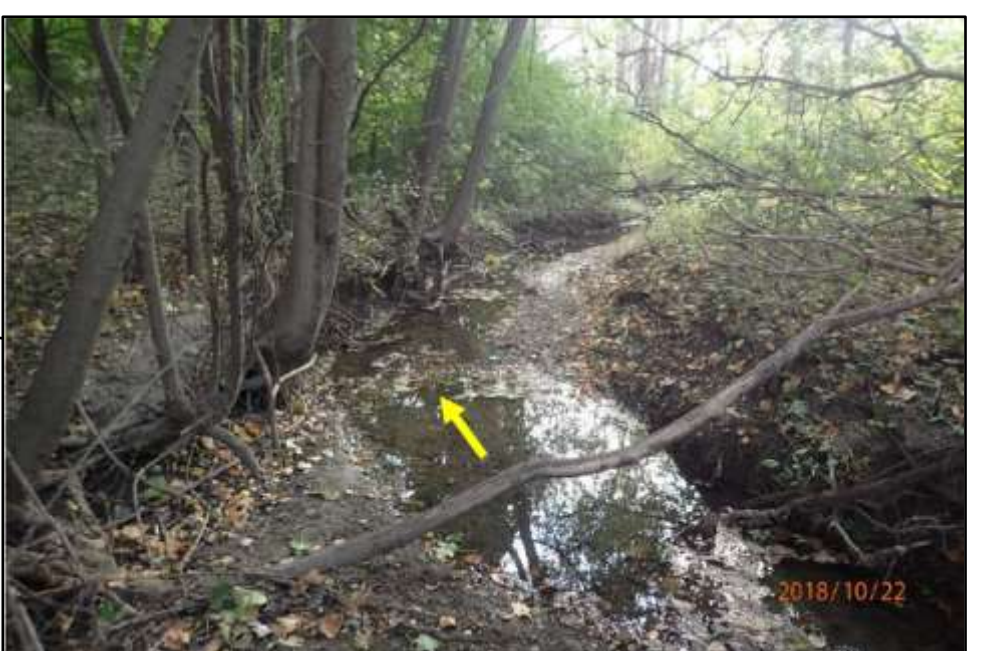
Lakeside Creek downstream of Lakeshore Road: natural channel through mature riparian vegetation

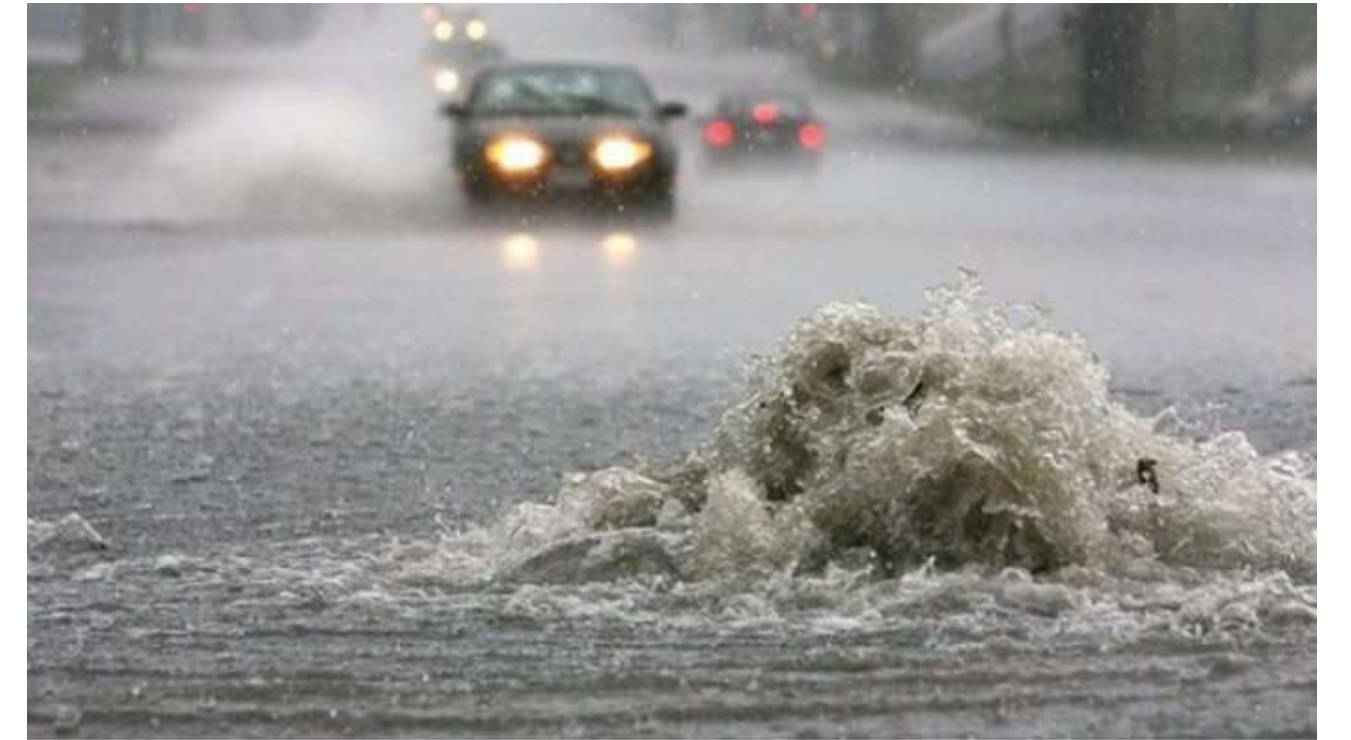
Computer modelling was completed to assess the capacity of the existing storm sewers and road drainage:

Storm sewer segments illustrated in green are big enough to meet the City's capacity standards under the current landuses. Sewer segments illustrated in red are undersized which may cause stormwater to "backup" and pond on the road.

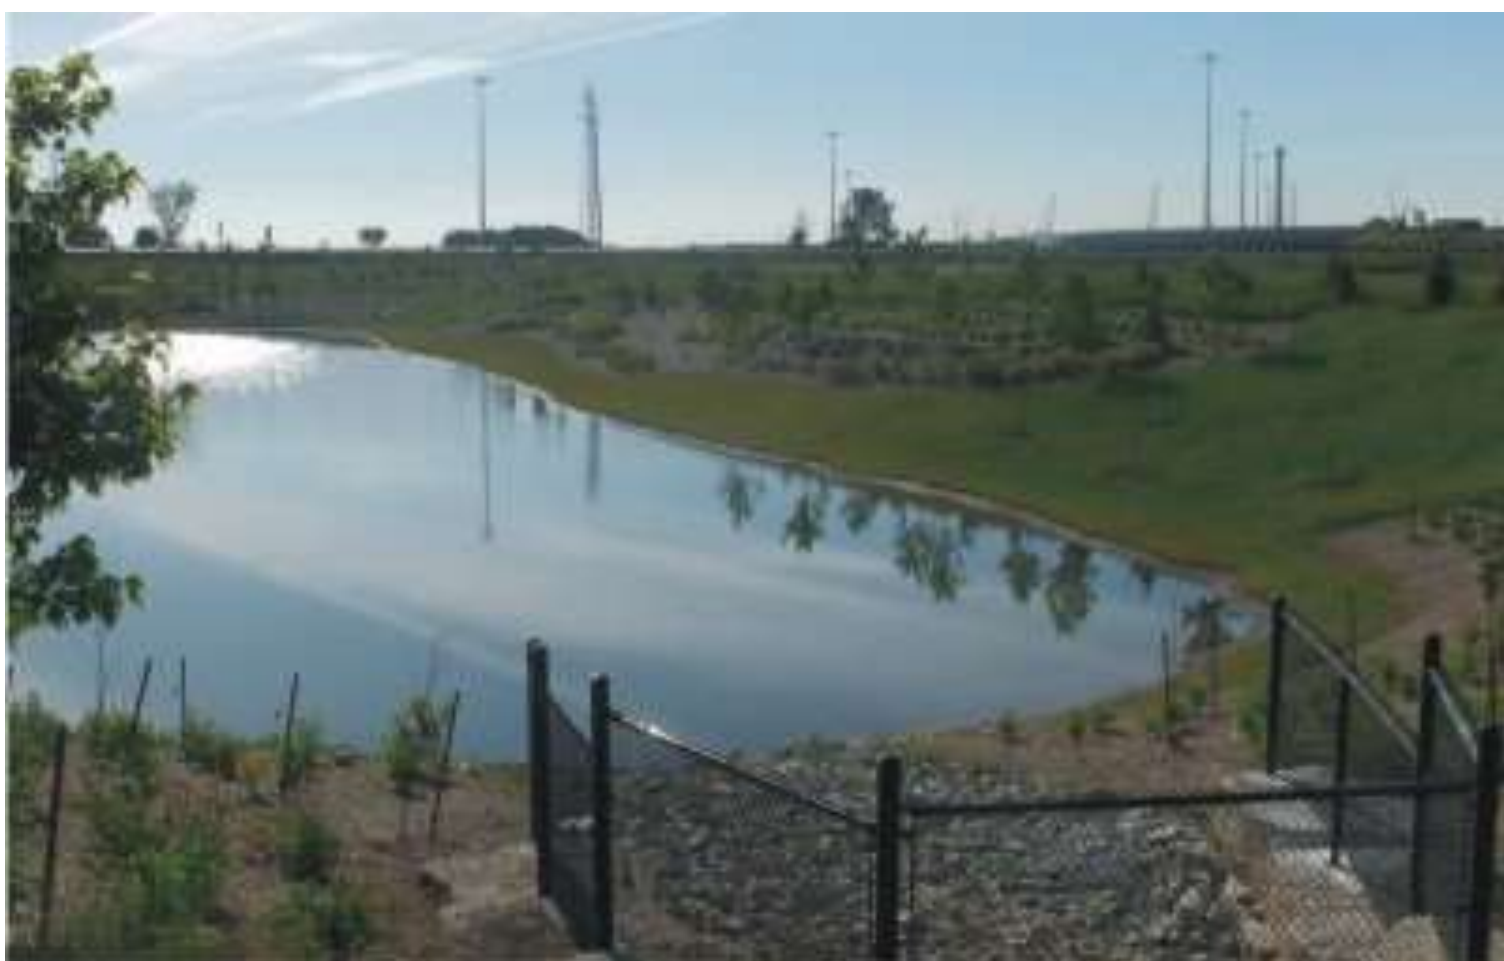
Traditional Stormwater Ponds

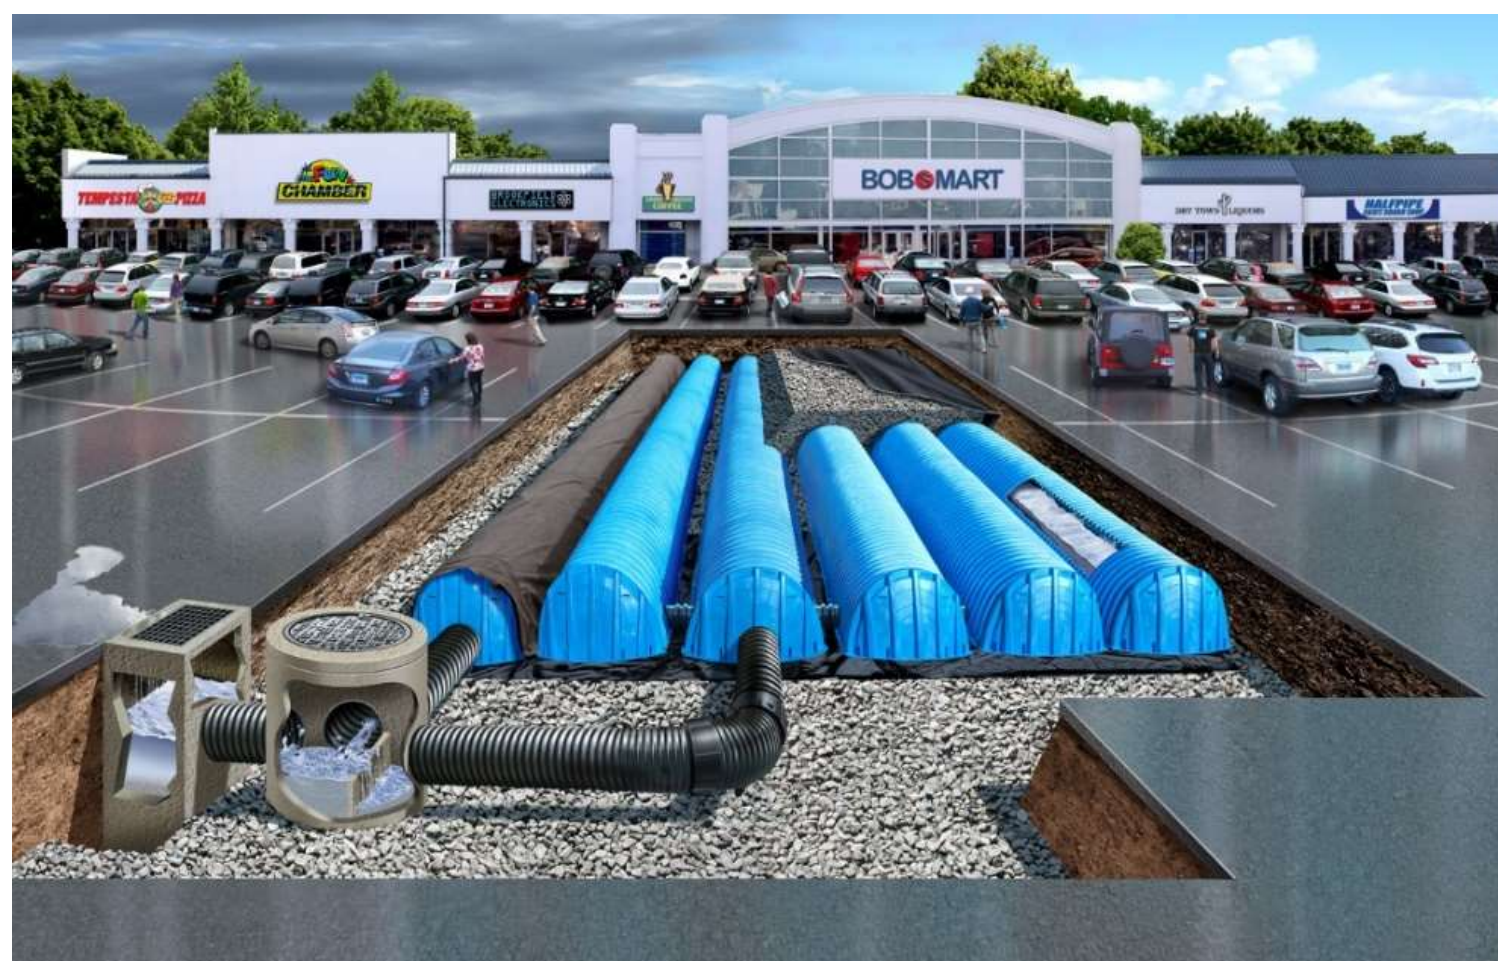
Underground Storage Systems

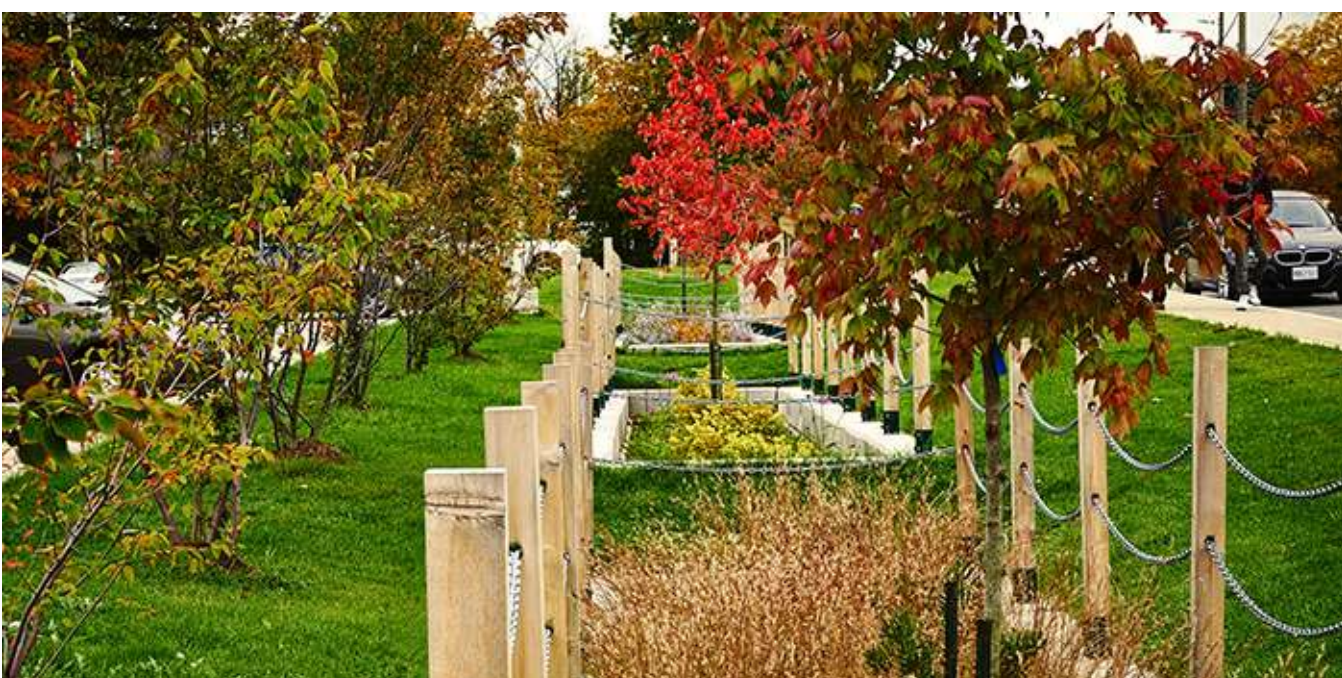
Low Impact Development Practices
