Natural Heritage Report

Southdown District Stormwater Servicing and Environmental Management Plan

Natural Environmental Conditions Report

PECG Project #
131129

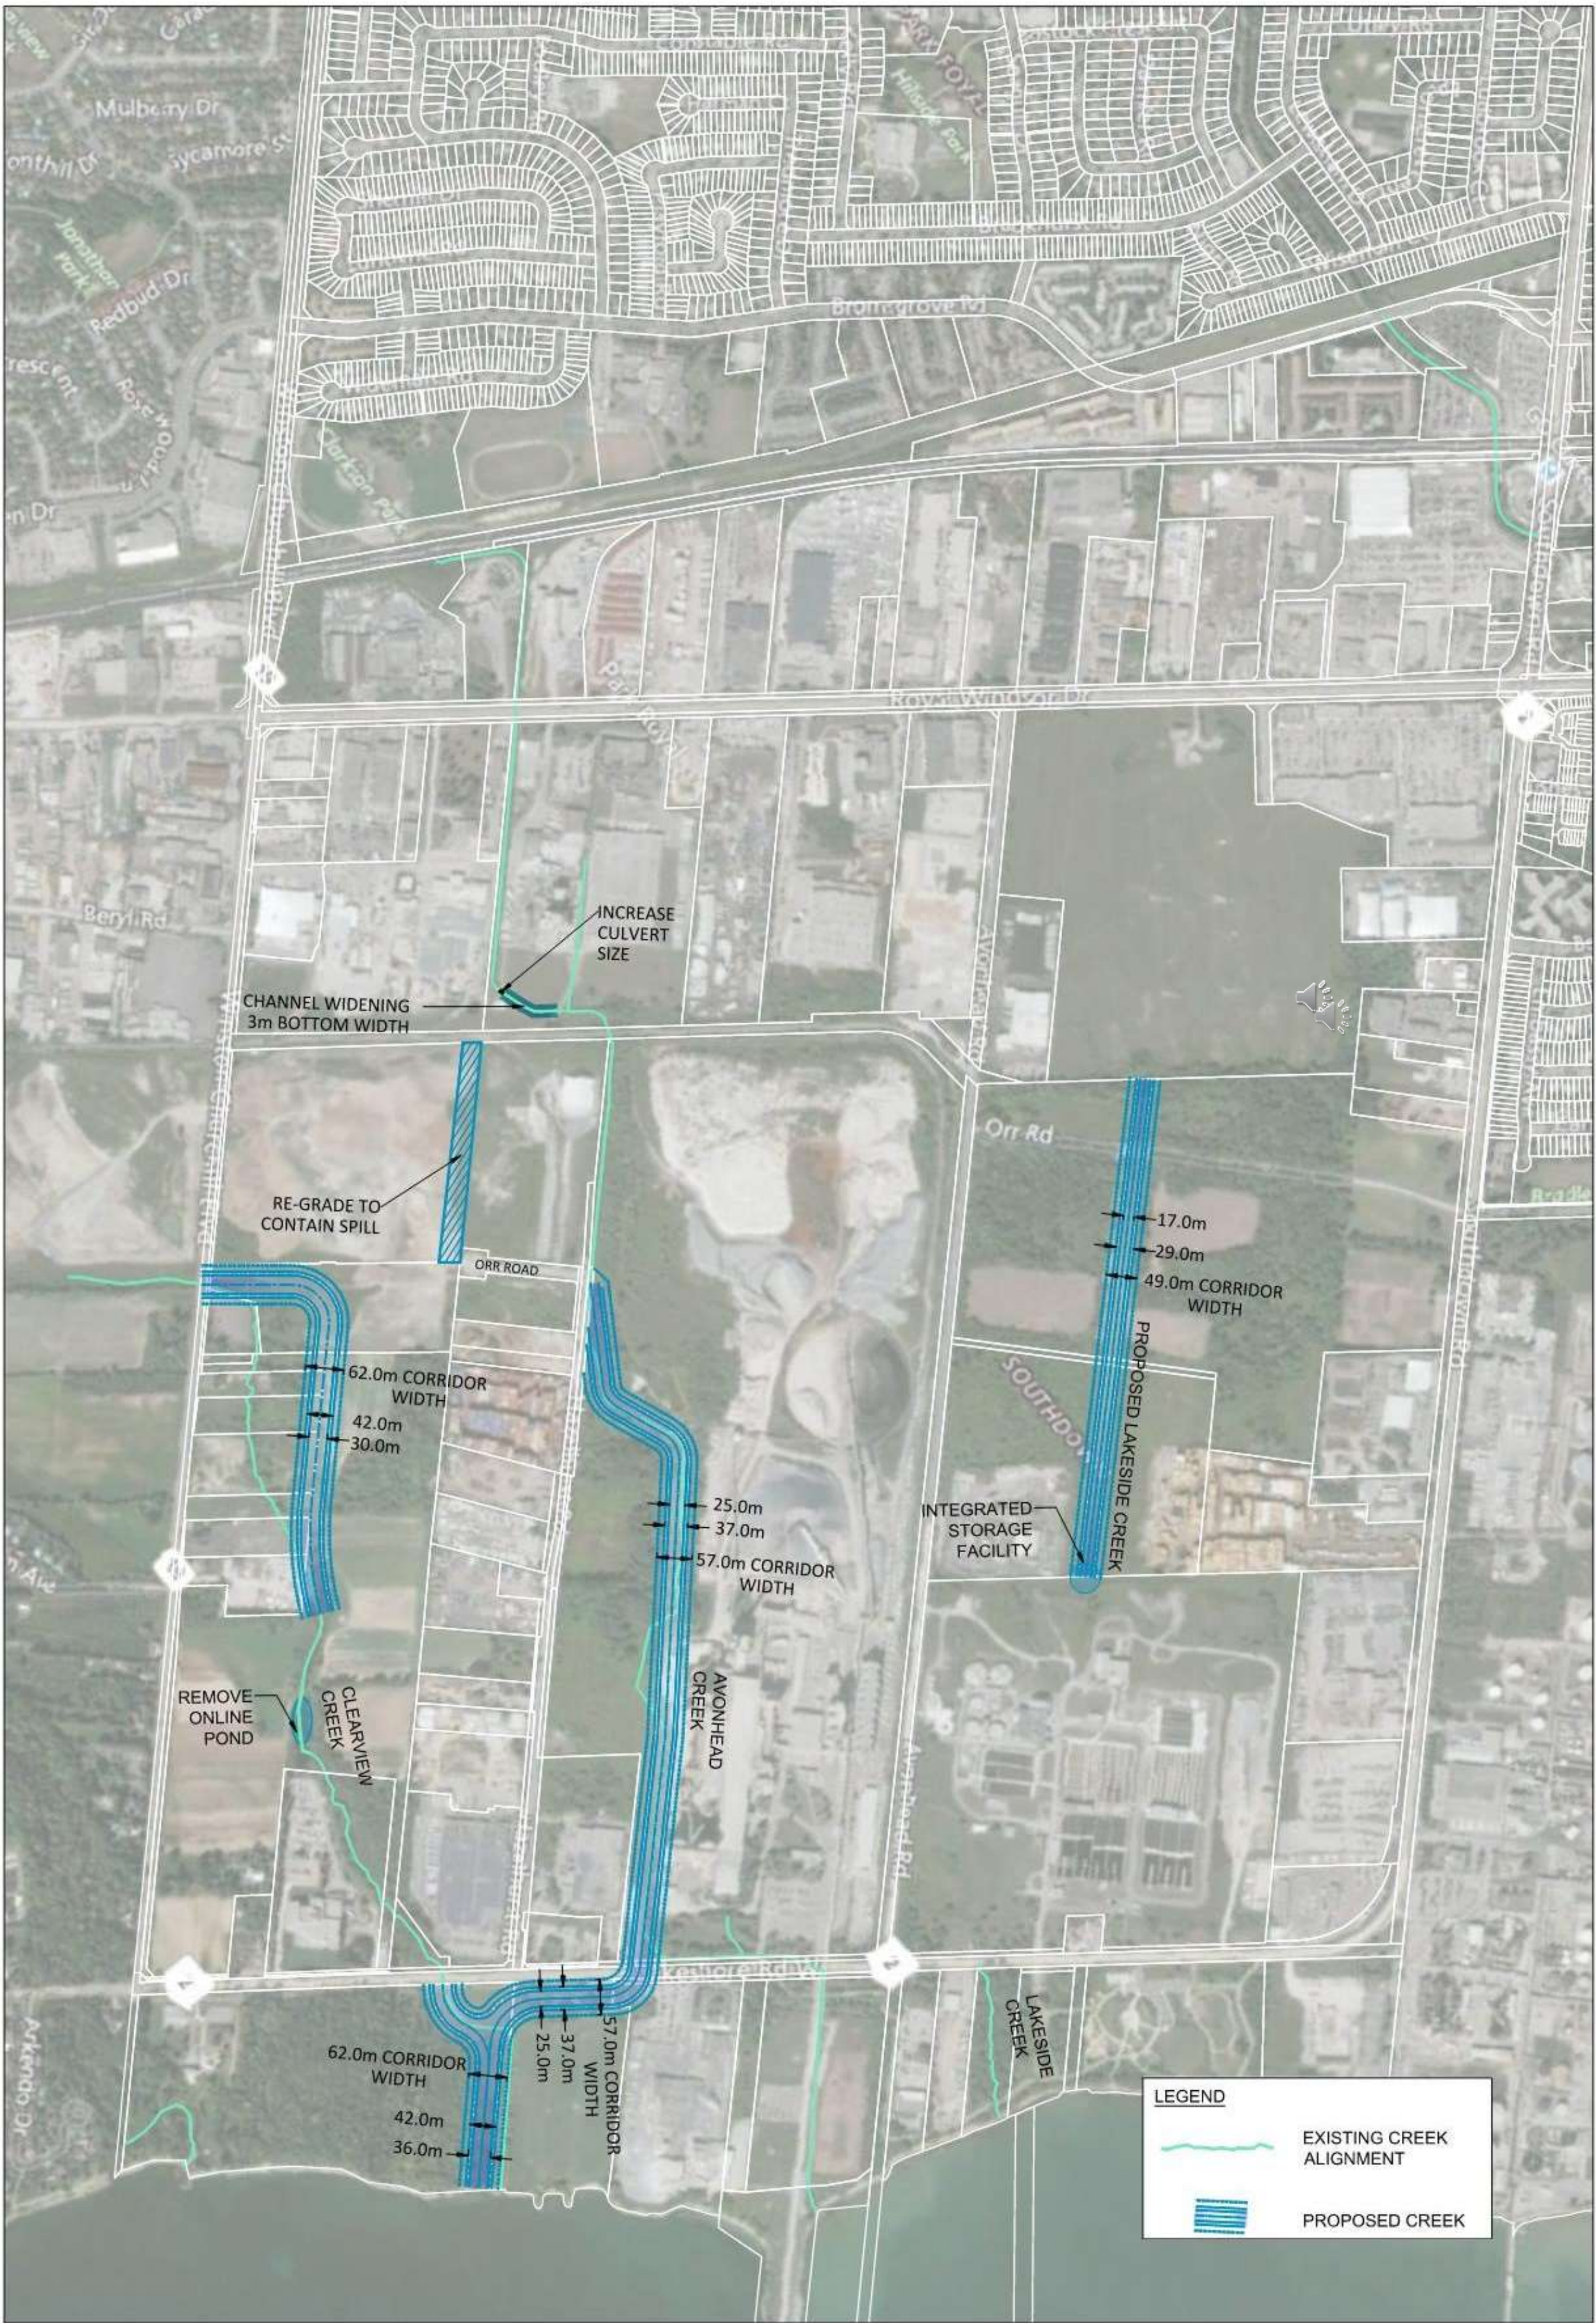
Alternative 5: Watercourse Improvements

Clearview Creek

- Realignment and reconstruction of channel west of Winston Churchill Boulevard (62 m wide corridor)
- Replacement of the concrete channel south of Lakeshore Road with a natural channel (62 m wide corridor)
- Removal of the online pond north of Lakeshore Road
- Cost: \$19.1 Million

2. *The ministry has concerns with the proposed realignment of the Clearview Creek channel downstream of Winston Churchill Blvd. Clearview Creek at that location has a natural meandering channel with vegetated buffers on both banks. The proposed realignment of the channel could disturb the established aquatic and floodplain habitat and the natural hydrologic regime of the creek. The proposed design of the new channel has a sharp 90 degree turn from the eastern direction to the south that could impede the streamflow during high water levels and discharges and cause flooding within upstream areas.*

Realignment and improvements to the creek will be subject to a Schedule B Municipal Class EA. The ministry recommends refining this solution to mitigate potential adverse impacts to the creek. A commitment should be made to develop a monitoring plan during the EA process to ensure any changes do not impede the streamflow and natural hydrologic function of the creek.
