**REPORT ON
PHASE II ENVIRONMENTAL SITE ASSESSMENT
3575 KANEFF CRESCENT
MISSISSAUGA, ONTARIO**

**REPORT NO.: 6027-22-EB
REPORT DATE: MAY 1, 2022**

**PREPARED FOR
KANEFF GROUP OF COMPANIES
8501 MISSISSAUGA ROAD
BRAMPTON, ONTARIO
L6Y 5G8**

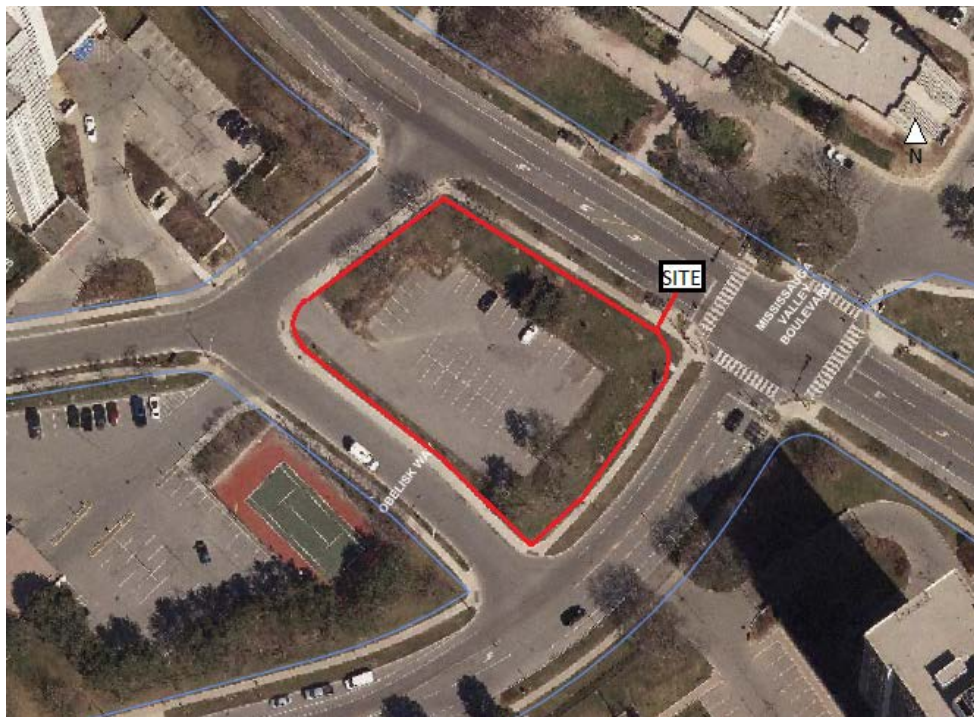
The Site, approximately 0.27 Ha in area and close to rectangle in shape, is bounded by Kaneff Crescent on the north side, Mississauga Valley Boulevard on the east side, Elm Drive East on the south side and Obelisk Way on the west side, approximately 200 m west of Hurontario Street, in Mississauga, Ontario. At the time of the investigation, the Site was occupied by a paved parking lot and associated landscape areas located on the perimeter.

Image 1: Aerial image of Site located 3575 Kaneff Crescent, Mississauga, Ontario
(Source: Mississauga Interactive Map, 2021)
