Re: Hydrogeological Assessment
1000 & 1024 Dundas Street East, Mississauga, Ontario
Pinchin File: 275471.004

Pinchin Ltd. (Pinchin) has been retained by Ahmed Developments Inc. (Client) to provide a hydrogeological assessment for the proposed redevelopment of the property located at 1000 & 1024 Dundas Street East (Site), in the City of Mississauga (City), Ontario.

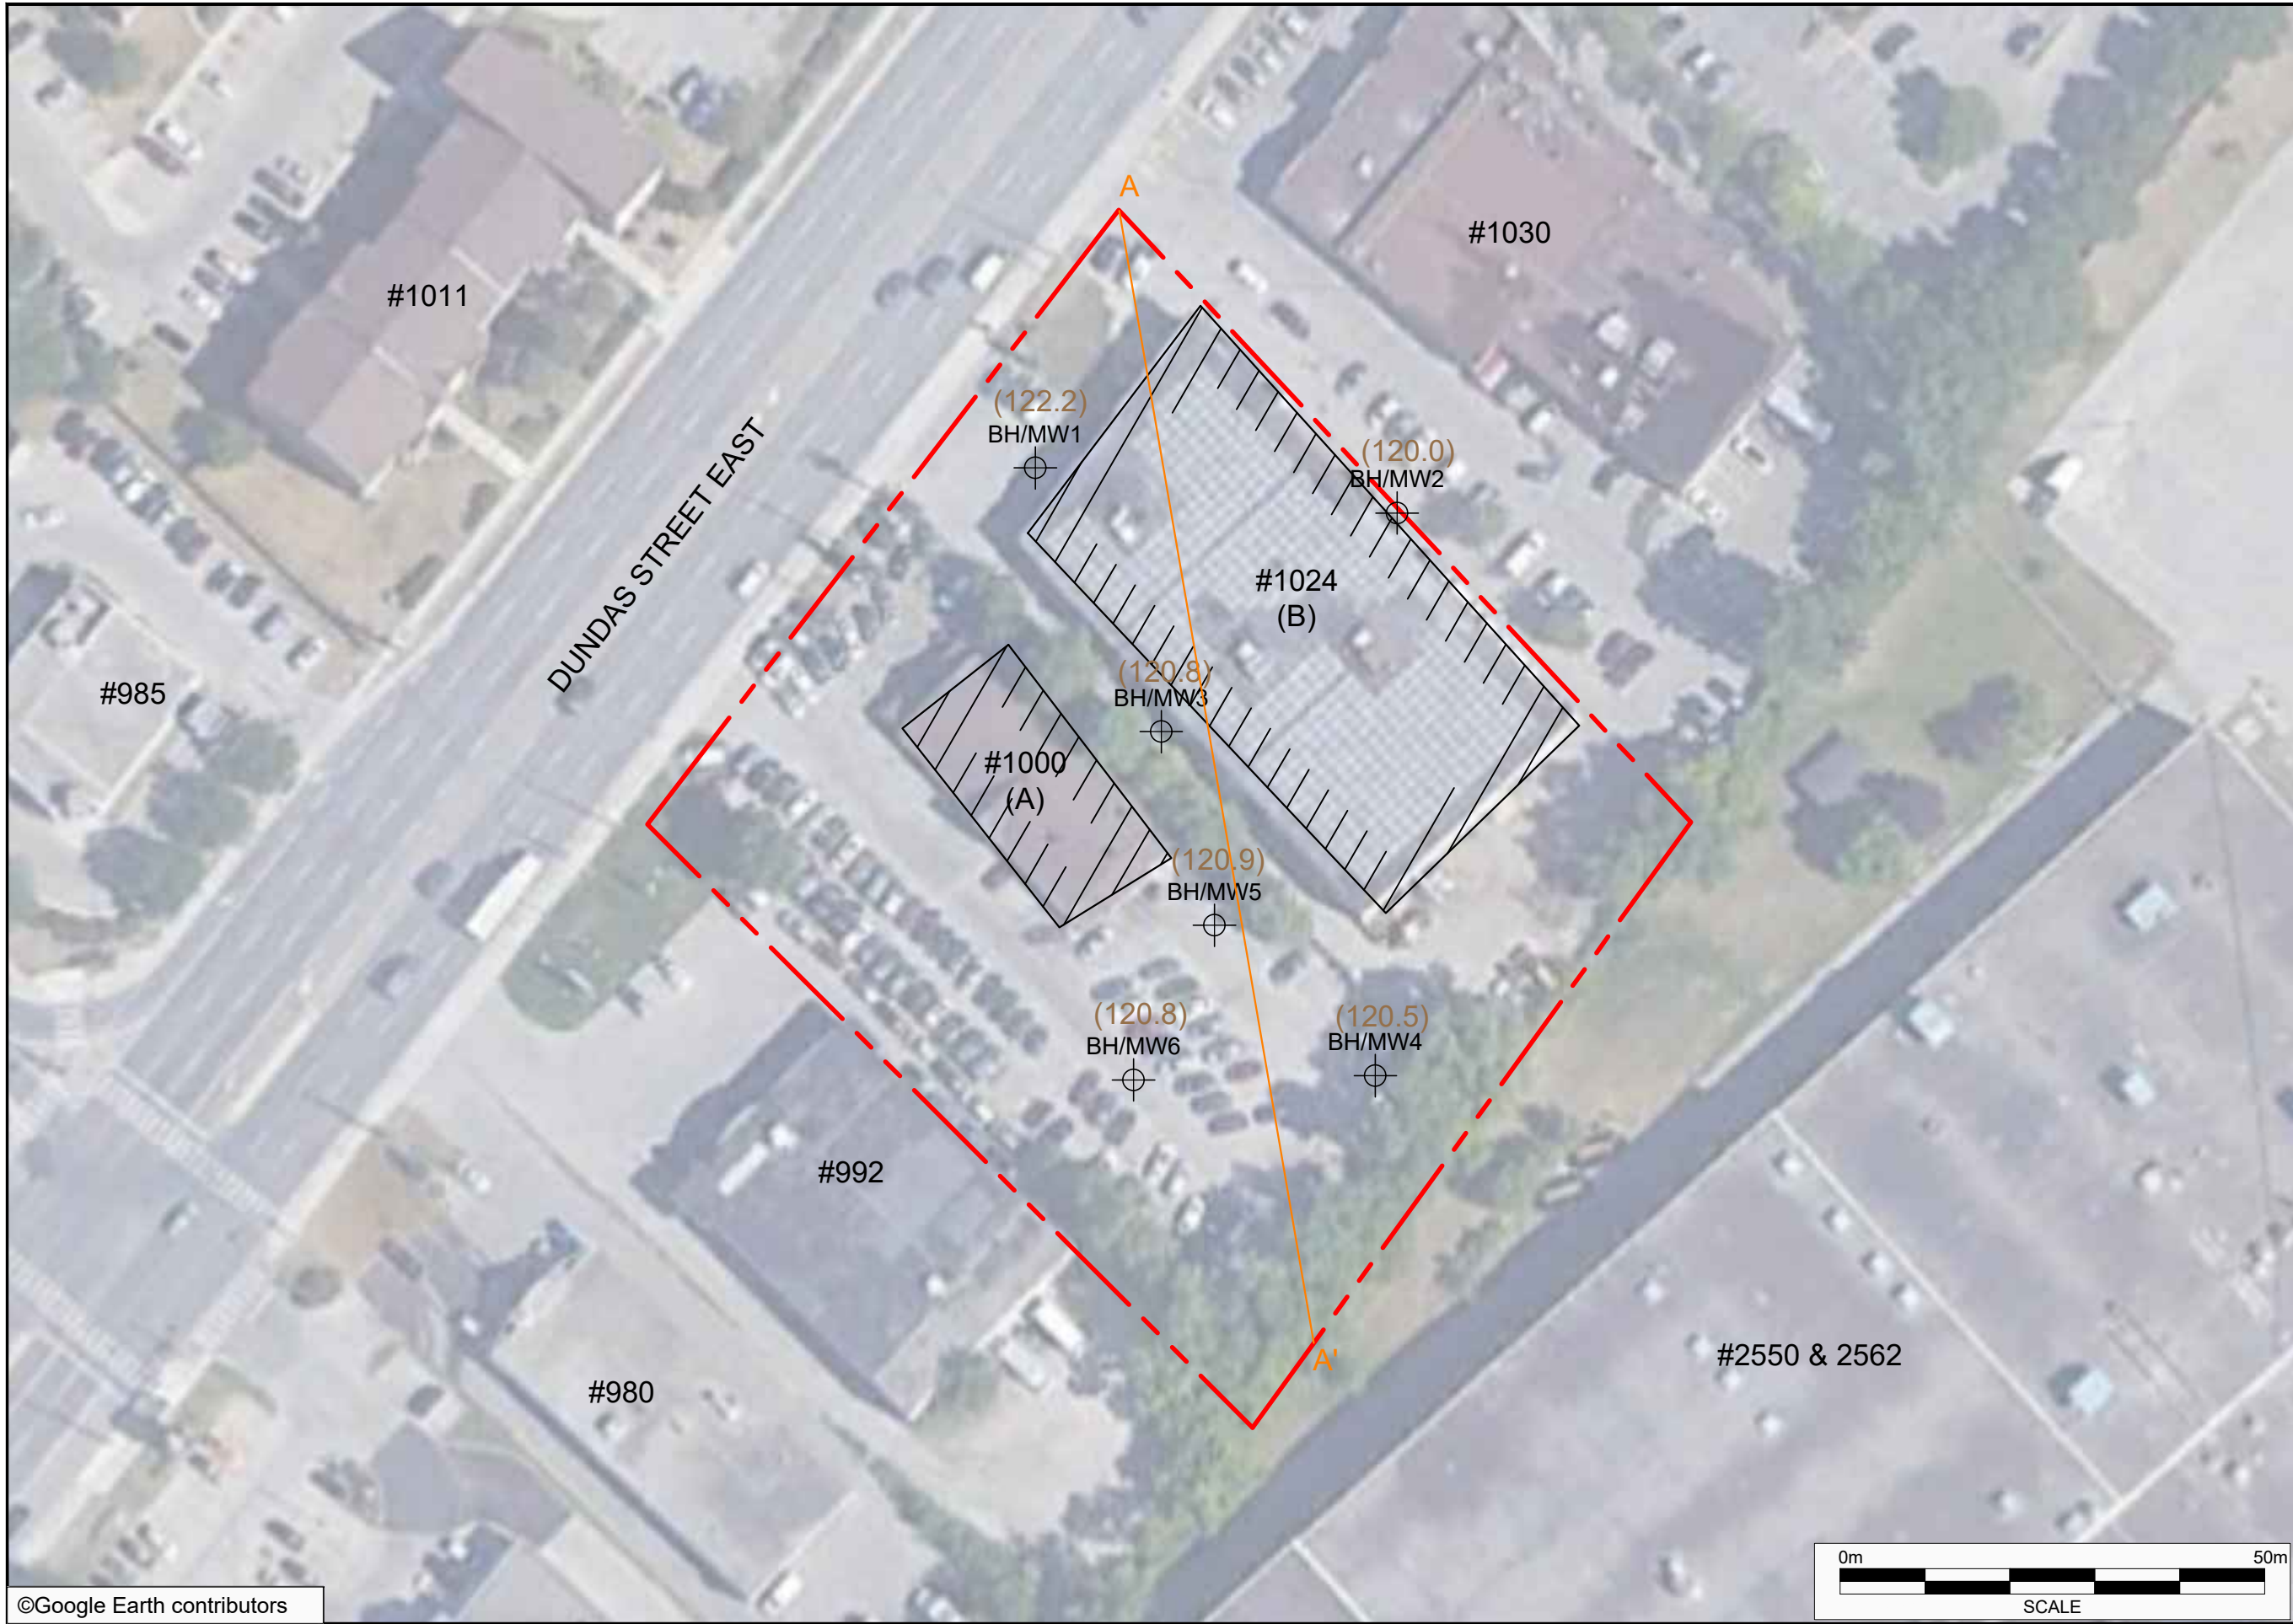
PROJECT NUMBER: 275471.004	SCALE: AS SHOWN
DRAWN BY: KP	REVIEWED BY: BG
DATE: NOV. 2021	FIGURE NUMBER: 2

The approximate borehole/monitoring well locations are shown on Figure 2. The borehole logs for the boreholes/monitoring wells are provided in Appendix III.

FIGURE NAME:
**BOREHOLE/MONITORING WELL
LOCATION PLAN**

Six monitoring wells were completed at the Site. The approximate monitoring well locations are shown in Figure 2 and the monitoring well construction details are presented in Table 1.

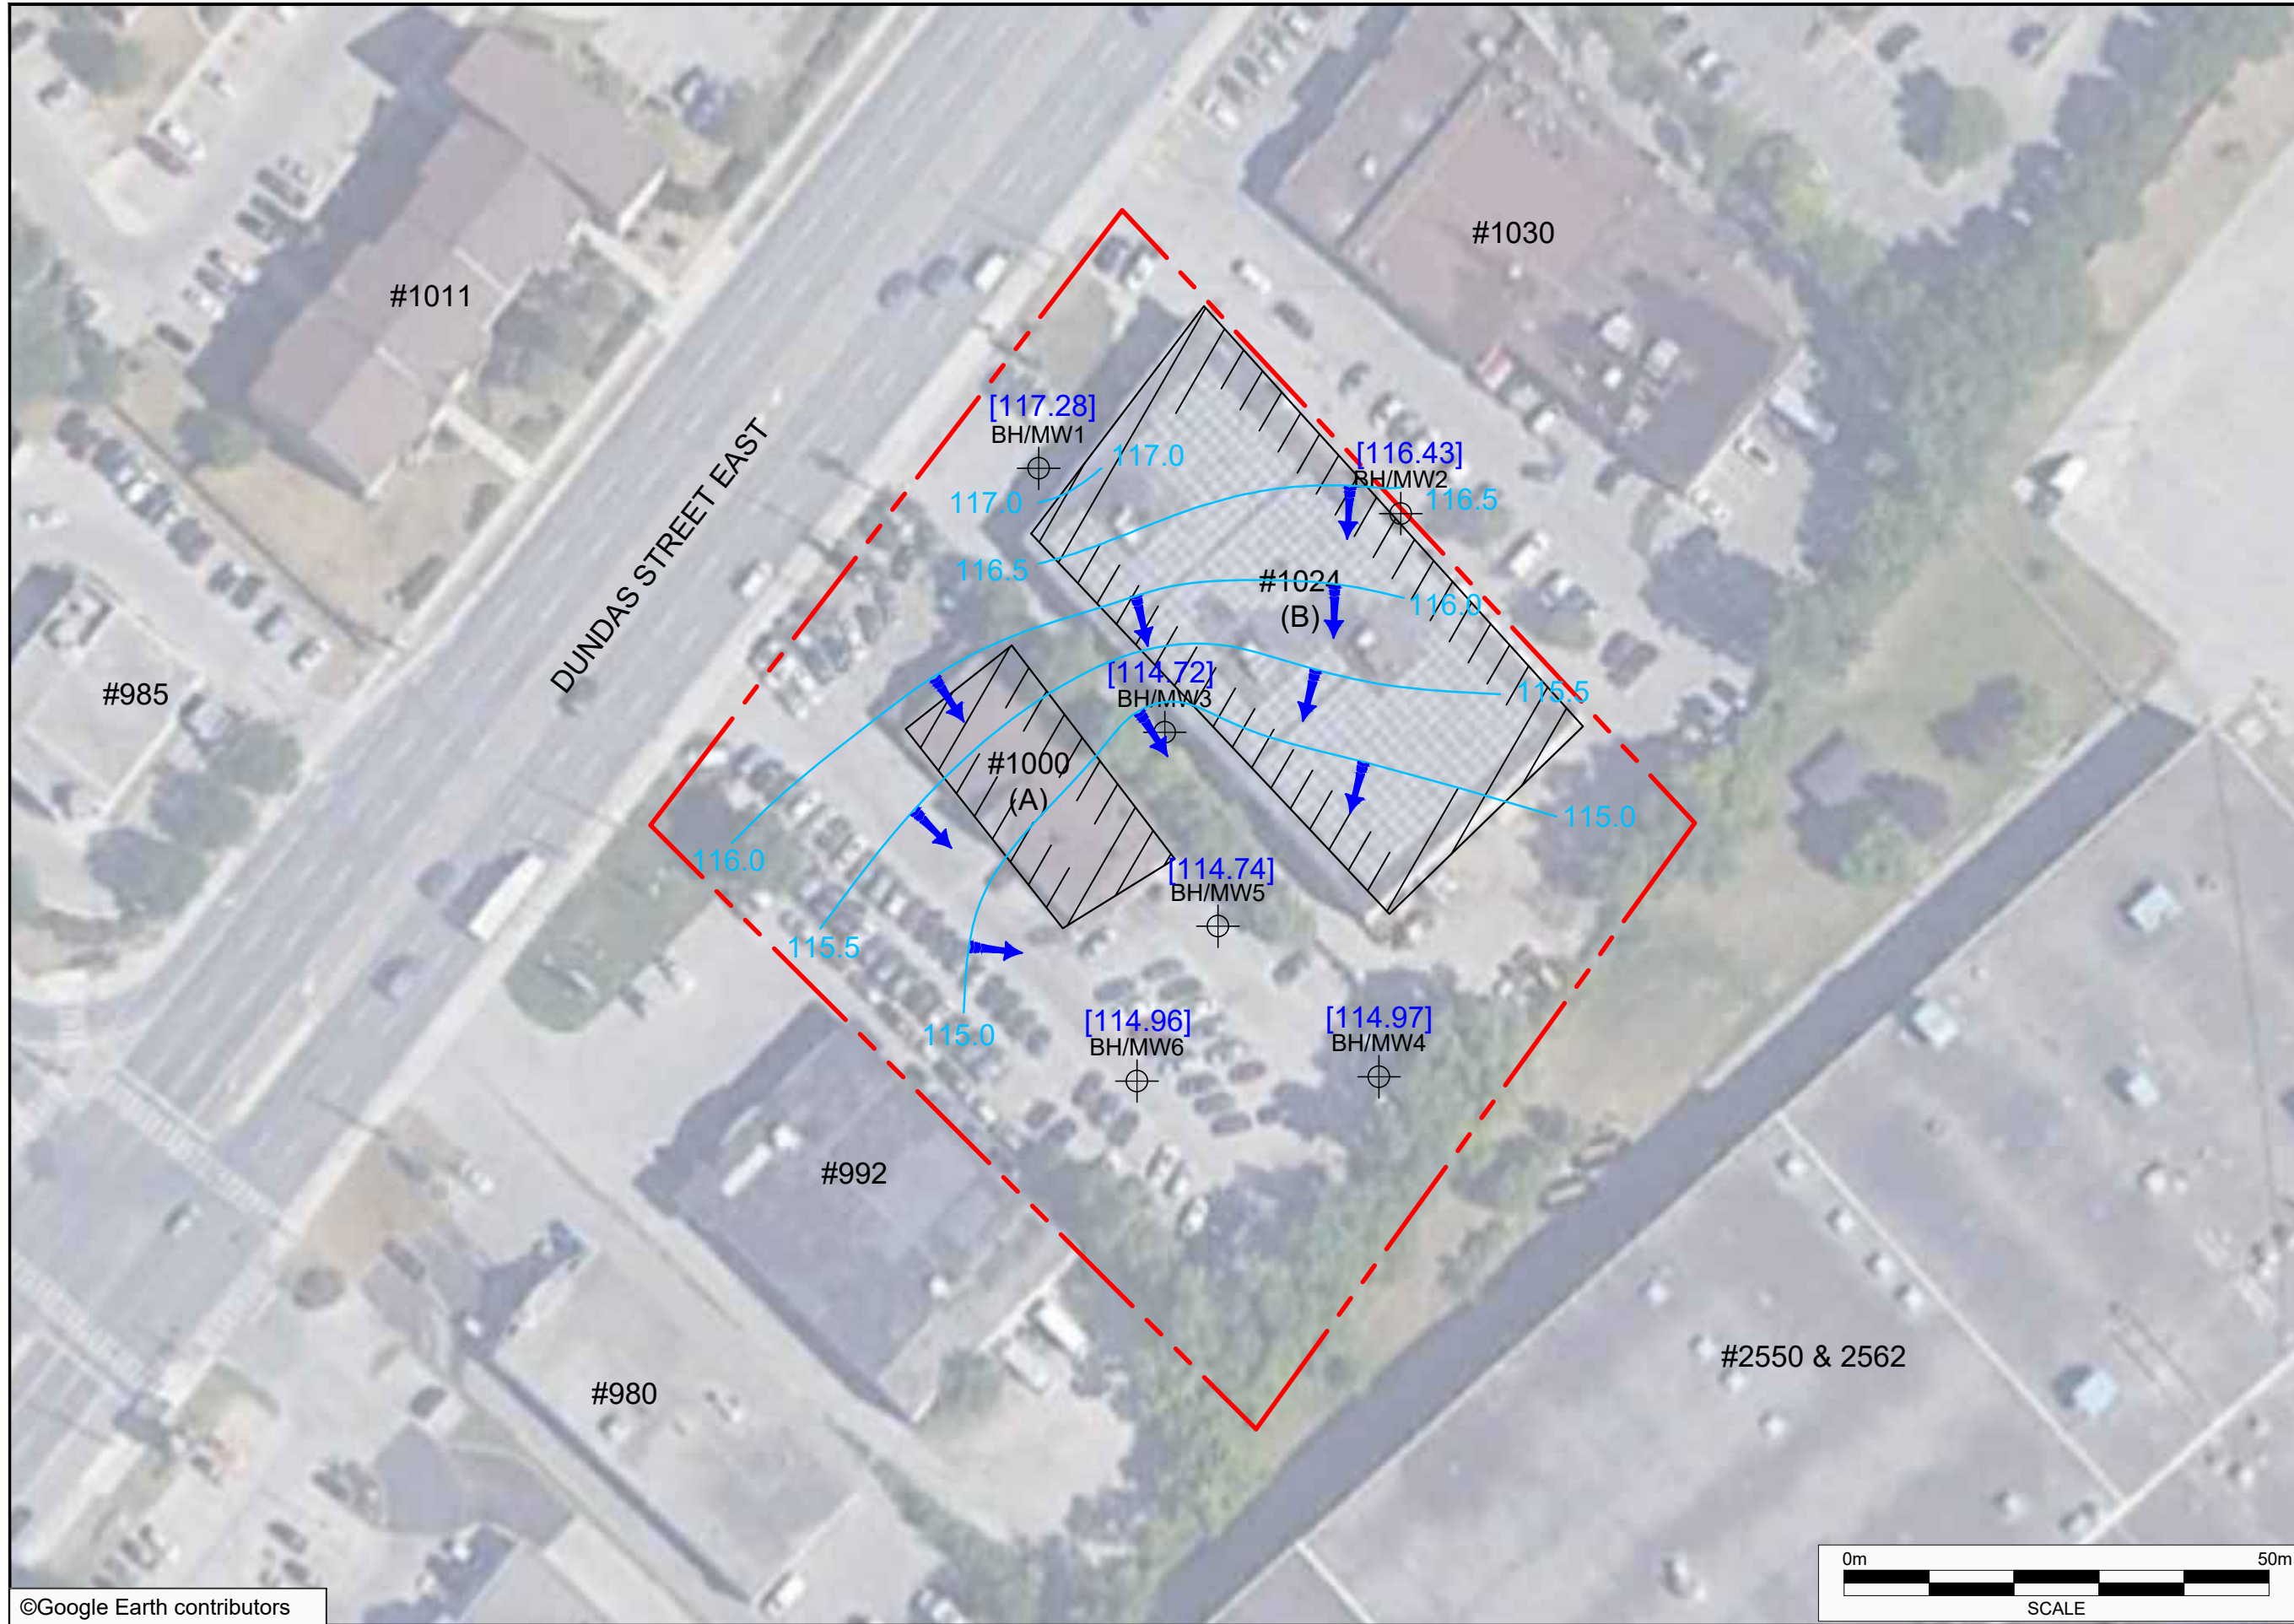
Based on the groundwater elevations obtained on November 23, 2021, groundwater elevation contours were prepared and are presented on Figure 5. The groundwater flow directions across the Site were inferred to be generally towards the south.

- SITE BOUNDARY
- SITE BUILDING
- BOREHOLE/MONITORING WELL (PINCHIN 2021)
- GROUNDWATER ELEVATION IN masl
- METRES ABOVE SEA LEVEL
- GROUNDWATER CONTOUR ELEVATION IN masl
- INFERRED GROUNDWATER FLOW DIRECTION

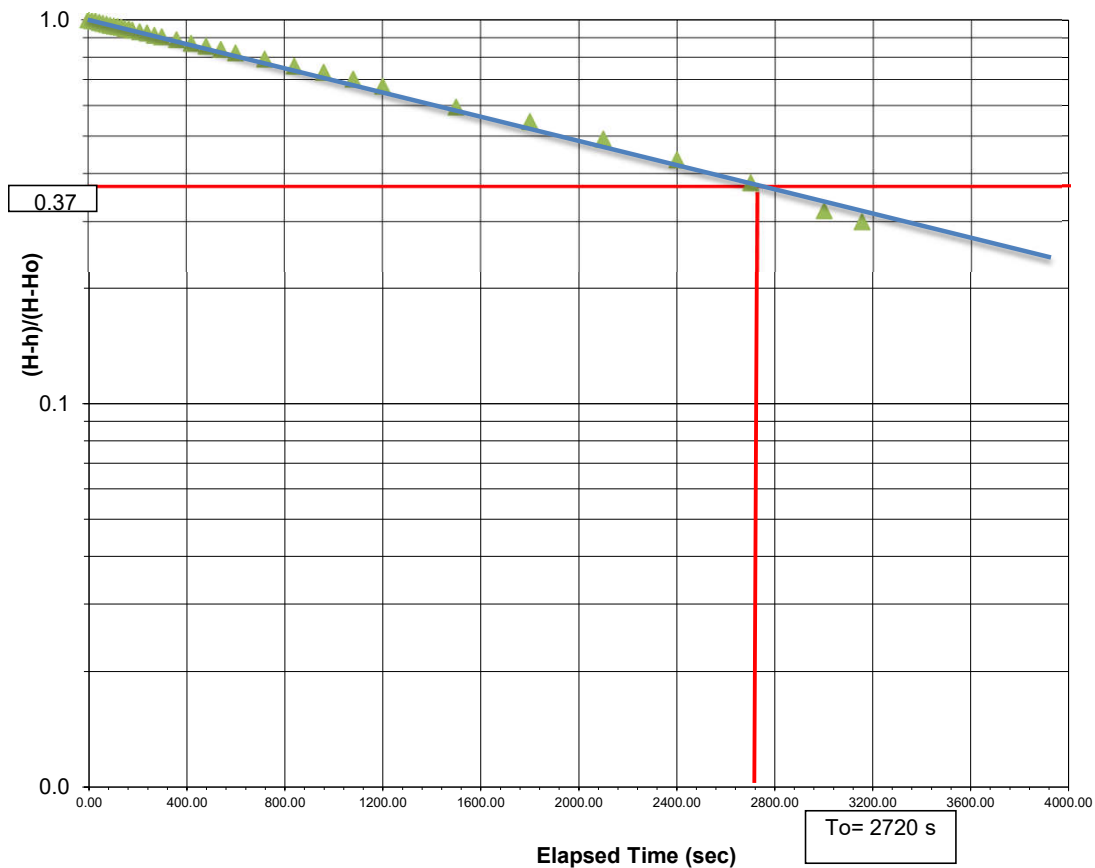
Slug Test Result (Hvorslev Method) - MW3
Based on Manual Measurement/Rising Head Method

$K = r^2 \ln(L/R) / (2LT_o) = 1.3E-05$ cm/s

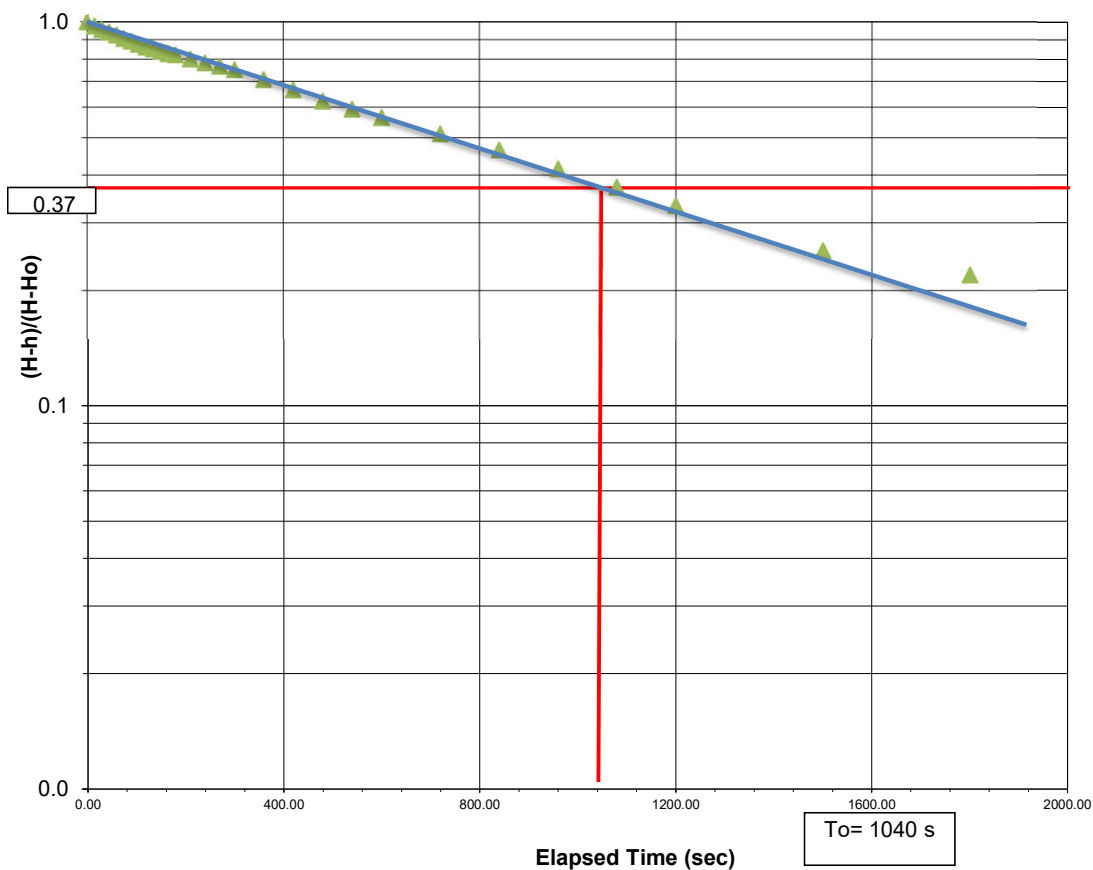
Slug Test Result (Hvorslev Method) - MW4
Based on Manual Measurement/Rising Head Method

Slug Test: MW4		Project No.: 275471	
Project Location: 1000 & 1024 Dundas Street East, Mississauga, Ontario			
Data Source: based on Manual Measurement as per Rising Head Method dated November 15, 2021			
Conducted by:		Yorgan Pitt	
Interpretted by:	Bujing Guan	H =	Initial Water Head prior to test
Processing Date:	11/22/2021	Ho =	Water Head at time = 0
Screen Depth (mBGS):	6.1 - 9.1	h =	Water Head/Level at time t
Screened Soil:		shale with limestone/dolostone stringers	
Well Diameter:	2.0" ID	L =	305 cm
Static Water Level (mBGS):	5.13	R =	10.2 cm
Initial Reading (mBGS)	5.13	r =	2.54 cm
Test Start Reading (mBGS)	6.92	To =	1040 sec
Test End Reading (mBGS)	5.486	$K = r^2 \ln(L/R)/(2LT_o) =$	<div>3.5E-05 cm/s</div>

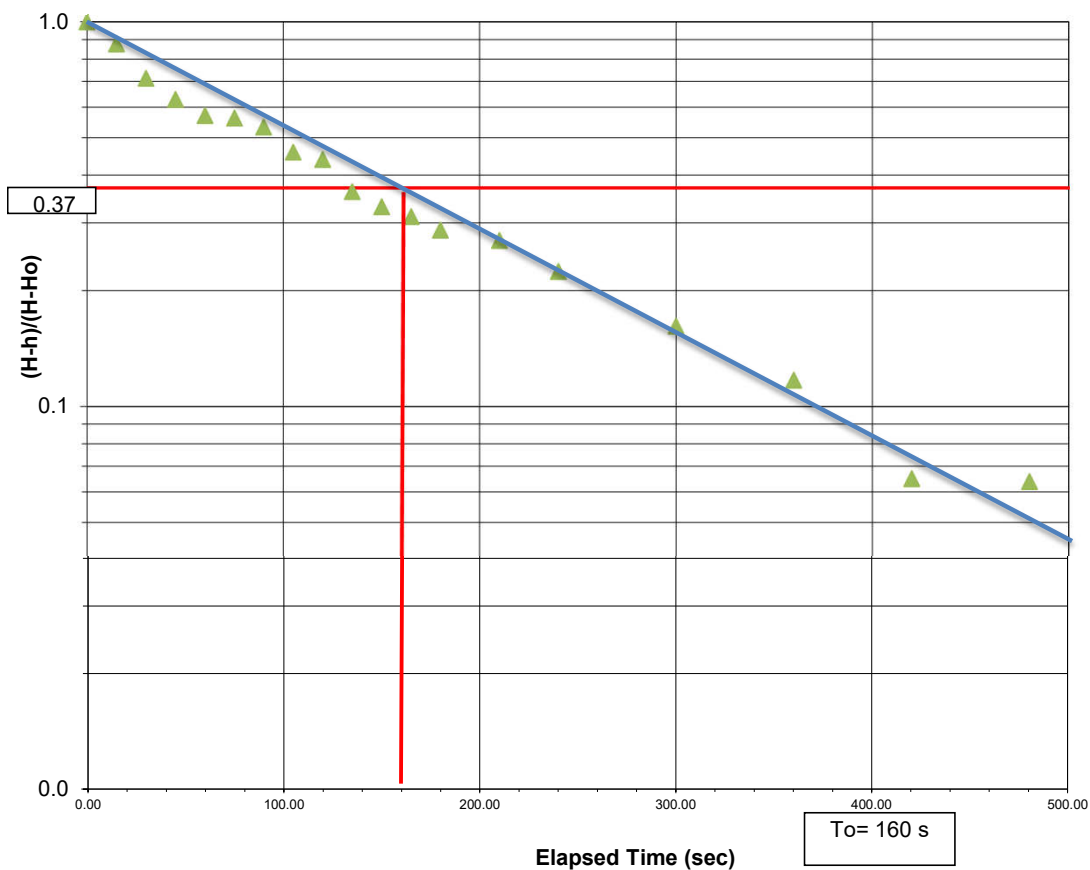
Slug Test Result (Hvorslev Method) - MW5
Based on Manual Measurement/Rising Head Method

Slug Test: MW5		Project No.: 275471	
Project Location: 1000 & 1024 Dundas Street East, Mississauga, Ontario			
Data Source: based on Manual Measurement as per Rising Head Method dated November 15, 2021			
Conducted by:		Yorgan Pitt	
Interpretted by:	Bujing Guan	H =	Initial Water Head prior to test
Processing Date:	11/22/2021	Ho =	Water Head at time = 0
Screen Depth (mBGS):	6.1 - 9.1	h =	Water Head/Level at time t
Screened Soil:		shale with limestone/dolostone stringers	
Well Diameter:	2.0" ID	L =	296 cm
Static Water Level (mBGS):	6.14	R =	10.2 cm
Initial Reading (mTOC)	6.07	r =	2.54 cm
Test Start Reading (mTOC)	7.01	To =	160 sec
Test End Reading (mTOC)	6.073	$K = r^2 \ln(L/R)/(2LT_o) =$	<div>2.3E-04 cm/s</div>

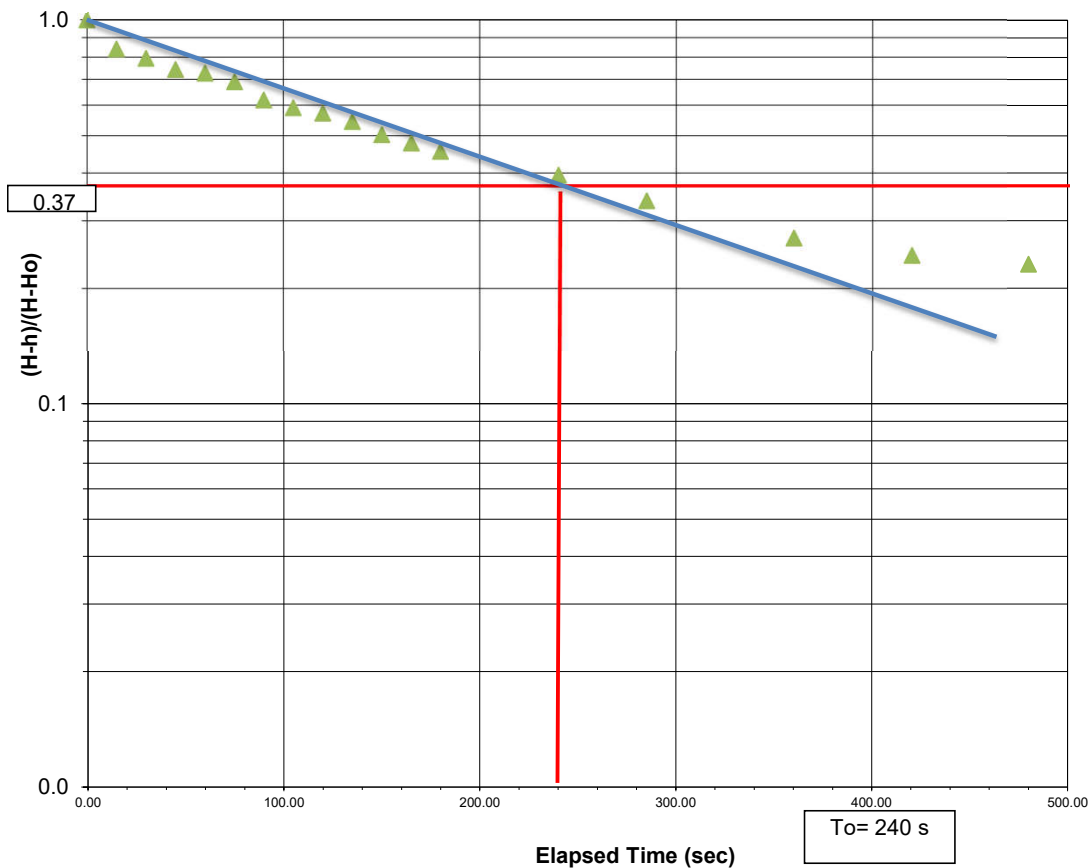
$K = r^2 \ln(L/R) / (2LT_o) = 1.5E-04$ cm/s**Slug Test Result (Hvorslev Method) - MW6**
Based on Manual Measurement/Rising Head Method
