# **Phase One Environmental Site Assessment**

1000 and 1024 Dundas Street East  
Mississauga, Ontario

**Ahmed Developments Inc.**

July 27, 2022

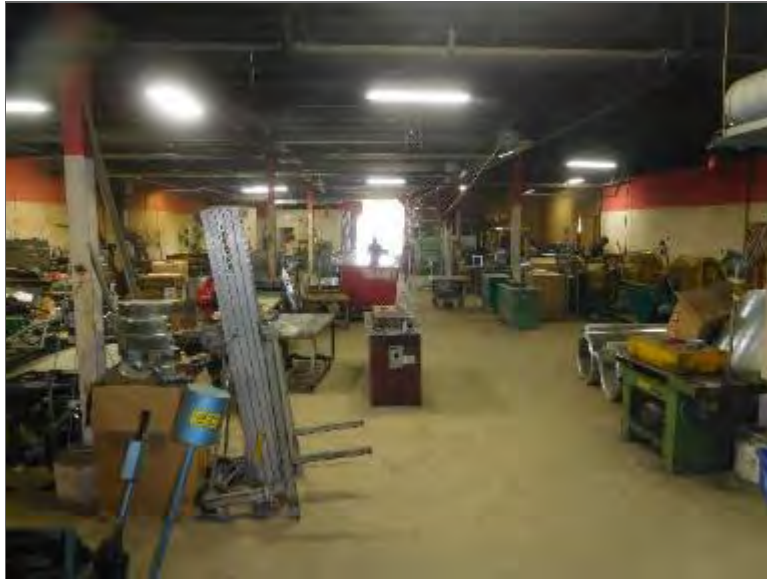
Photo 11 – Sheet metal fabricator in the southeastern portion of the basement of Site Building B, facing southeast.

- On-Site metal fabricating activities in part of the basement of Site Building B. As described in Section 6.2.1, the same sheet metal fabricator was observed in the southeastern portion of Site Building B during the Site reconnaissance; and

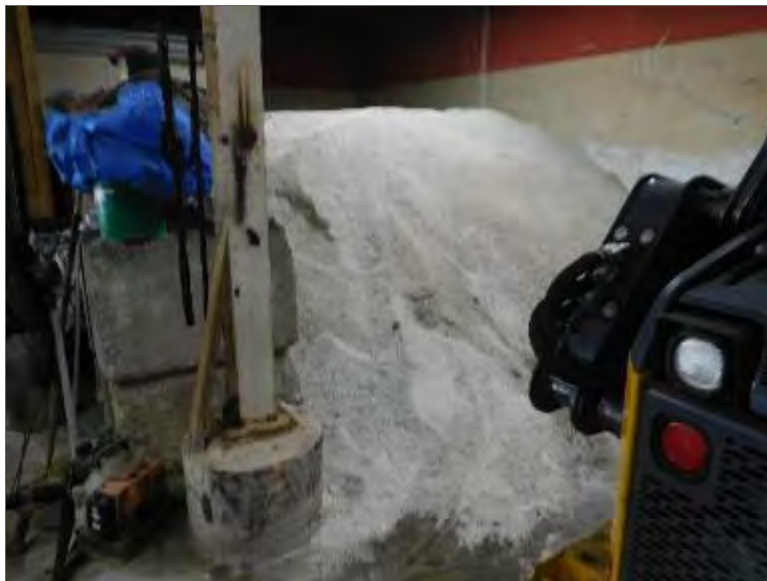
Photo 12 – Bulk salt storage in the southwestern portion of the basement of Site Building B, facing south.

The Phase One Property has paved driveways, access routes and parking areas exterior to the Site Buildings. It is Pinchin's understanding that salt has historically been applied to the exterior paved areas for safety reasons during winter conditions to remove snow and ice, which represents a PCA and an APEC at the Phase One Property. However, it is the opinion of the QP supervising the Phase One ESA that, although salt-related parameters such as Sodium Adsorption Ratio and electrical conductivity in soil and sodium and chloride in groundwater may be present at concentrations exceeding the applicable Site Condition Standards, the exemption provided in Section 49.1 of O. Reg. 153/04 can be applied. As such, these parameters would be deemed to meet the Site Condition Standards and do not need to be assessed as part of a Phase Two ESA.

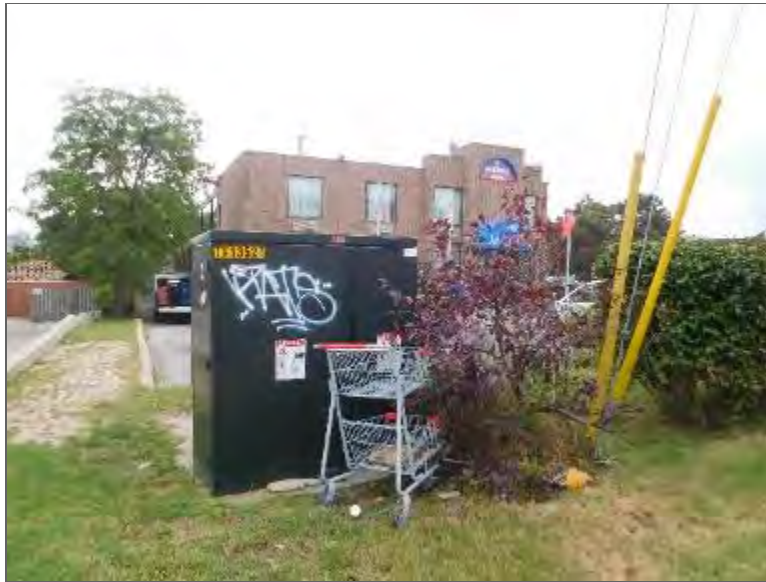
Photo 17 – Electrical transformer at 1060 Dundas Street East, facing south.

PCA-14	1060 Dundas Street East.	Item 55 - Transformer Manufacturing, Processing and Use	Off-Site	No	Not Applicable
PCA-15	2580 Stanfield Road.	Item 27 - Garages and Maintenance and Repair of Railcars, Marine Vehicles and Aviation Vehicles	Off-Site	No	Not Applicable
PCA-16	Approximately 160m southeast of the Phase One Property.	Item 46 - Rail Yards, Tracks and Spurs	Off-Site	No	Not Applicable
PCA-17	922 Dundas Street East.	Item 27 - Garages and Maintenance and Repair of Railcars, Marine Vehicles and Aviation Vehicles	Off-Site	No	Not Applicable
PCA-18	2493 Haines Road.	Other - Industrial Operations	Off-Site	No	Not Applicable

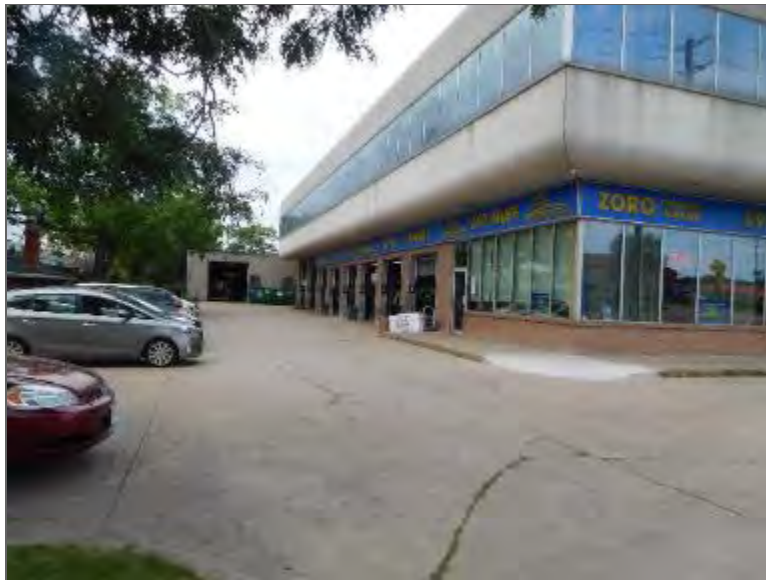
Photo 18 – Auto repair facility located at 2580 Stanfield Road, facing southwest.

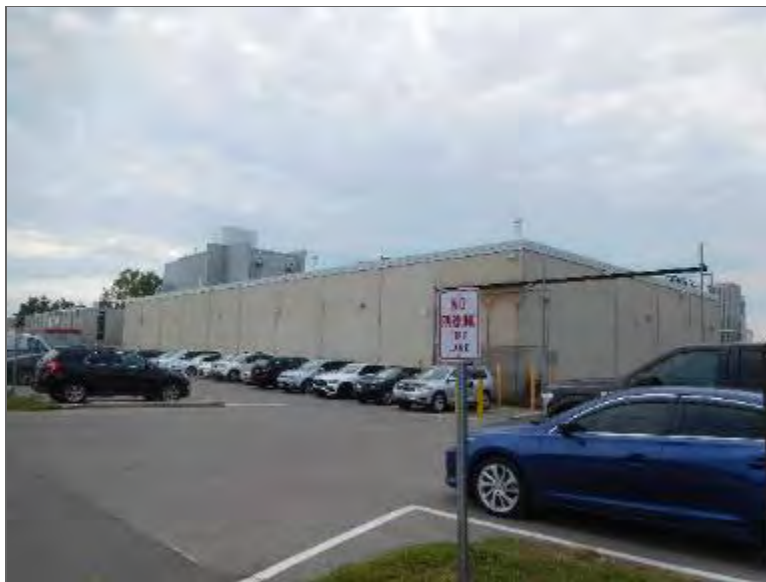
Photo 20 – Industrial bakery located at 2530 Stanfield Road, facing southwest.
