**PHASE ONE ENVIRONMENTAL SITE ASSESSMENT
65 AND 71 AGNES STREET
MISSISSAUGA, ONTARIO**

SIRATI & PARTNERS CONSULTANTS LTD.

Project: SP21-826-20
April 30, 2021

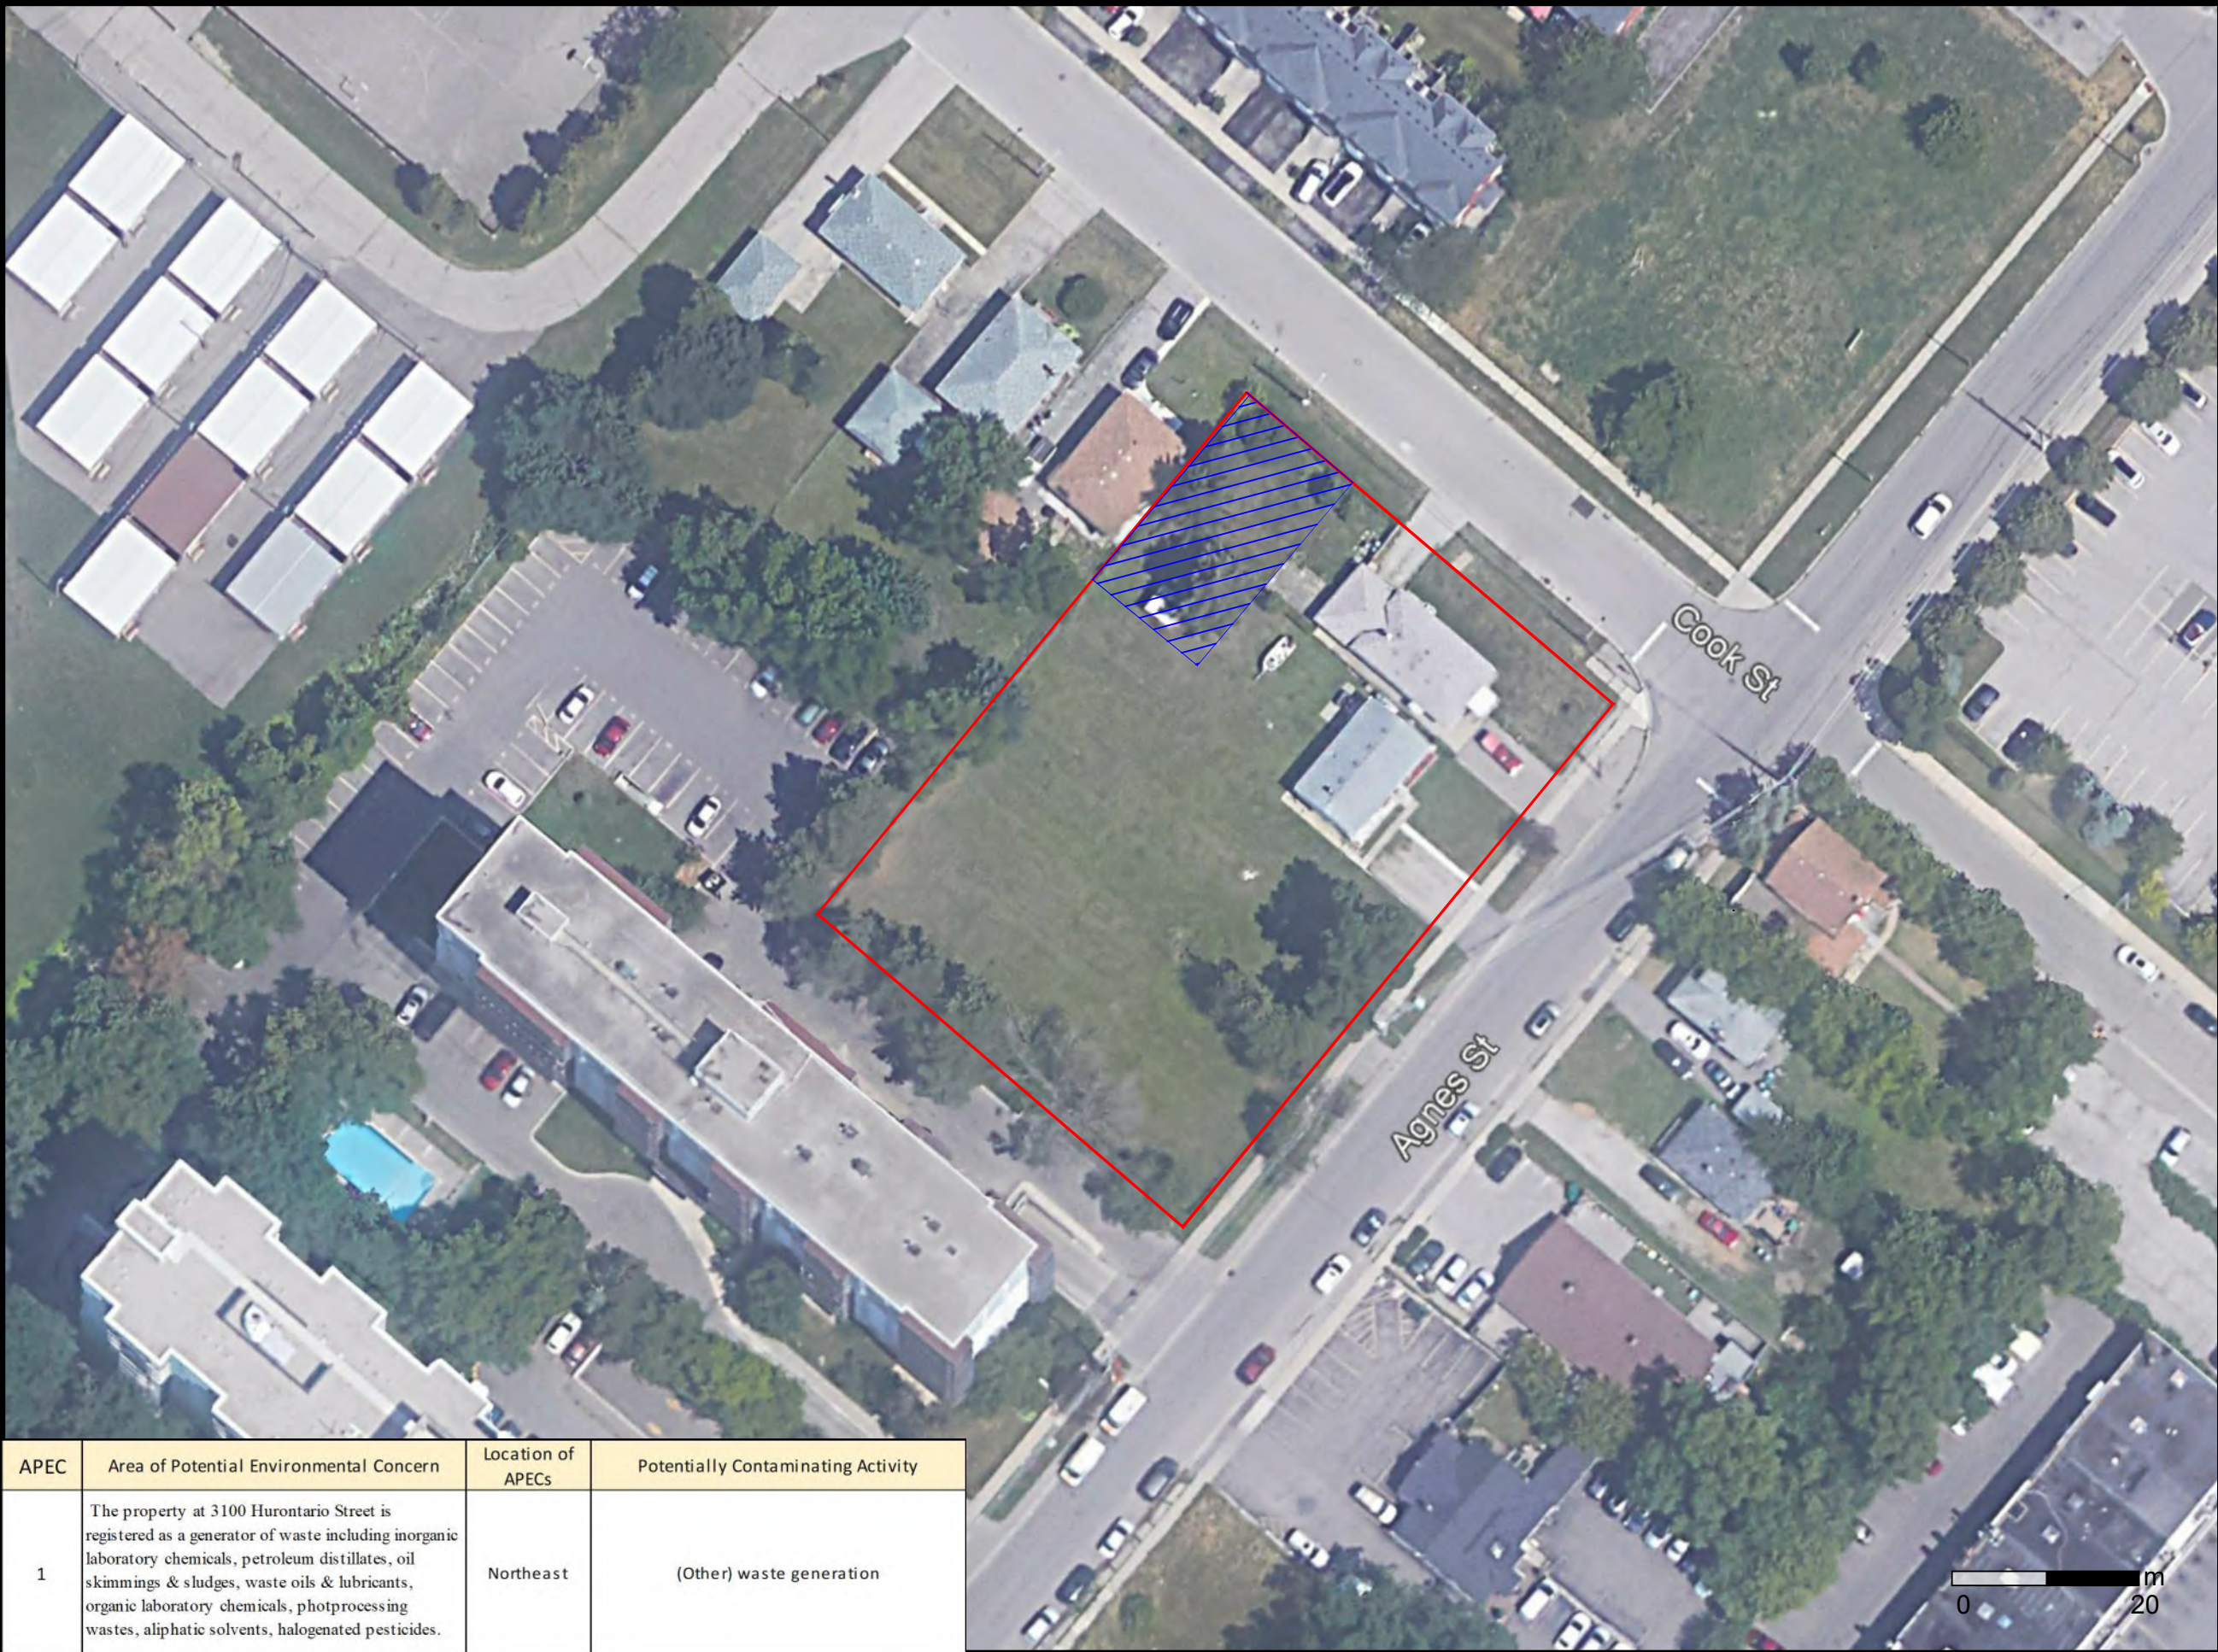
3

Based on the information obtained by the aerial photographs (Section 4.3.1), property use records (Section 4.1.6), previous reports (Section 4.1.5), environmental source information (Section 4.2), interview (Section 5.0) and Site Reconnaissance (Section 6.0) indicate ten (10) activities that are considered to be PCAs, as defined by Table 2 of Schedule D in O. Reg. 153/04, and are summarized in Table 1 in Executive Summary. These PCAs have historically been or are currently located within the Phase One Study Area. The column identifying the PCAs as being up-gradient (Y/N) refers to the inferred southeast groundwater flow direction in the area relative to the Phase One Property. A comprehensive list of PCA types and locations present in the Phase One Study Area are also shown on Figure 3.

The location of these PCAs are presented on Figure 3.

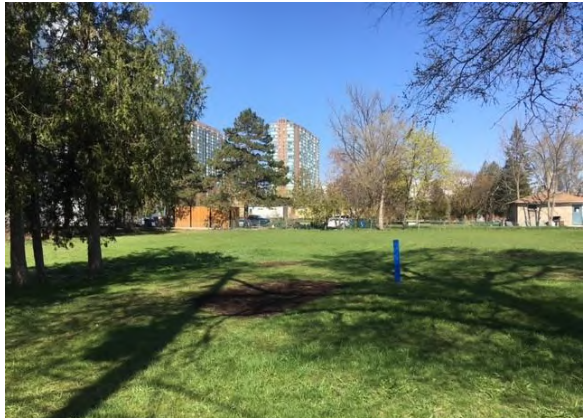
During the site visit, a monitoring well, was observed at the west central portion of the Site. The purpose of this well is not known. It is likely related to historic geotechnical investigation.

<p>Photograph 2</p> <p>Location: West portion of the Site</p> <p>Viewing: North-westly</p> <p>Description: View of the empty lot on the west side of 71 Agnes Street. One existing monitoring well was observed.</p>

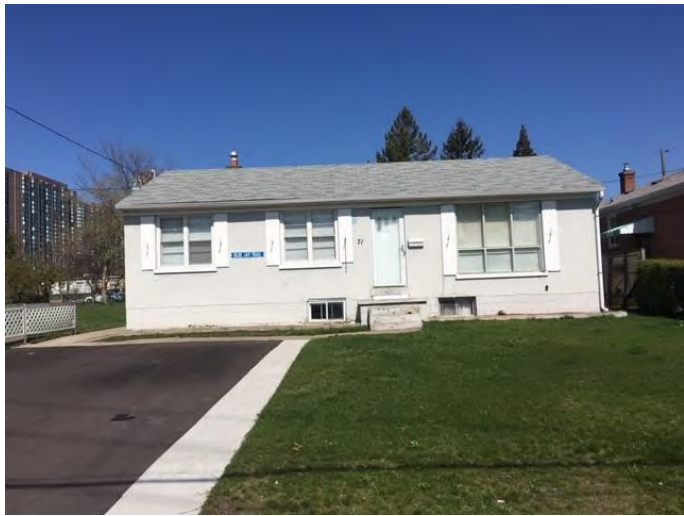
<p>Photograph 3</p> <p>Location: West portion of the Site</p> <p>Viewing: North</p> <p>Description: Front view of the property on 71 Agnes Street.</p>

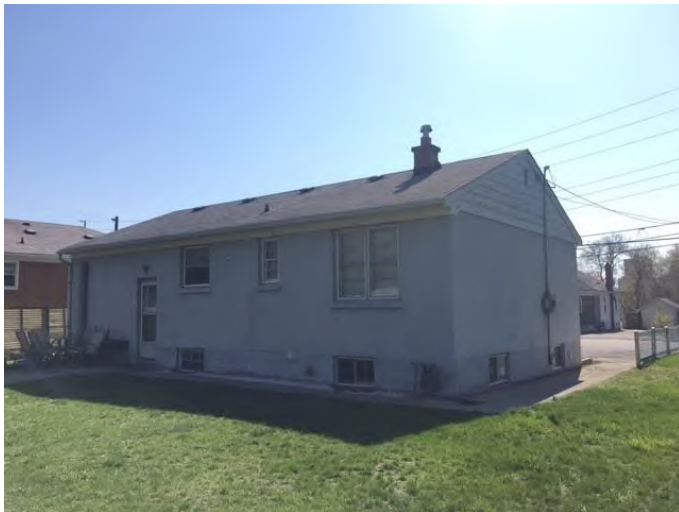
Photograph 4

Location: Back of the Site Building on 71 Agnes Street
Viewing: South-eastly
Description: Gas meter was observed on the side of Site Building.

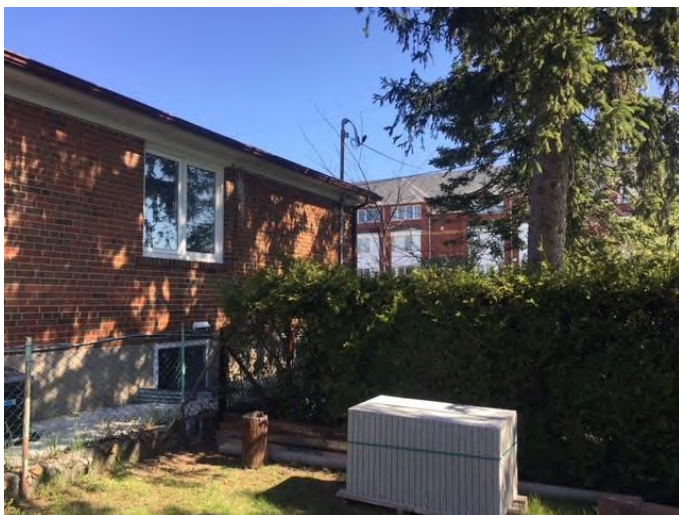
Photograph 5

Location: East side of the Site Building on 65 Agnes Street
Viewing: North-eastly
Description: Gas meter was observed on the side of Site Building.

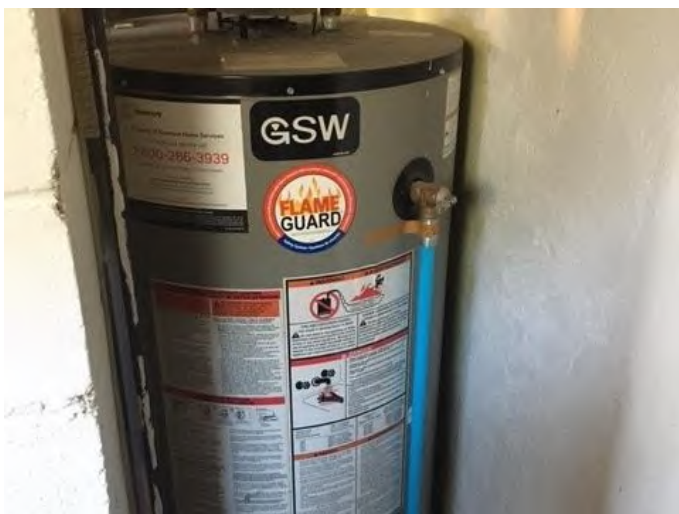
Photograph 6

The Phase One Property is heated by natural gas-fired boilers and hot water heating. The boilers and hot water heater were observed in the basement of the building.

Location: Basement of the Site Building on 65 Agnes Street
Viewing:
Description: Hot water boiler observed at the basement of the Site Building.

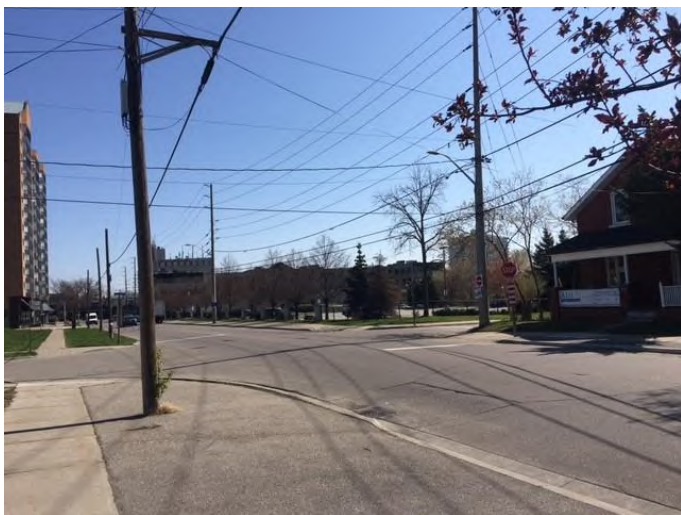
Photograph 7

Location: North boundary of the Site

Viewing: South-eastly

Description: View of the properties on the north of the Site. One residential building located on the west side of property.

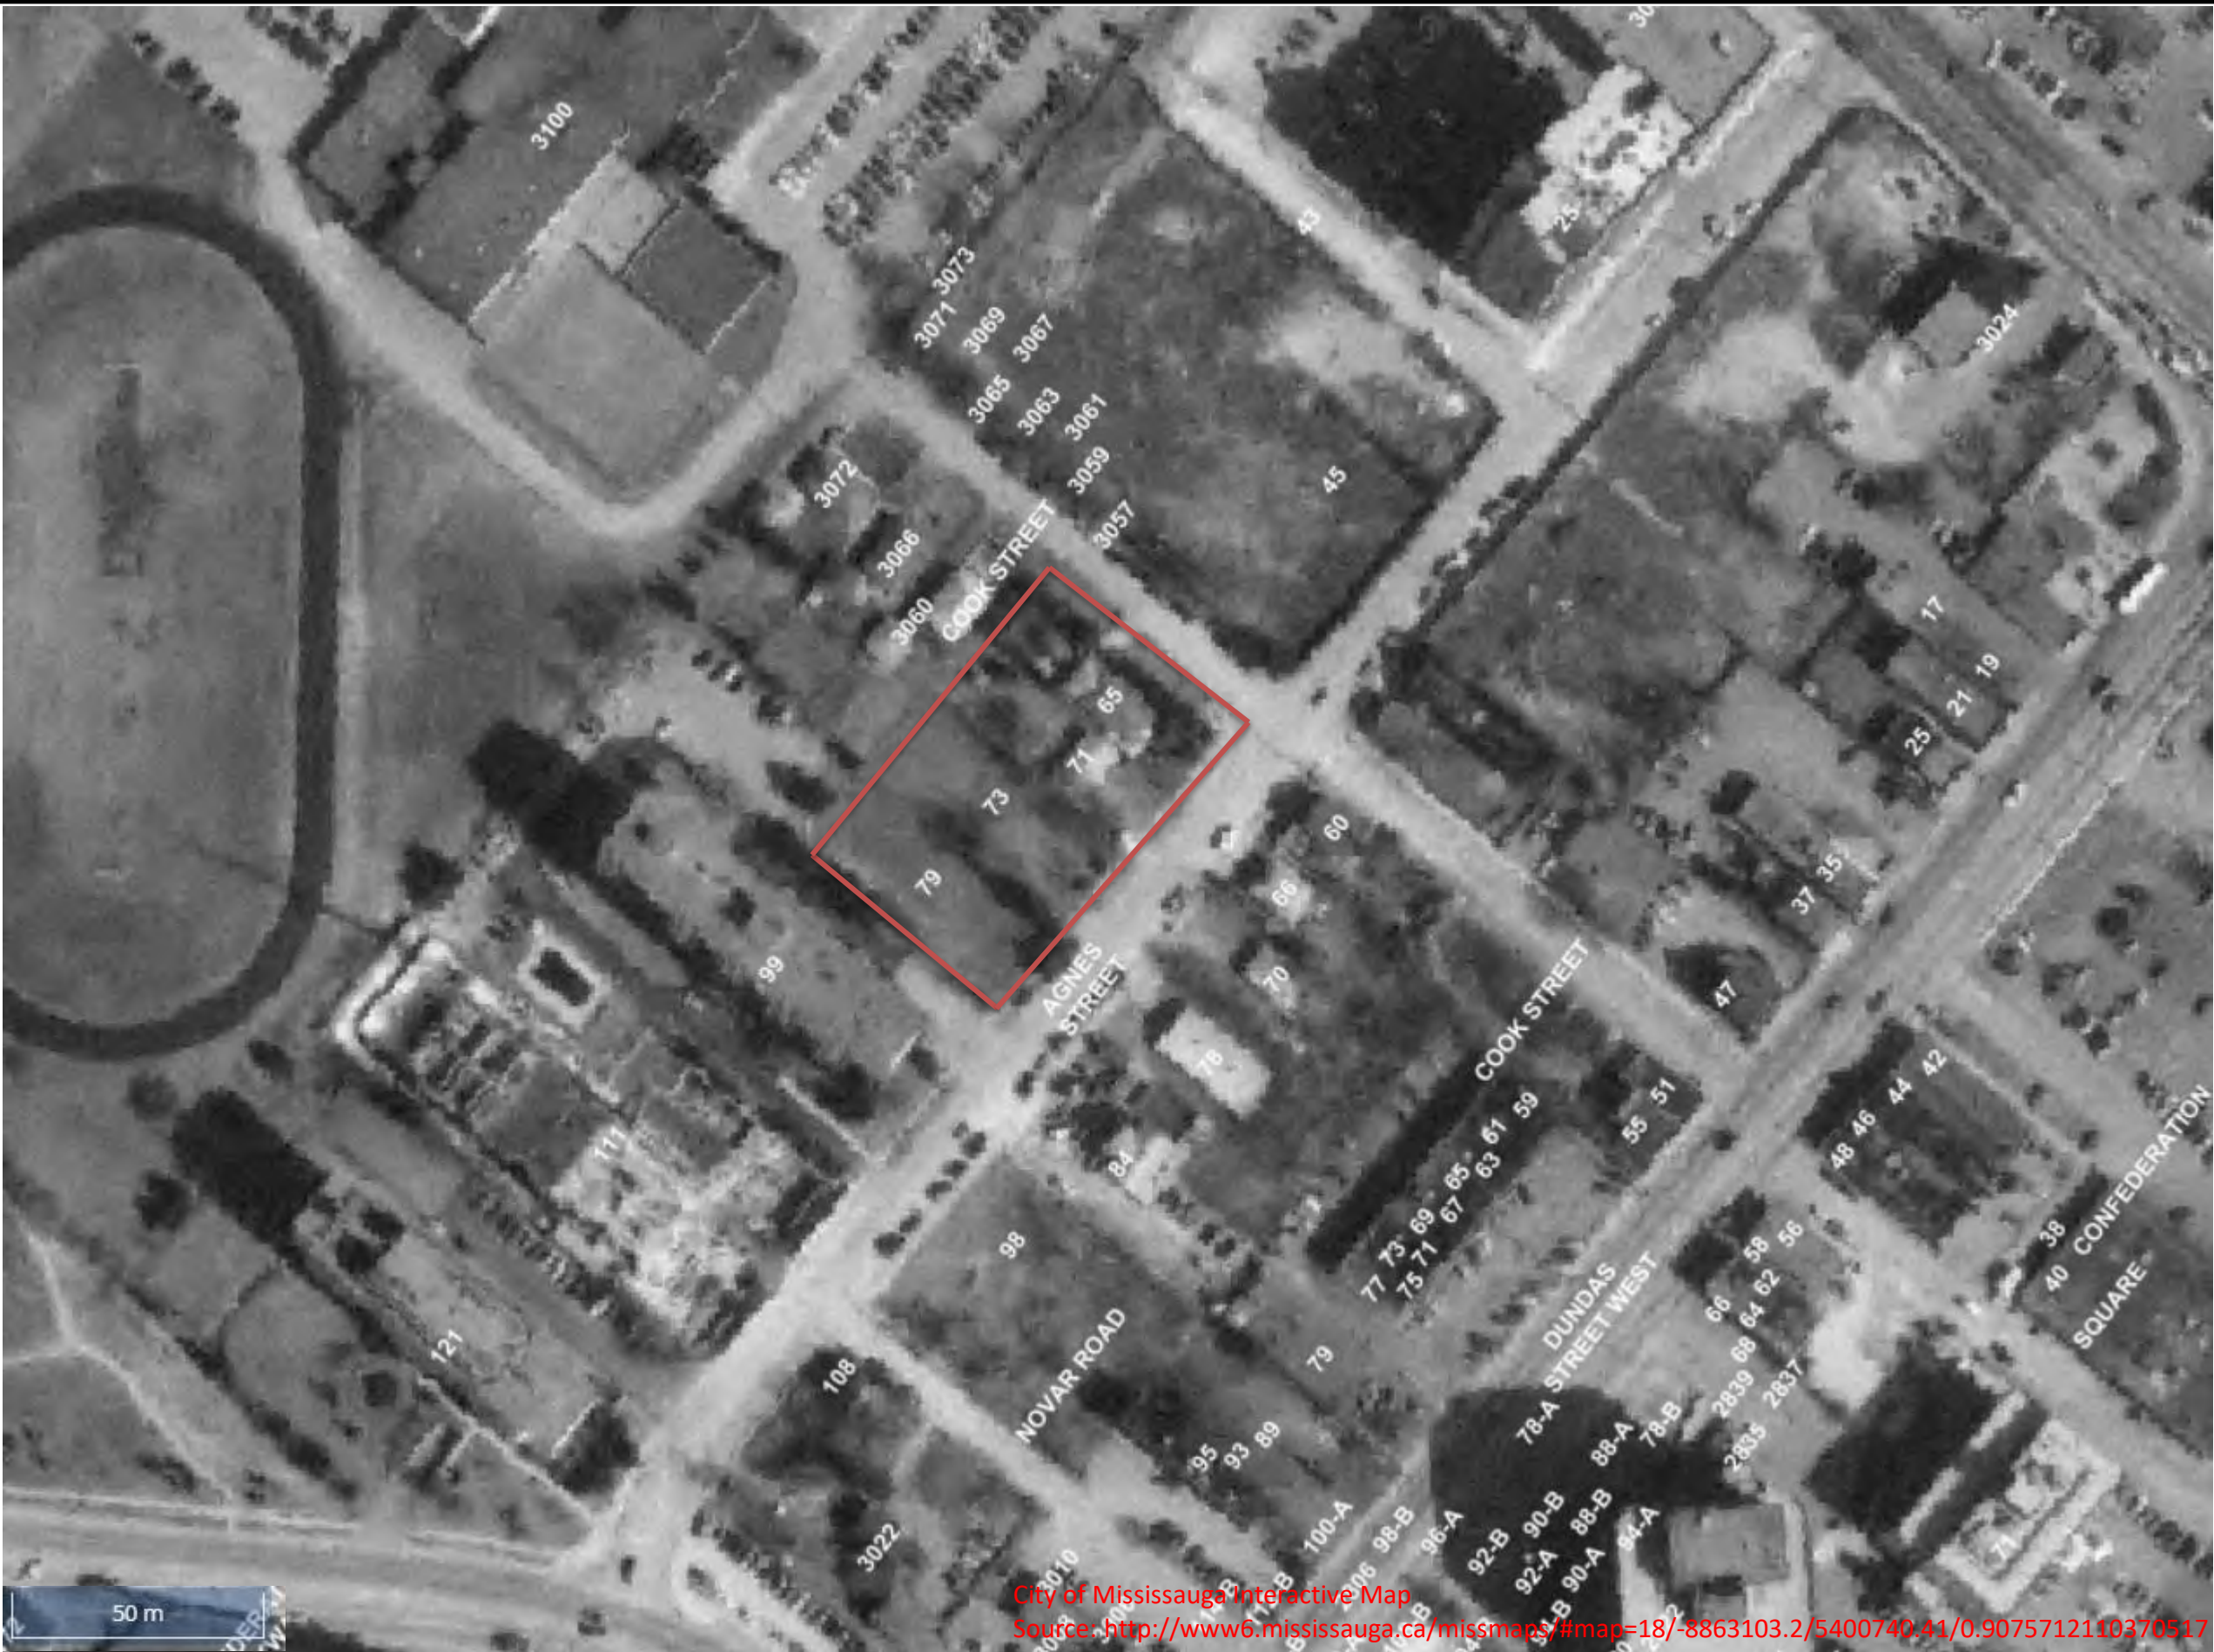
Project Title: Phase I Environmental Site Assessment	
Site Location: 65 & 71 Agnes Street, Mississauga, ON	
Figure Title: 1992 Historical Aerial Photo	
Scale: As Shown	Project Number: SP21-826-00
Date: April 2021	Figure Number 5
