PROJECT FILE REPORT

**ETOBICOKE CREEK EROSION  
CONTROL – BLOOR STREET TO  
PONYTRAIL DRIVE**

FINAL • OCTOBER 2022

**KSGS ENGINEERING  
CORP.**

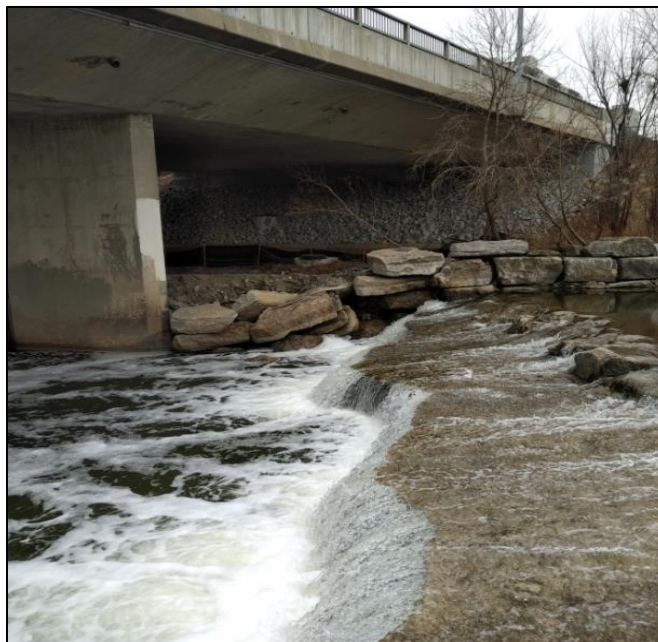
**Figure 1.2 Scour Pool and Failed Armourstone Wall (April 2018)**

The pier and channel works were necessitated due to the alignment of the existing weir structure approximately 10m north of Bloor Street Bridge crossing. The weir was undermined and there was a drop of approximately 1m in elevation. Downstream of the drop, a deep scour pool had formed and was causing significant hydraulic impact to the north-west pier. The deep scour pool had also undermined the base of the stacked armourstone causing them to collapse as shown in **Figure 1.2**.

General reach observations made during the field assessment indicated that both banks of the channel were lined with stone protection. Approaching the Bloor Street bridge, bank protection transitioned to an armourstone retaining wall treatment. Immediately upstream of the bridge, the grade control structure appeared to have partially failed, resulting in the formation of a large knickpoint and plunge pool. Scour associated with the plunge pool was impacting the northwest bridge pier, causing it to be undermined.

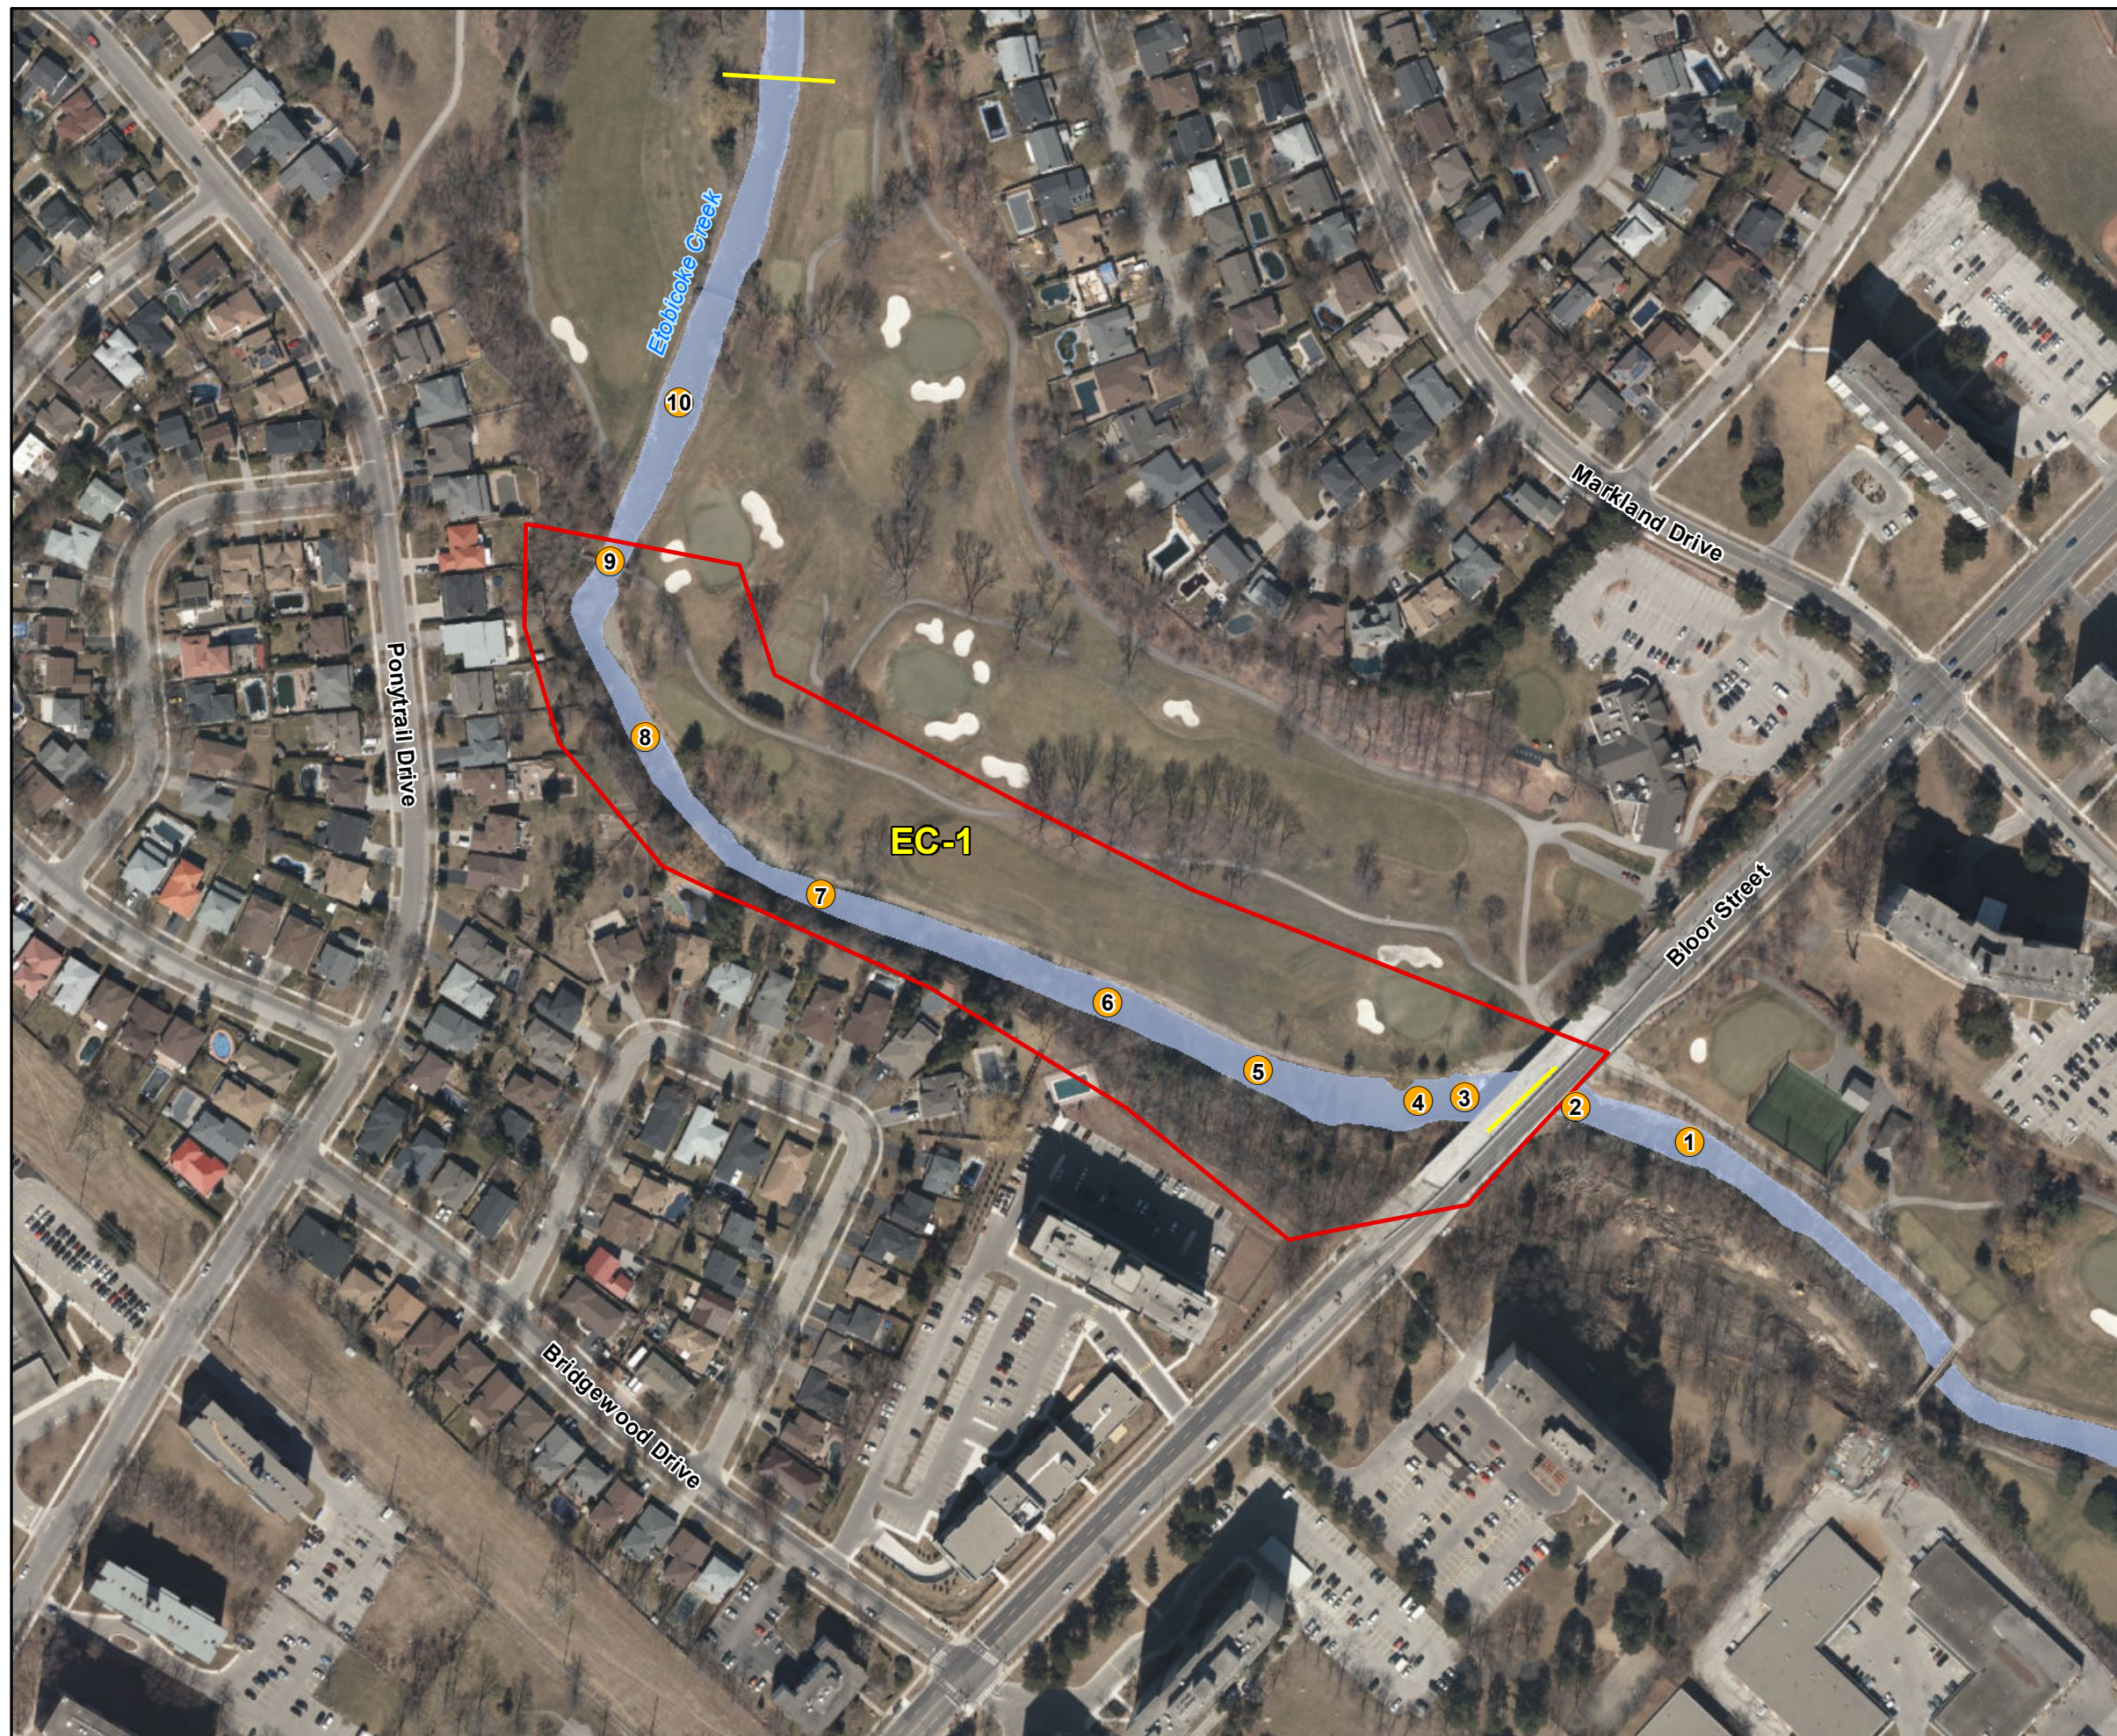
A field investigation was completed on December 6, 2018 to confirm existing geomorphic conditions along the relevant portion of Etobicoke Creek. The location of the assessment is shown on **Figure 2.1**.

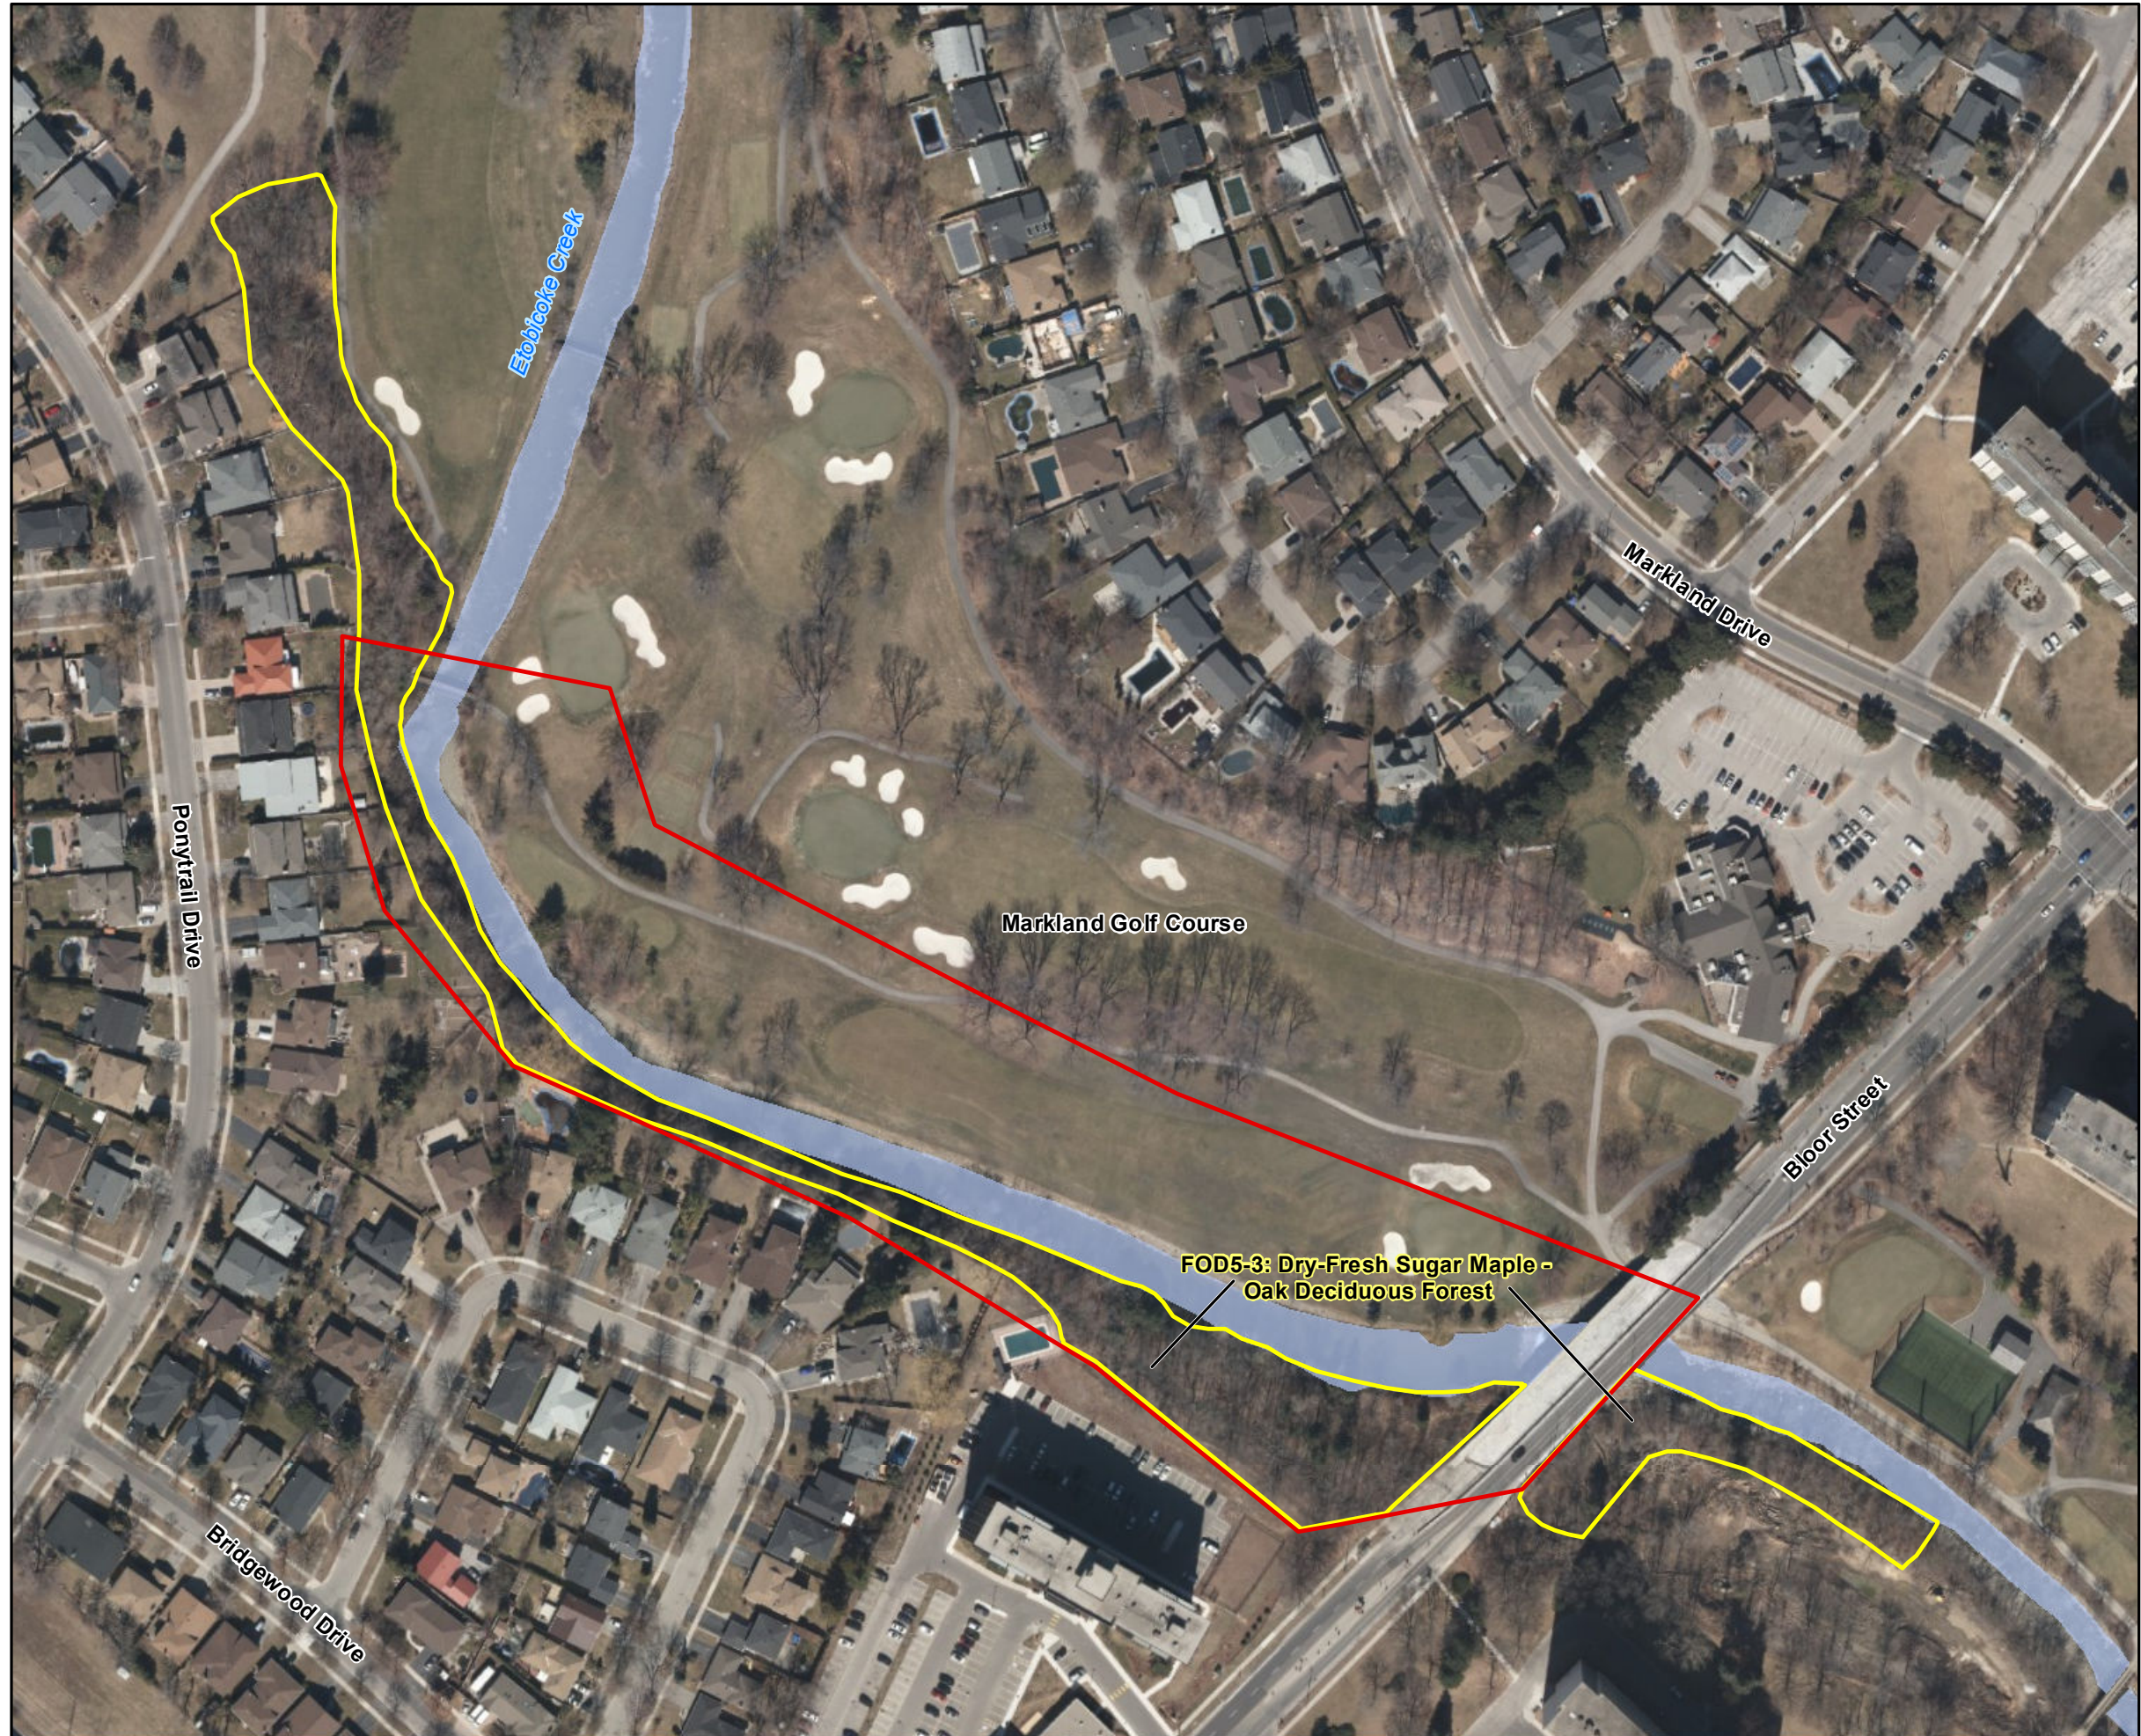
**Figure 2.2**

**Vegetation Communities**

As illustrated in Figure 2.2, most of the subject property consists of a manicured golf course. The singular natural vegetation community recorded, a Dry-Fresh Sugar Maple - Oak Deciduous Forest (FOD5-3) (**Photograph 1**), is located along the western valley slope adjacent to Etobicoke Creek, and is adjacent to anthropogenic features including roads, residential areas, and the Markland Golf Course. Though some tree willows are scattered along the base of the slope, in the opinion of Beacon, the classification of the entire forest community in the Mississauga Natural Areas Inventory as a Fresh-Moist Willow Lowland Deciduous Forest Type (FOD7-3) is not applicable to the Study Area.

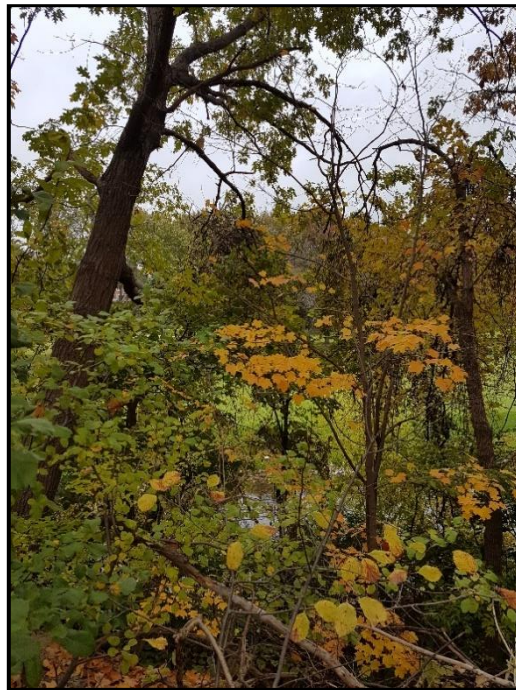
**Photograph 1.** Dry-Fresh Sugar Maple - Oak Deciduous Forest

The vegetation community showed signs of disturbance, particularly at the top of the slope where the forest abuts the parking lot of an existing apartment building complex near Bloor Street. The forest occupies a steep slope adjacent to Etobicoke Creek and contained areas of bare cliff and slope faces. Due to safety concerns

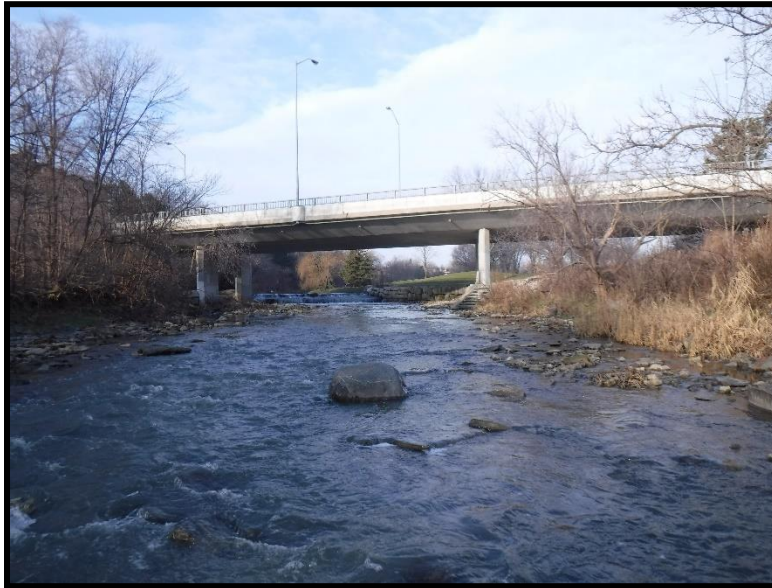
**Photograph 2.** Conditions downstream of Bloor St. bridge.

Beacon conducted an aquatic habitat assessment on December 6, 2019. The portion of Etobicoke Creek downstream of the Bloor St. bridge is defined by a riffle sequence (**Photograph 2**). The substrate is predominantly cobble and boulder with sand and silt in between. The banks are lined with rip rap and armourstone. Riparian vegetation consists of deciduous forest with grasses growing closer to the creek. No aquatic vegetation was observed. At the time of the assessment, the average water depth downstream of the bridge was 0.32 m. This portion of the creek provides refuge opportunities for aquatic species among the cobble boulder substrate.

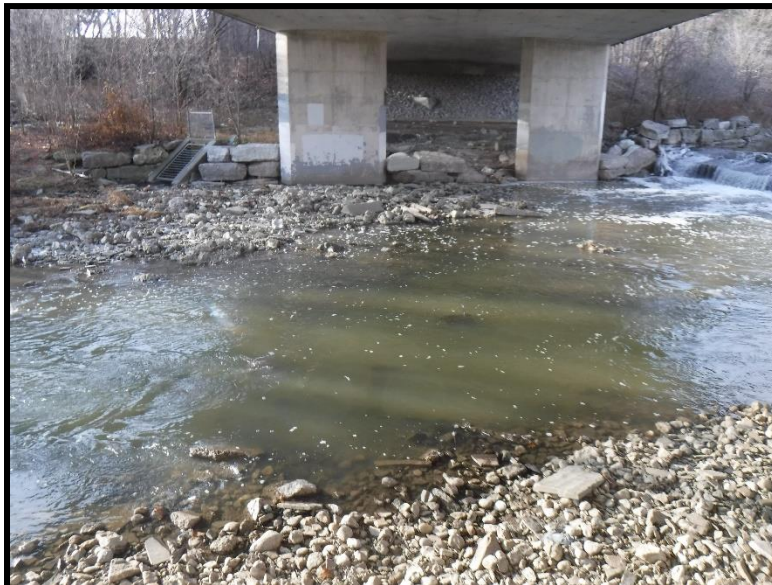
**Photograph 3.** Conditions below the Bloor St. bridge.

Directly below the bridge the channel morphology is a run-riffle sequence (**Photograph 3**). The substrate is predominantly cobble and boulder with sand. There is also rip rap along the banks with armourstone on the right bank. An outfall structure is present on the left bank below the bridge. There is no riparian vegetation below the bridge. At the time of the assessment, the run sequence was approximately 0.5m deep.

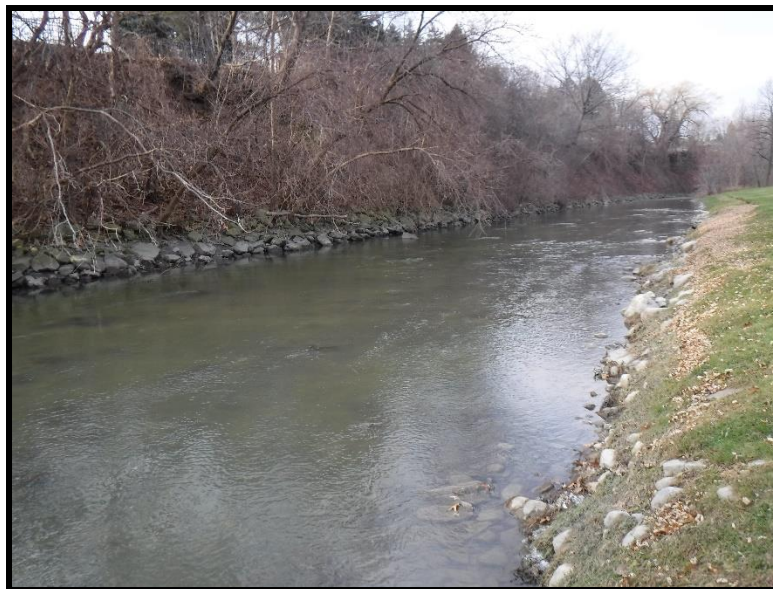
**Photograph 4.** Conditions upstream of Bloor St. bridge.

Upstream of the bridge there is a concrete weir that is approximately 1 m high. This can prevent fish from migrating upstream. A scour pool has developed in association with the weir. Armourstone retaining walls line the channel banks at the weir. The channel morphology directly upstream of the weir is a run (**Photograph 4**). The channel is primarily composed of cobble gravel substrate with a small segment of the creek having only sand and gravel. Banks are lined with rip rap. The riparian vegetation on the left bank is deciduous forest and the right bank is manicured lawn. Average water depth was 0.5 m at the time of the assessment. The channel upstream of the weir does provide some in stream cover within the cobble and gravel areas. The segment with only sand and gravel substrate provides little in stream cover for aquatic species.

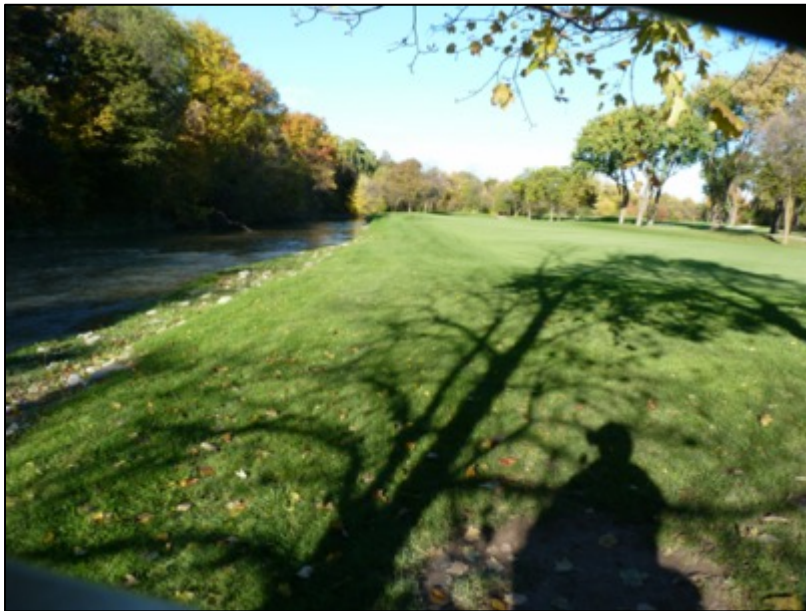
**Image 3:** Shows Etobicoke Creek, disturbance associated with channelization of creek and overlying Bloor Street bridge.

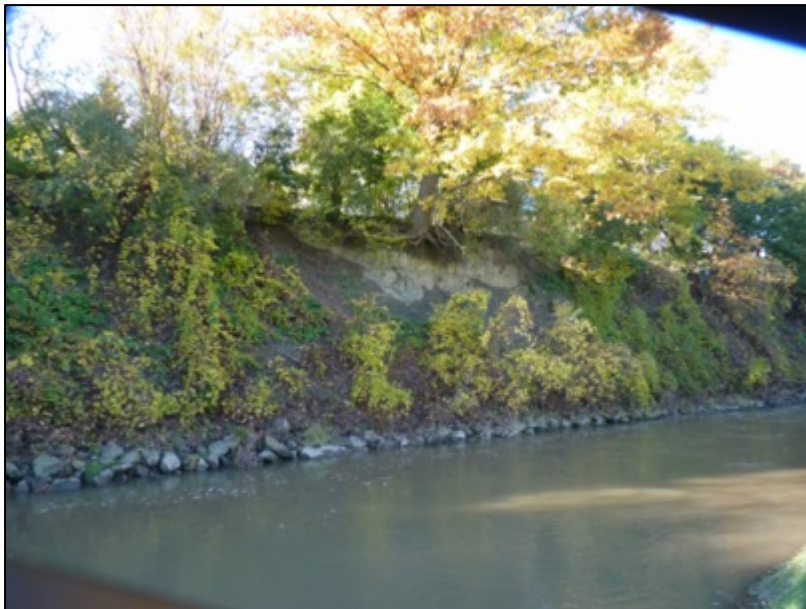
**Image 6:** Shows steep slope and erosion on west bank of Etobicoke Creek.

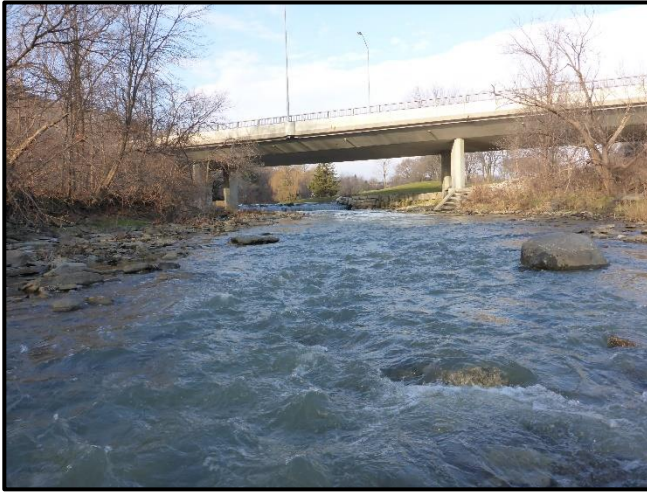
**Photo 1.**

Upstream view of the Bloor Street bridge. Note bank erosion along the right bank (left side of photo).

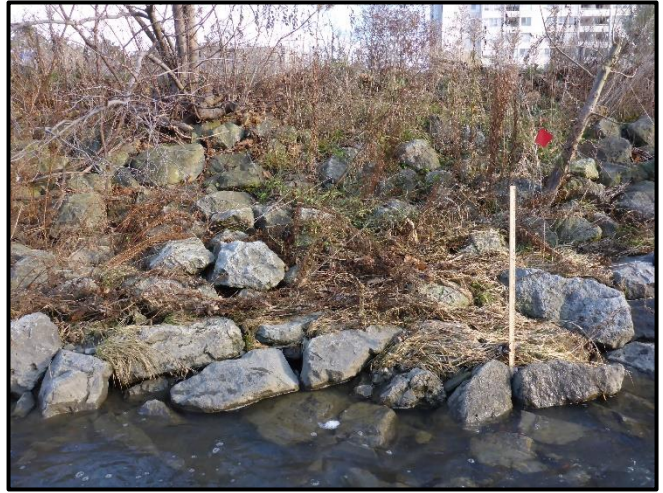
**Photo 2.**

Existing stone bank treatment immediately downstream of Bloor Street bridge (left/east bank).

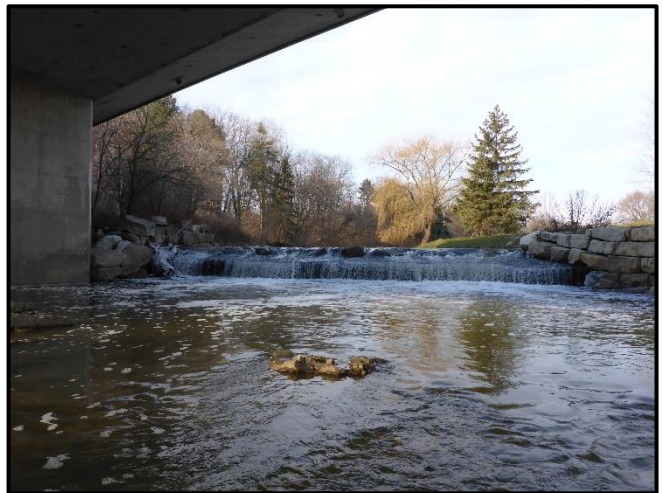
**Photo 4.**

Existing conditions under Bloor Street bridge. Failed armour stone and bank protection stone has formed a medial bar under the bridge.

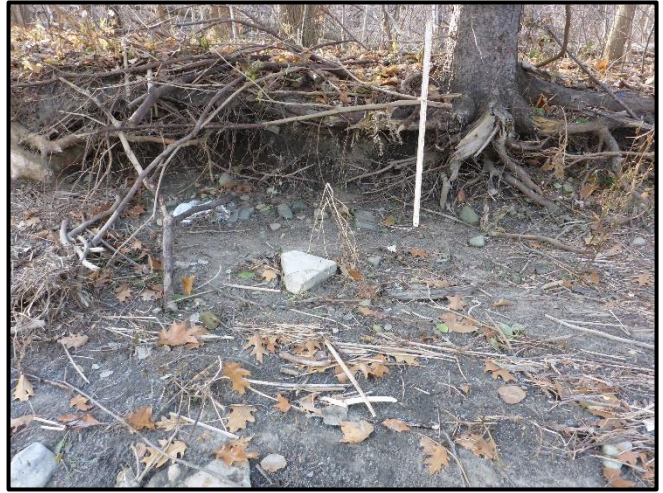
**Photo 6.**

Evidence of active bank erosion along right (west) bank.

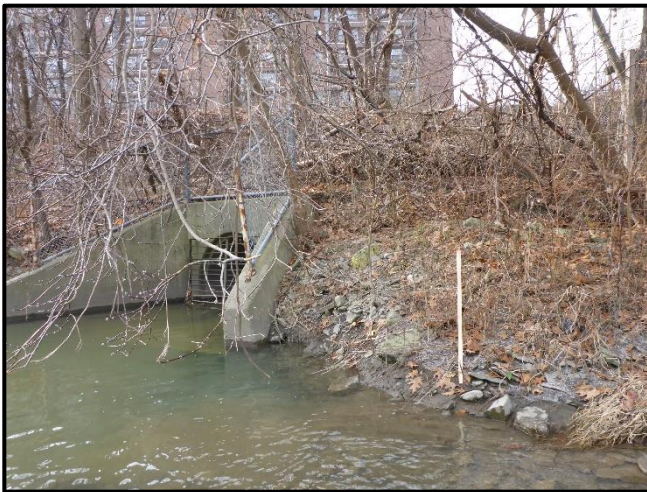
**Photo 7.**

Existing stormwater outlet on right (west) bank.

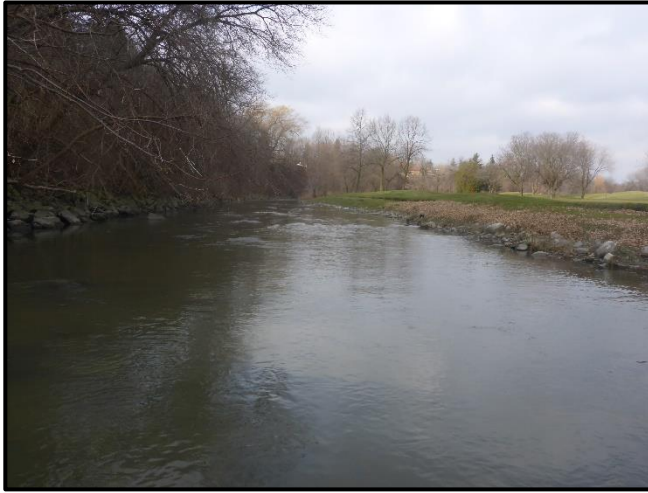
**Photo 9.**

Upstream view of Etobicoke Creek within Markland Golf Club. Note: existing stone protection along both banks.

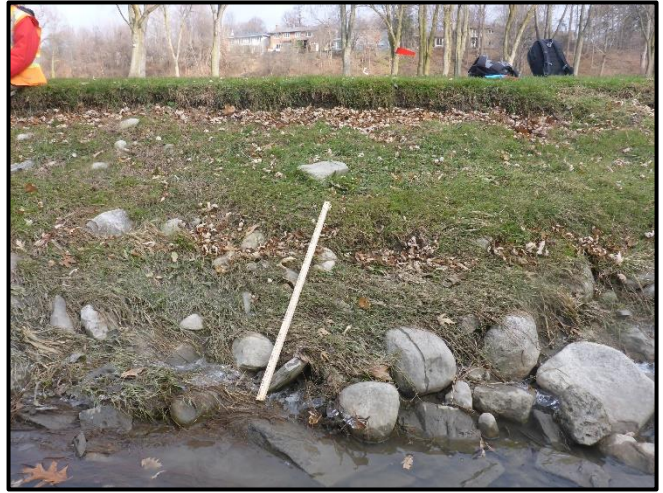
**Photo 10.**

Existing stone protection along left (east) bank within golf course.

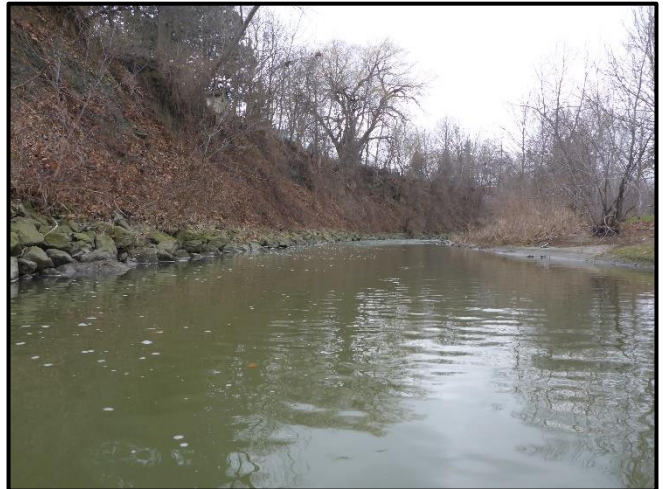
**Photo 12.**

Upstream view of valley wall contact with existing stone toe protection.

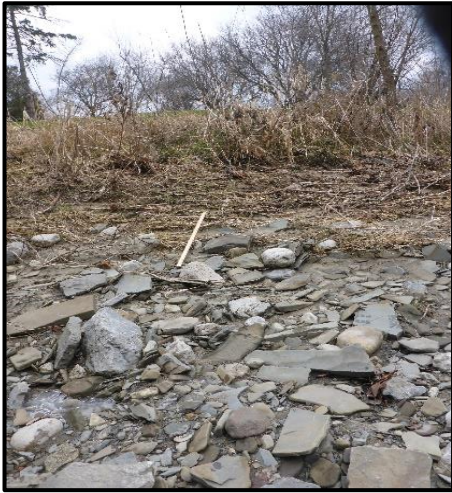
**Photo 13.**

Point bar formation (shale bedrock) along left (east) bank.

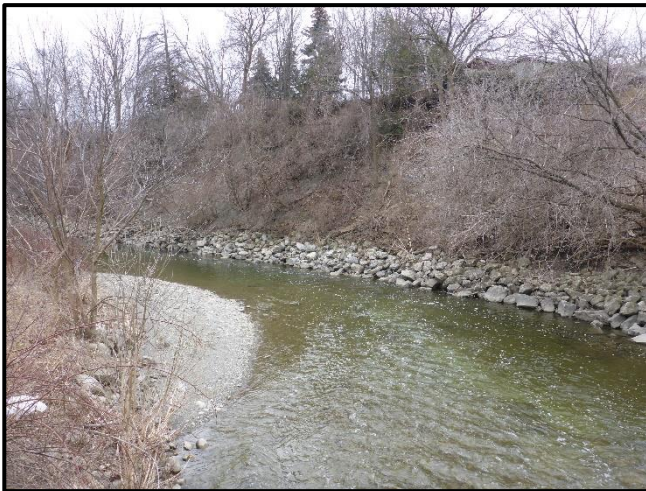
**Photo 15.**

Downstream view of valley wall contact from cart path crossing. Note: shale point bar (photo left) and existing stone protection along toe of valley slope.

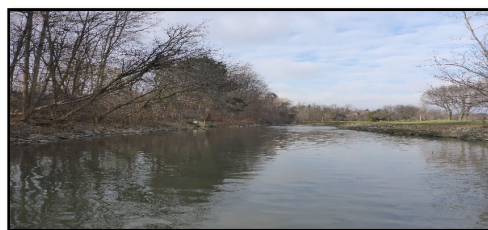
### Representative Cross-Section (#1)

Minimum	Maximum	Average
Bankfull Width (m):	18	35	25
Average Bankfull Depth (m):	0.68	1.50	0.94
Bankfull Width/Depth:	14	38	28
Wetted Width (m):	7.9	27	16
Average Water Depth (m):		0.94	
Average Wetted Width/Depth:		136	
Max. Wetted Depth (m):		0.75	
Manning's n:		0.037

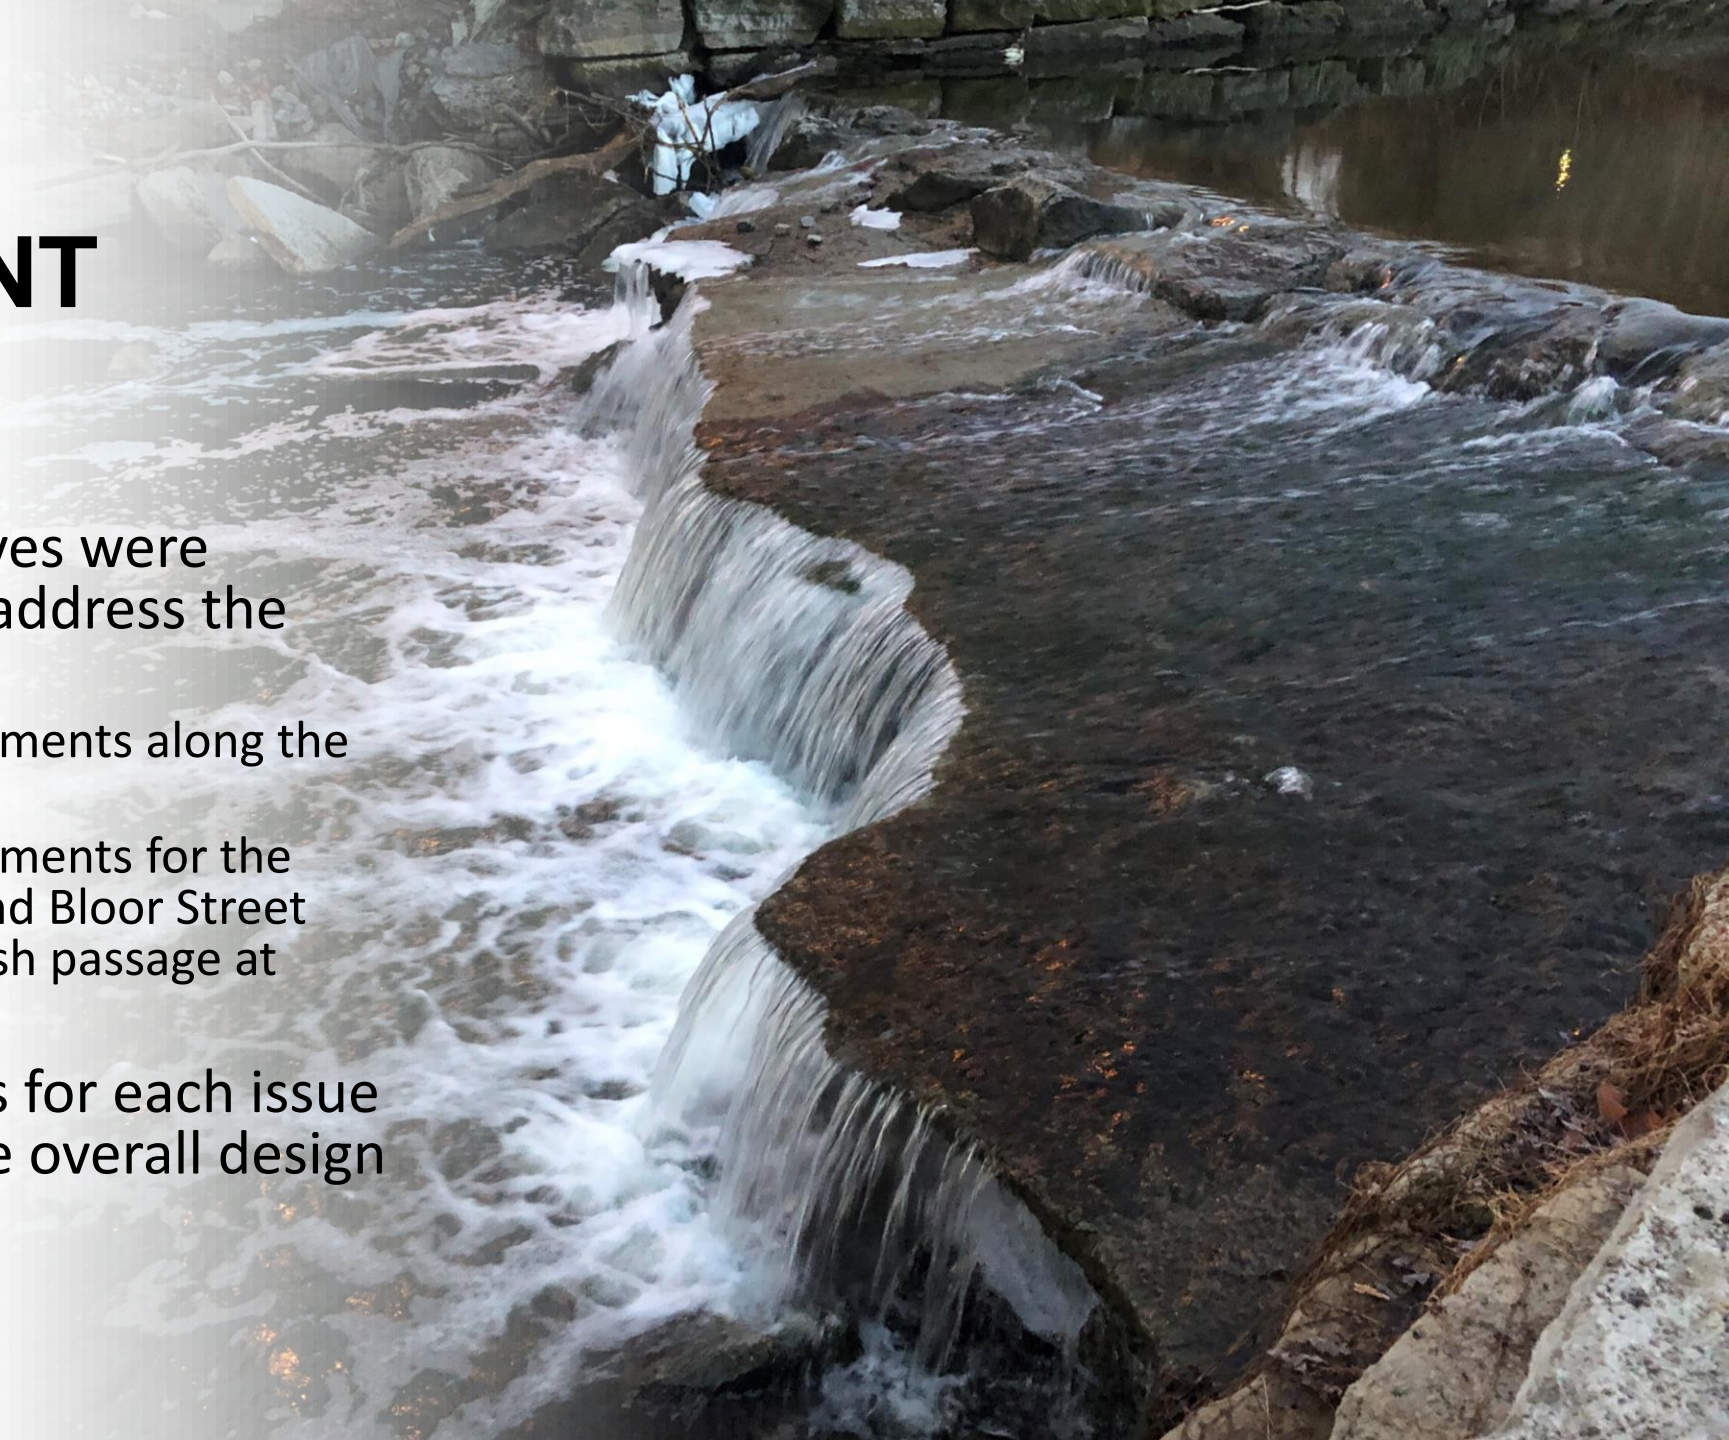
# EROSION IMPROVEMENT OPTIONS

- Separate design alternatives were developed to specifically address the two identified issues:
  - Erosion protection requirements along the west side of the creek
  - Erosion protection requirements for the Region's Sanitary Sewer and Bloor Street abutments and improve fish passage at Bloor
- The preferred alternatives for each issue will be integrated into one overall design solution

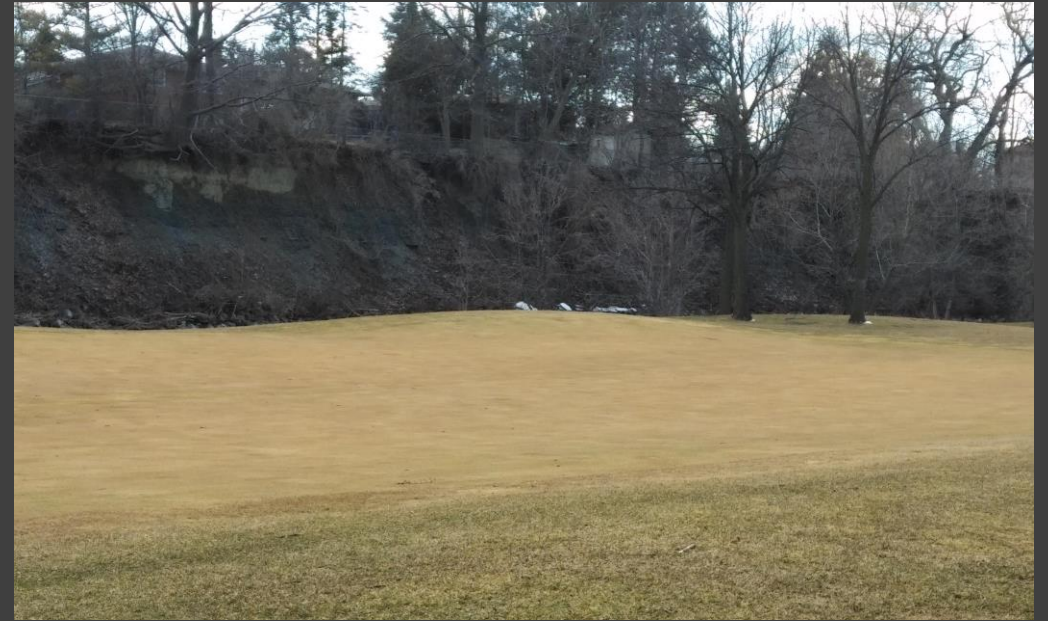
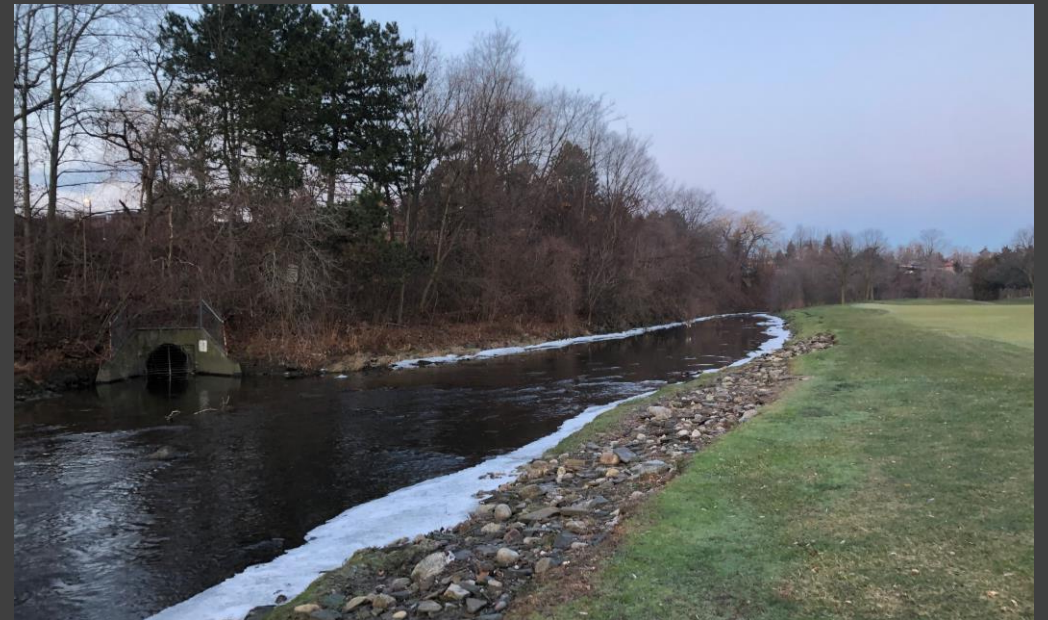
# SECTION NORTH OF BLOOR STREET

- 1) Do Nothing
  - Status quo (do not undertake erosion protection works)
  - Creek erosion would continue and eventually affect private property west of creek
- 2) Implement erosion protection
  - Provide erosion protection on east and west sides of creek
  - Protect creek while minimizing impacts to natural features and property
- 3) Realign creek and implement erosion protection
  - Realign creek to move it away from the slope and provide erosion protection on east and west sides of creek
  - Potential for enhanced erosion protection along west side of creek but will impact property east of creek (golf course) and impact sanitary trunk sewer

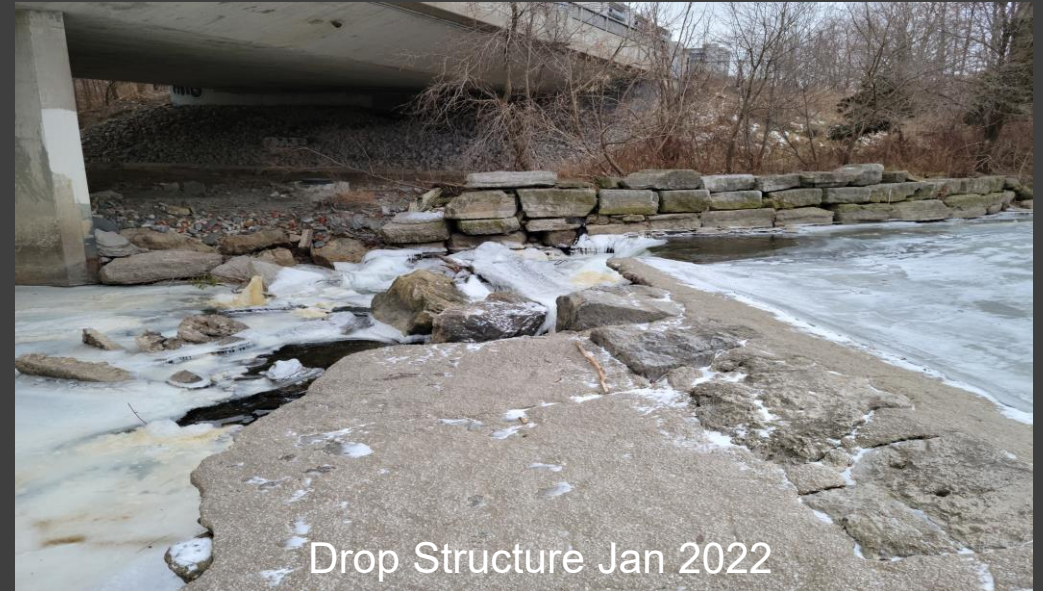
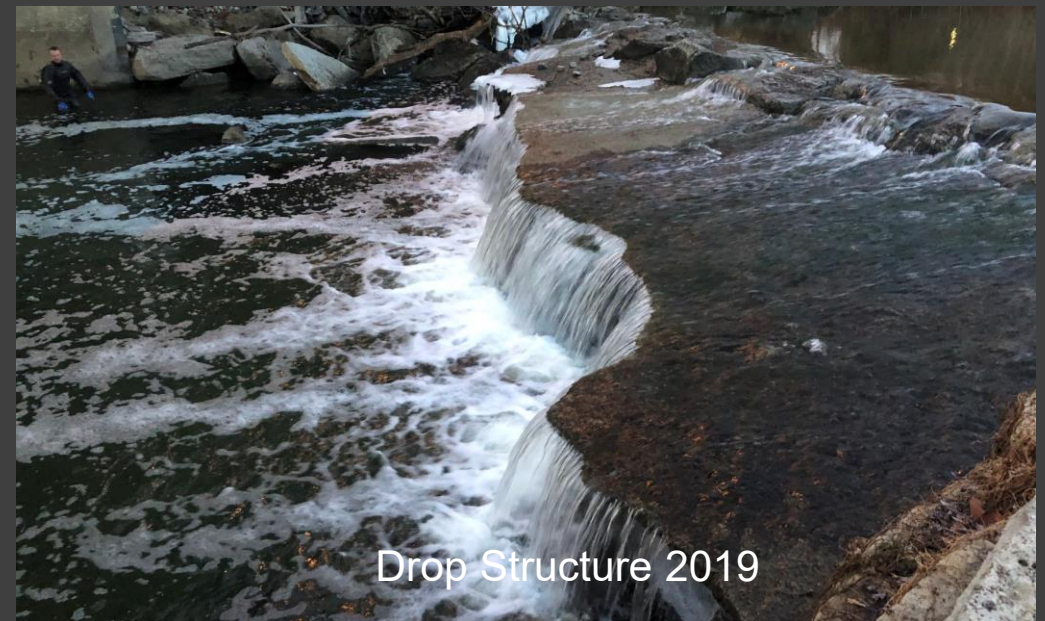
# BLOOR STREET CROSSING

- 1) Do nothing
  - Status quo (do not undertake erosion protection works)
  - Creek erosion would continue and eventually drop structure would fail, affecting Regional Trunk Sewer and Bloor Street bridge
- 2) Implement erosion protection
  - a) Repair drop structure
    - Reinforce drop structure and provide erosion protection for Bloor Street abutments and Regional sewer
  - b) Replace drop structure
    - Remove existing drop structure and provide erosion protection for Bloor Street abutments and Regional sewer
- 3) Implement enhanced erosion protection
  - Remove existing drop structure, provide erosion protection for Bloor Street abutments and enhanced erosion protection for Regional sewer

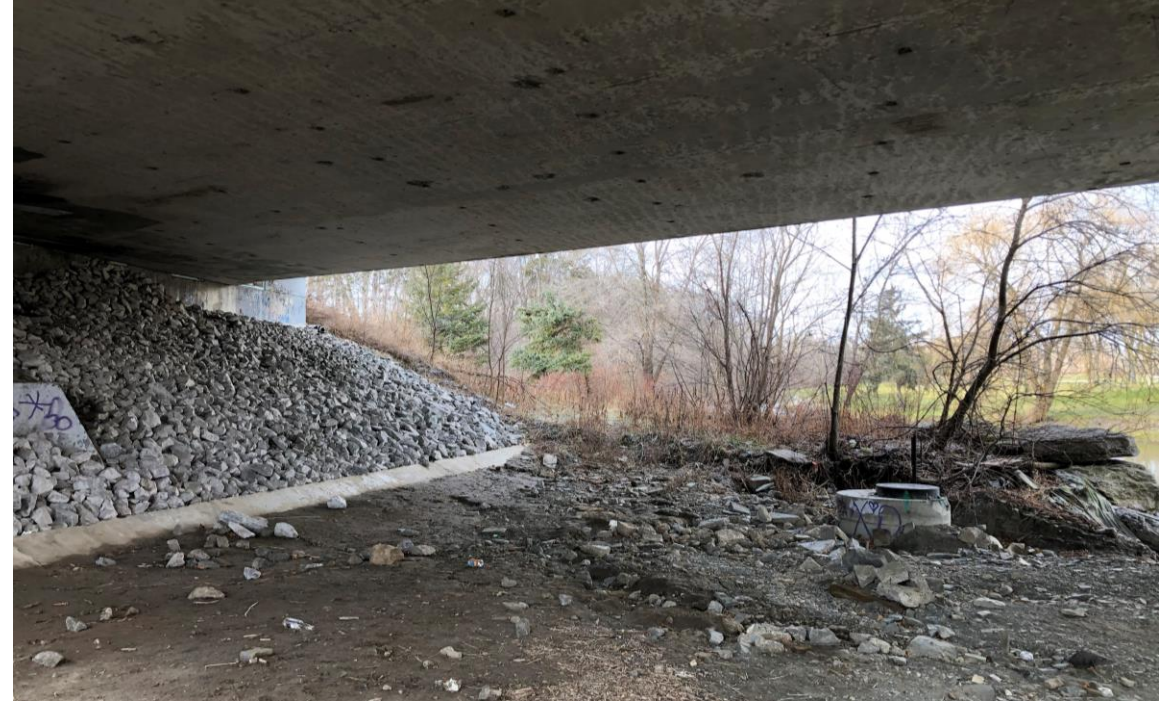
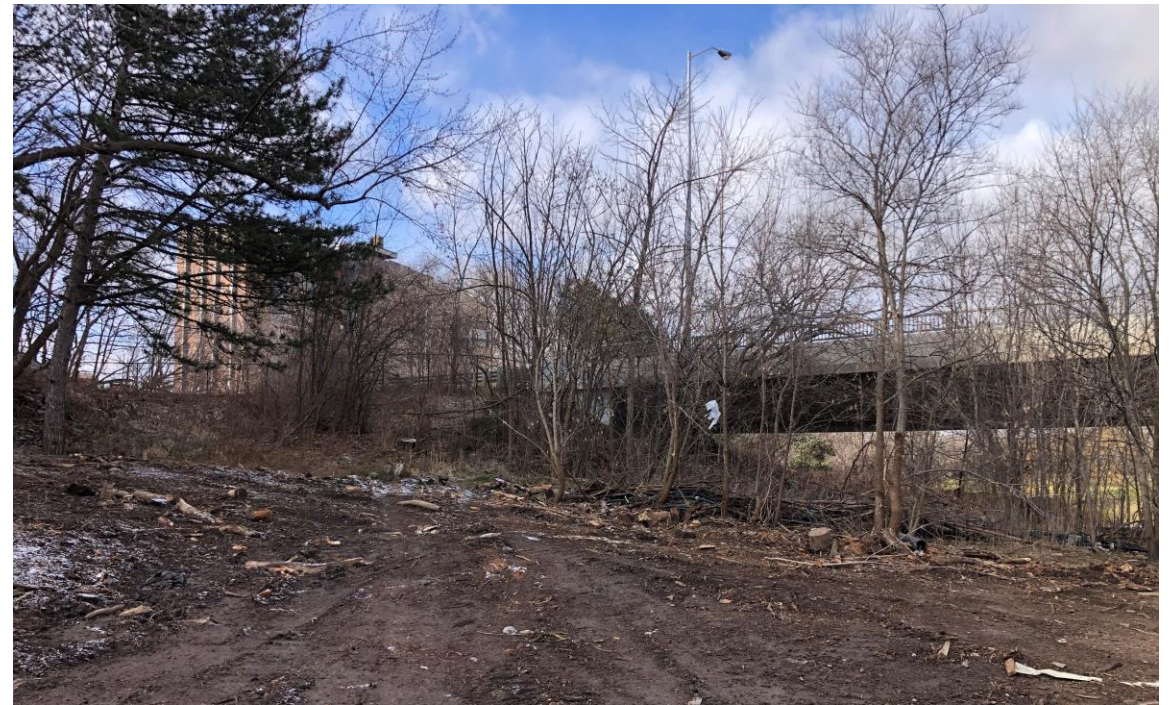
# CONSTRUCTION ACCESS

- Access is restricted and difficult. Three access point will need to be used
  1. From west side of creek and north side of Bloor Street with one westbound lane partially closed
    - To unload Armourstone and other material
  2. From west of creek and south side of Bloor Street
    - To do works under Bloor Street
    - To bring material in and out
    - Low clearance under bridge will limit type of equipment that can be move
  3. From Markland Woods Golf Course
    - To bring equipment and material in and out of site
