Phase One Environmental Site Assessment

1785 Bloor Street
Mississauga, Ontario

January 14, 2022

Pinchin File: 291885

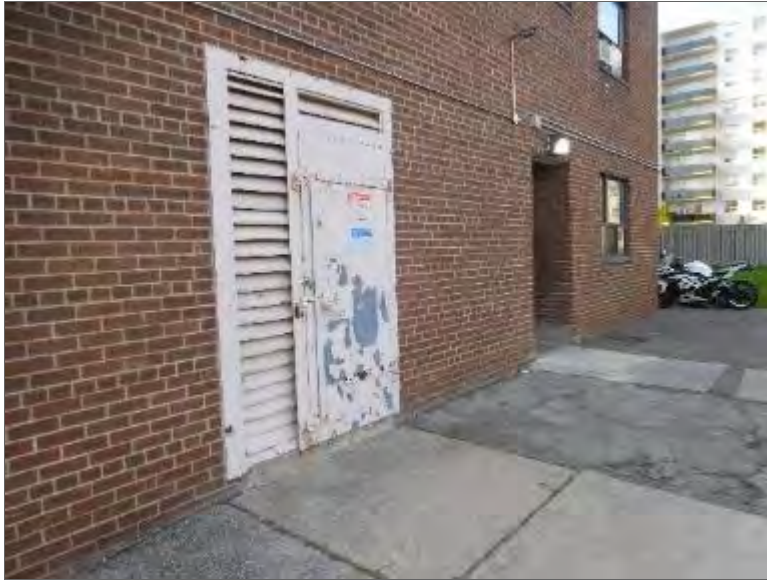
Photo 5 – Hydro vault located in the northwestern portion of the Site Building, looking southeast.

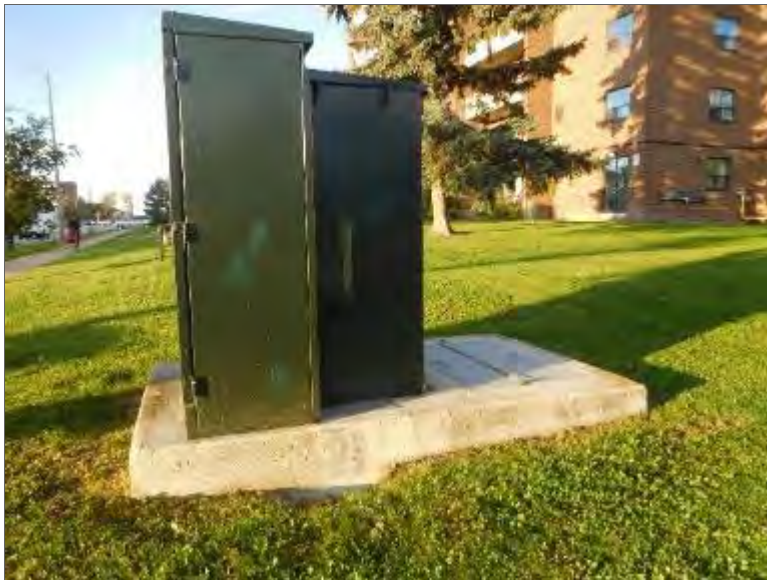
Photo 6 – Pad-mounted oil-cooled transformer located in the southeastern corner of the Phase One Property, looking southwest.

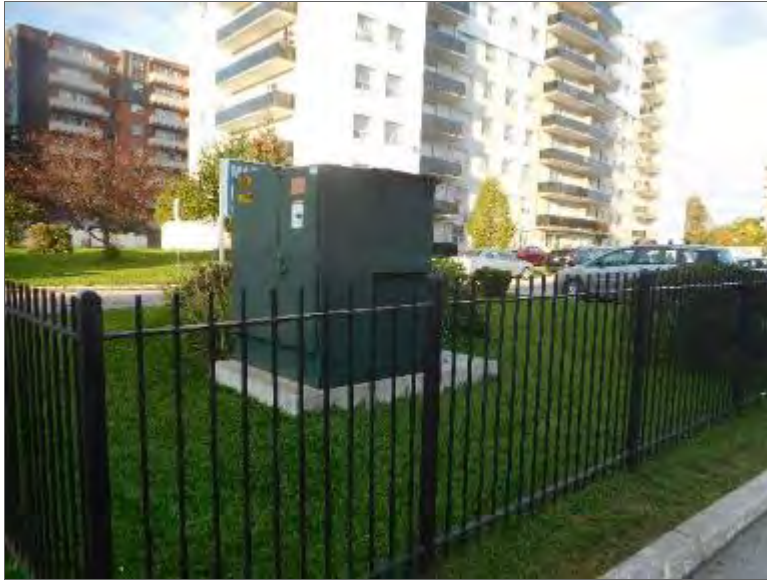
Photo 11 – Pad-mounted oil-cooled electrical transformer located in the southeastern corner of 1759 Bloor Street, looking west.

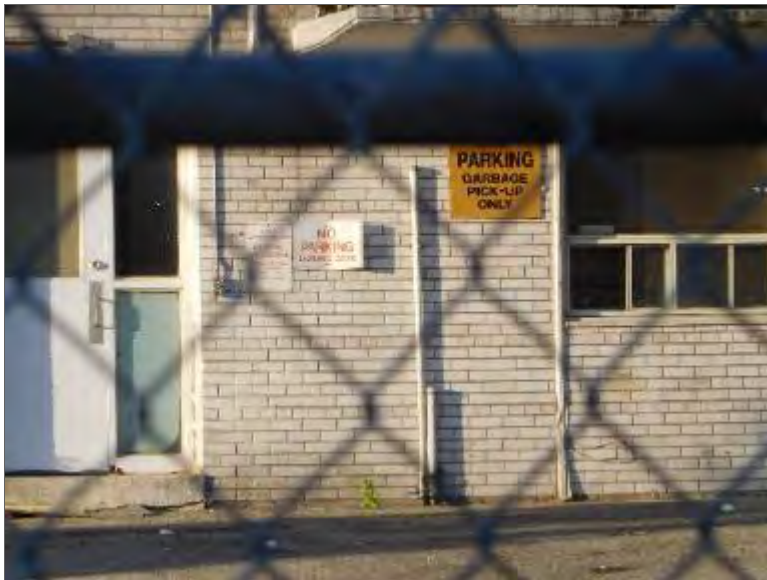
Photo 12 – Fill and vent pipes along the northwestern elevation of the building at 1759 Bloor Street, facing southwest.

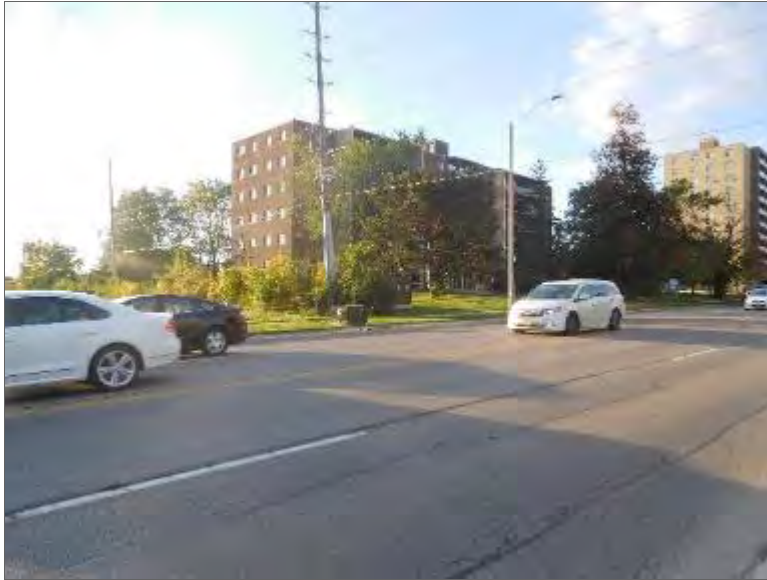
Photo 13 – Pad-mounted oil-cooled electrical transformers located within the hydro corridor and at 1780 Bloor Street East, looking south.

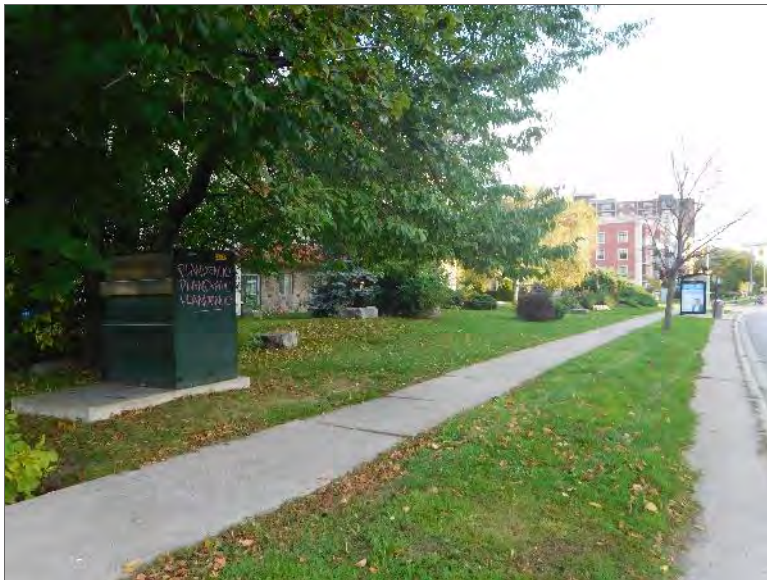
Photo 14 – Pad-mounted oil-cooled electrical transformer located at 1835 Bloor Street, looking northeast.

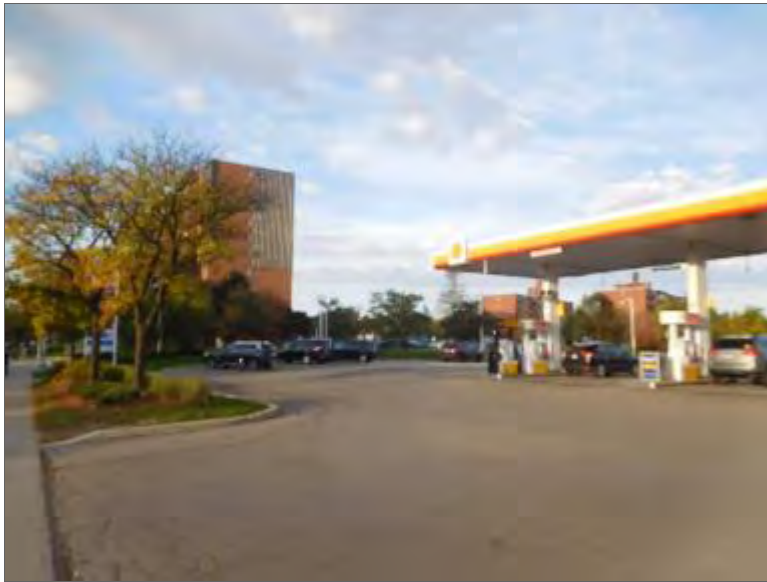
Photo 15 – Retail fuel outlet located at 1715 Bloor Street, looking west.

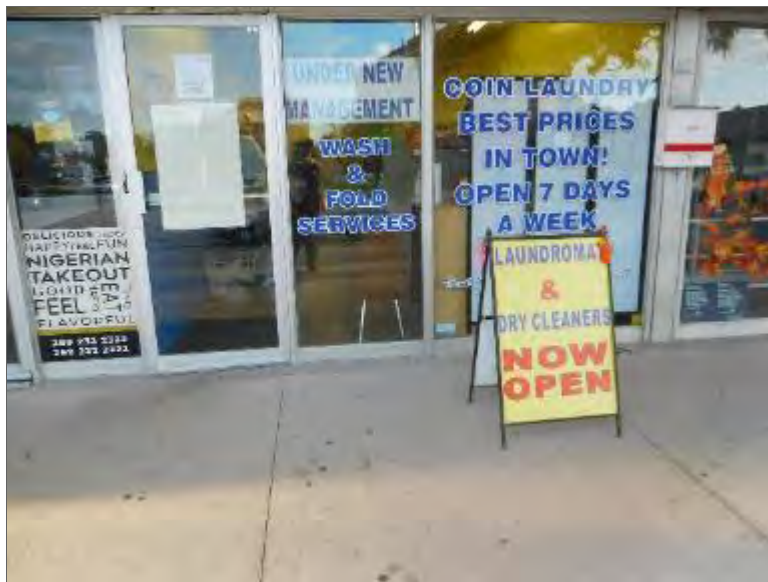
Photo 16 – Dry cleaners located at 3403-3445 Fieldgate Drive, looking northeast.
