Phase One Environmental Site Assessment (ESA)

49 South Service Road, Mississauga, ON

2204701

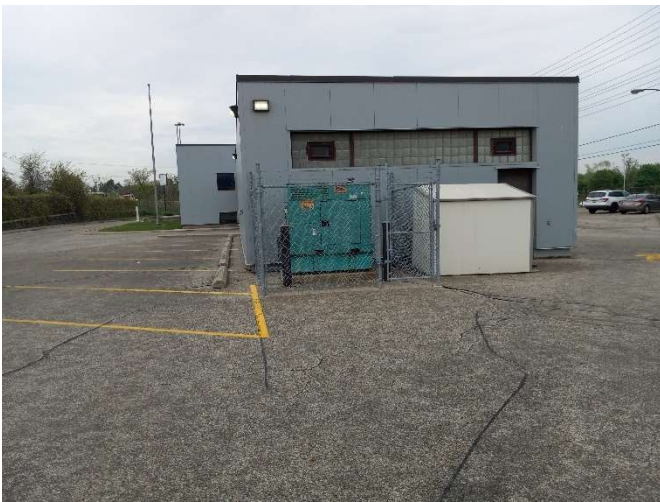
Photograph 7

Photo depicts the north facing view of the Phase One Property, including the diesel backup generator.

ASTs were observed on the Site, including an integrated 50-gallon diesel fuel tank within the backup generator, as well as a 1,000 L double-walled water storage tank and associated sump pit located in the basement that is no longer in use. No staining or evidence of leaks and/or spills were observed in the vicinity of the ASTs.

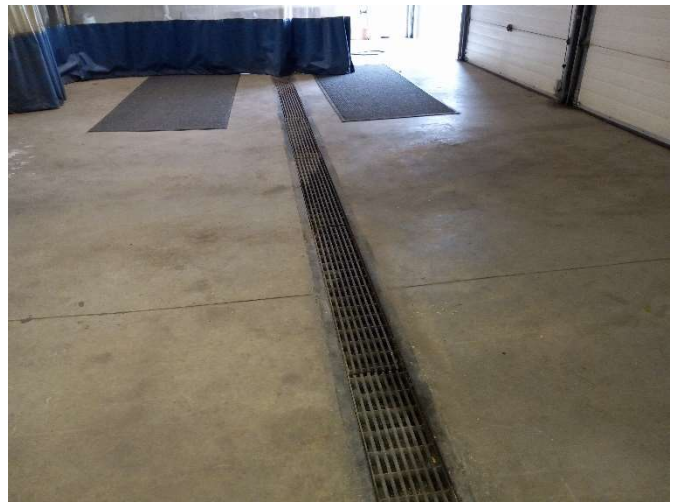
Photograph 8

Photo depicts the inside of the garage building, and the trench drain.

Floor drains were noted in the basement of the main building, as well as a trench drain that leads to a catch basin in the garage. It has been reported that this trench drain discharges to the municipal sanitary sewer system. Two (2) sump pump pits are located in the pump room within the basement. One (1) of the sump pits is associated with a storage tank and this system is reported to be used to pump stormwater to the municipal storm sewer system.

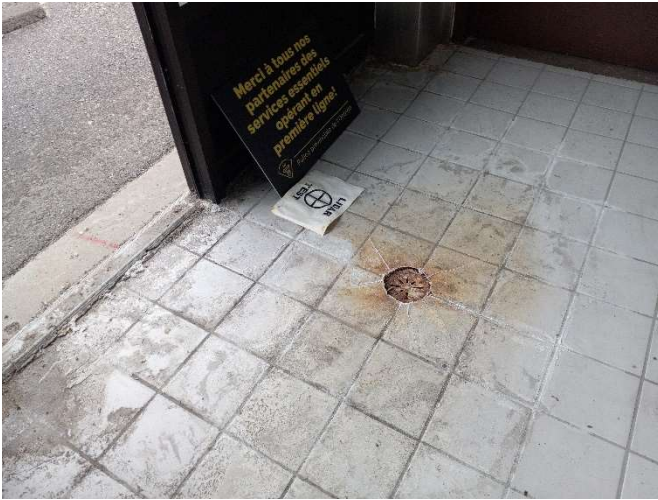
Photograph 9

Photo depicts the de-icing salt stain on the floor in the attached glass entryway.

A de-icing salt-related stain was present on the floor in the attached glass entryway of the main building. Ground water monitoring wells were also observed in two (2) locations in the basement of the main building.

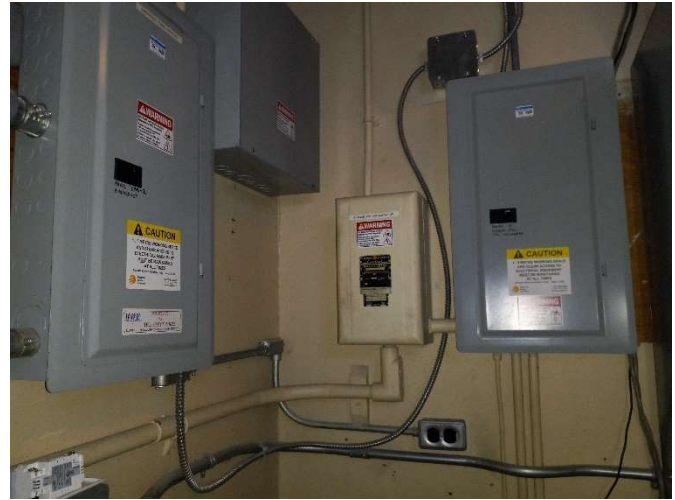
Photograph 10

Photo depicts electrical panels located in the electrical room in the basement.

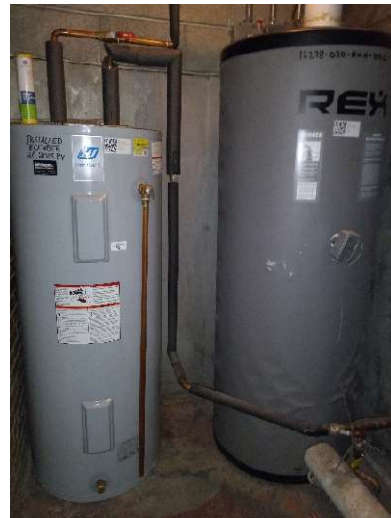
Photograph 16

Photo depicts hot water heaters located in the hot water heater room in the basement.

The buildings are heated by a combination of hot water and forced air heating. Two (2) natural gas fired boiler systems are located in the basement of the main building. Electric hot water heaters are located in the basement of the main building and in the attached garage. No evidence of any heating oil storage tanks was noted with the exception of the levelometer located in the boiler room which was connected to the former heating oil UST (APEC #4).

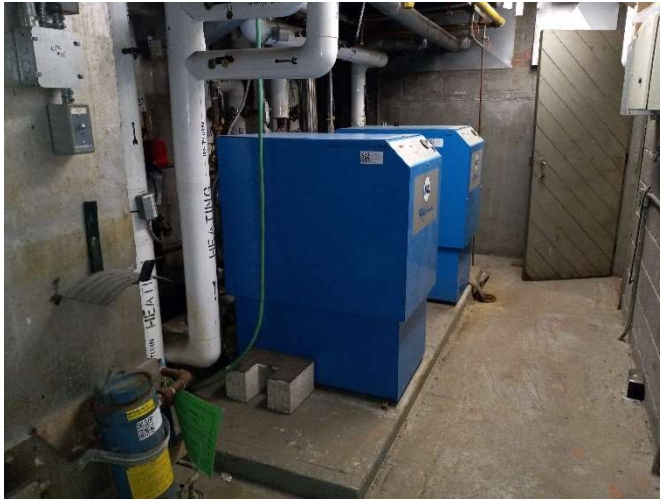
Photograph 17

Photo depicts natural gas fired boilers located in the boiler room in the basement.

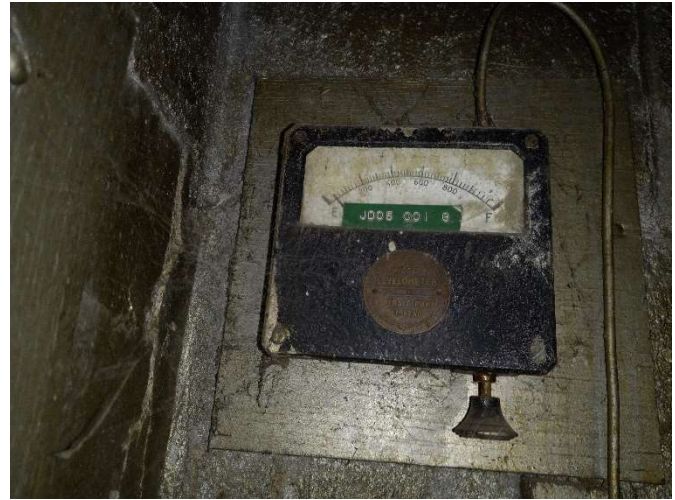
Photograph 18

Photo depicts levelometer that was connected to the 1,000-gallon heating oil UST.

During the site reconnaissance, a levelometer was observed in the boiler room of the basement, which was connected to the former fuel oil UST. The owner-provided plans indicated that a 1,000-gallon heating oil tank was used to fuel the former boilers within the main building (APEC #4). In addition, recent asphalt repair was observed along the east exterior wall of the main building, which is indicative of the UST being removed.

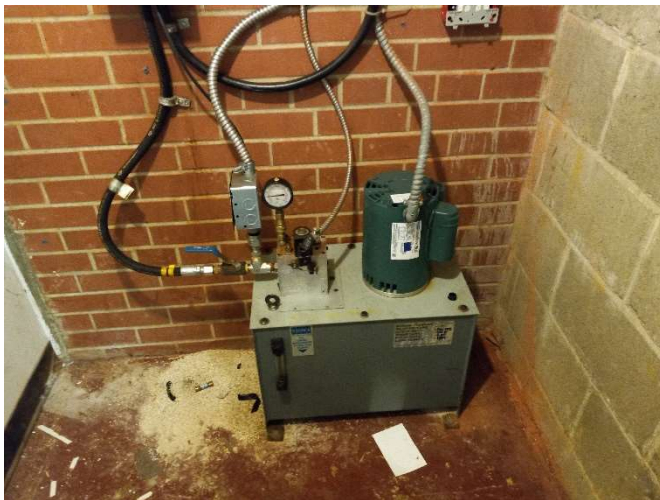
Photograph 19

Photo depicts hydraulic elevator unit located in the elevator room in the basement.

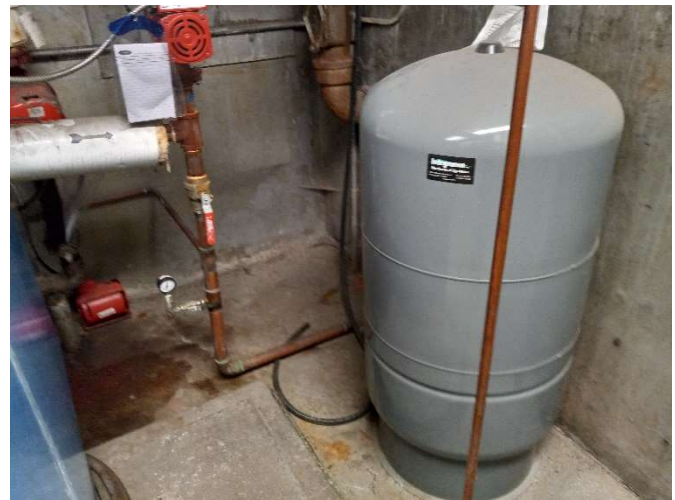
Photograph 20

Photo depicts a water expansion tank located in the boiler room in the basement.

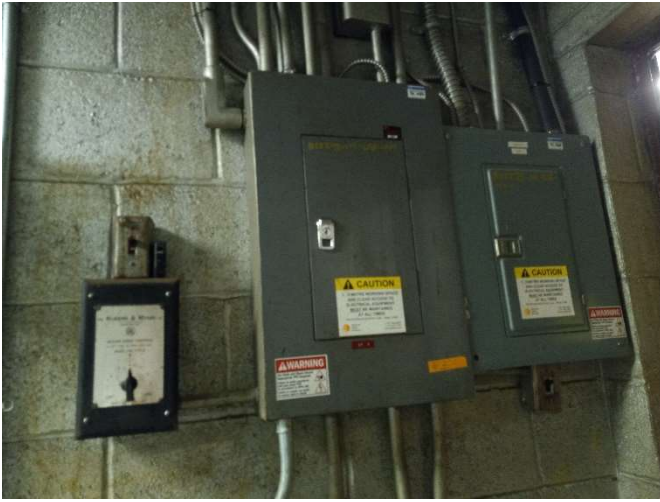
Photograph 21

Photo depicts electrical panels located in the boiler room in the basement.

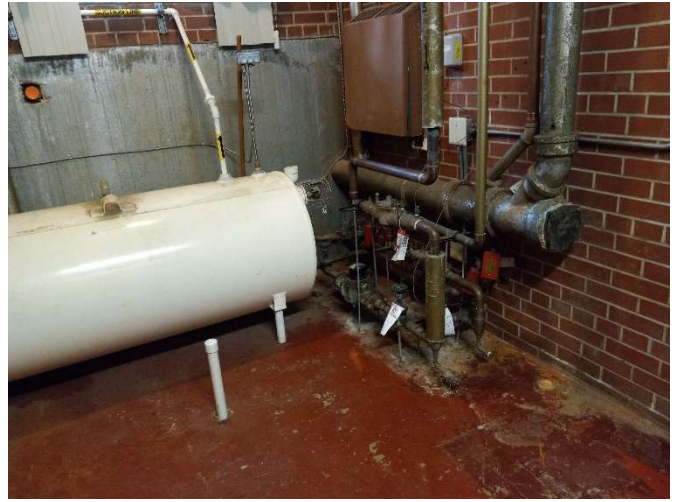
Photograph 22

Photo depicts stormwater storage tank that is no longer in use, and previously installed Monitoring Well located in the basement.

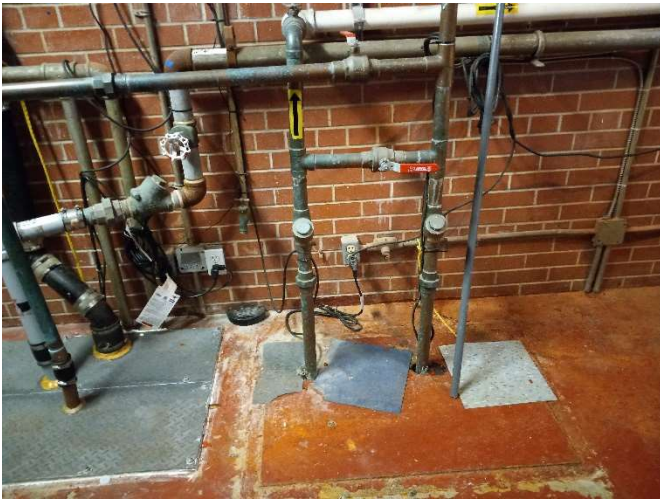
Photograph 23

Photo depicts a sump pump located in the basement.

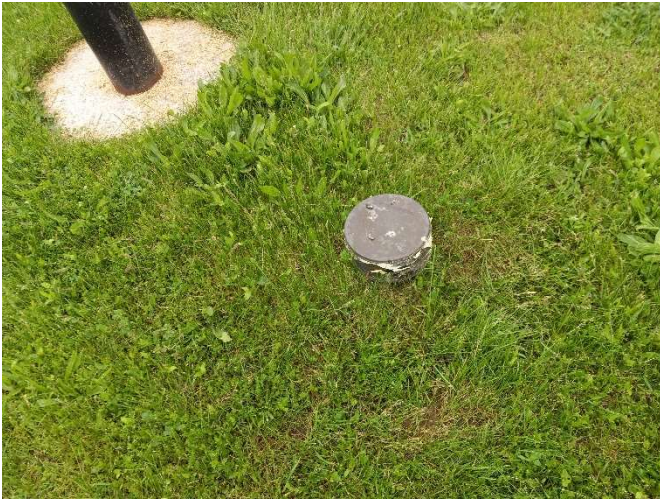
Photograph 25

Photo depicts a potential septic tank port in the north portion of the Property.

Underground utilities at the Phase One Property include sanitary sewer, potable water, storm sewer, hydro, and natural gas services. One 6" capped port for a potential septic tank was observed at the north portion of the Phase One property. Based on the owner-provided legal plan of survey, a concrete septic tank was located in this area.
