# **Phase Two Environmental Site Assessment (ESA)**

**49 South Service Road, Mississauga, ON**

*Project #*

2204701

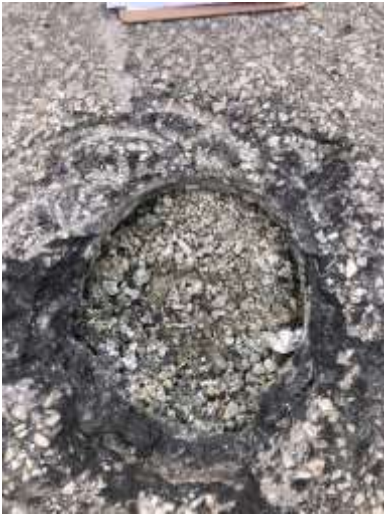
**Photograph 1**

Photo depicts damaged monitoring well (MW1-20) from previous Phase Two study.

- Due to prior damage to monitoring wells MW1-20, BH5, and BH2 being observed and monitoring wells deemed inaccessible, ground water sampling did not occur and was instead carried out in BH4 and BH1.
- Due to monitoring well BH7 being dry, BH6 was sampled as an alternative.

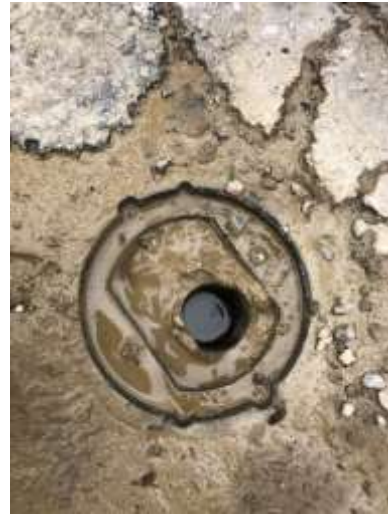
**Photograph 2**

Photo depicts previously installed monitoring well with no casing.

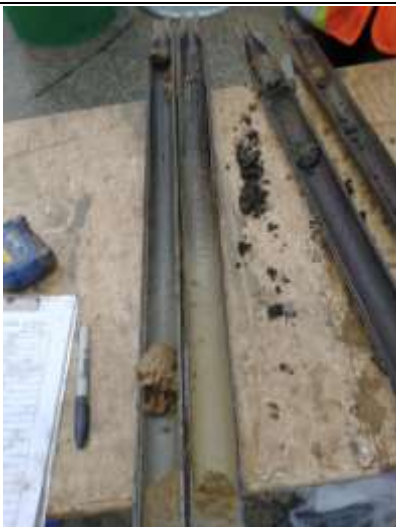
**Photograph 3**

Photo depicts soil core sample from BH22-7.

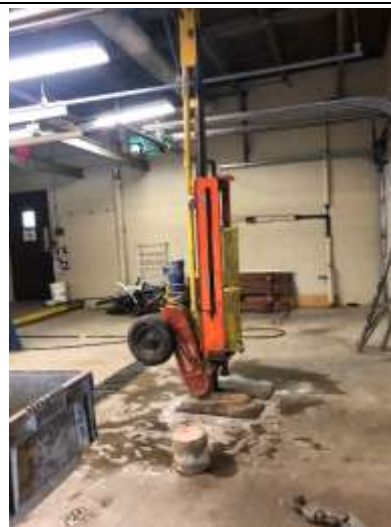
**Photograph 4**

Photo depicts drilling occurring in the garage building.
