3115 Hurontario Street, Mississauga

Phase One Environmental Site Assessment

Clearbrook Developments Ltd.
80 Front Street E, Suite 506
Toronto, ON M5E 1T4

MTE Consultants
1016 Sutton Drive, Unit A
Burlington, ON L7L 6B8

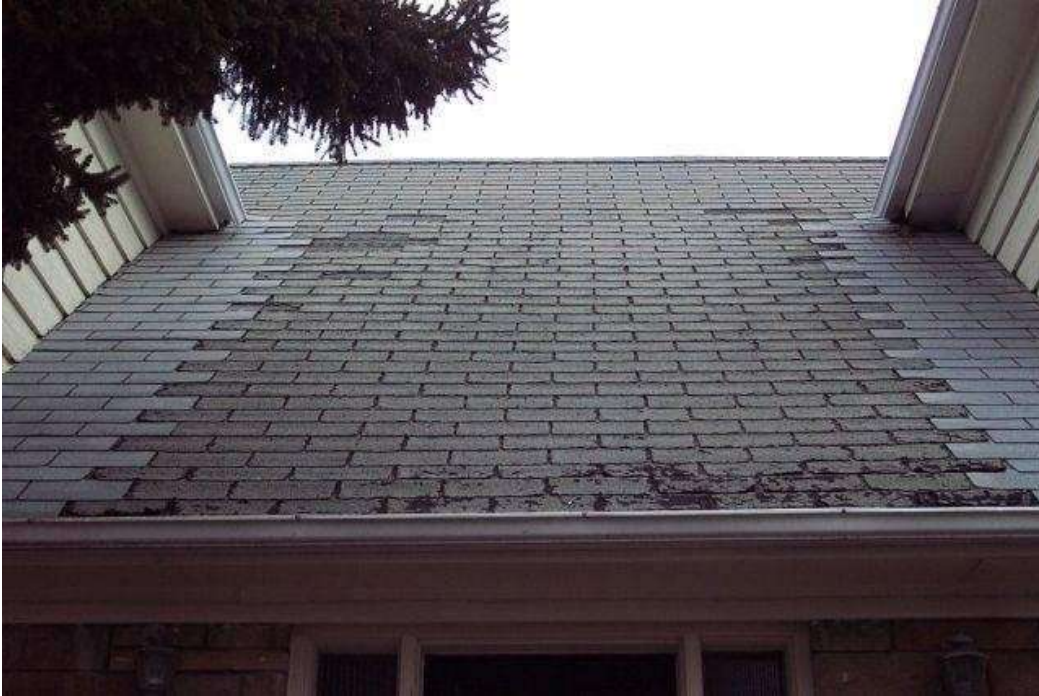
Shingle deterioration

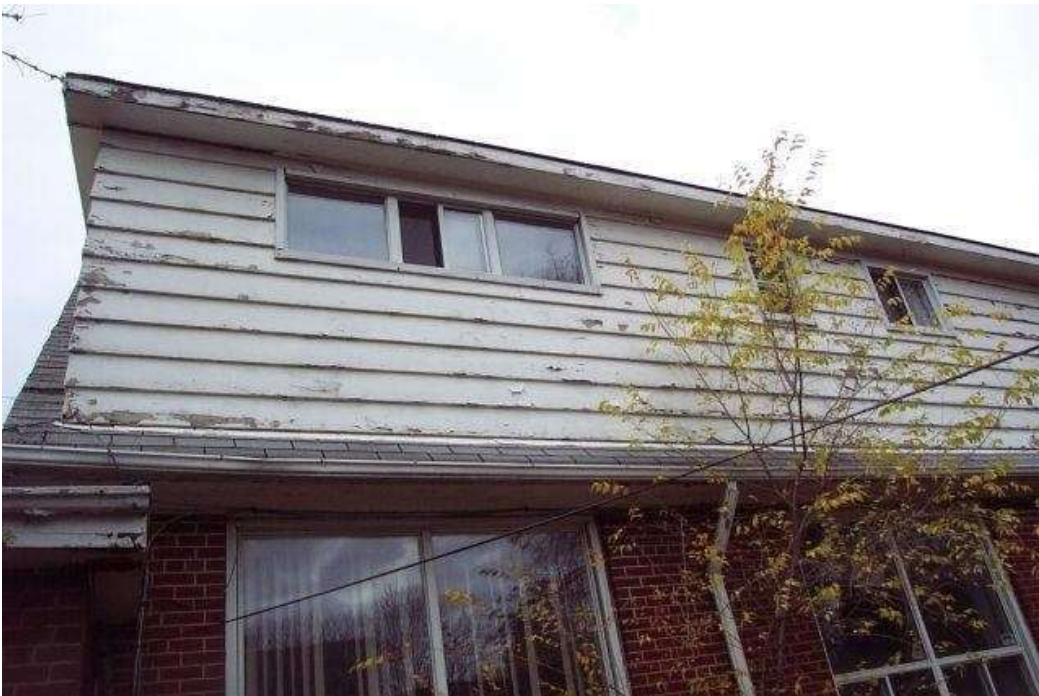
Peeling paint

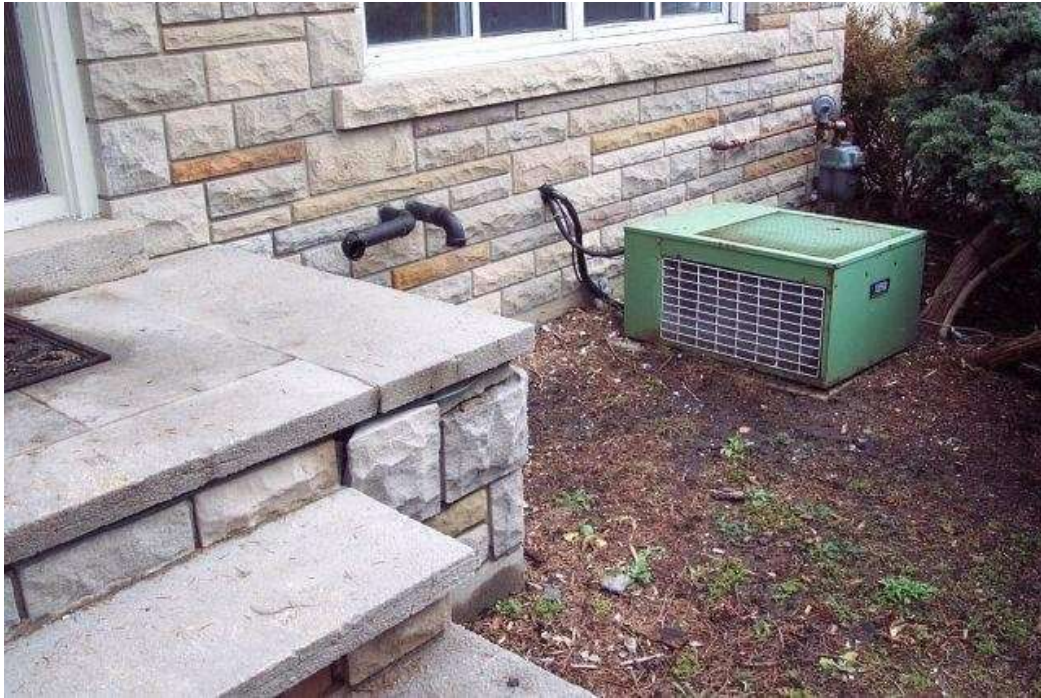
Broken facing frt stairs

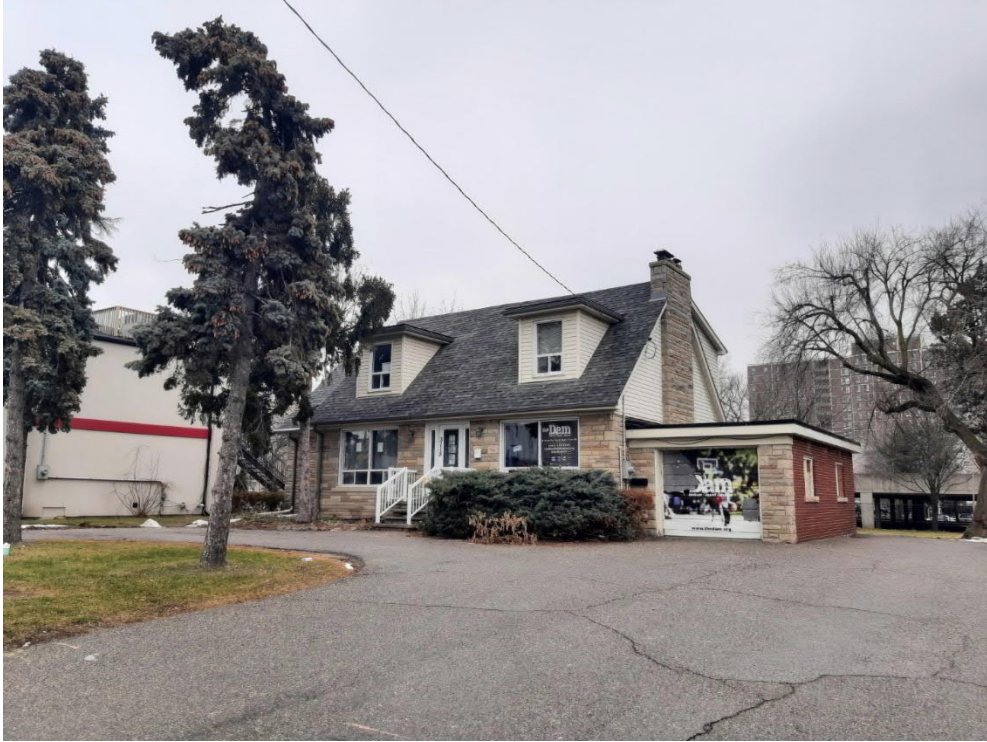
Photograph No. 1 – View of the south and west elevations of the 3115 Hurontario Street building (the Site), facing northeast.

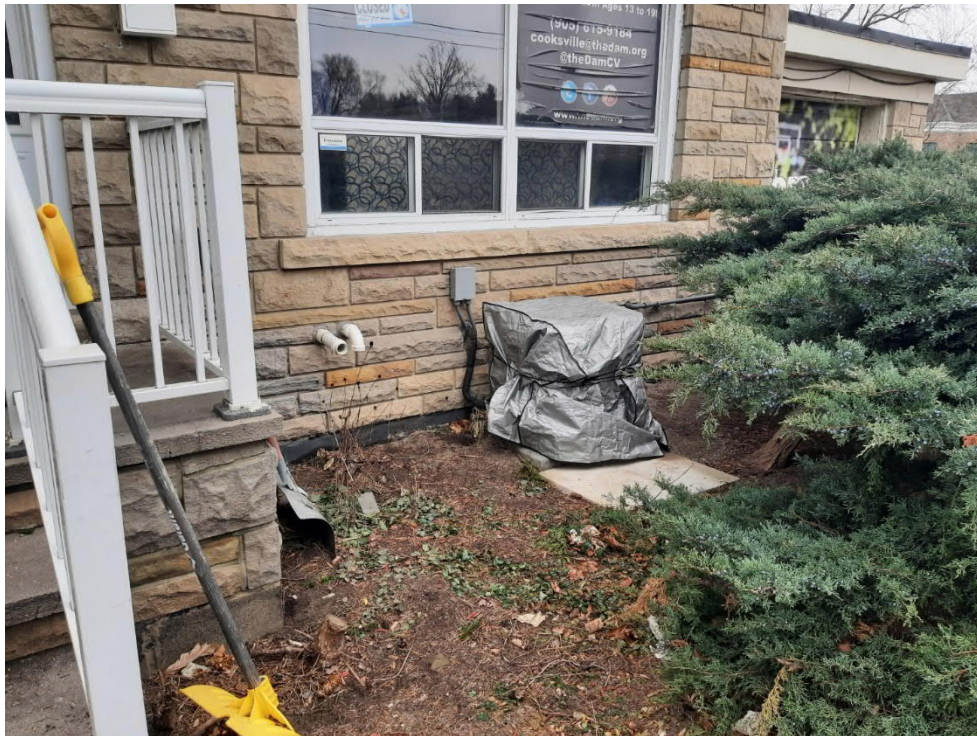
Photograph No. 6 – View of the furnace intake and exhaust pipes, and air conditioning unit located on the southwest elevation of the Site building.

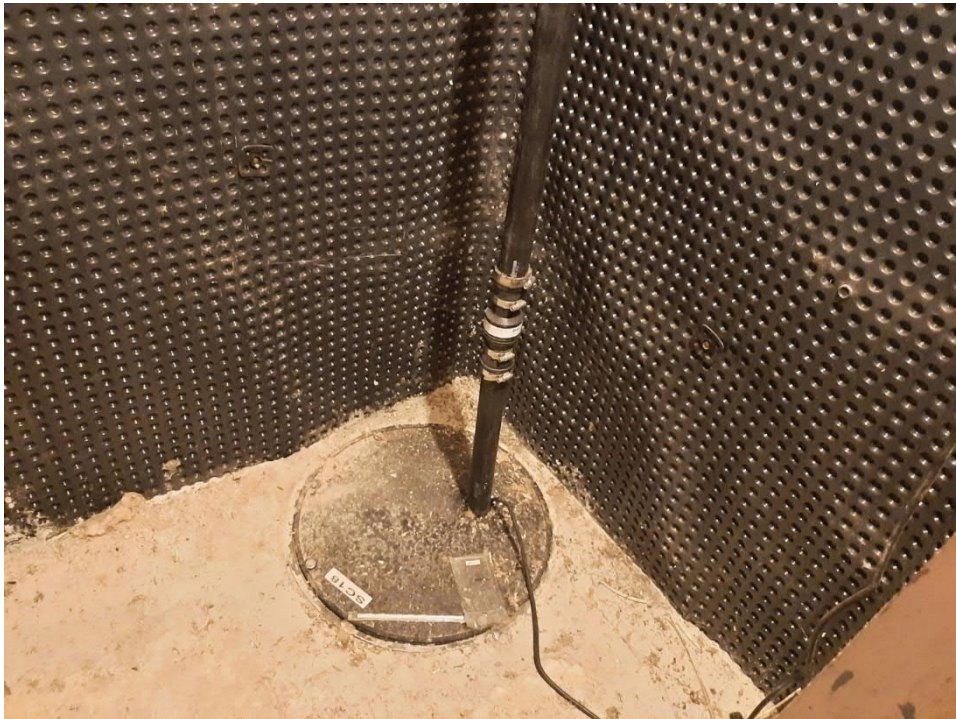
Photograph No. 12 – View of a sump in the east of the Site building basement.

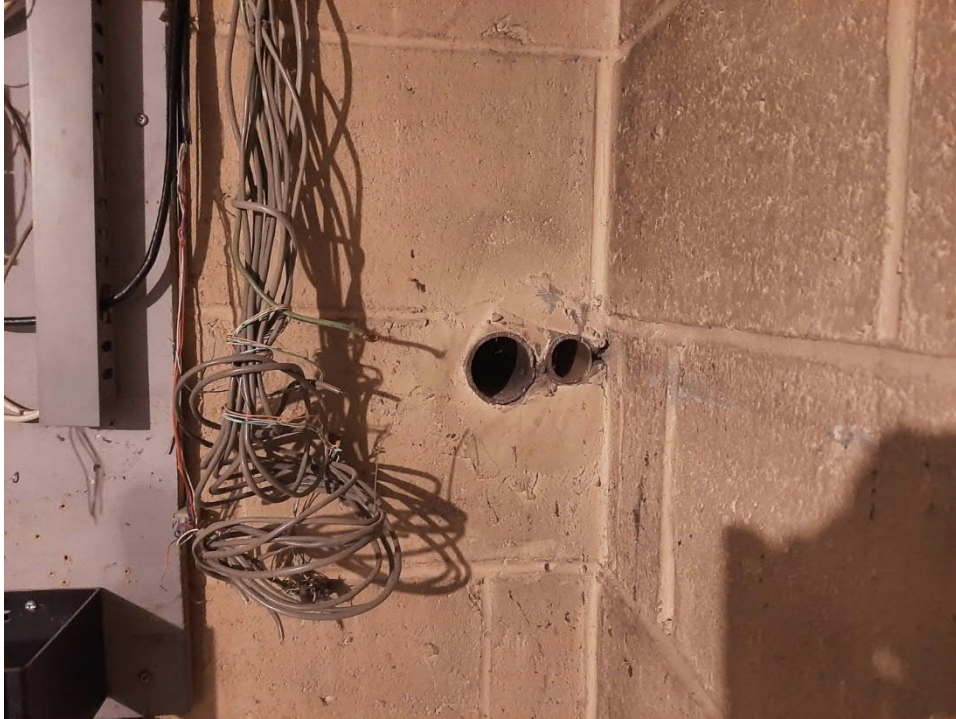
Photograph No. 13 – View of the former vent and fill pipe for the former basement AST in the southeast of the Site building.

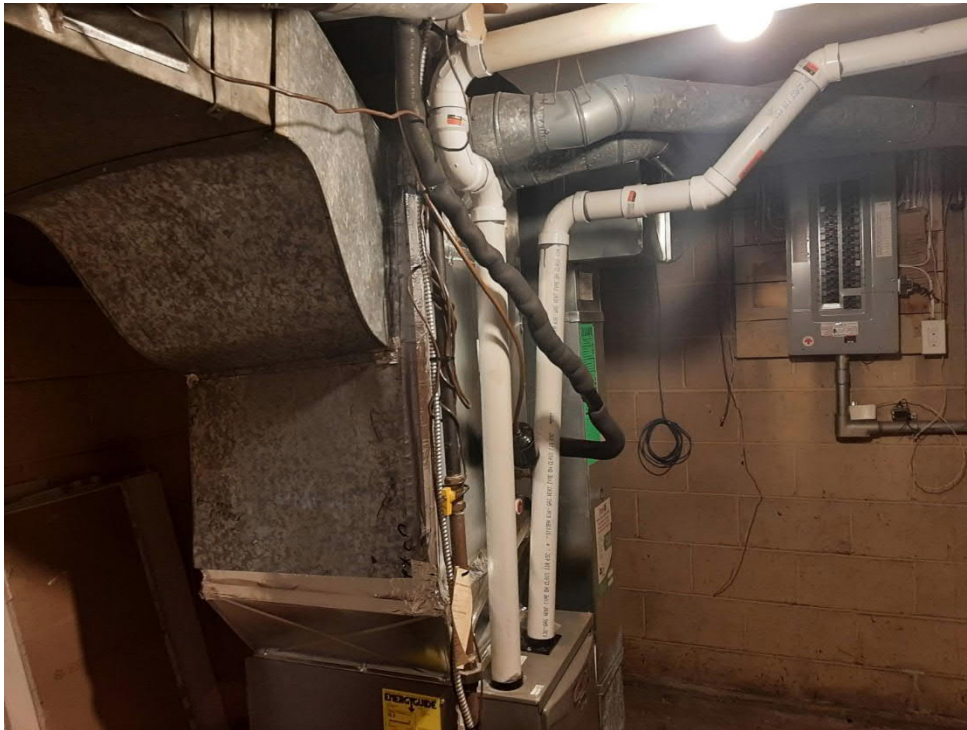
Photograph No. 15 – View of the furnace in the southeast of the basement of the Site building.

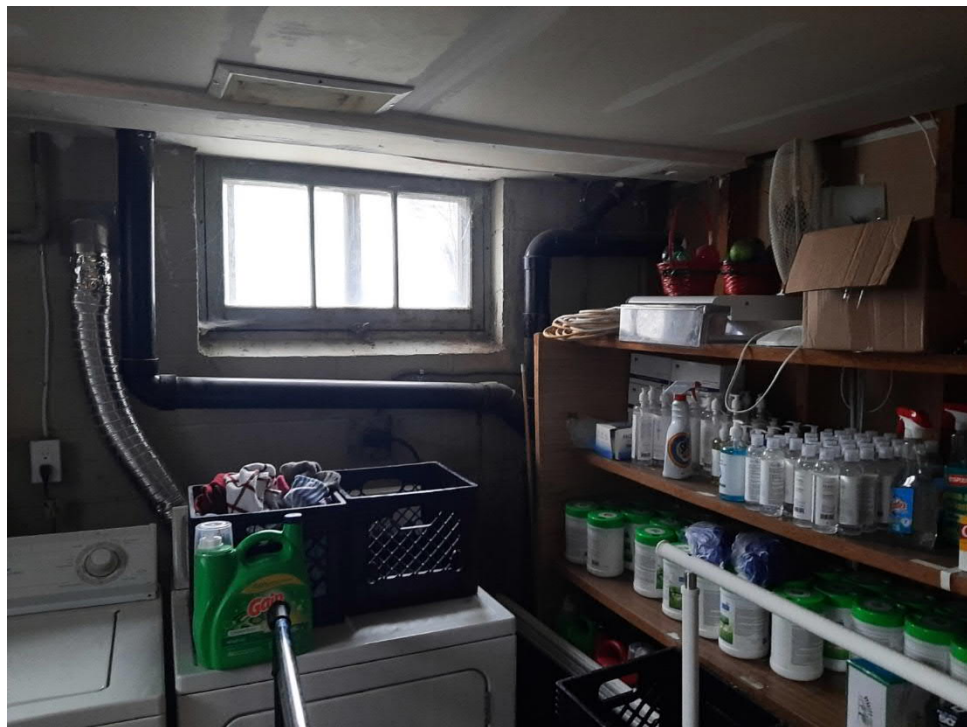
Photograph No. 16 – View of cleaning chemical storage in the basement of the Site building.
