3115 Hurontario Street, Mississauga

Phase Two Environmental Site Assessment

MTE Consultants
1016 Sutton Drive, Unit A
Burlington, ON L7L 6B8

May 27, 2022

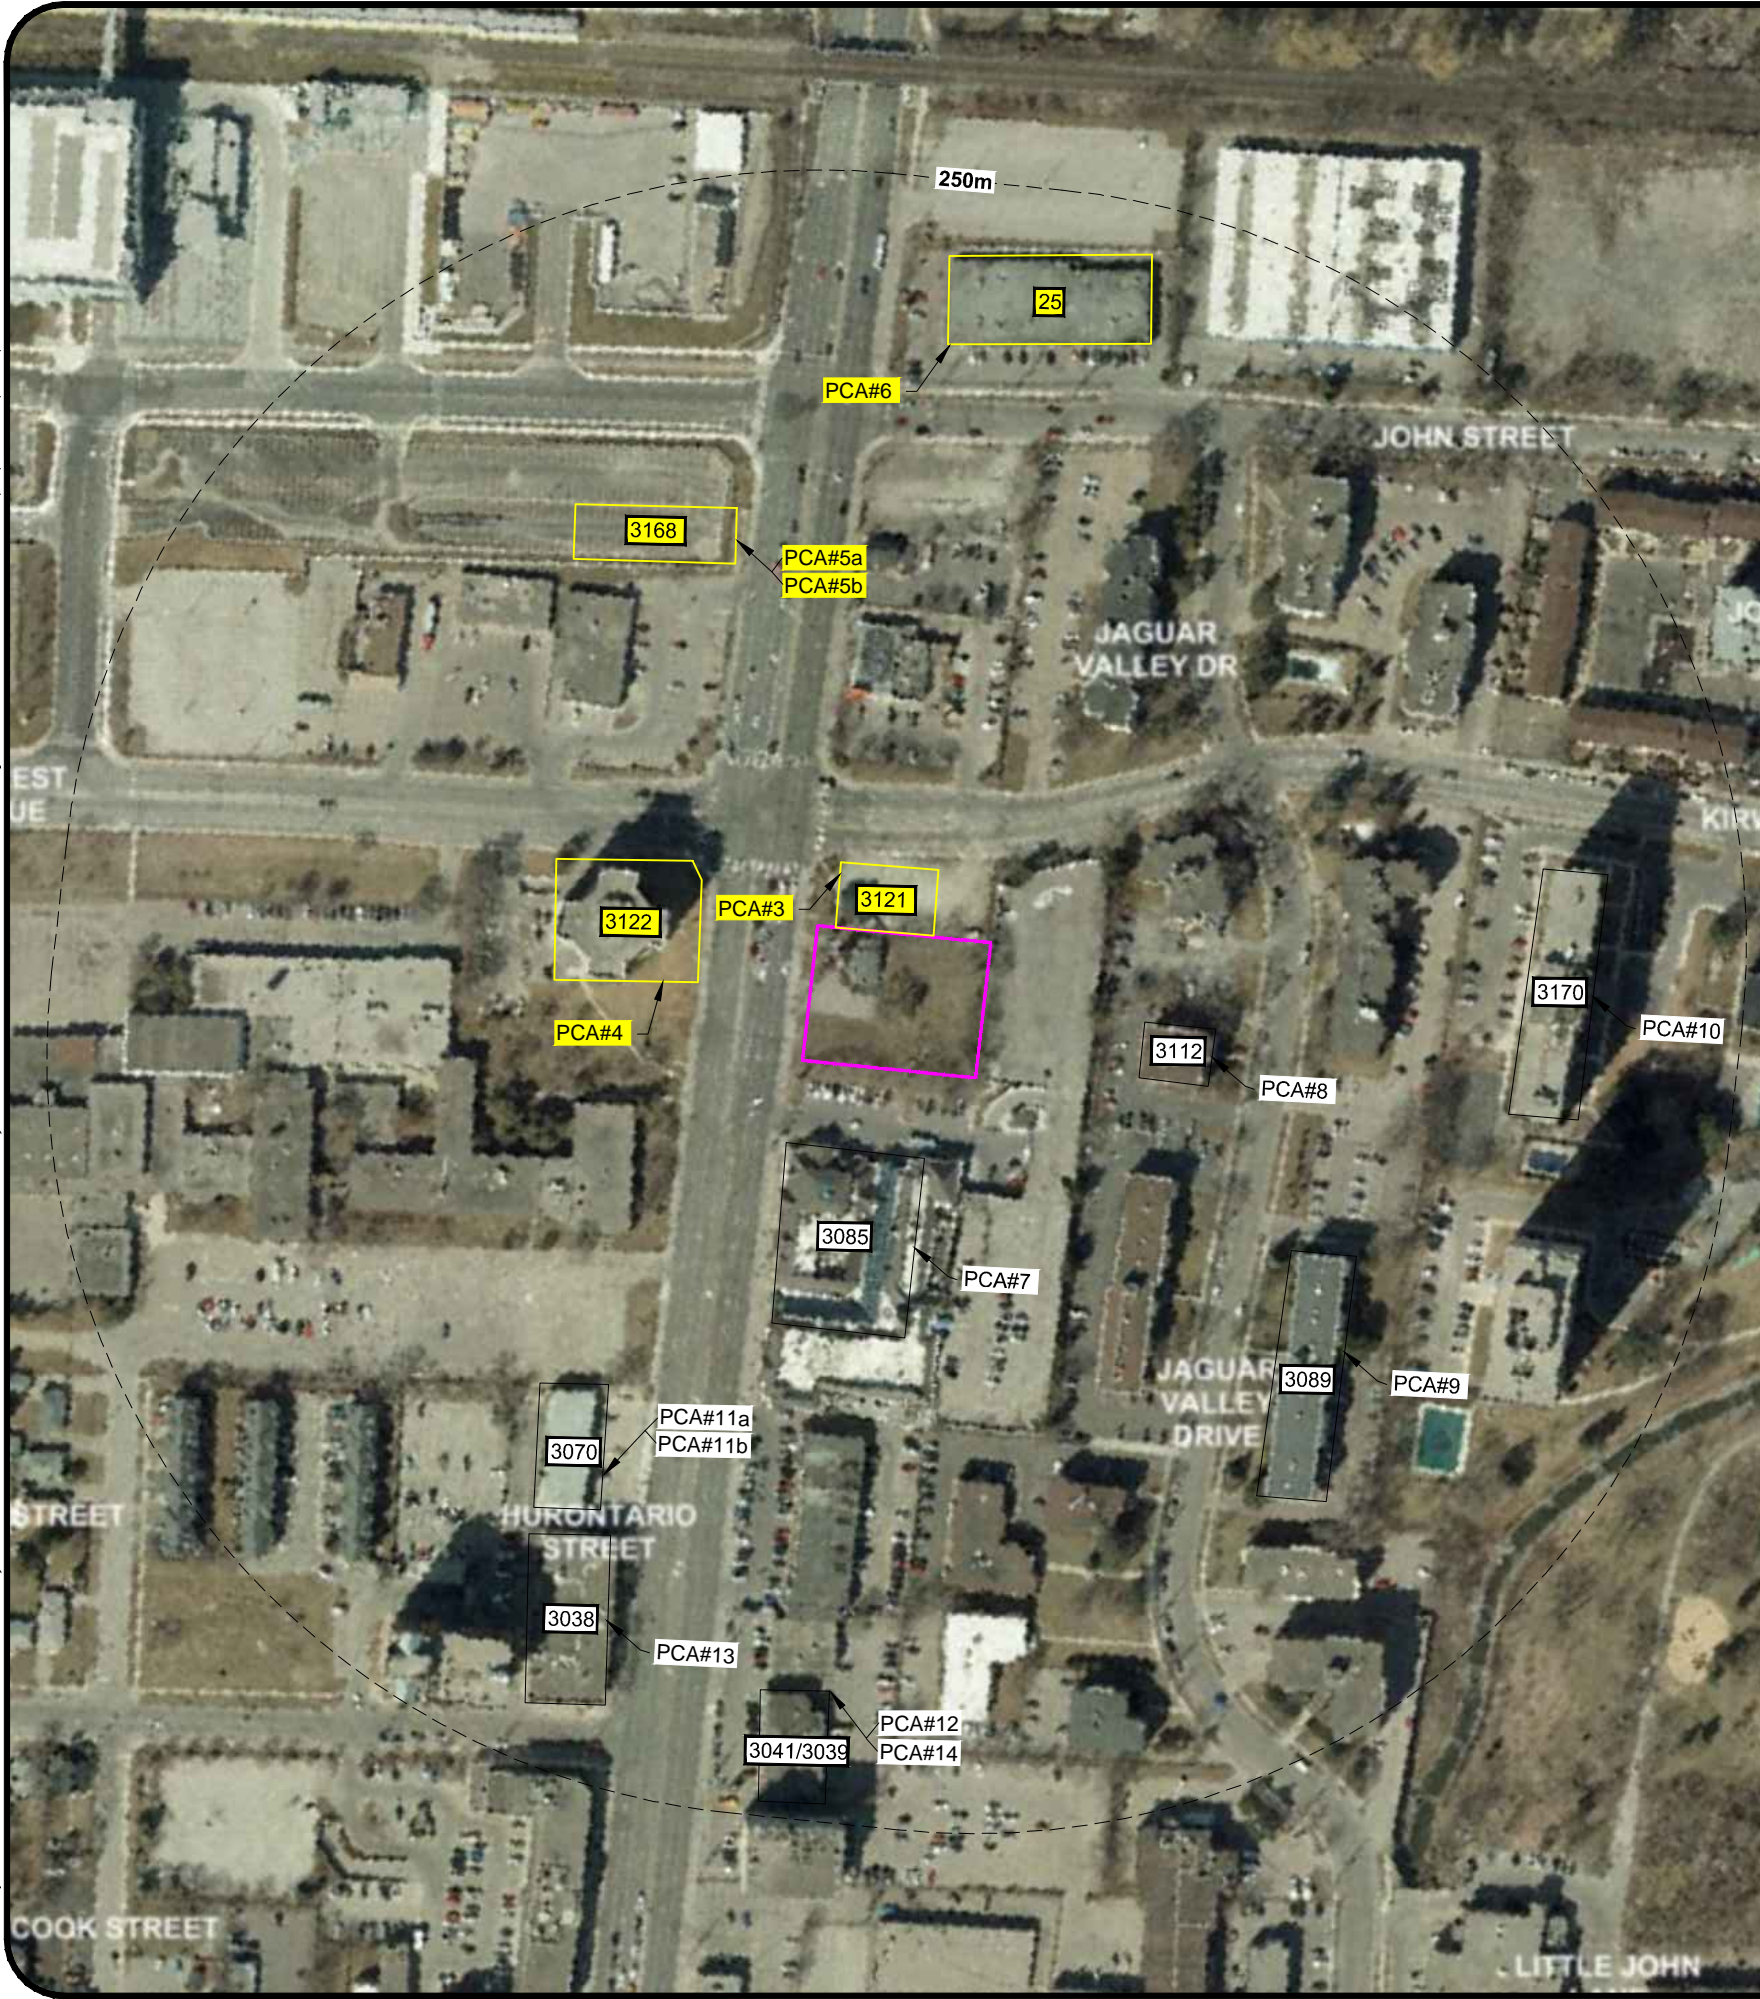
Reviewed By	TJJ	Project No.	50347-100
Prepared By	KDH	Figure No.	4
Drawn By	TXS		
Date	May 2022

Off-Site PCA Resulting in an APEC		
PCA Number	Municipal Address of Off-Site PCA Area	PCA According to Table 2. Schedule D of O.Reg. 153/04
3	3121 Hurontario Street	27. Garages and Maintenance and Repairs of Railcars, Marine Vehicles and Aviation Vehicles
4	3122 Hurontario Street	34. Metal Fabrication
5a	3168 Hurontario Street	10. Commercial Autobody Shops
5b	3168 Hurontario Street	27. Garages and Maintenance and Repairs of Railcars, Marine Vehicles and Aviation Vehicles
6	25 John Street	37. Operation of Dry Cleaning Equipment (where chemicals are used)

Off-Site PCA Not Resulting in an APEC		
PCA Number	Municipal Address of Off-Site PCA Area	PCA According to Table 2. Schedule D of O.Reg. 153/04
PCA #7	3085 Hurontario Street	Other - Fire
PCA #8	3112 Jaguar Valley Drive	18. Electricity generation Transformation and Power stations
PCA #9	3089 Jaguar Valley Drive	27. Garages and Maintenance and Repairs of Railcars, Marine Vehicles and Aviation Vehicles
PCA #10	3170 Kirwin Avenue	18. Electricity generation Transformation and Power stations
PCA #11a	3070 Hurontario Street	27. Garages and Maintenance and Repairs of Railcars, Marine Vehicles and Aviation Vehicles
PCA #11b	3070 Hurontario Street	31. Ink Manufacturing, Processing and Bulk Storage
PCA #12	3041 Hurontario Street	37. Operation of Dry Cleaning Equipment (where chemicals are used)
PCA #13	3038 Hurontario Street	31. Ink Manufacturing, Processing and Bulk Storage
PCA #14	3039 Hurontario Street	27. Garages and Maintenance and Repairs of Railcars, Marine Vehicles and Aviation Vehicles

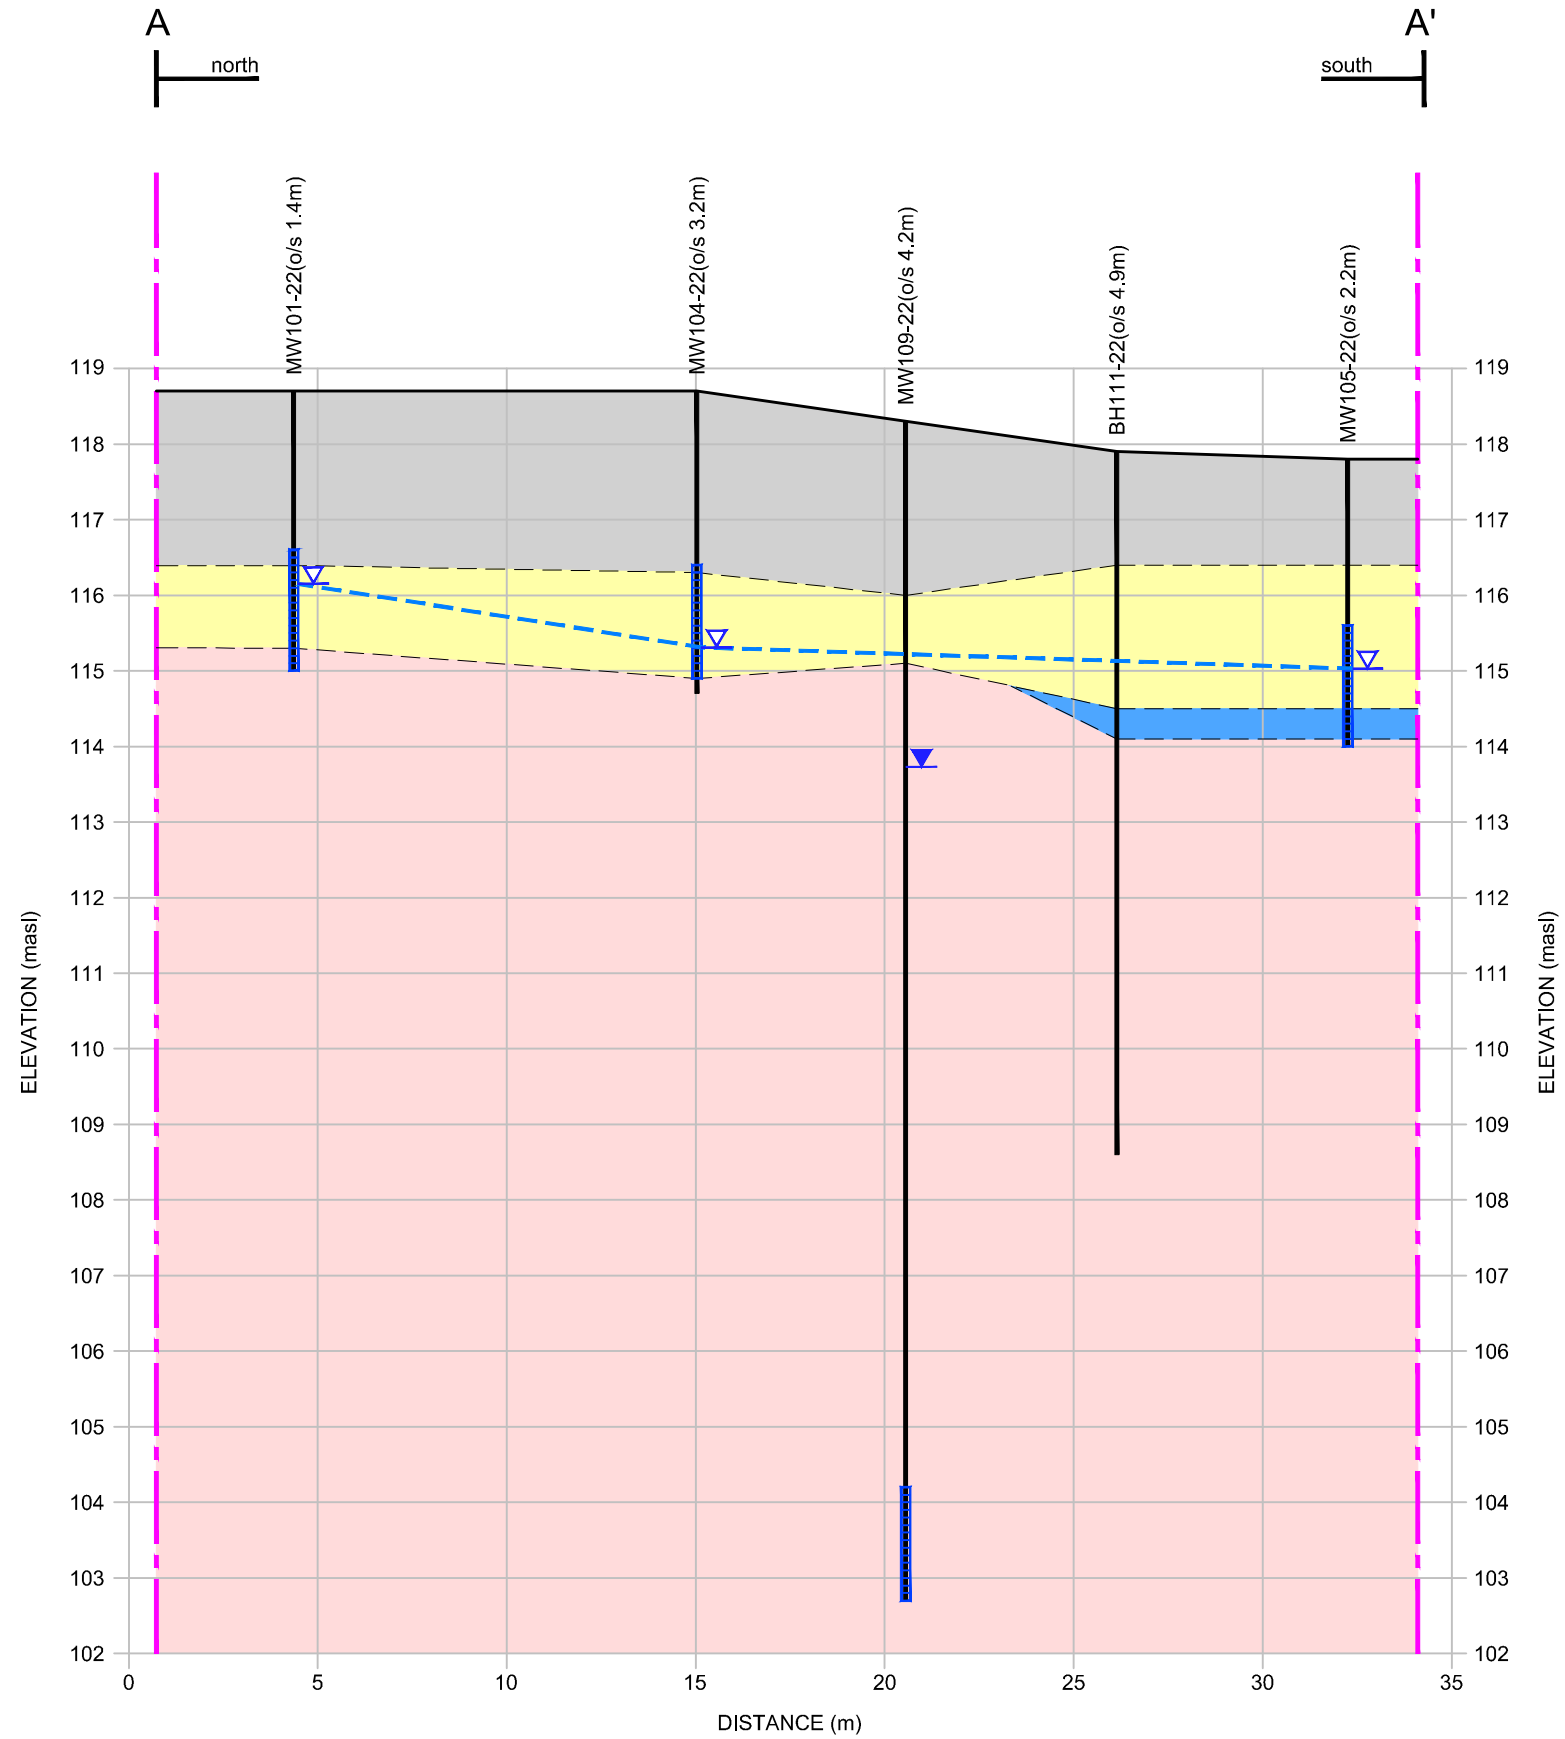
7

- Property Line
- Fill
- Sand/ Silty Sand
- Clayey Silt Till
- Shale

mamsl - metres above mean sea level
Water levels measured on 2022/03/22

The soil stratigraphy generally consisted of topsoil or asphalt underlain by sand and gravel fill and native sand/silty sand, with the exception of the basement where native silty sand was underlain by the concrete floor. The depth of the fill material ranged from 1.5 to 2.4m bgs and no non-soil materials (i.e. brick, concrete) were observed. The native sand/silty sand was underlain by clayey silt till soil at some borehole locations. Bedrock consisting of weathered shale was encountered below the sand/silty sand or clayey silt till at depths ranging from 3.0m to 4.0m bgs.

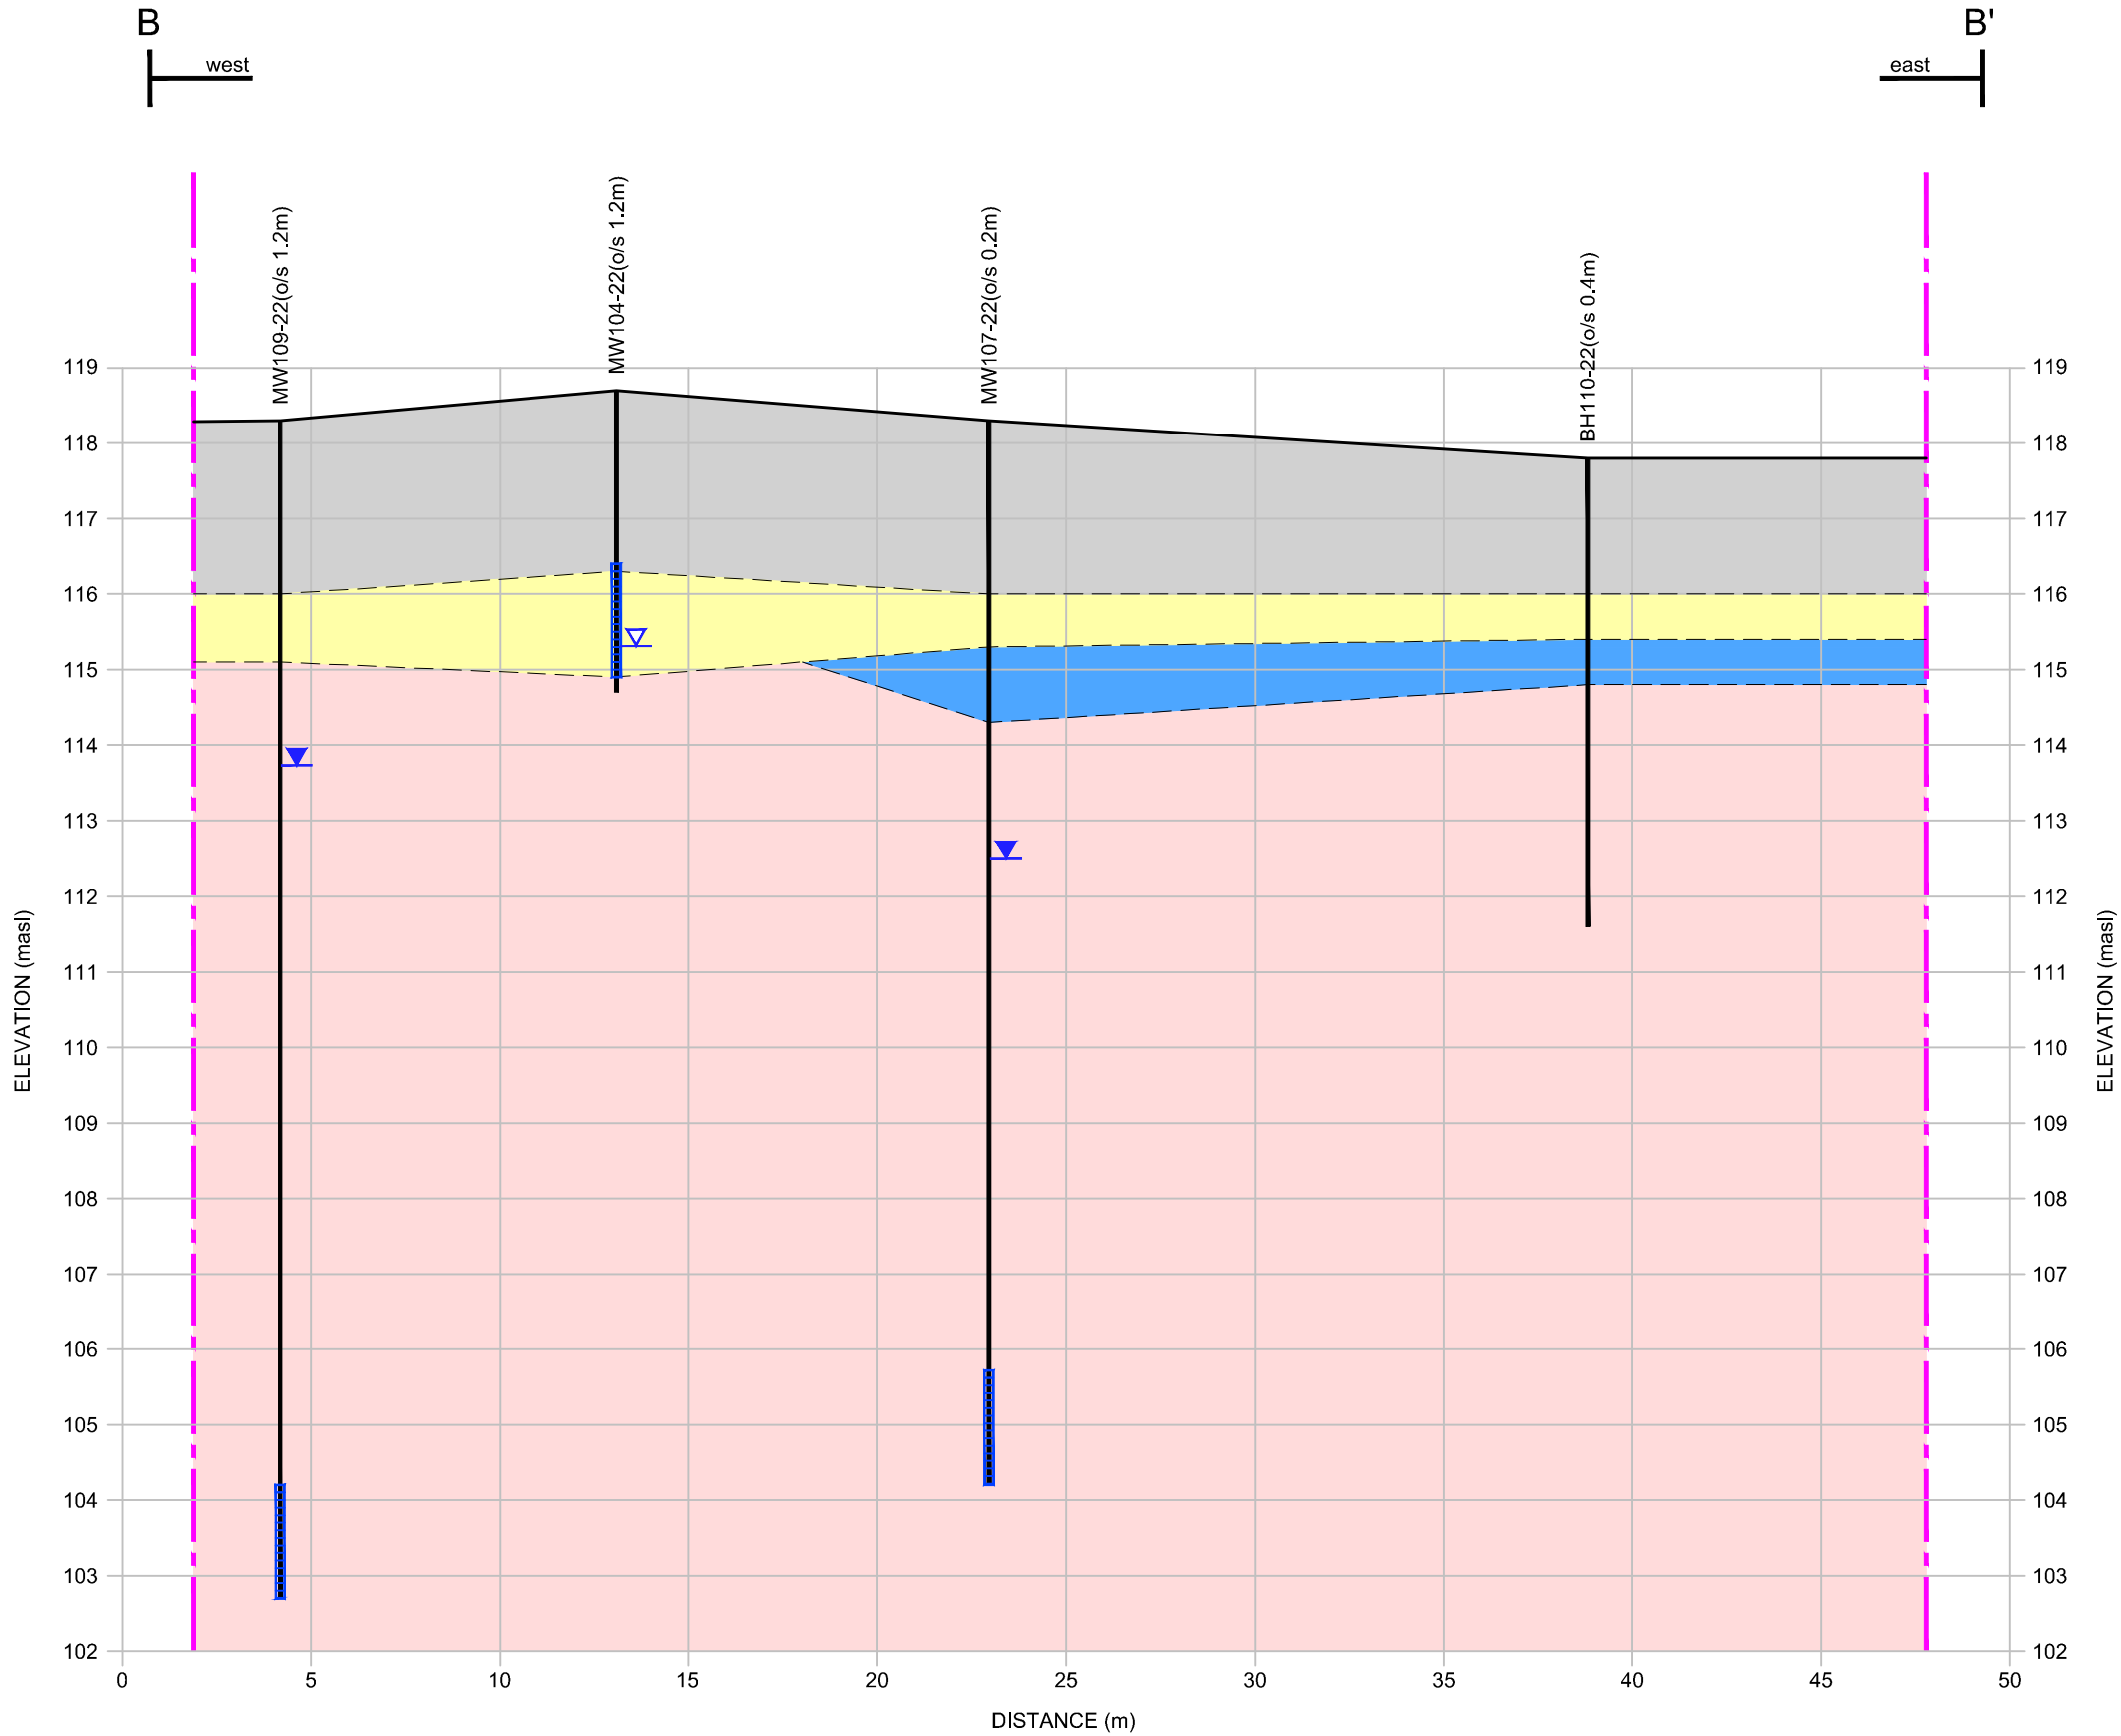
- Property Line
- Fill
- Sand/ Silty Sand
- Clayey Silt Till
- Shale

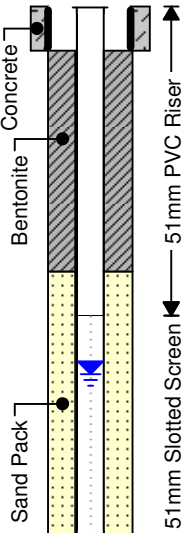
0		ASPHALTIC CONCRETE 100 mm	0.0	1	SS	67		1	0	
2		FILL dense brown sand and gravel, trace silt, wet dense to compact brown sand and silt, trace gravel, wet to very moist	118.1 0.6	2	SS	33	Metals, As, Sb, Se , Hg, B-HWS, pH, PHCs, BTEX	0	0	
4										
6				3	SS	75		0	0	
8		SAND AND SILT compact brown sand and silt, trace gravel, very moist	116.4 2.3	4	SS	83	pH	0	0	
10		saturated	115.6 3.0							
12		SHALE dense weathered grey shale, moist	115.3 3.4	5	SS	58		0	0	
14		Drilling Terminated	115.0 3.7							
16										
18										
20										
22										
24

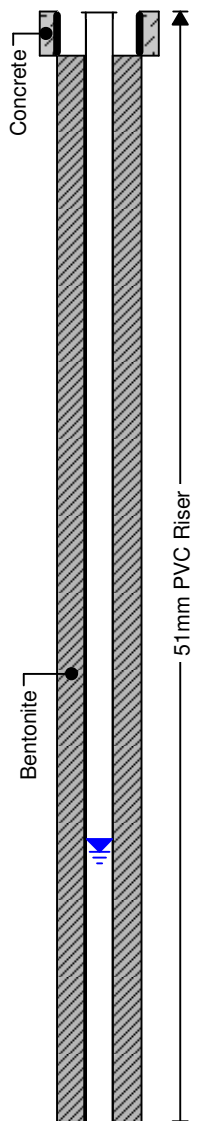
0		FILL (TOPSOIL) compact dark brown sandy silt, trace gravel and organics, wet (250mm)	0.0	1	SS	83		0	10		
2		FILL compact brown sand and silt, trace gravel, very moist some gravel, with brick fragments	117.6	2	SS	63		0	30		
4			0.8								
6				3	SS	88		0	25		
8		SILTY SAND compact brown silty sand, trace gravel, very moist saturated	116.0	4	SS	88		0	15		
10			2.3								
12		CLAYEY SANDY SILT TILL hard grey clayey sandy silt, trace gravel, DTPL	115.7	5	SS	92		0	5		
14			2.6								
16		SHALE very dense weathered grey shale, very moist	115.3	6	SS	50		0	15		
18			3.0								
20			4.0	7	RC	-					
22				8	RC	-					
24				9	RC	-

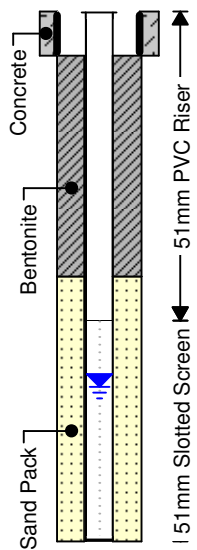
0		FILL (TOPSOIL) compact dark brown sandy silty topsoil, trace gravel and organics, very moist (200mm)	0.0	1	SS	79		0	10		
2		FILL compact dark brown sand and silt, trace gravel, very moist	116.9	2	SS	63		1	0		
4		loose brown silty sand, trace gravel, very moist	116.1								
6		SILTY SAND compact brown silty sand, trace gravel, very moist	1.5	3	SS	75		0	10		
8		saturated	115.0	4	SS	100		0	10		
10		CLAYEY SILT TILL hard grey clayey silt, trace sand and gravel, DTPL	2.6					0	5		
10		SHALE compact weathered grey shale, very moist	114.6	5	SS	83		0	0		
12			3.0								
12			114.0								
4		Drilling Terminated	3.7								
14											
16											
18											
20											
22
