17-19 Ann Street, 84-90 High Street East Mississauga, Ontario **HERITAGE IMPACT ASSESSMENT (OZ/OPA 22-3 W1)**

November 4, 2022

Project # 21-110-01
Prepared by PE / SI / EA / PB

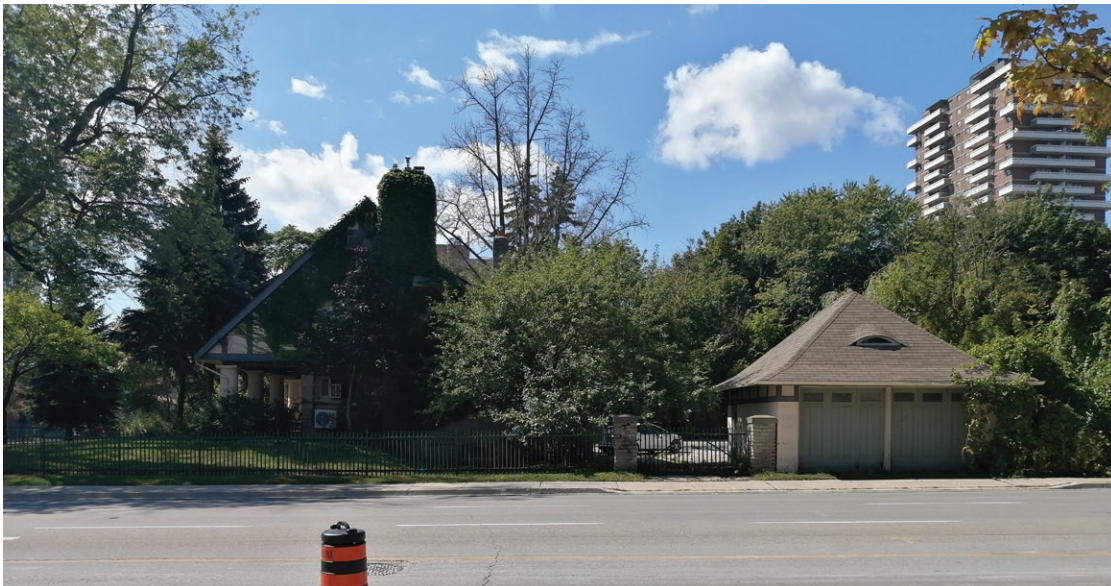
East elevation of 90 High Street East. Note steel fencing and detached two-car garage (ERA, 2021).

continues to sit within the North Public Park lands and maintains a rear condition relationship to the house at 90 High Street East. The garage is of architectural and contextual interest, and there is potential for it to be adapted for reuse as a City of Mississauga public-park building or utility.

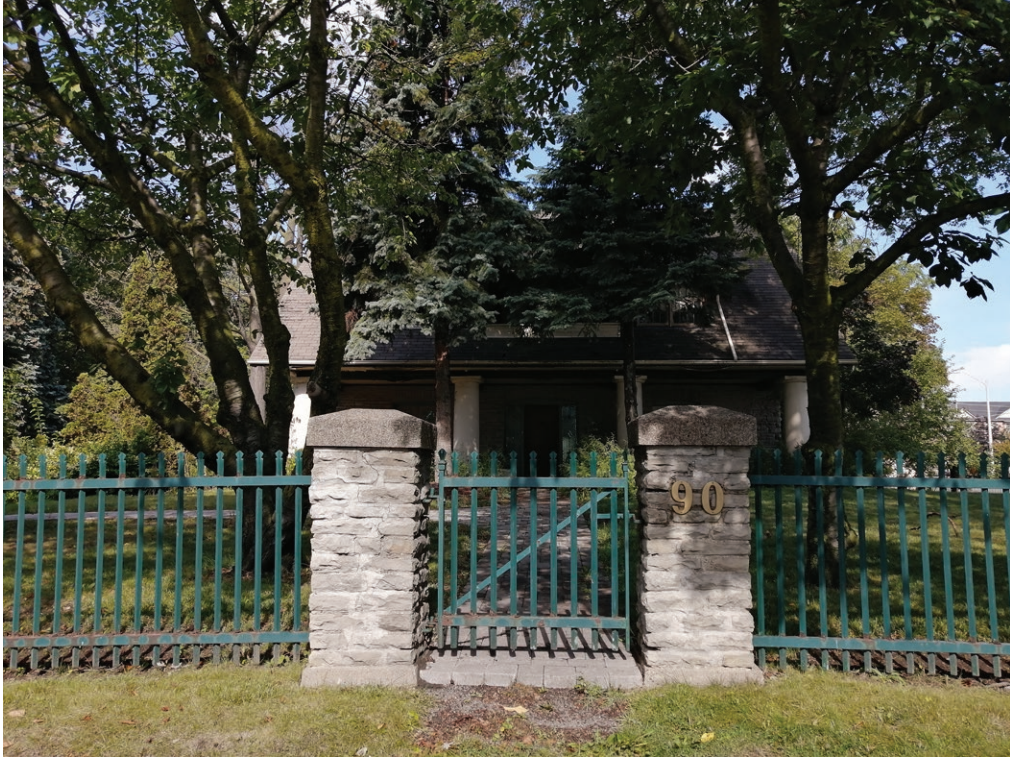
South elevation of 90 High Street East. Note stone gate posts and steel gate and fencing (ERA, 2021).

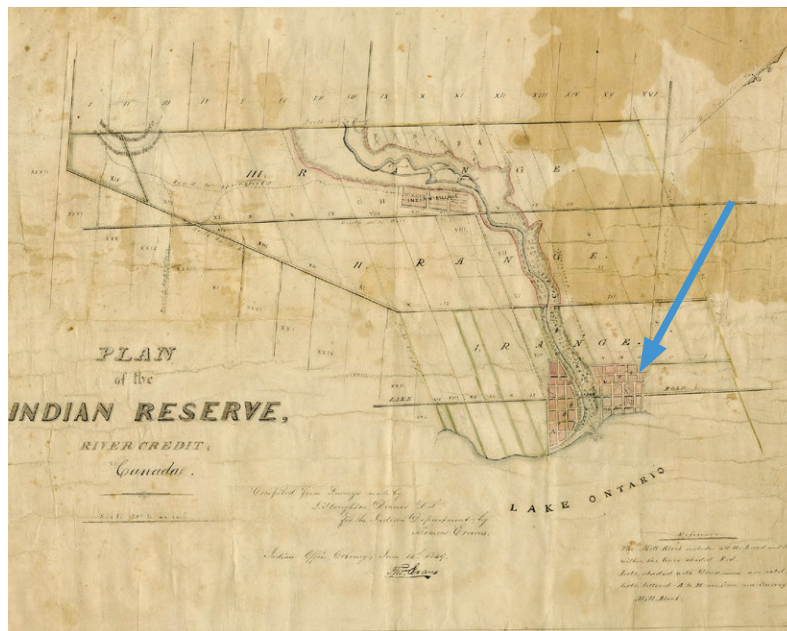
1849 map of the Credit River Indian Reserve and Port Credit Village. The Site is indicated with a blue arrow (Peel Gallery, Museum and Archives).

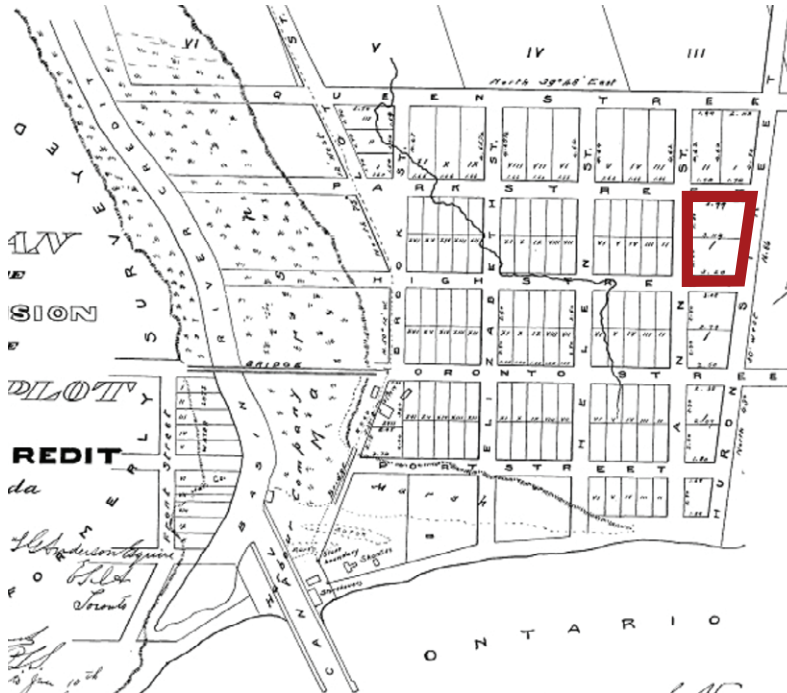
1846 Survey Plan for the extension of Port Credit with the Site outlined in red (Heritage Mississauga, annotated by ERA).

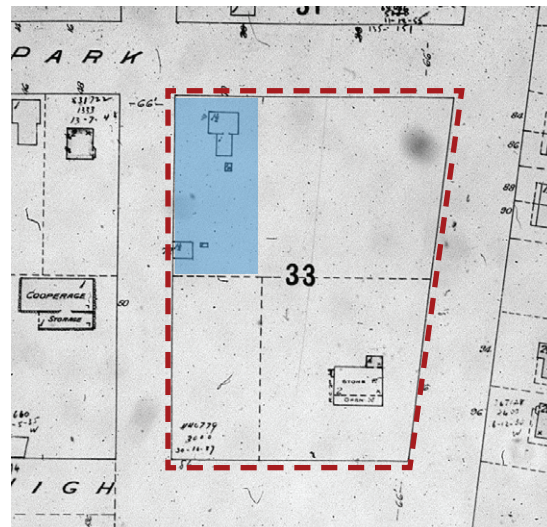
1910 fire insurance plan showing the Site outlined in red and the westerly 66-ft frontage lot shaded blue (Peel Art Gallery, Museum and Archives, annotated by ERA).

The 1910 Fire Insurance Plan for Port Credit shows a one-and-a-half storey home with one storey rear wing on the northwest corner of Lot 1 Park Street South Side, near the intersection of Ann Street and Park Street East.

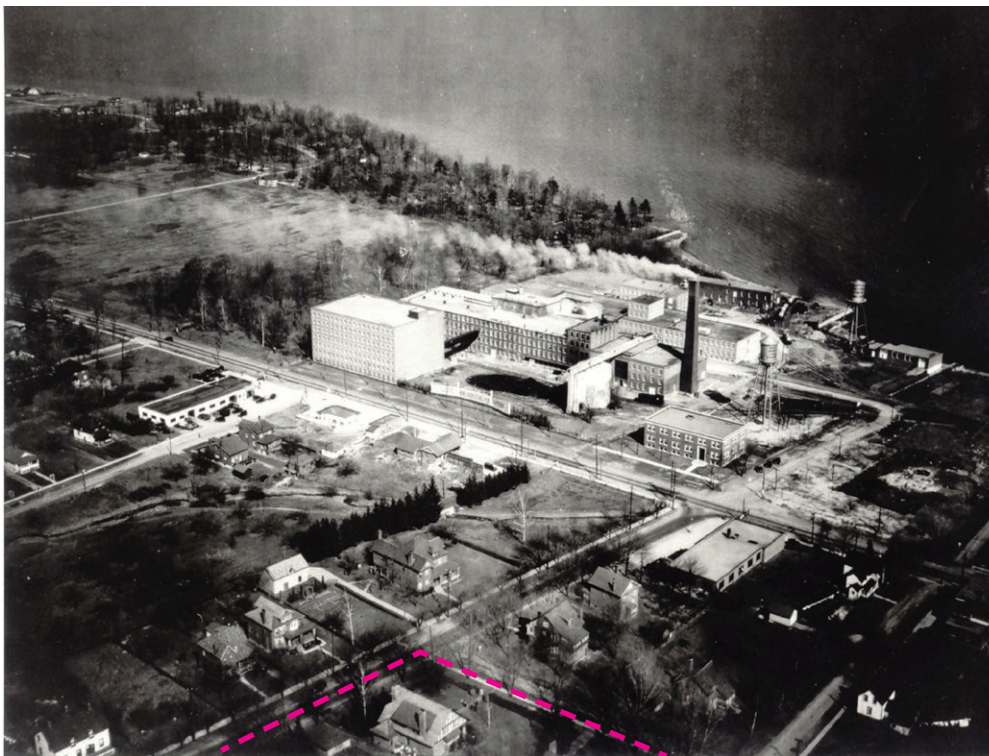
1935 aerial southeast-facing photograph with the Site outlined in pink. The house and garage at 90 High Street is the only portion of the Site that's visible (Heritage Mississauga, annotated by ERA).

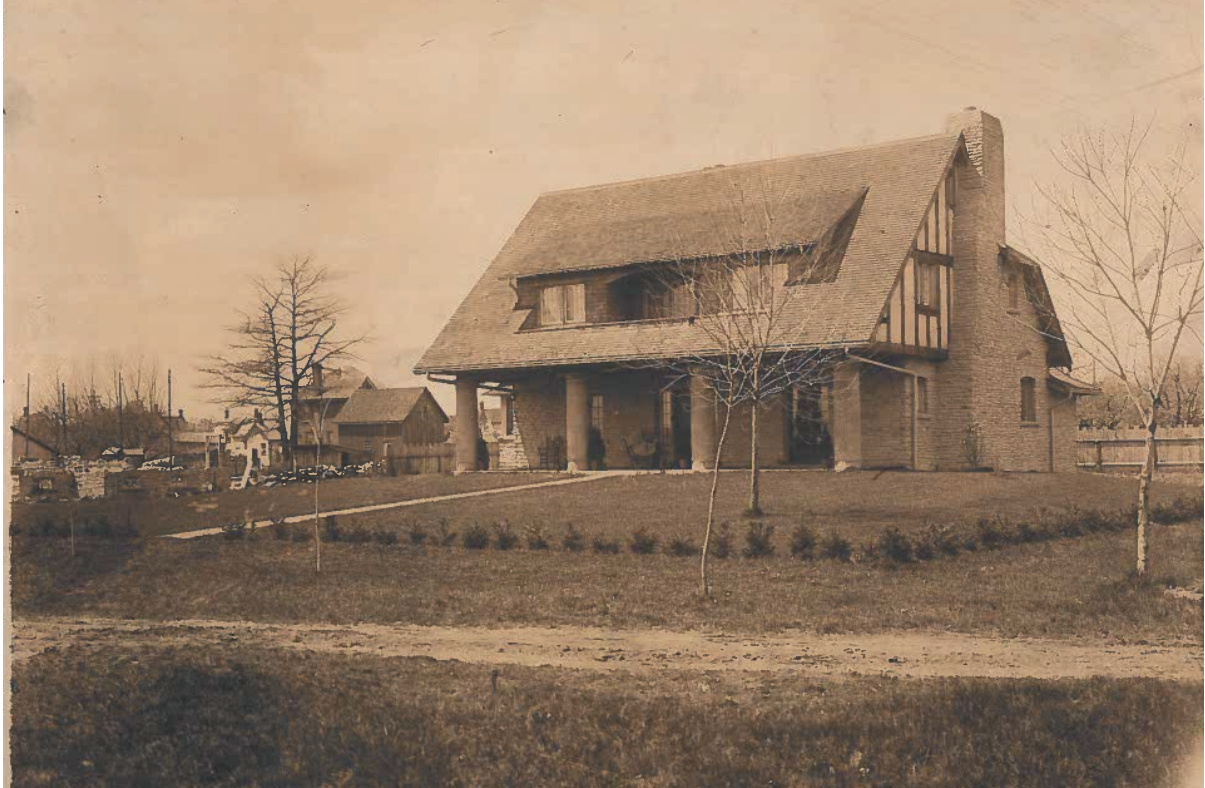
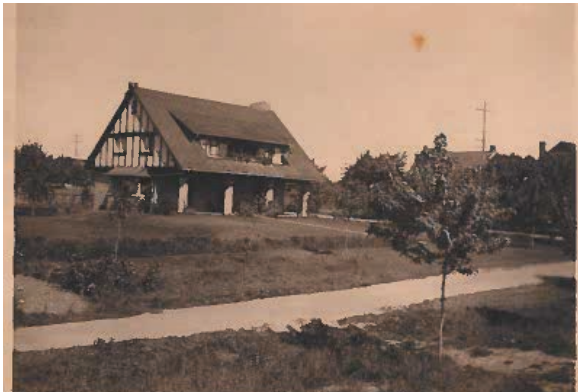
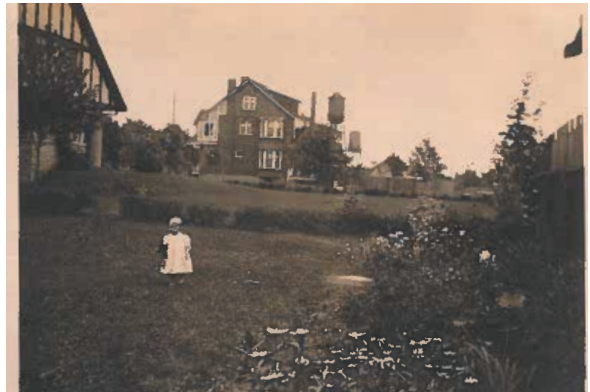
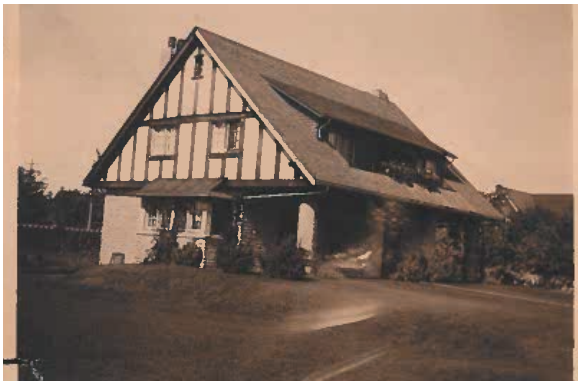
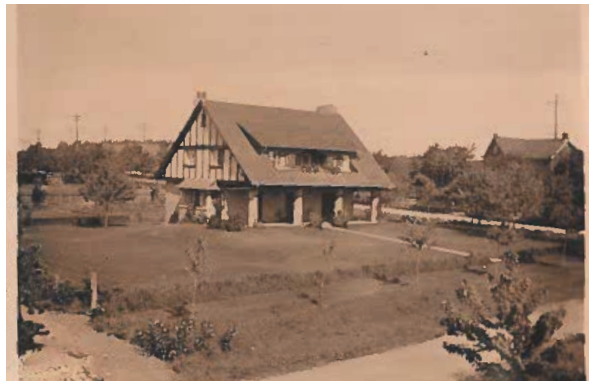
Undated photographs of 90 High St E, clockwise from top: (1) looking northwestward; (2) looking southward across High Street, showing historic landscape condition between 84 and 90 High Street; (3) looking northeastward; (4) looking northeastward from lawn; (5) looking northeastward across High Street (FRAM + Slokker).

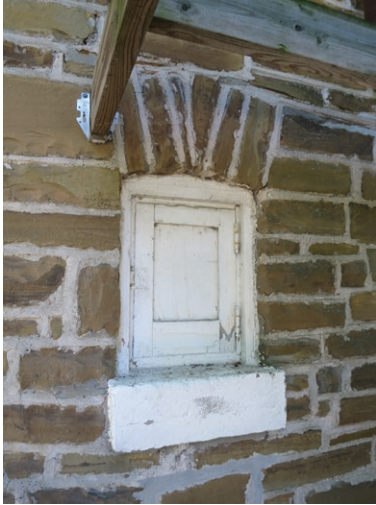
Fig. 1 (ERA, 2021).

- The ground floor masonry details around the building perimeter appear to be in fair to good condition in most locations, with isolated locations of step cracks, open mortar joints, and insensitive past repointing between the stone units (see Fig. 1).

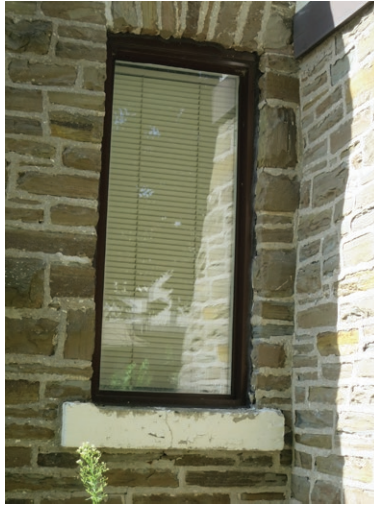
Fig. 2 (ERA, 2021).

- There are isolated locations of cracked or deteriorated cast-concrete details such as window sills or stone wall copings (see Fig. 2).
- The rough cast stucco on the upper floors appears to be generally in good condition in most locations, with isolated areas of cracking or poor past repairs using an inappropriate cement-based patching compound (see Fig. 3).

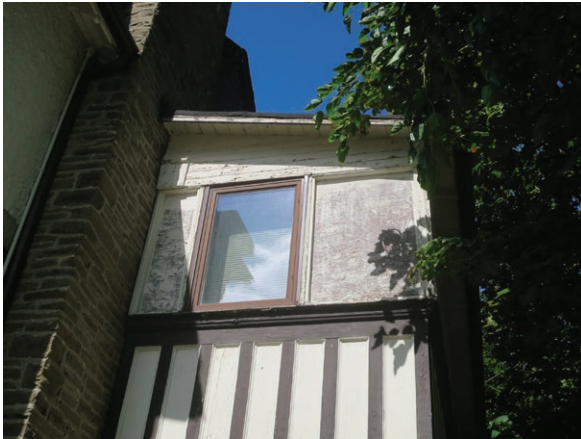
Fig. 4 (ERA, 2021)..

- Wood details around the building perimeter appear to be generally in fair condition, with some wood elements in poor condition. Exposed wood eave details and rafter tails appear to be in good condition in most locations, as well as the main front porch and landing wood ceiling and perimeter trim details. There is wood rot present in some locations on the second-floor east sunporch projection (see Fig. 4).

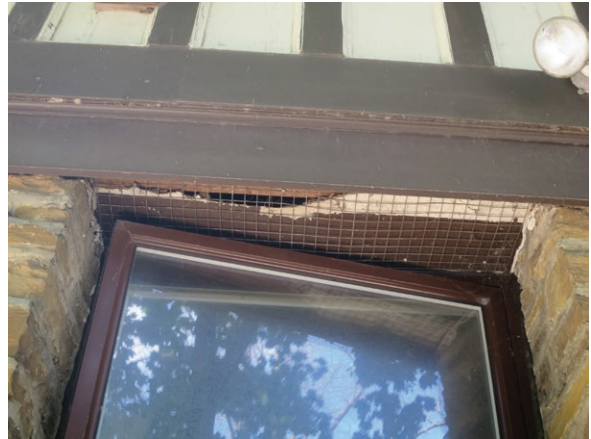
Fig. 5 (ERA, 2021).

- Wood trim details around the windows and doors, as well as the applied wood half timbering details appeared to be in fair to good condition. There are isolated locations of missing or animal damaged perimeter wood window casings or trim (see Fig. 5).

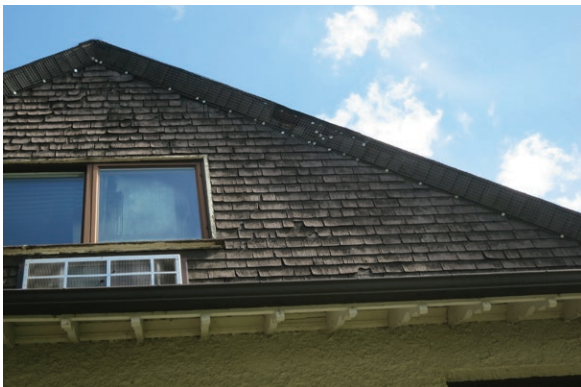
Fig. 6 (ERA, 2021).

- The wood shingles in the gable end walls are at the end of their serviceable lifespan. The wood gable end eave-line details have been damaged due to animal intrusion (see Fig. 6).

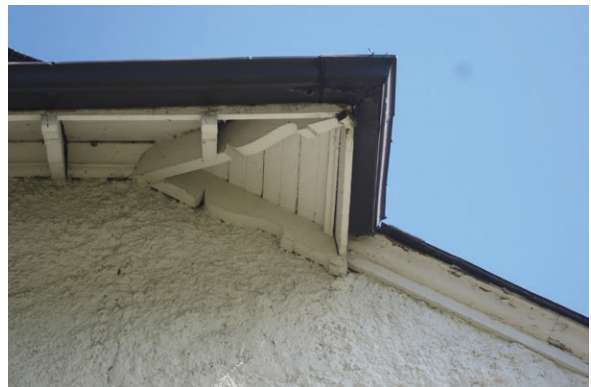
Fig. 7 (ERA, 2021).

- All the windows have been replaced with what appear to be modern metal inserts. They're currently in good condition.
- The asphalt shingles on all the roof surfaces and associated perimeter prepainted metal flashings appear to be intact and in serviceable condition in most locations. The gutters and downspouts are continuous and functioning as intended in most locations, although there are isolated locations where the gutters are rusted or damaged and downspouts have become detached. (see Fig. 7).

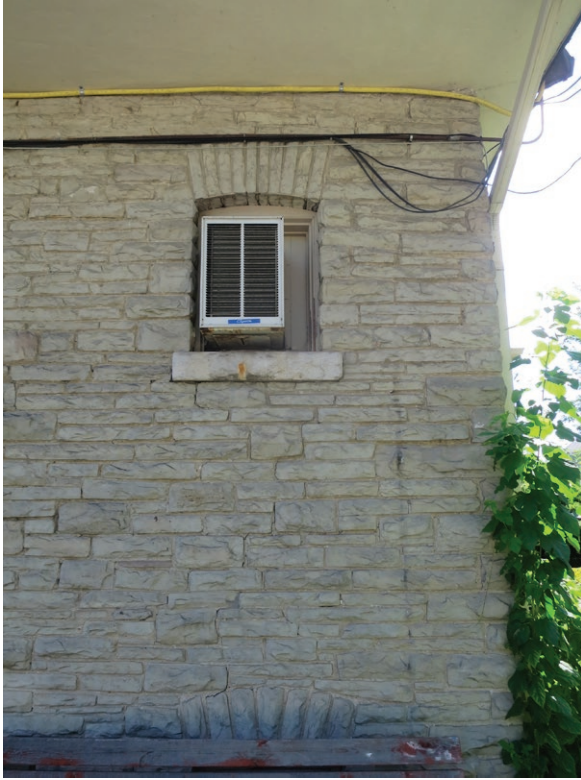
Fig. 8 (ERA, 2021).

- The ground floor and chimney masonry details appear to be in fair to good condition in most locations, with isolated locations of step cracks and open mortar joints between the small stone units. The stone window sills appeared to be in good condition (see Fig. 8).

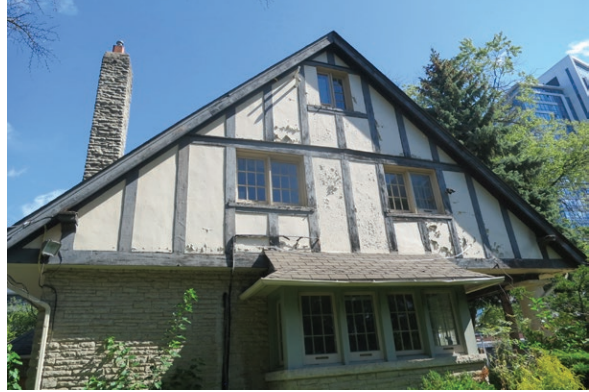
Fig. 9 (ERA, 2021).

- The smooth painted stucco in the east and west upper floor gable ends appears to be in generally good condition with no visible cracks or delamination. However, the paint on the stucco is peeling badly (see Fig. 9).

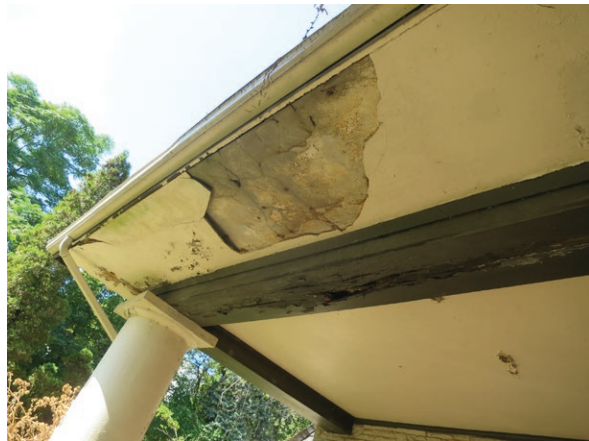
Fig. 10 (ERA, 2021).

- The stucco used for the ceiling of the front porch is in defective condition, and is delaminating from the ceiling areas (see Fig. 10).
- Wood details around the building perimeter are in fair to poor condition in many locations. Wood trim details around the windows and doors, as well as the applied wood half timbering details appear to be in fair condition. Some of the upper storey wood window sills are rotten. The applied faux ceiling beams in the front porch area and the gable end brackets are badly rotten (see Fig. 11 and 12).

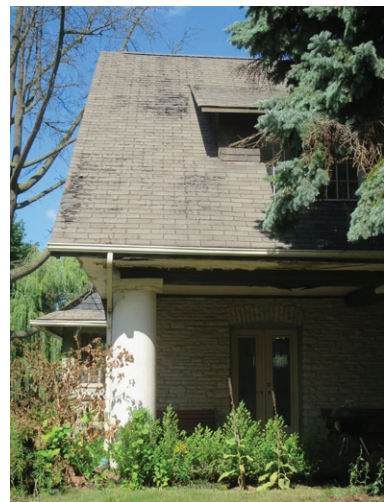
Fig. 13 (ERA, 2021).

- The asphalt shingles and associated perimeter flashings on the roof are in poor condition. The prepainted metal gutters and downspouts are also in poor condition around the building perimeter (see Fig. 13).

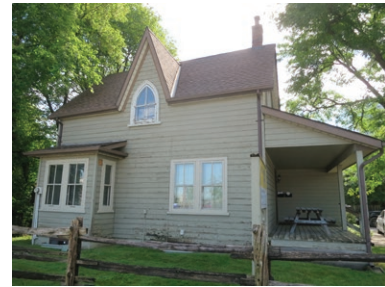
Fig. 14 (ERA, 2021).

- The Dutch lap tongue and groove wood siding appeared to be in fair to good condition in most locations with isolated locations of rot in some siding boards, primarily near grade where frequently subjected to water saturation. The paint on the siding is peeling and flaking in many locations leaving the wood exposed and subject to potential deterioration (see Fig. 14).

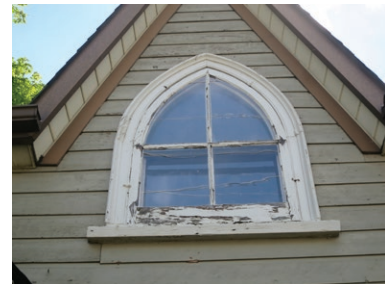
Fig. 15 (ERA, 2021).

- The exterior doors and windows appeared to be generally in fair to good condition in most locations, although at least one upper storey window is nearing poor condition. Most of the windows are covered with exterior wood storm windows, which currently require stripping and repainting (see Fig. 15)

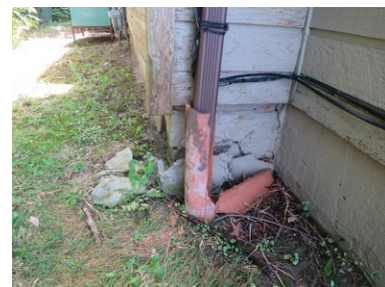
Fig. 16 (ERA, 2021).

- The gutters, downspouts and associated metal flashings appeared to be intact and functioning as intended. There is a broken clay drain tile near the northeast corner which requires replacement. (see Fig. 16)

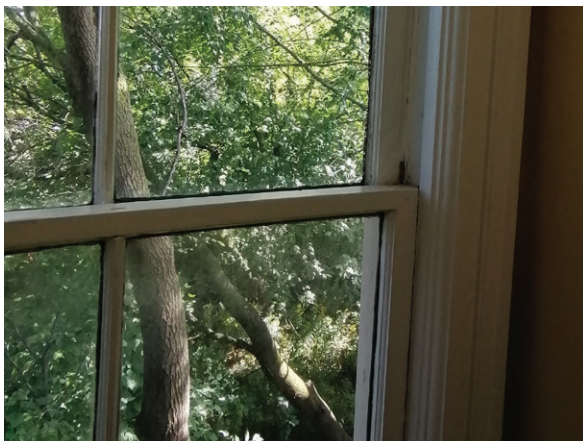
Detail of east elevation second storey window and trim showing cut sash cord (ERA, 2021).

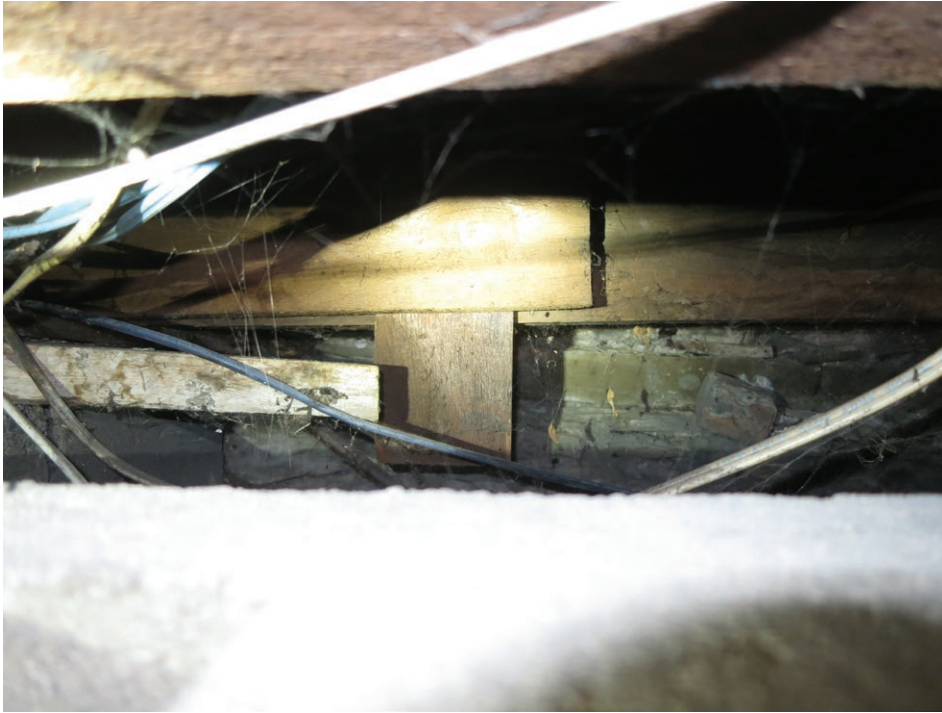
The review showed that the exterior of the basement wall was constructed of rubble stone with cement parging, with the interior constructed of cement block in front of a stone rubble wall. There is also a significant variation in the thickness of the basement walls. Together, this suggests an earlier foundation that was altered or reinforced at a later date. There is no evidence to suggest that the building was not constructed on Site.

Exposed rubble foundation wall (ERA, 2022).

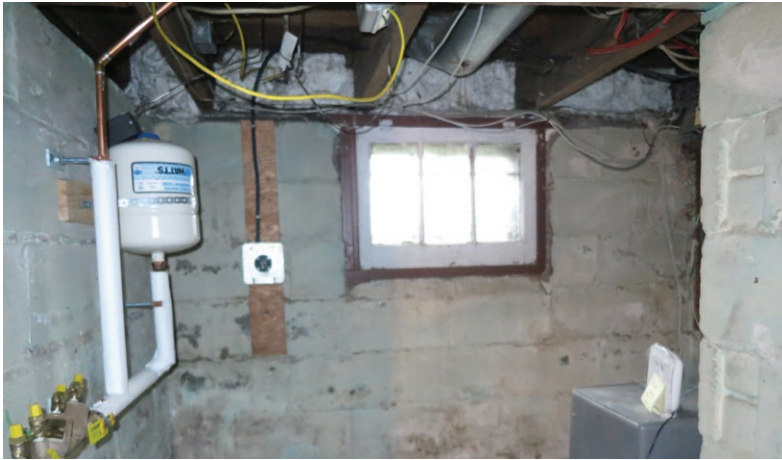
Foundation wall, not thinness compared to previous image (ERA, 2022).

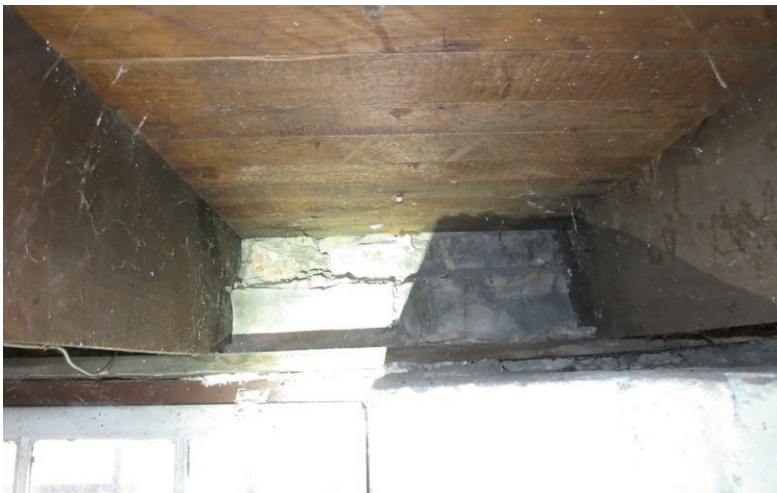
Top of foundation wall (ERA, 2022).
