# Geotechnical Investigation Transit Project Assessment Process (TPAP) for Lakeshore Road – Parts C – Cycling Path/Car Parking (Railway Crossing at Credit River)

Ref. No: GEO22-04-20A

January 27, 2023

Prepared for: HDR Corporation

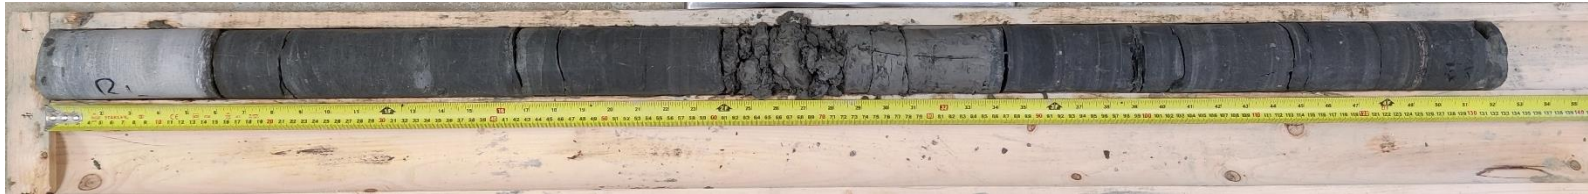
**Rock Core Photo BH-01(Part-C) Run 1**

**Run 1: 47'6" - 51'10" (14.48 – 15.80 m)**

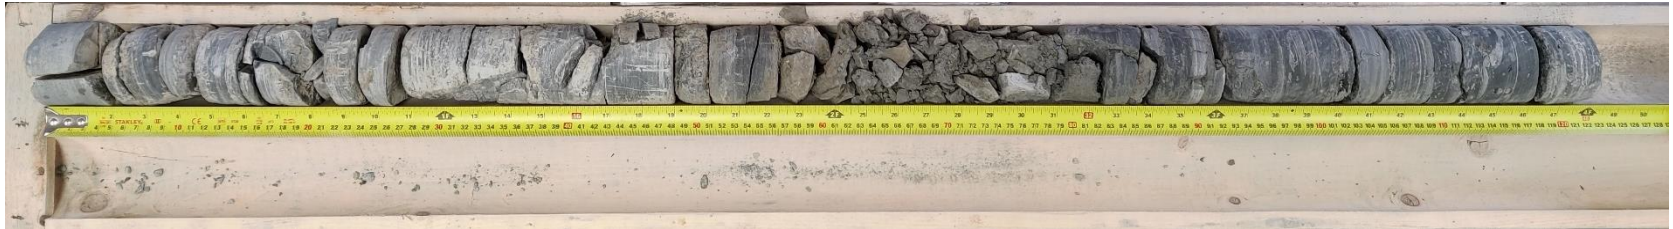
**Rock Core Photo BH-03(Part-C) Run 1**

**Run 1: 28'0" - 32'0" (8.53 – 9.75 m)**

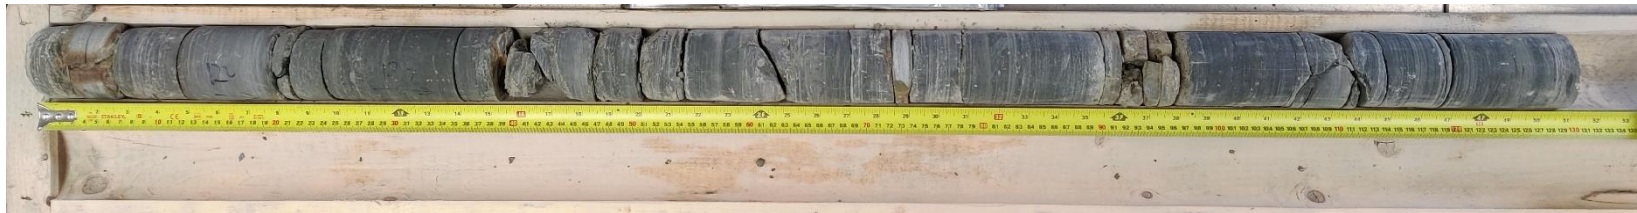
**Rock Core Photo BH-03(Part-C) Run 2**

**Run 2: 32'0" - 36'3" (9.75 – 11.05 m)**

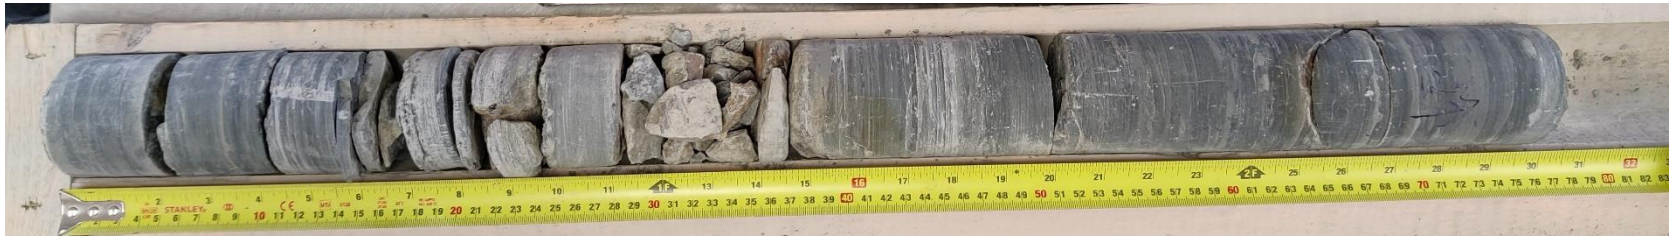
**Rock Core Photo BH-03(Part-C) Run 3**

**Run 3: 36'3" - 38'9" (11.05 – 11.81 m)**

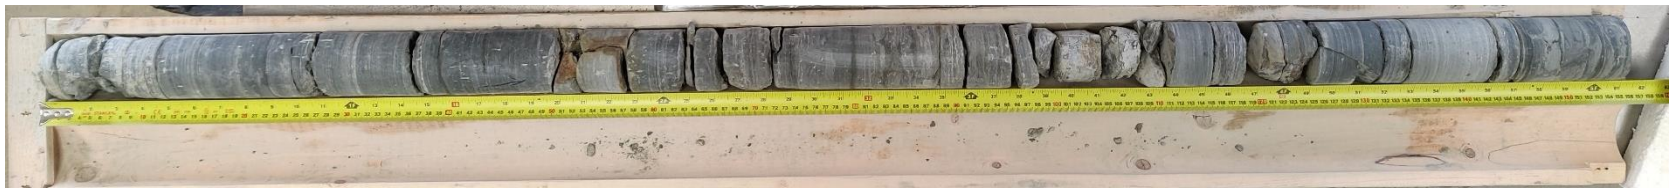
**Rock Core Photo BH-03(Part-C) Run 4**

**Run 4: 38'9" - 43'10" (11.81 – 13.36 m)**

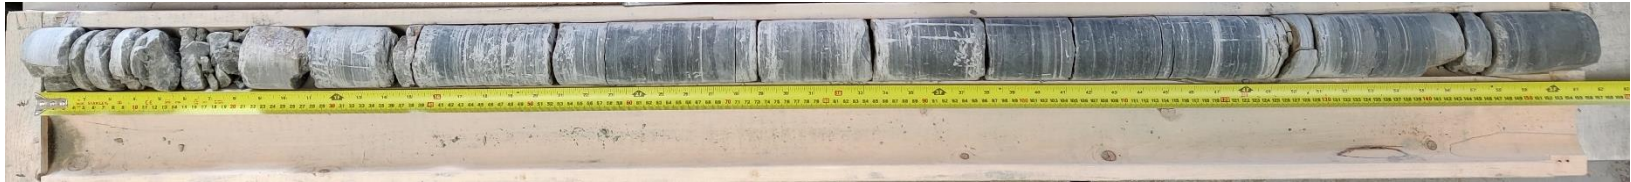
**Rock Core Photo BH-04(Part-C) Run 2**

**Run 2: 35'5" - 40'6" (10.79 – 12.34 m)**

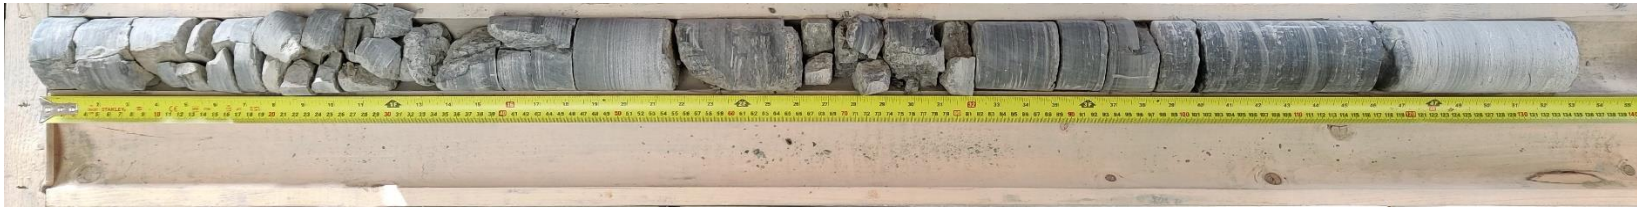
**Rock Core Photo BH-04(Part-C) Run 3**

**Run 3: 40'6" - 44'11" (12.34 – 13.69 m)**
