Re: Preliminary Hydrogeological Assessment
2077, 2087, 2097 and 2105 Royal Windsor Drive, Mississauga, Ontario
Pinchin File: 306354.003

Pinchin Ltd. (Pinchin) has been retained by Slate Asset Management on behalf of CRW 1 LP and CRW 2 LP (Client) to conduct a preliminary hydrogeological assessment for the proposed redevelopment of the properties located at 2077, 2087, 2097 and 2105 Royal Windsor Drive (collectively referred to as the Site), in the City of Mississauga (City), Ontario.

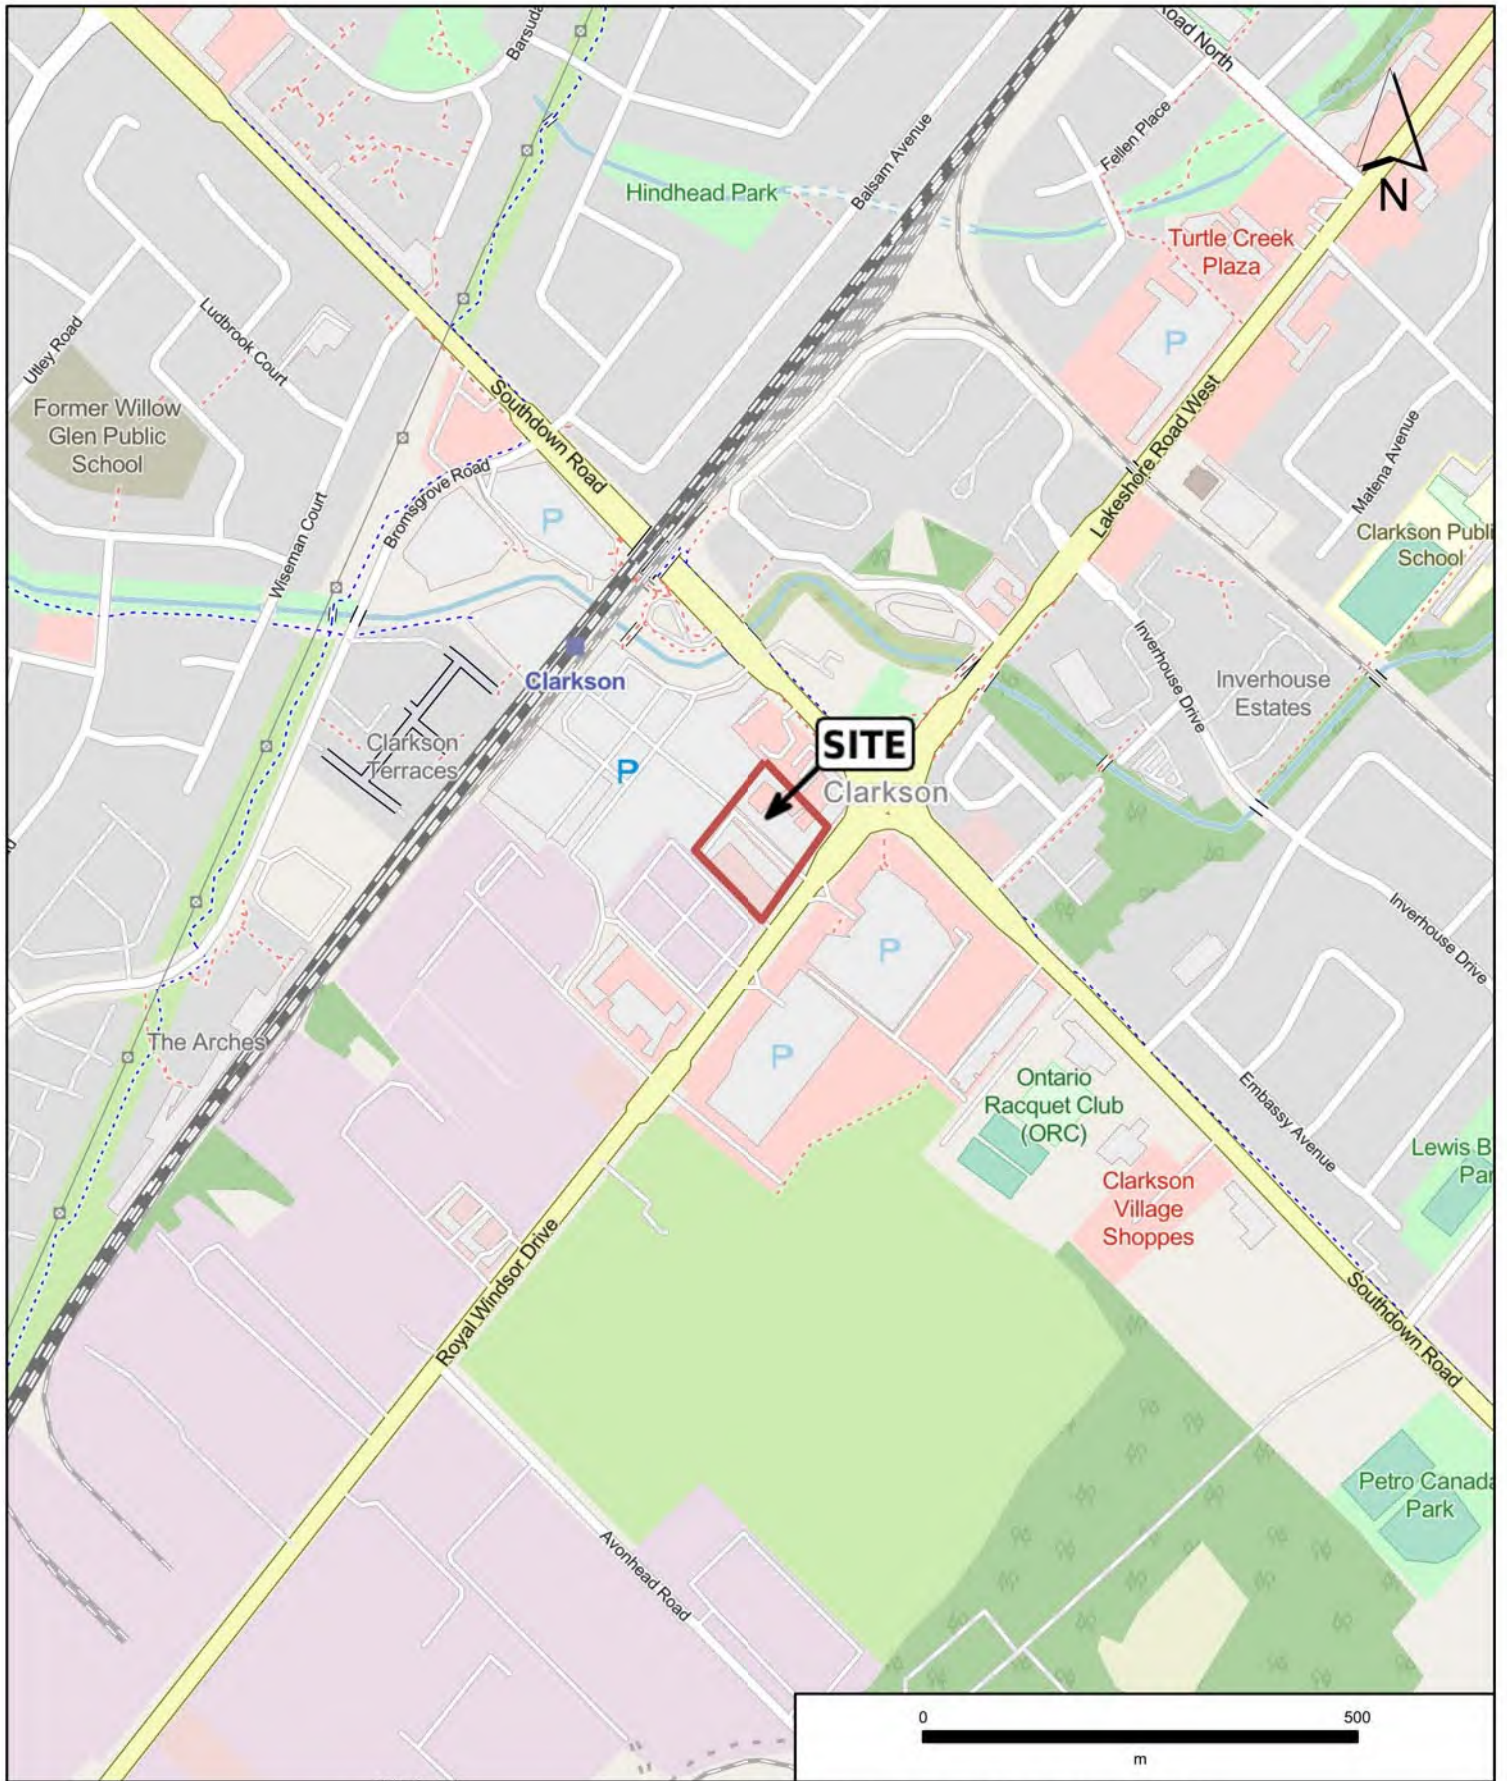
The Site is located on the northwest side of Royal Windsor Drive, approximately 50 m southwest of the intersection of Royal Windsor Drive and Southdown Road, in Mississauga. The approximate site location is shown on Figures 1 and 2.

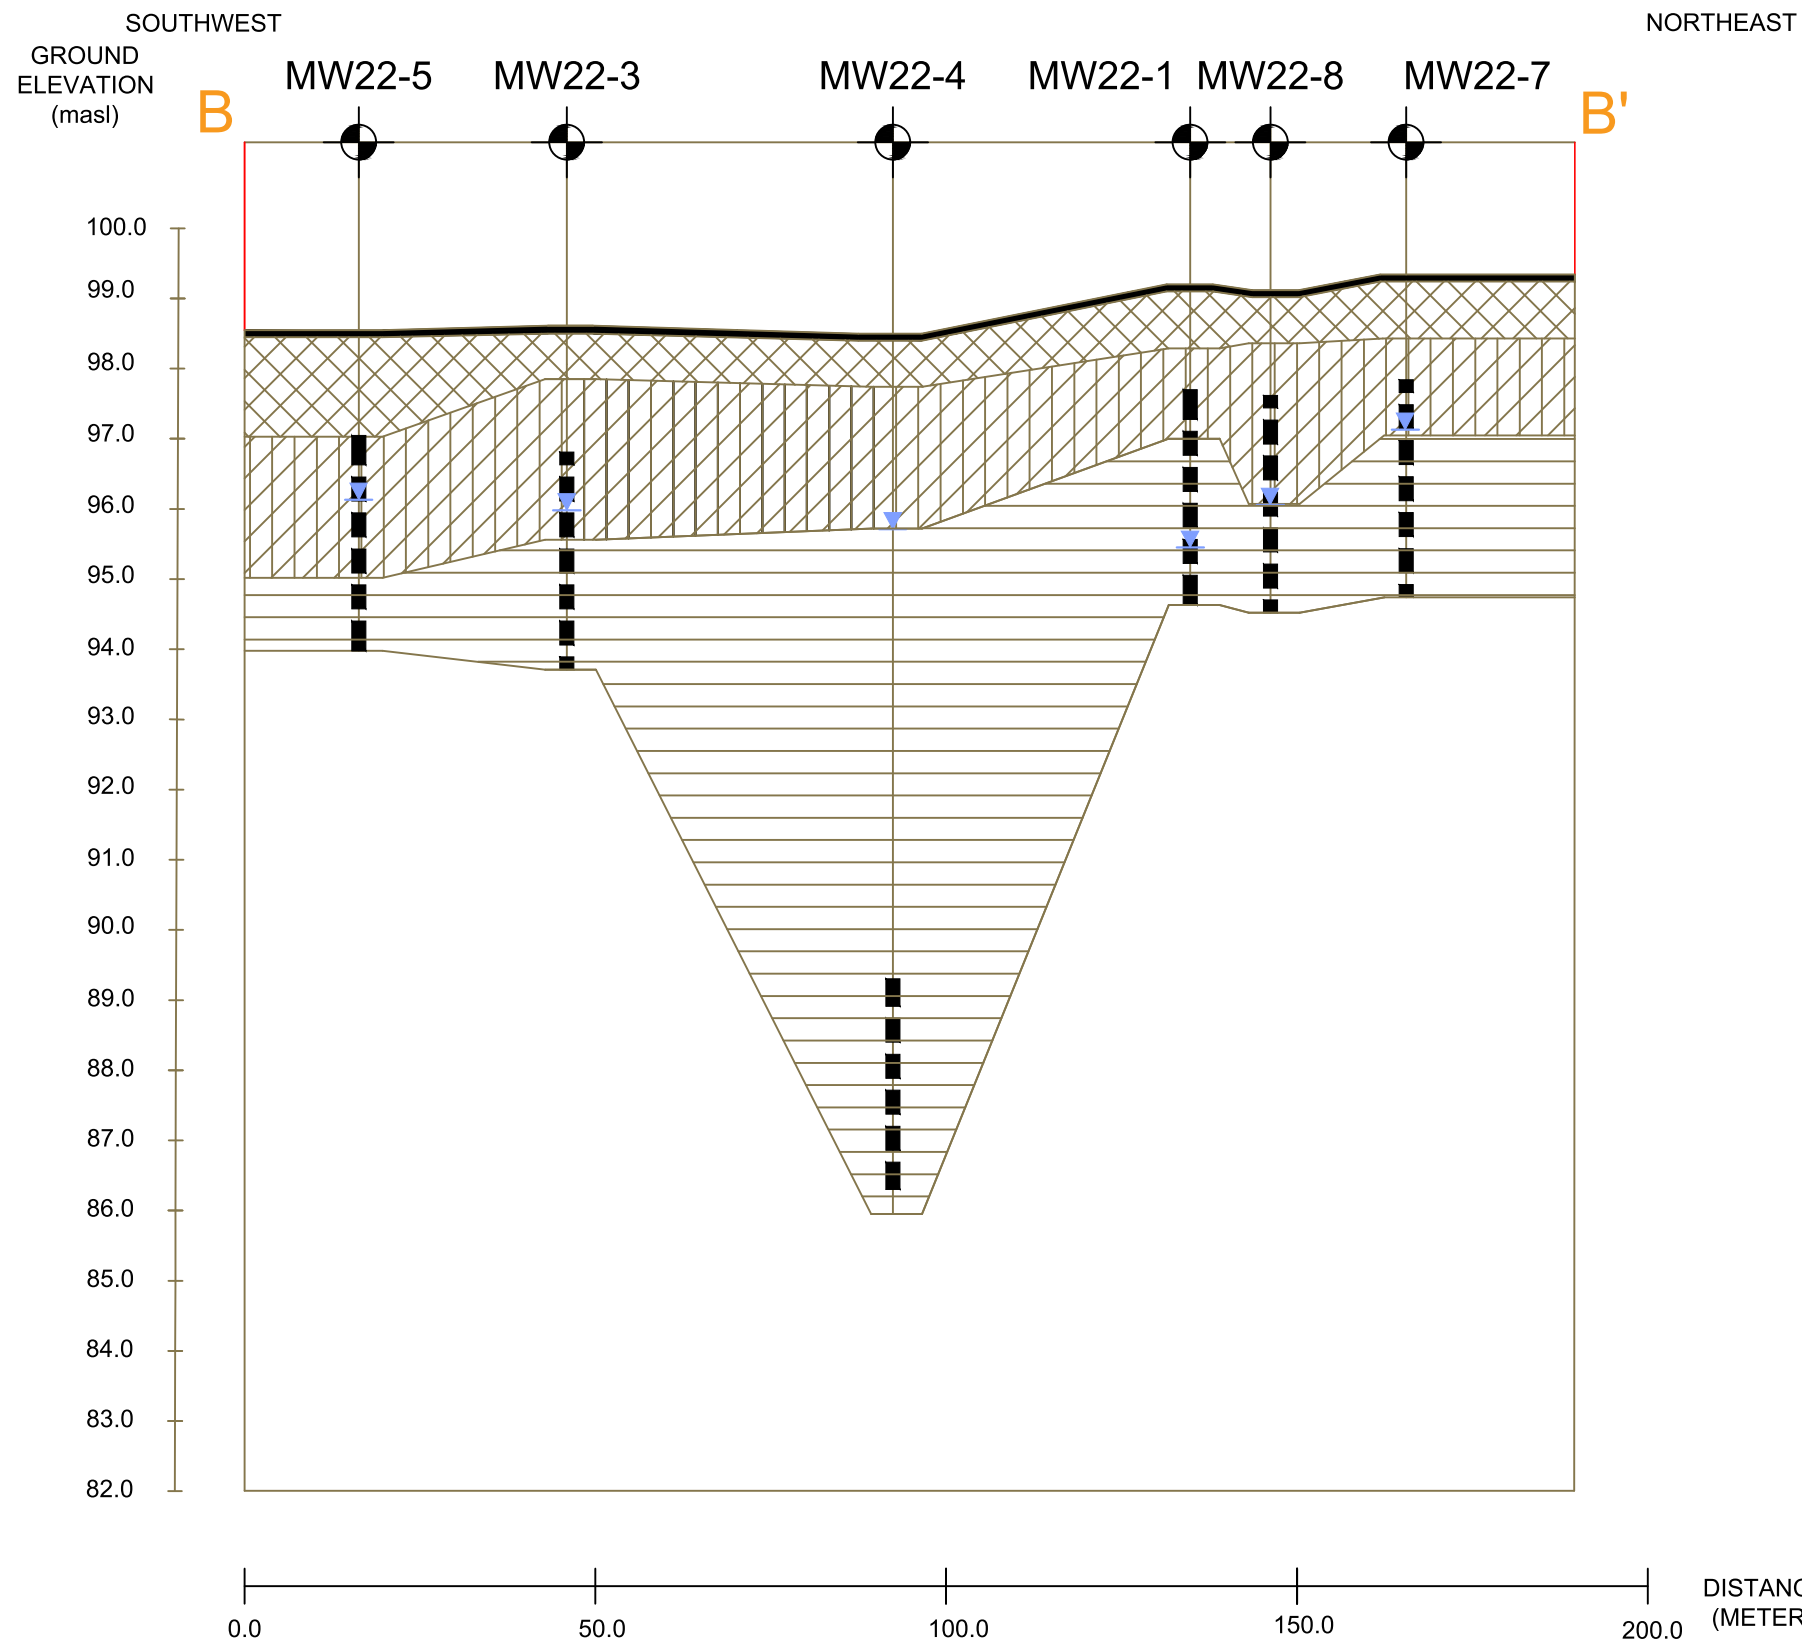
PROJECT NUMBER: 306354.003	SCALE: AS SHOWN
DRAWN BY: KM	REVIEWED BY: BG
DATE: OCT. 2022	FIGURE NUMBER: 4B

- LEGEND**
- SITE BOUNDARY
 - A — A' CROSS SECTION LINE
 - MONITORING WELL
 - ASPHALT
 - FILL
 - CLAYEY SILT
 - SHALE
 - WELL CASING/ BENTONITE
 - MEASURED GROUNDWATER ELEVATION (AUGUST 15, 2022)
 - WELL SCREEN

FIGURE NAME:
CROSS SECTION B-B'

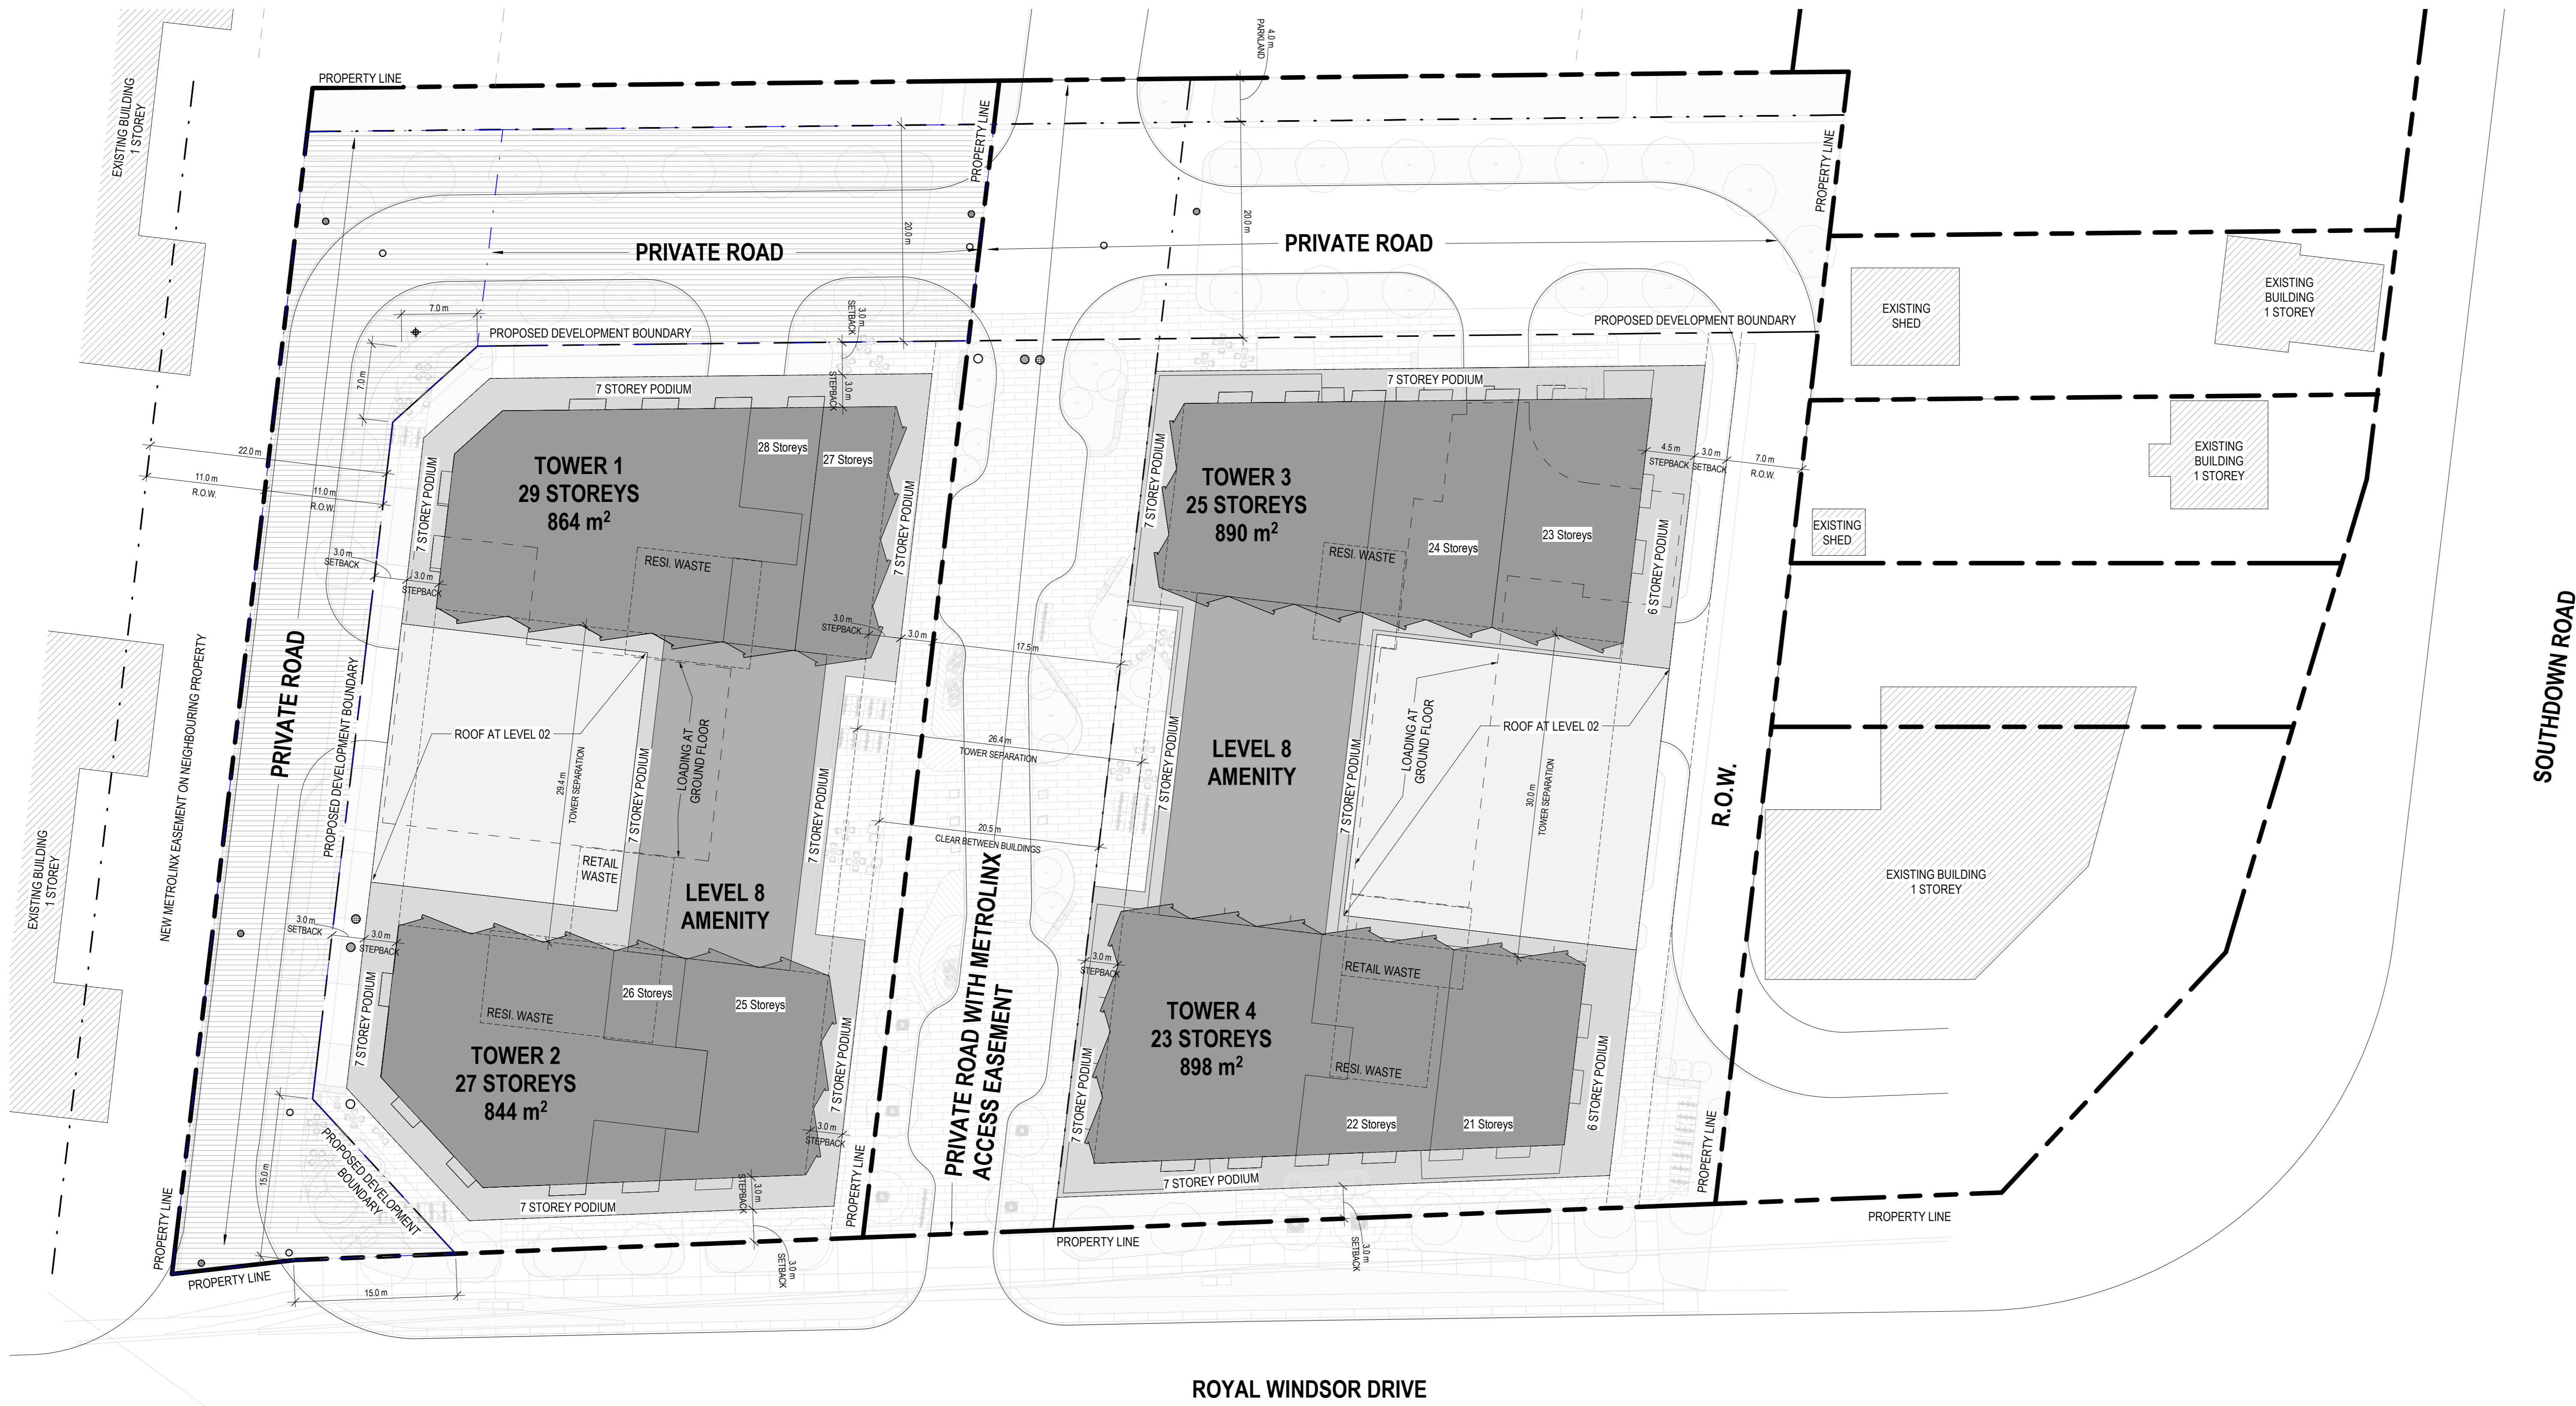
01 SITE PLAN

The proposed development consists of four tower buildings (23-, 25-, 27- and 29-storey with one additional mechanical level on the top), new private roads, and parkland/landscape open spaces. The development is proposed in two phases:

The site plans for the proposed development, dated December 13, 2022 and prepared by Gensler are provided in Appendix I.
