Schedule B Municipal Class Environmental Assessment Study

Credit River Active Transportation Bridge
Study

Project File Report

City of Mississauga

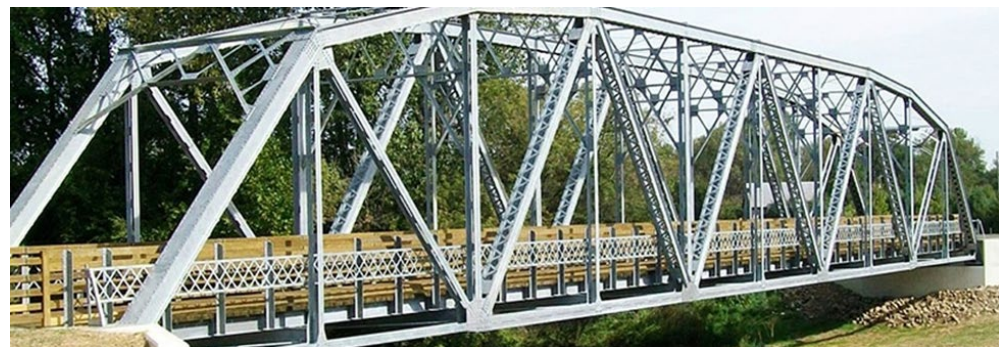
Figure ES- 18 Example of Pedestrian Truss Bridge

See Figure ES- 18 and Figure ES- 19 for examples of a Prefabricated Truss Bridge and a Signature Tied Arch Bridge that were included in the short list evaluation.

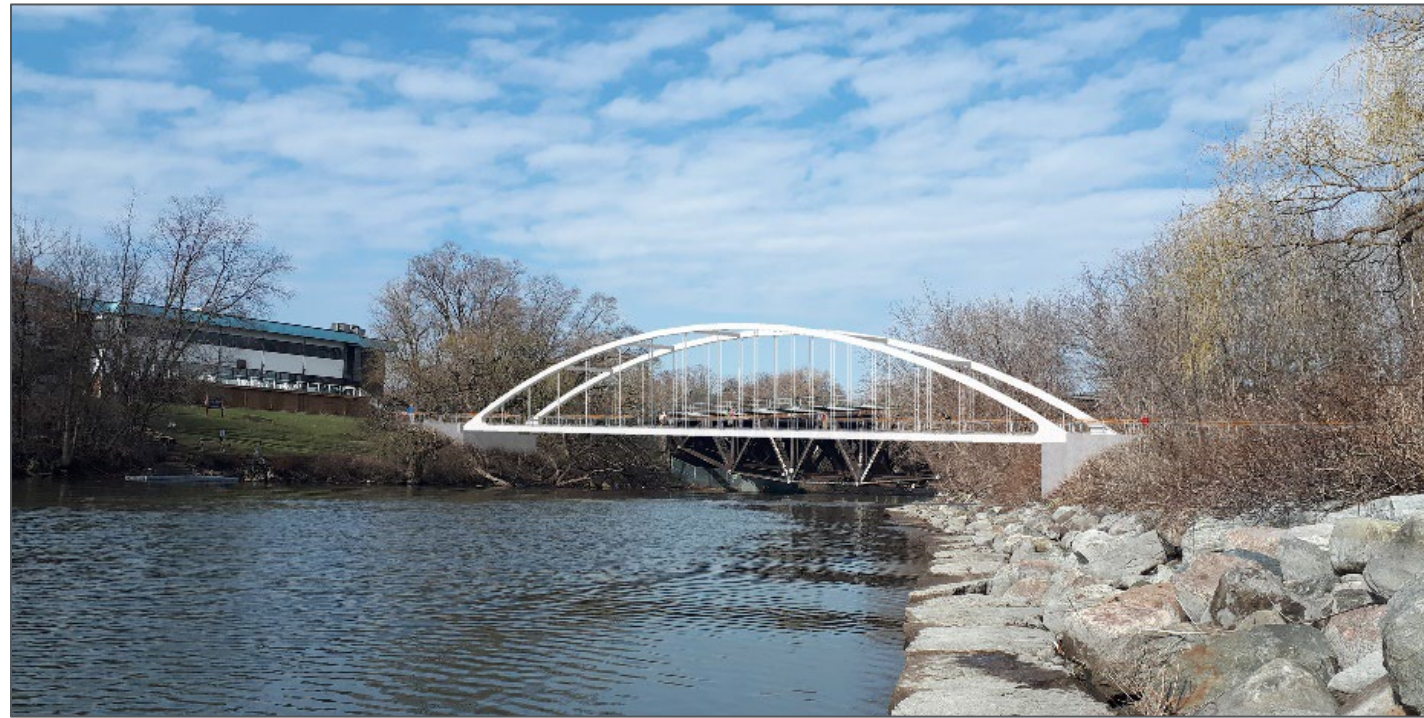
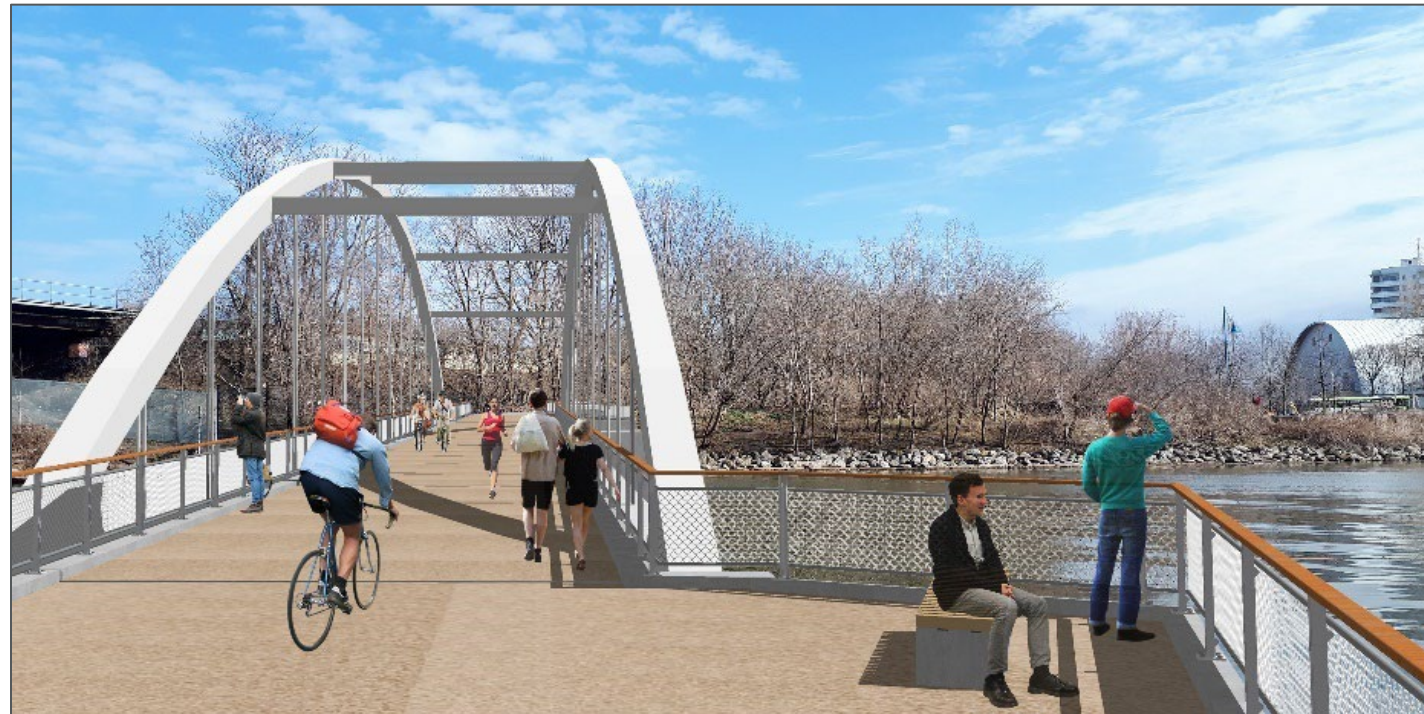
Figure ES- 21 Conceptual Renderings of Above-Deck Arch Bridge

See Figure ES- 21 and Figure ES- 22 for sample renderings of both bridge alternatives.

The above-deck arch bridge features lookout and seating areas on the south side of the bridge and could be designed to accommodate either a multi-use path or separate pedestrian and cyclist lanes. See Figure 4-11 and Figure 4-12 for the sample layout of the above-deck arch bridge.

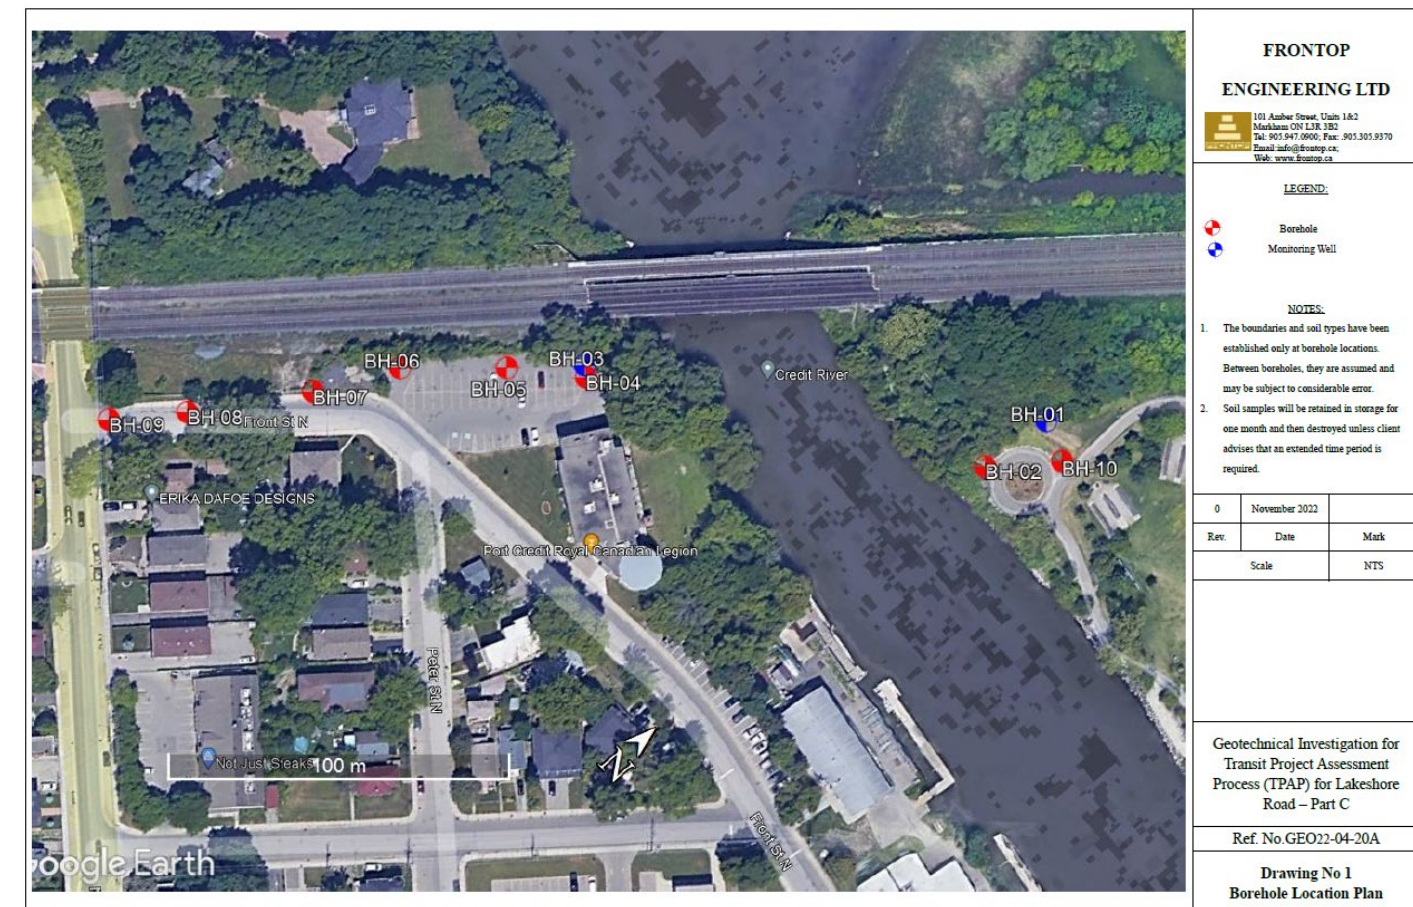
Figure 3-18 Borehole Locations

Asphalt thickness as observed at boreholes ranges from 80 mm to 280mm; granular base thickness ranges from 250mm to 500mm.

As part of the geotechnical investigation, a total of ten (10) boreholes were drilled for the current investigation on both sides of the Railway Crossing at Credit River, Mississauga. Samples were retrieved at regular intervals with a 50 mm O.D. split-barrel sampler driven with a hammer weighing 624 N and dropping 760 mm in accordance with the Standard Penetration Test (SPT) method.

Asphalt thickness as observed at boreholes ranges from 80 mm to 280mm; granular base thickness ranges from 250mm to 500mm. Silty sand and gravelly sand were encountered at two boreholes (BH-01 and BH-02) on the east side of Railway Crossing in the deposit underneath the peat material. Silt was encountered at BH-03 at west side of Railway Crossing deposit underneath the fill material. Silty clay till deposit was found in all boreholes except BH-02.

Two boreholes (BH-03 and BH-04) were drilled on the grass area at west side of Railway Crossing at Credit River and encountered a 150 mm thick topsoil layer at the surface. Fill material was encountered below the topsoil or pavement and consists of sandy silt to silty sand and was generally present in a very loose to compact state. Clayey silt with peat, clayey peat, silty sand with peat were encountered at two boreholes (BH-01 and BH-02) at east side of Railway Crossing. Four (4) boreholes (BH-05 to BH-09) were drilled on the road and car parking surface. BH-07 and BH-10 were drilled on the grass area and encountered a 0 to 100 mm thick topsoil layer at the surface. Fill material was encountered below the pavement structure or topsoil in majority of the boreholes and was heterogeneous and consisted of clayey silt, sandy silt to silty sand and gravelly sand and was generally present in a compact state / soft to stiff consistency. Underneath the fill material, silty sand and sandy silt soil deposits were present.

The grey shale bedrock encountered in all boreholes belongs to Georgian Bay Formation. The assumed shale bedrock surface was found at depths varying from 7.6 to 14.2 m below the existing grade.

At the time of drilling, groundwater was observed in all boreholes except BH03, BH-06 and BH-09. Two (2) monitoring wells were installed within bedrock at all boreholes for the longer-term monitoring of groundwater level.

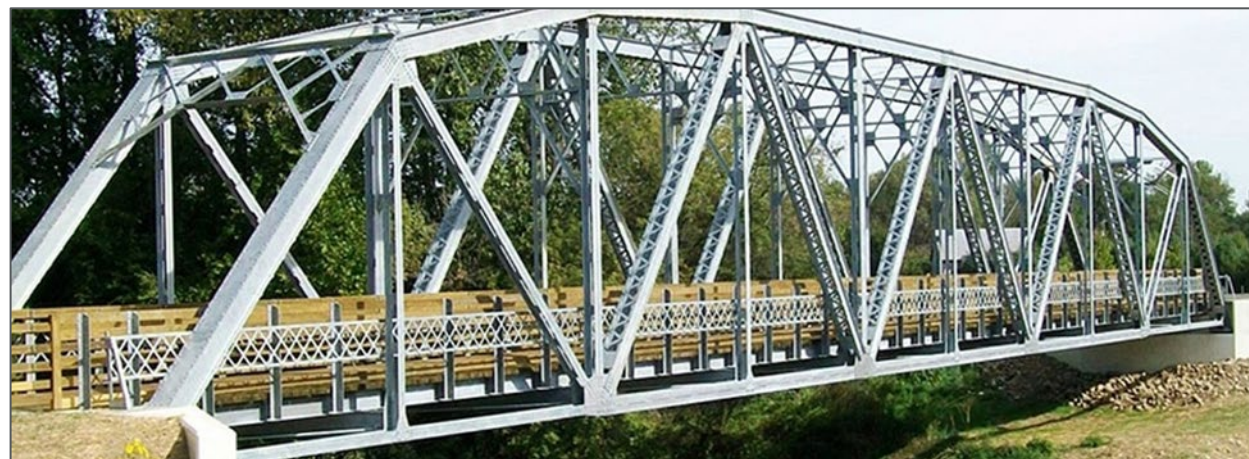
Figure 4-5 Example of Pedestrian Truss Bridge

A Truss Bridge is a common bridge type used for an array of crossings from pedestrian and vehicular bridges, where the load bearing structure is composed of a series of trusses in triangular units. Truss bridges are an economical choice, and are typically prefabricated and pre-designed off-site, and assembled on-site in a relatively short amount of time. See Figure 4-5 for an example of a pedestrian Truss Bridge. See Figure 4-7 and Figure 4-8 for general arrangement drawings of Alignment 1: Alternative 3 (Prefabricated Truss Bridge).

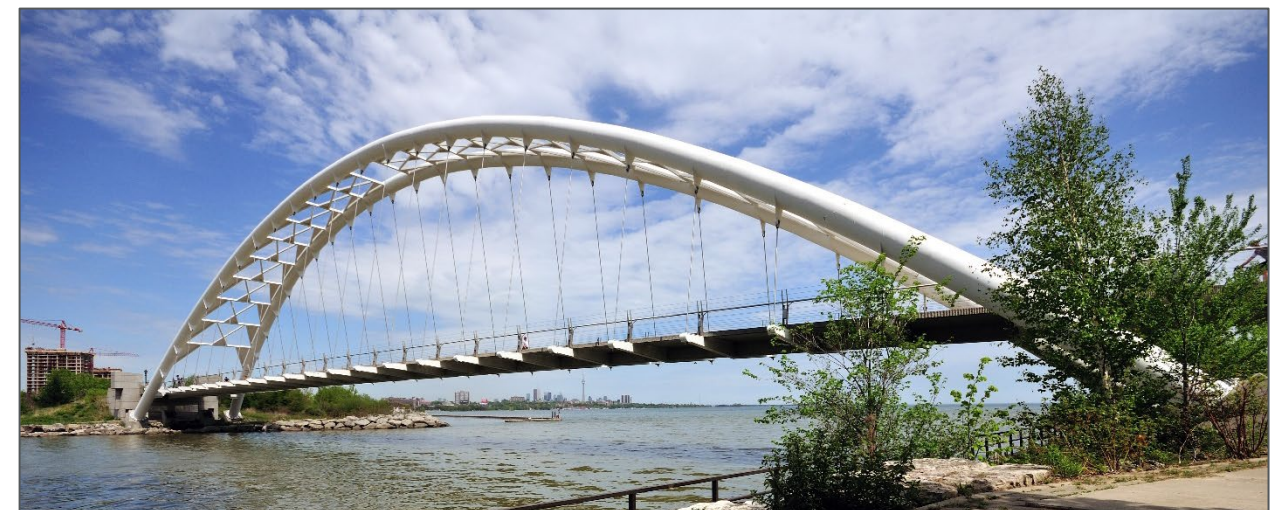
Figure 4-6 Example of Tied-Arch Bridge

A Signature Tied Arch is an arch bridge with inclined hangers where hangers intersect other hangers at least twice. Signature bridges are custom designed to meet context-specific requirements, have more maintenance requirements, and require longer construction durations. Given the bespoke nature of a tied-arch bridge, this alternative will bear a higher cost. The benefit of this alternative is that it has a strong aesthetic quality that provides an opportunity to communicate a unique community identity. See Figure 4-6 for an example of a pedestrian Tied Arch Bridge. See Figure 4-9 and Figure 4-10 for general arrangement drawings of Alignment 1: Alternative 4 (Signature Tied Arch Bridge).

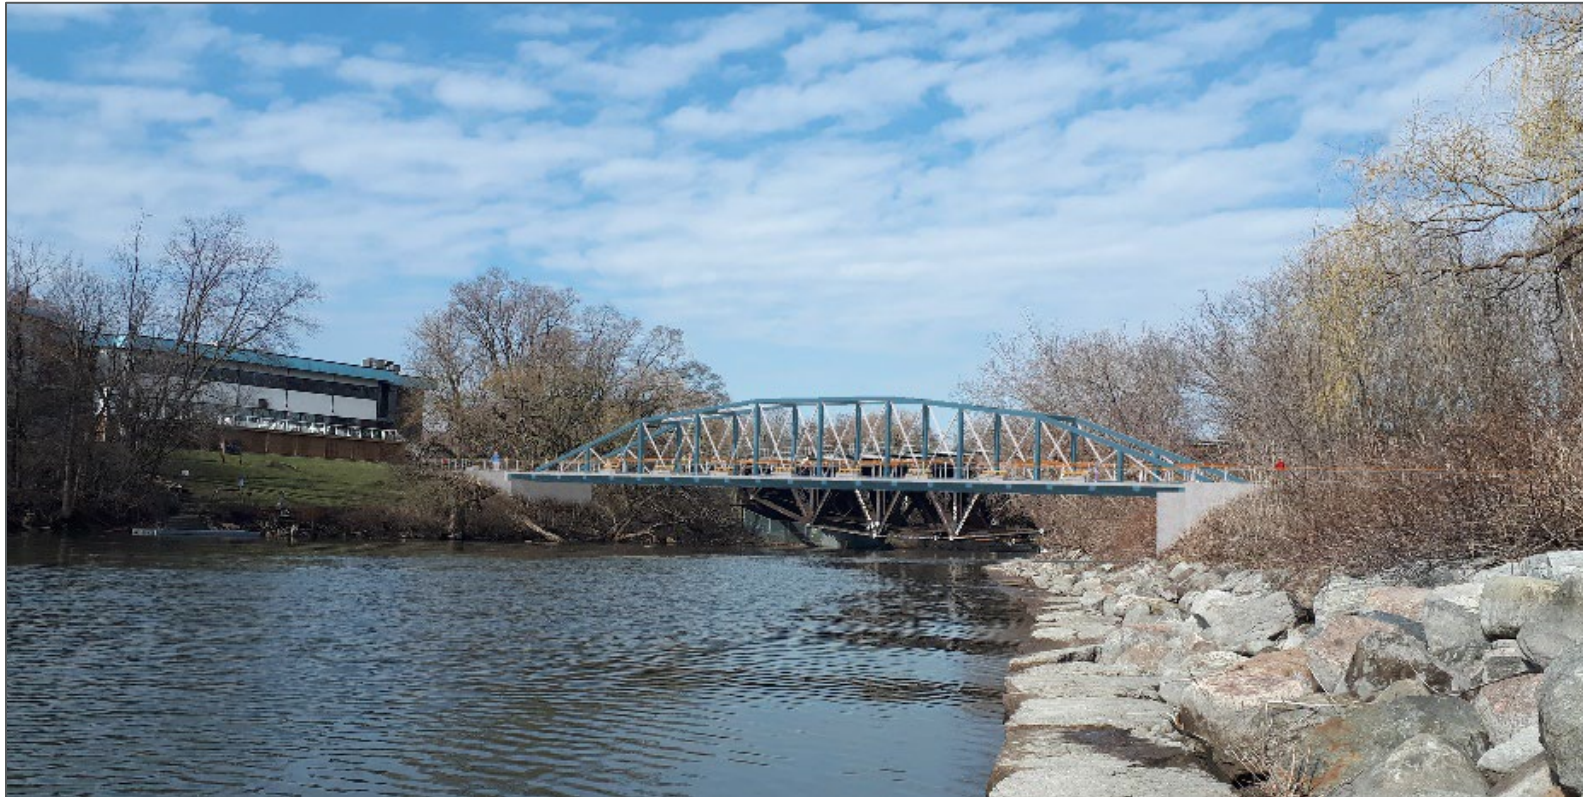
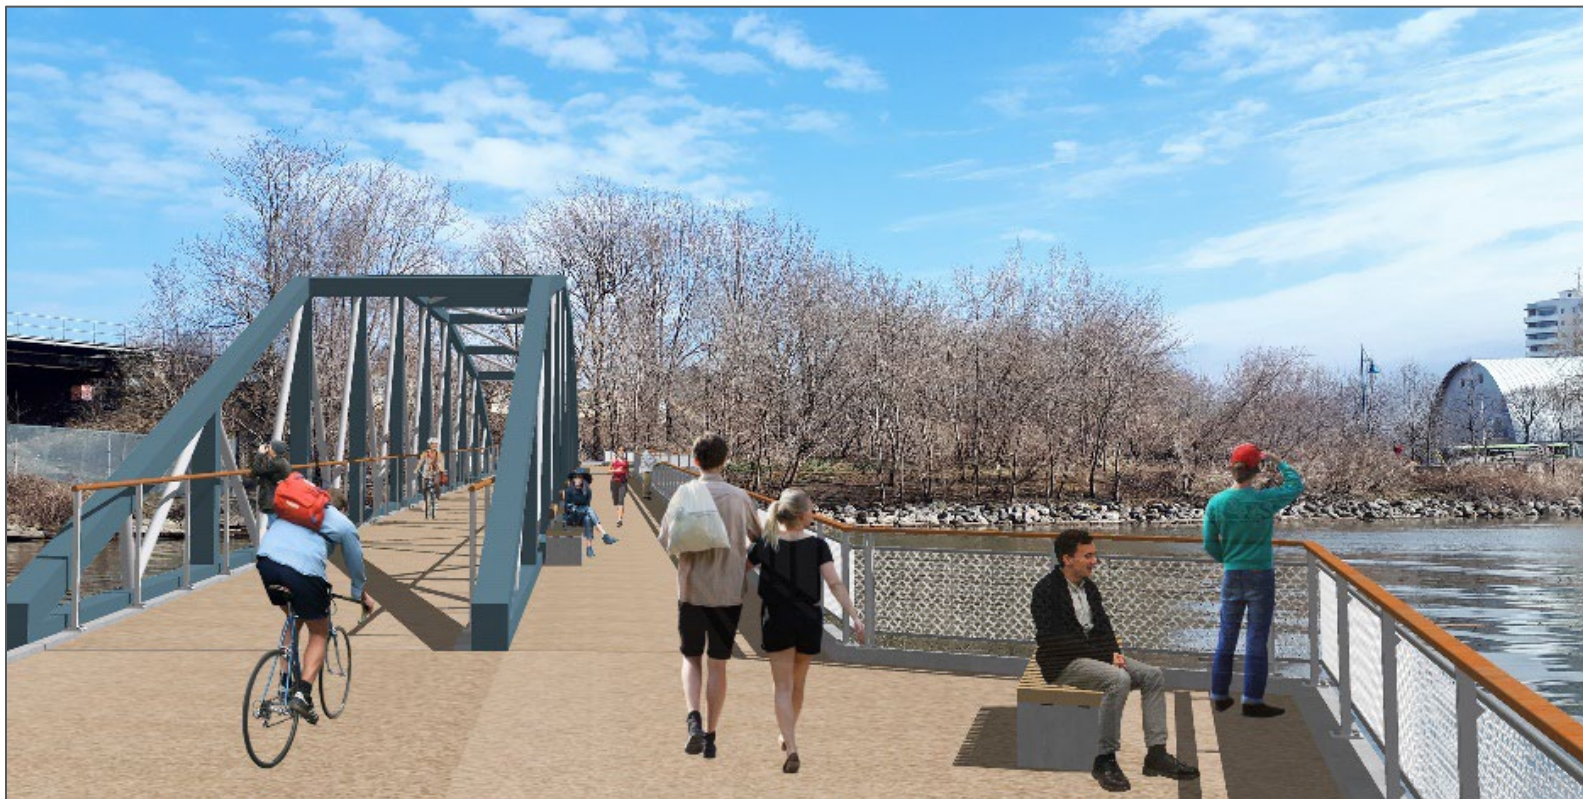
Figure 4-14 Conceptual Renderings of Bowstring Truss Bridge

In addition to the lookout and seating areas on the south side of the bridge similar to the above-deck arch bridge, the bowstring truss bridge also features public seating along the pedestrian walkway throughout the length of the bridge. Under this design, pedestrians and cyclists would be fully separated by a barrier. See Figure 4-13 and Figure 4-14 for the sample layout of the bowstring truss bridge.

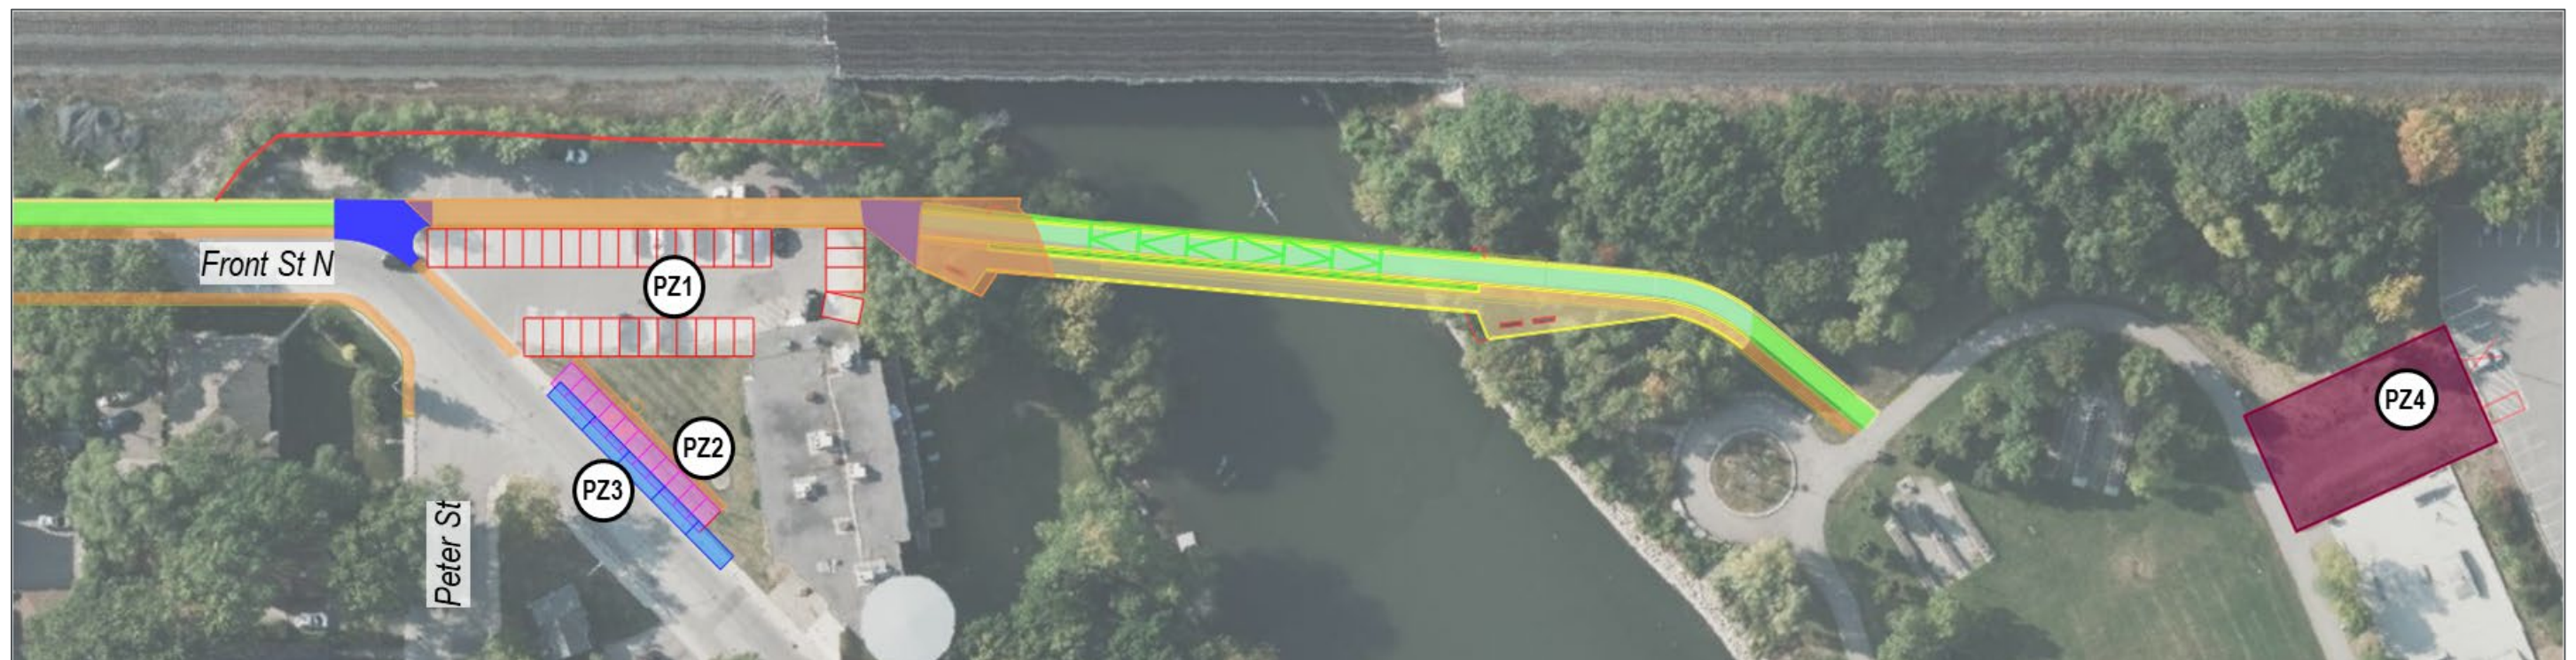
Figure 4-16 Alignment 1A – Parking Compensation Options

Since parking impacts to the Legion continue to remain, Alignment 1A offers the option to provide additional parking spaces in other locations, as shown in Figure 4-16 and in Table 4-6.
